## Investigation report

C1/2011L

# Serious Incident caused by Smoke in the Cockpit North of Pori on 28 November 2011

ATR 72-212A

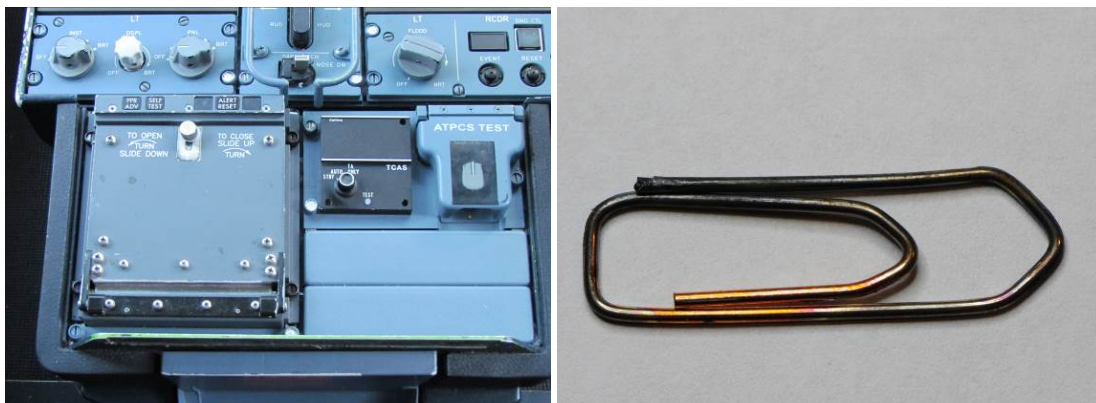
The ACARS system’s thermal printer was damaged. No other damage was caused to the aircraft.

Figure 4. The printer and the paper clip.

The serious incident was caused by a paper clip having fallen into the ACARS printer. An arriving ACARS message activated the printer, at which time the paper clip created a short circuit which resulted in transitory thick smoke generation.

The printer was sent to the repair shop: a new transformer and print head were installed. The device was then tested and found to be operating normally.

The operator's maintenance programme does not specify any requirements for printer cleaning. Nor does the manufacturer require any regular cleaning. All printers in the operator's ATR fleet were inspected and cleaned in 2011. Only dust and other comparable dirt was found. The printers will be re-inspected during the summer of 2013.

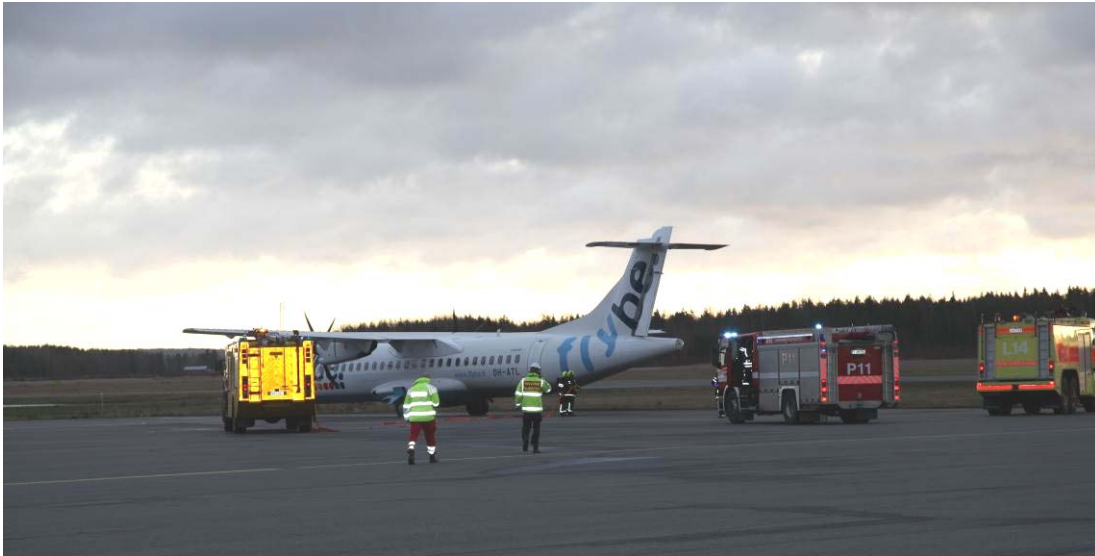
*Figure 5. FCM631W parked at the edge of the apron.  
(Photo: Satakunta Police Department)*

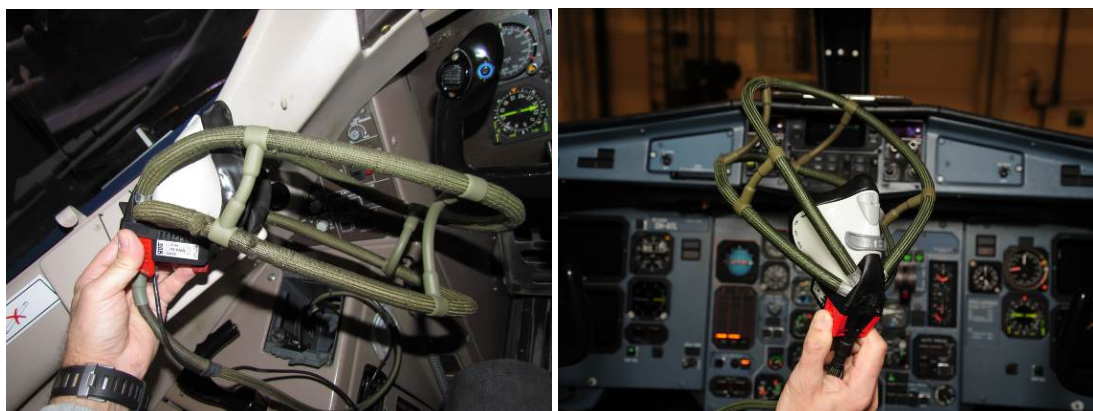
Figure 7. On the left the oxygen mask used in the ATR flight simulator and on the right the oxygen mask used in the aeroplane (OH-ATL). The straps of the oxygen masks used in the simulator had slacked through use.

During the course of the investigation it was discovered that the oxygen masks in the flight simulator are extremely worn. The tubular straps have slacked in the course of

training and they are not in as good condition as those in aeroplanes. The Finnish Transport Safety Agency is responsible for the supervision of flight simulators. The simulator in question was annually inspected as per the FSTD evaluation work order. The order designates the content of simulator inspections carried out by the supervising authority.

*Safety Investigation Authority, Finland recommend that the Finnish Transport Safety Agency ensure that the validation of the oxygen masks' condition during the annual flight simulator inspections be carried out via subjective testing. The condition of oxygen masks used in flight simulators must be equivalent to that of oxygen masks in aircraft.*
