Investigation report

D1/2011L

In-flight fuel leak in a passenger aircraft on 15 January 2011

OH-AFJ

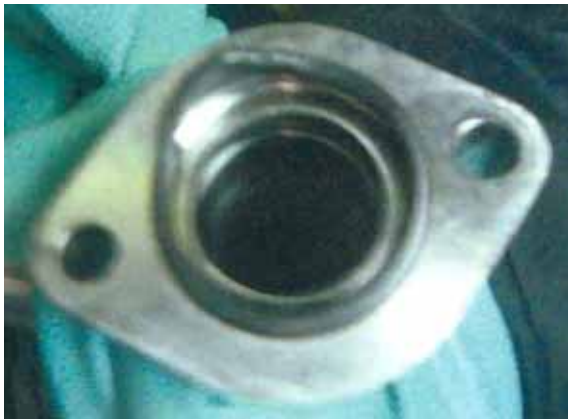
At the airport, the defect was located to a coupling in the fuel tube that leads to the right engine high-pressure fuel pump. An o-ring (Figure 1) used for sealing the coupling had partly bulged out from its groove. A total of about 4100 kg of fuel leaked out through this coupling during the flight.

Figure 1. Damaged o-ring photographed at Charles de Gaulle airport.

The engine manufacturer has established a connection between the manufacturing tolerance of the seal groove and the seal used. It is possible that the fitting of the seal becomes too tight, in which case the seal may be pressed incorrectly against the edge of the groove. The metal surfaces of the flanges will then not settle tightly against each other, even if the bolts of the couplings are tightened to the correct value. Engine vibration and changes in fuel pressure may weaken the incorrectly pressed seal. The failed seal will cause a fuel leak after some time.

installation, the flange mounting bolts must be tightened to the value of 100 lb.in. The coupling from which the fuel leaked with its attachment bolts was relatively well visible. However, it is difficult to find enough space for the torque wrench when tightening the bolts, because several tubes for different engine systems are routed past or under the mounting flange. The investigators consider this maintenance error as a possible cause of the fuel leak.

The third alternative is that a wrong seal had been installed. The investigators do not regard the installation of a wrong part as a likely cause of the fuel leak, but it cannot be fully excluded. The mechanism in which a wrong seal could have caused a fuel leak could not be traced. The maintenance staff that made the defect repair in Paris had discarded the replaced parts, and the installed seal could not be inspected to check the part number or to detect any damage. The documentation of FTS maintenance work was inadequate and could not be used to ascertain the correctness and airworthiness of the part used.

As a corrective action, it had been recorded in the technical log that the seal ring in the fuel tube to the high-pressure fuel pump was found damaged and the seal ring was replaced. The item of instructions used for the replacement was also recorded.⁴ In connection with the defect repair, the maintenance staff had opened another defect, which required right engine run-up for leak check.⁵ As a corrective action, it was recorded that right engine run-up had been performed and no fuel leak was found.⁶ The part number

⁴ Found H.P. fuel tube to H.P. fuel pump seal ring damaged. Seal ring replaced I.A.W. AMM 73-11-03 Fig. 401. – SA-TIS.
