## Investigation report

L2012-01

# Risk of Runway Collision Between Two Airliners at Helsinki-Vantaa Aerodrome on 29 December 2011

YL-RAG, SAAB 340A

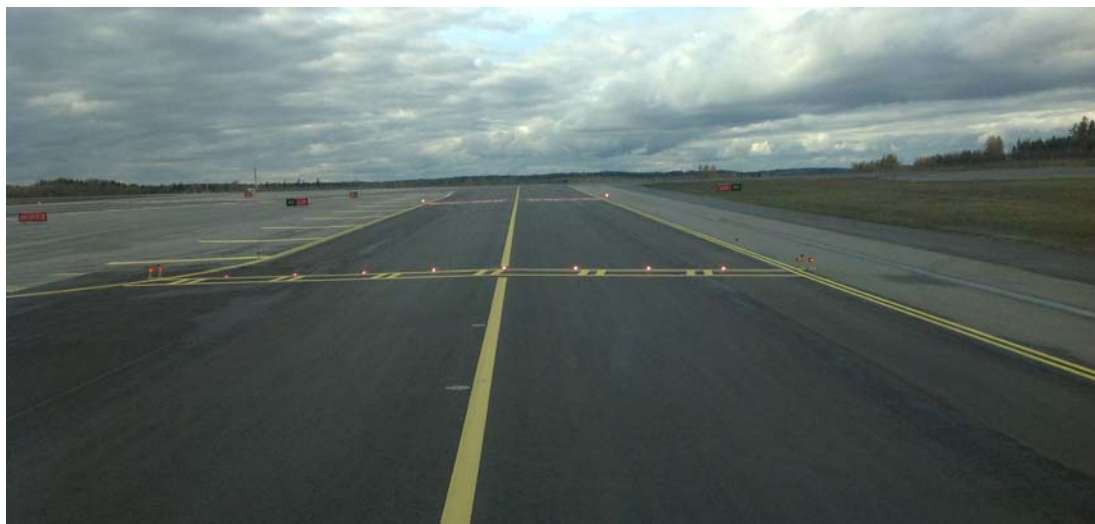
NEF025 decelerated and almost came to a halt at the red stop bar. The stop bar is located at approximately 80 m before holding point WD.

According to the Rules of the Air (OPS M1-1, 3.2.2.7.3) an aircraft taxiing shall stop and hold at all lighted stop bars and may proceed further in accordance with the air traffic control clearance when lights are switched off. As an exception, the air traffic control can permit an aircraft to cross an illuminated stop bar if the stop bar lights cannot be switched off due to a technical malfunction.

Figure 2. The stop bar on taxiway WD.

*Safety Investigation Authority, Finland recommend that the Latvian Civil Aviation Agency ensure that the pilots of RAF-AVIA Airlines are familiar with the procedures related to stop bars.*

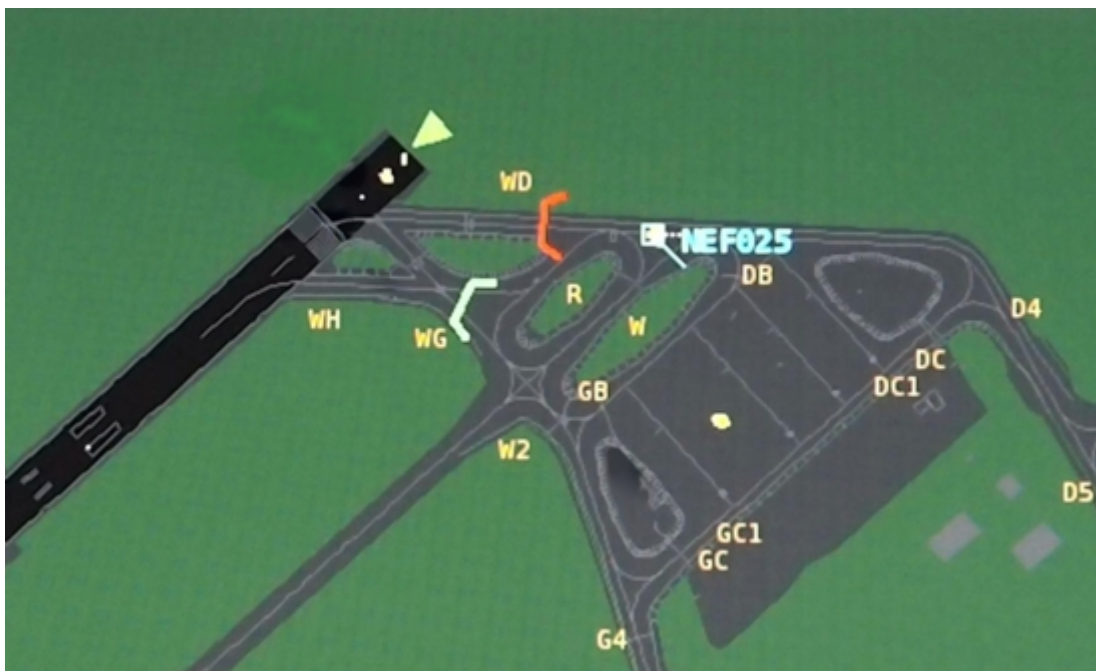
TWR-W was waiting for NEF025's call on its frequency. As this did not happen, at 14:38 the controller switched on the red stop bar lights at holding point WD so as to make certain that NEF025 would not taxi onto RWY 22R. At 14:39 the controller cleared BLF218 to land on RWY 22R.

Figure 3. Surface movement radar picture showing illuminated stop bar.

*Safety Investigation Authority, Finland recommend that Finavia Corporation study the possibilities of introducing a system that alerts air traffic controllers of runway incursions.*
