Investigation report

L2012-05

Forced Landing of an Ultralight Aircraft at Hyvinkää on 26 August 2011

OH-U478

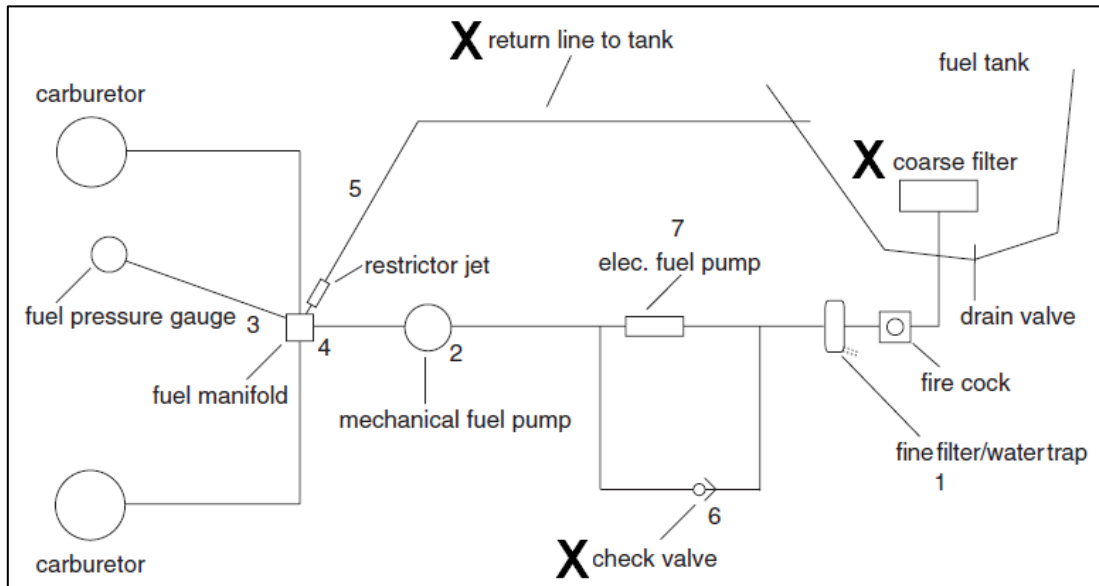
As the fuel system was being inspected it was noticed that there were significant discrepancies between the fuel system itself and the system diagram published by the engine manufacturer. A coarse filter was missing from the end of the line inside the fuel tank. Furthermore, there was no return line to the tank from the fuel manifold for the purpose of eliminating vapour lock, and there was no check valve in the electric fuel pump's bypass line.

The valve had been replaced by a restrictor jet which was 2.3 mm in diameter.

Figure 1. The engine manufacturer's fuel system diagram. The letter X indicates the parts that were missing from OH-U478. All of them are important for the reliable functioning of the fuel system. Source: BRP-Rotax Installation Manual, figure 54.

There were significant discrepancies between the fuel system and the system diagram published by the engine manufacturer. The diagram resembles that of many other type certified aircraft. The three identified differences fundamentally degrade the engine's reliability. The missing coarse filter from the end of the fuel line inside the fuel tank allows large contaminants (leaves, insects, etc.) to enter the fuel line. A restrictor jet which was 2.3 mm in diameter was in the electric fuel pump's bypass line, replacing the diagram-specific check valve. Fuel passed from the supply side to the suction side through the restrictor jet. The pressure was at the minimum permissible level. The third irregularity involved no return line from the fuel manifold for the purpose of eliminating vapour lock. The missing return line possibly contributed to the earlier engine malfunctions during taxiing. The residual heat from the previous flight had vaporised the fuel in the fuel manifold and the mechanical fuel pump. Because of this the fuel level in the carburettors had fallen too low, resulting in engine stoppage. The low power of the fuel pumps, for their

11. There was no check valve in the electric fuel pump's bypass line. It had been replaced with a small-diameter restrictor jet. This construction contributed to the low fuel pressure.

The Safety Investigation Authority, Finland recommends that Deutscher Aero Club e.V. (ultralight aircraft type certificate approval organization in Germany) advises the aircraft manufacturer to comply with the engine manufacturer's instructions and recommendations as regards the construction of fuel systems.

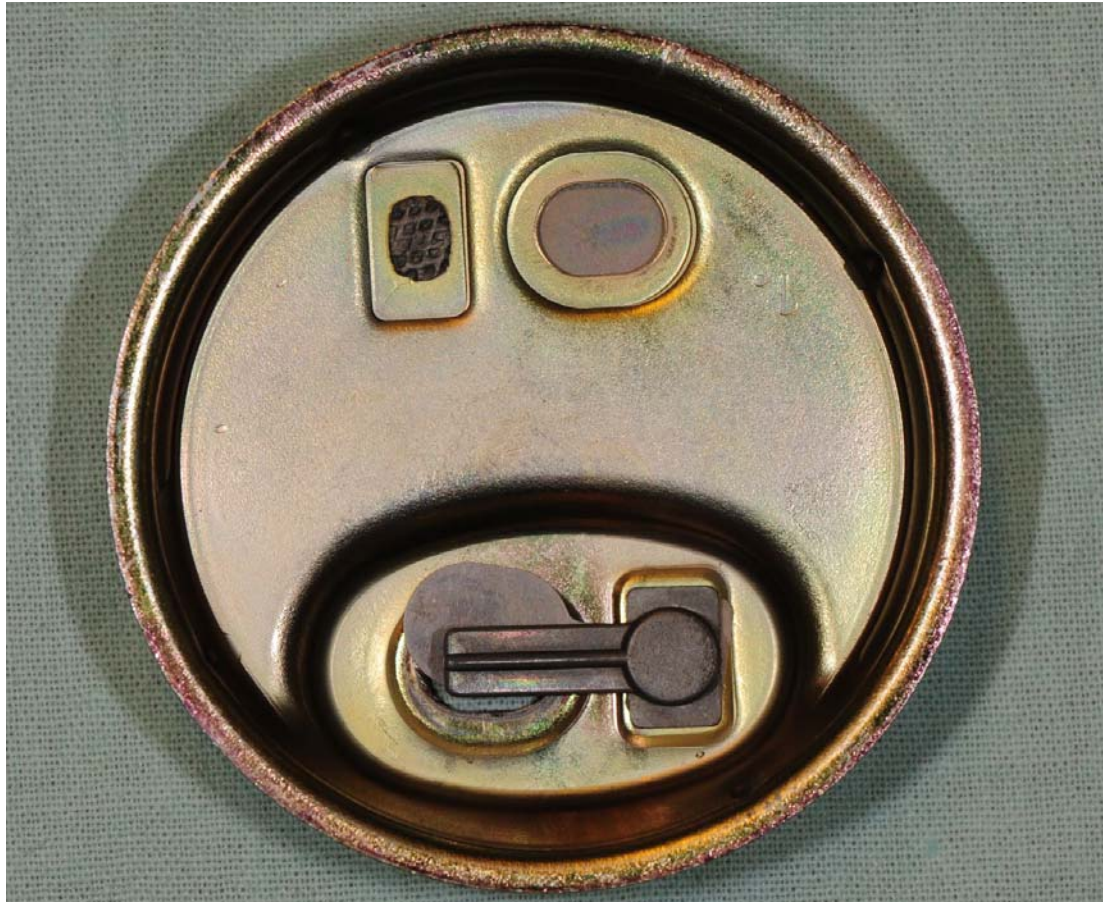
The mechanical fuel pump was opened by force, since it is not designed to be disassembled. Once this was done it was discovered that the suction valve cover was slightly off of its correct position over the intake port. As a result, the pump did not generate pressure. Sideways scoring was visible on the valve cover, which indicated that the pump had periodically functioned normally and periodically operated either partially or not at all. Because the fastening of the valve cover was loose the valve could turn in a sideways direction. The running time of the pump was the same as that of the engine.

Figure 2. Suction valve cover turned slightly off of its correct position.

The suction valve of the mechanical pump was damaged to such an extent that its bypass had greatly varied. The more the valve was in the open position the more fuel would return to the suction side, thereby supplying less fuel to the carburettors. If the electric fuel pump is switched on it should be able to transfer fuel to the carburettors through the mechanical fuel pump. This, however, requires sufficient electric fuel pump pressure. In this particular fault the mechanical pump moved fuel towards the electric fuel pump because the pressure of the electric fuel pump was only one half or so of the pressure generated by the mechanical pump. The lack of power was caused by a missing check valve on the electric fuel pump's bypass line. The check valve had been replaced by a 2.3 mm restrictor jet. When the electric fuel pump's bypass line was blocked using hose clamp pliers, pressure in the electric fuel pump's bypass line rose to the level of the mechanical pump.

The engine stoppage was caused by the mechanical fuel pump's damaged suction valve and the subsequent fuel feed failure. Low fuel pressure in the electric fuel pump was a contributing factor.

During the investigation BRP-Powertrain (Rotax) published a line maintenance manual (ver. 3 /1.9.2012), where replacement of the fuel pump is mandatory in every 5 years.

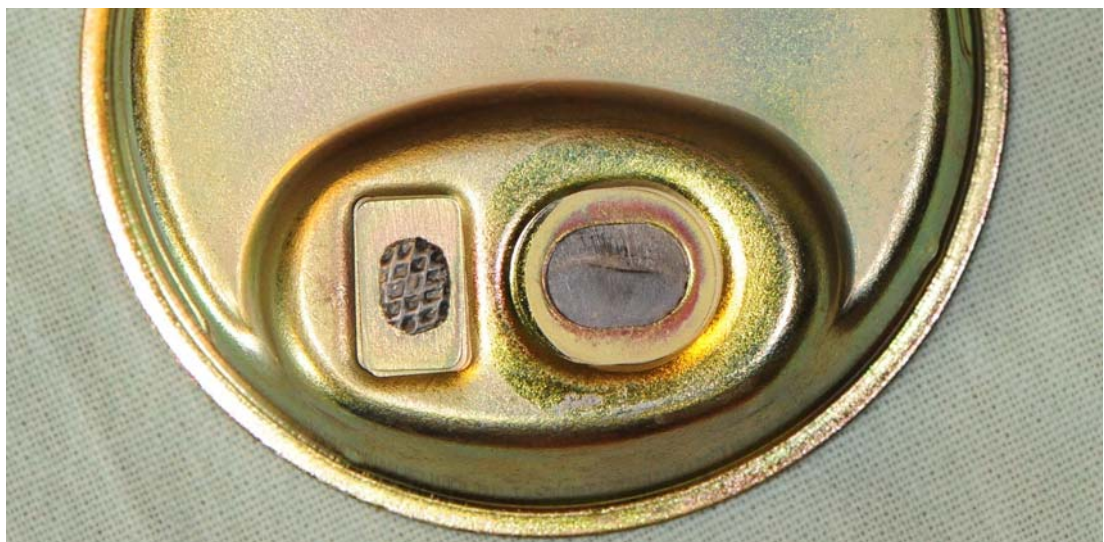
over the intake port. Hence, the pump was not generating pressure. Sideways scoring was visible on the valve cover which indicated that the pump had periodically functioned normally and periodically operated either partially or not at all.

Figure 3. Sideways wear grooves are clearly discernible on the valve cover. Judging by the scoring the cover had constantly been moving between the fully closed and a half open position.
