Investigation report

L2014-01

Experimental Aircraft Accident and Risk of Explosion at Nummela Aerodrome on 27 March, 2014

OH-XAC

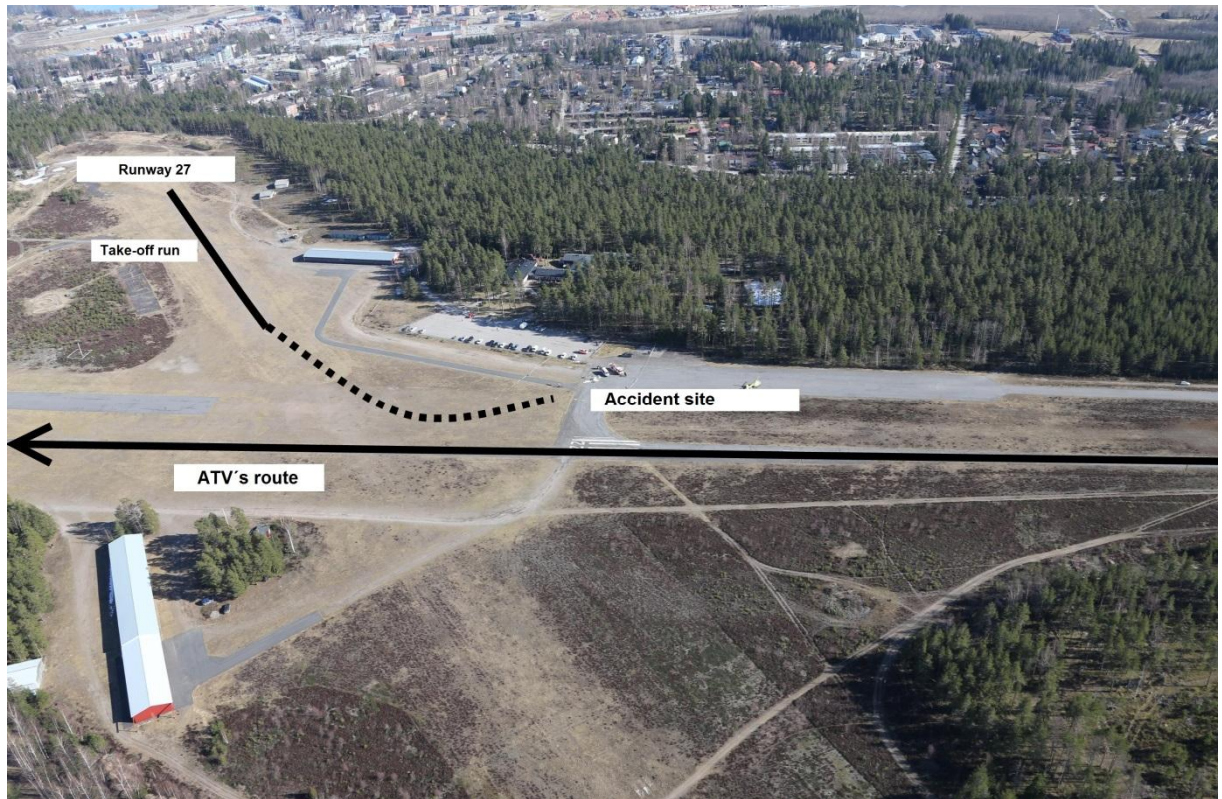
Figure 1. The grass-surface cross runway 09/27 at Nummela aerodrome, viewed from the west. The accident site, where the wreckage and rescue vehicles can be seen, is in the centre of the photo. The black dotted line represents the flight path of the aircraft, drawn as per eyewitness accounts. (Photo: Finnish Border Guard)

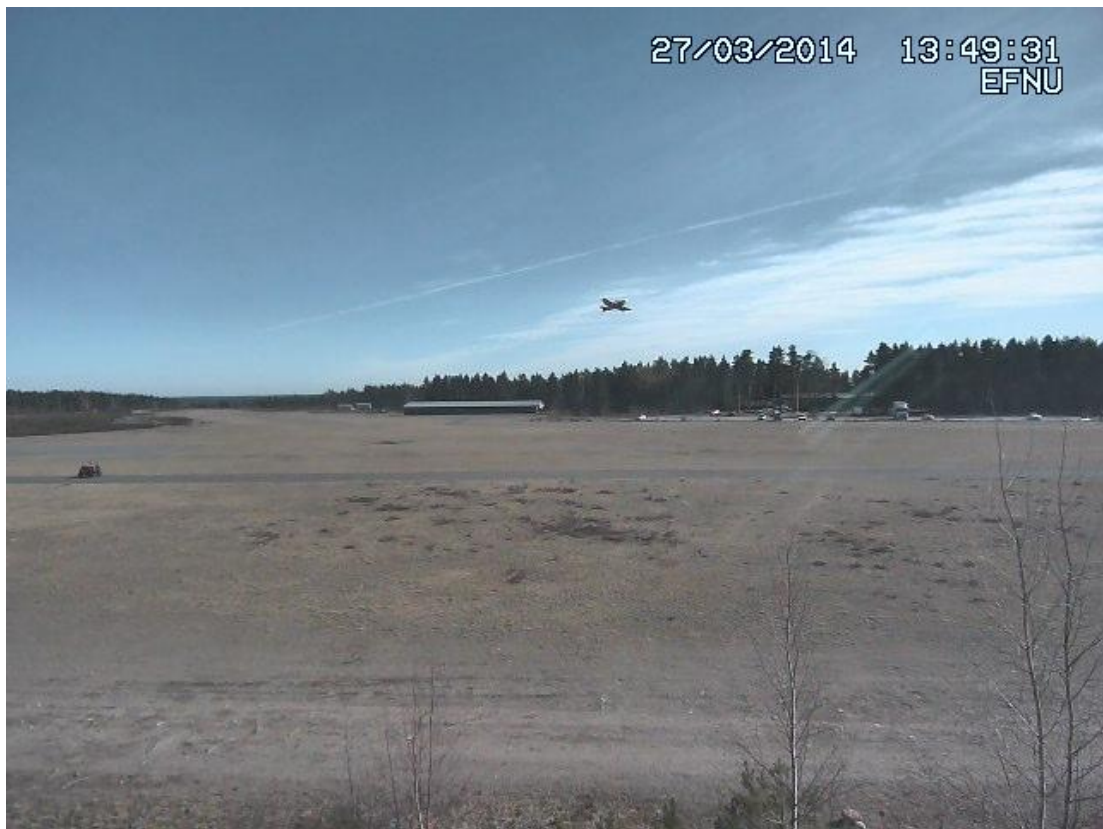
Figure 2. OH-XAC on the accident flight immediately after takeoff at the onset of the turn, only seconds before the accident. The all-terrain vehicle at the left is the ATV used by paragliders. A moment before the photo was taken the ATV crossed the runway (Photo: Nummela flight centre webcam).

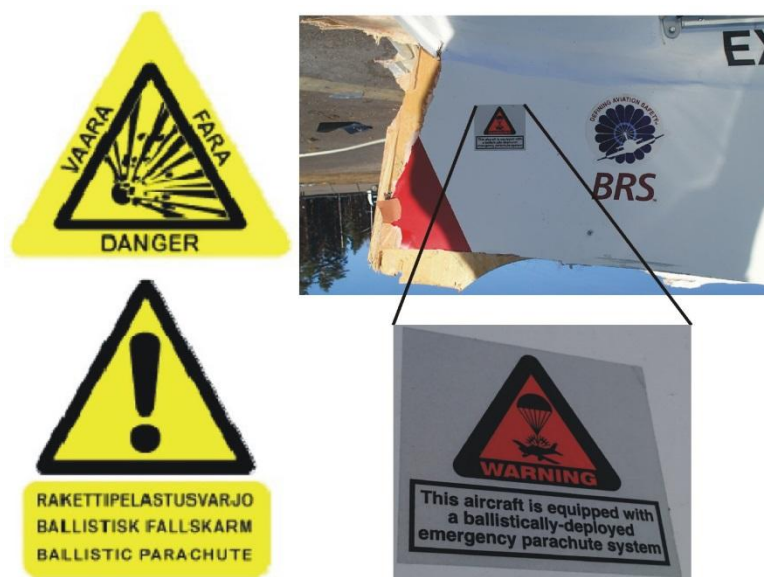
Although an airworthiness inspection was carried out on the aircraft prior to the commencement of the test flights, the markings that warn of the presence of a pyrotechnical system did not comply with Airworthiness Directive M/3102/06.

Figure 4. There is a BRS system warning decal, approximately 50 mm wide, on the right side of OH-XAC. On the left side there is a warning decal which complies with directive M3102/06, requiring a 120 mm wide decal. There was no marking on the accident aircraft which indicated the location of the rocket motor assembly. (Photos: SIAF and Finnish Transport Safety Agency).

The accident aircraft only displayed the manufacturer's decals warning of the presence of the system; they did not guide the rescuers to operate in such a fashion that the hazard would have been taken into consideration. Although the airworthiness inspection had been completed prior to the start of the test flight programme, the markings did not comply with Airworthiness Directive M3102/06.

The markings that comply with Finnish requirements are larger than those on the accident aircraft. They also indicate the hazard more clearly. For example, they would have made it possible to identify the loose suspension lines of the parachute or the activation handle inside the wreckage. However, this would have required training. Generally speaking, it is difficult to recognise the presence of pyrotechnical system in an aircraft or identify its parts because so many variations exist. Moreover, warning markings and practices are not internationally standardised.

Safety Investigation Authority, Finland recommends that the European Aviation Safety Agency (EASA) standardise the warning markings for pyrotechnical systems.
