Nose landing gear malfunction in aircraft OH-BEX at Helsinki-Vantaa airport on 26 August 2015

Investigation number: L2015-02

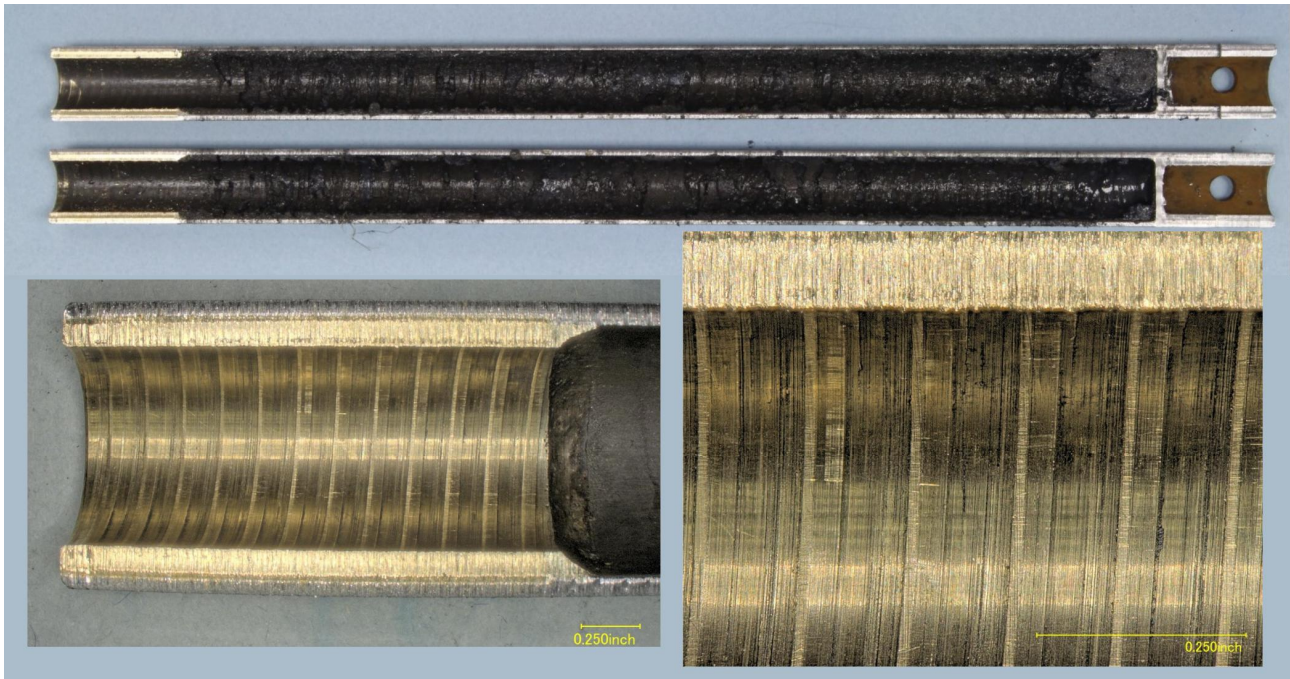
According to the report, there appeared to be a normal amount of lubricating grease inside the actuator (Figure 3). The analysis included a spectrometer inspection (FTIR method) of two lubricant samples, the results of which were compared with the most commonly used

lubricating grease products. The spectrum and the color was found to correspond to the quality of lubricants normally used in aircraft constructions, Aeroshell 64⁵ which is approved according to MIL-G-21164D. Soot particles and a small amount of water were found in the grease. However, no bronze particles that would have indicated thread wear during use were present in these two samples. Some sand particles were detected in the steel threads of the screw assembly.

Figure 3. Actuator nut assembly (number 9 in Figure 2) sawn open. The dark substance inside the tube is lubricating grease. After cleaning, a close-up photo of the aluminium bronze part shows that the threads were worn before they were cut off. (Photos: NTSB, Materials Laboratory Report No. 16-020B)

Based on the NTSB report and the SIAF investigations, it can be concluded that the nut thread in the nut assembly of the screw (close-up in Figure 3) had been stripped, and the threads were significantly worn before being cut off. Otherwise the actuator, including the pinion and its bearings, appeared to be in serviceable condition apart from normal wear.

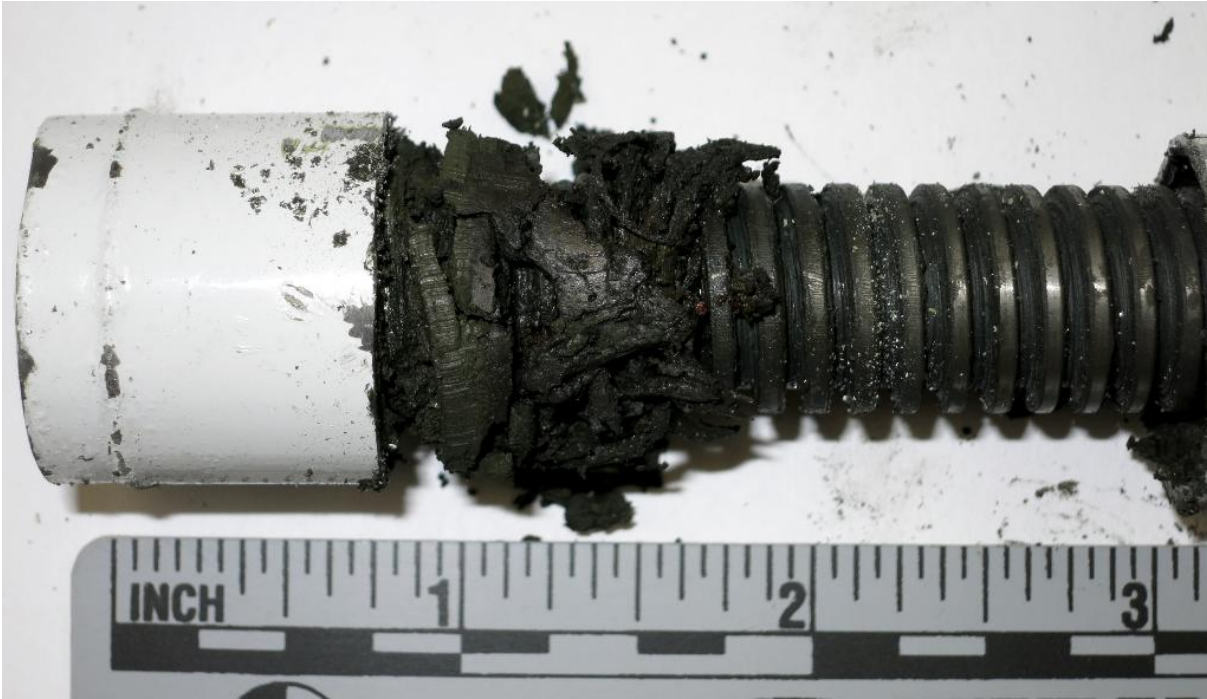
After the component was returned to Finland, investigations continued at the Safety Investigation Authority. The screw assembly housing was cut open so that the whole screw thread could be inspected (Figure 4). Thick lubricating grease and bronze particles were found right at the root of the screw part. Layers of different colour could be discerned in the grease. Right at the dips of the screw threads at the root, a small amount of red grease was found, which indicates that some old grease had been left under the new lubricating grease despite cleaning.

Figure 4. The actuator screw assembly housing was cut open. Lubricating grease and bronze particles had deposited right at the root of the screw. Layers of different colour could be discerned in the grease. A small amount of red grease was found lowest at the bottom. (Photo: Safety Investigation Authority, Finland)

In further investigations made by SIAF, thick lubricating grease with metal particles in it was found at the root of the screw assembly after the housing was removed.

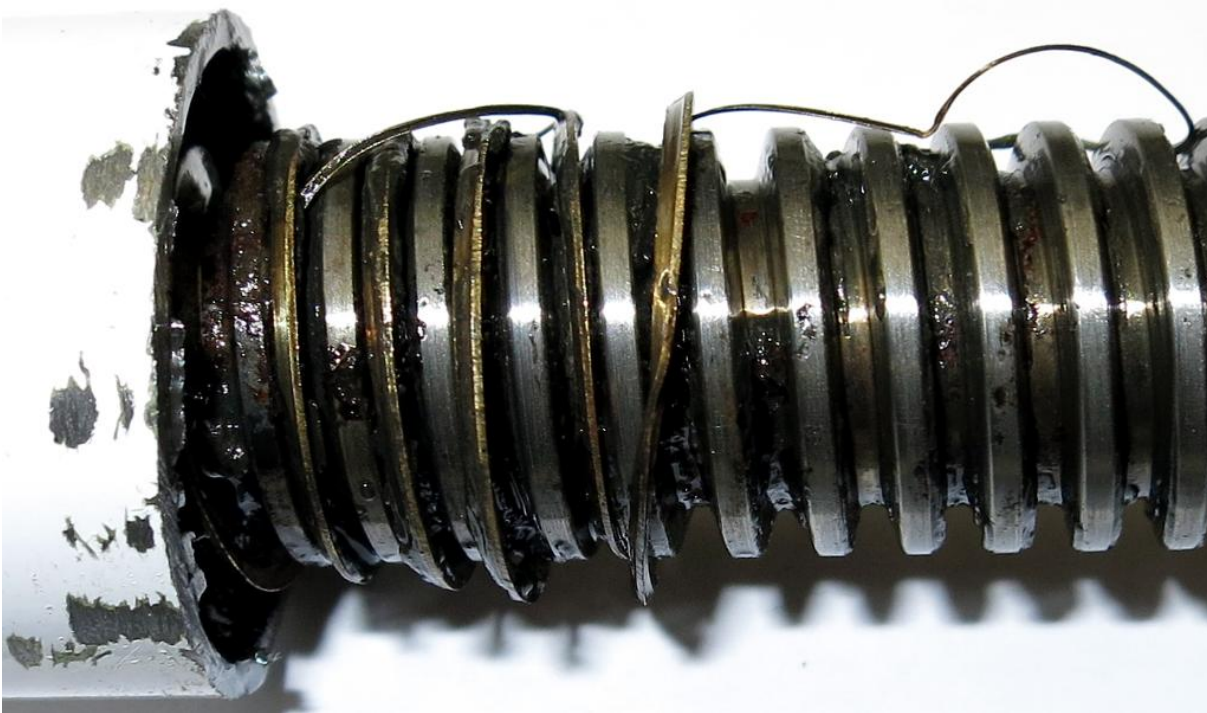
When the grease had been washed away, the loose threads were also found at the screw root. Some of the threads had been broken in parts, while some had maintained their ribbon structure (Figure 5). The fracture surface of the thread was about 0.4 mm wide, which corresponds to the root fracture surface in the bronze nut assembly (Figure 3).

Figure 5. After the grease had been washed away, the bronze threads cut off from the nut assembly were found right at the root of the screw assembly. The nut thread fracture surface was about 0.4 mm wide, which corresponds to the fracture surface that can be seen in Figure 3. (Photo: Safety Investigation Authority, Finland)

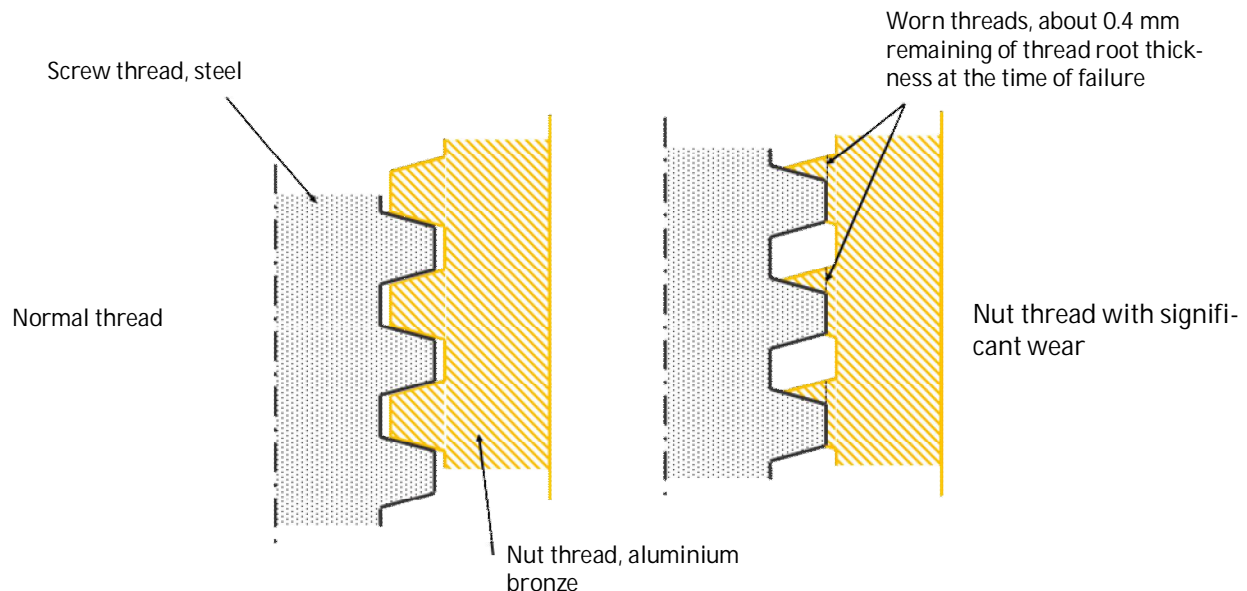
When the thread finally was cut off, the thickness of the root end was only 0.016 in (0.4 mm), which is less than one third of the original thread thickness (Figure 6).

Figure 6. Trapezoid thread used in the screw assembly. Thread in normal condition on the left. The picture on the right shows a situation where the screw thread of steel has abraded the softer bronze thread to a thickness of only about 0.4 mm at the root, when the remaining thread no longer sustained the transmitted force but was cut off. (Graphics: Safety Investigation Authority, Finland)

7. Technical investigations revealed that the nut threads of the nose landing gear actuator screw assembly had been cut off. The threads were significantly worn, even to less than one third of the original thickness.

Excessive wear can be detected with more frequent end play checks. Considering that the check is rather simple, quickly performed, and does not require significant resources, shortening the inspection interval can be regarded as a reasonable means to prevent similar accidents. However, the inaccuracies involved in end play measurements must be known to ensure that reliable results are obtained.

The Federal Aviation Administration (FAA) require the aircraft manufacturer, Beechcraft Corporation, to review the maintenance requirement so that the end play check interval will be significantly shortened and that the thread wear rate is also observed. [2016-S19]
