# Airliner Overrun at Helsinki-Vantaa Airport on July 11, 2017

L2017-03

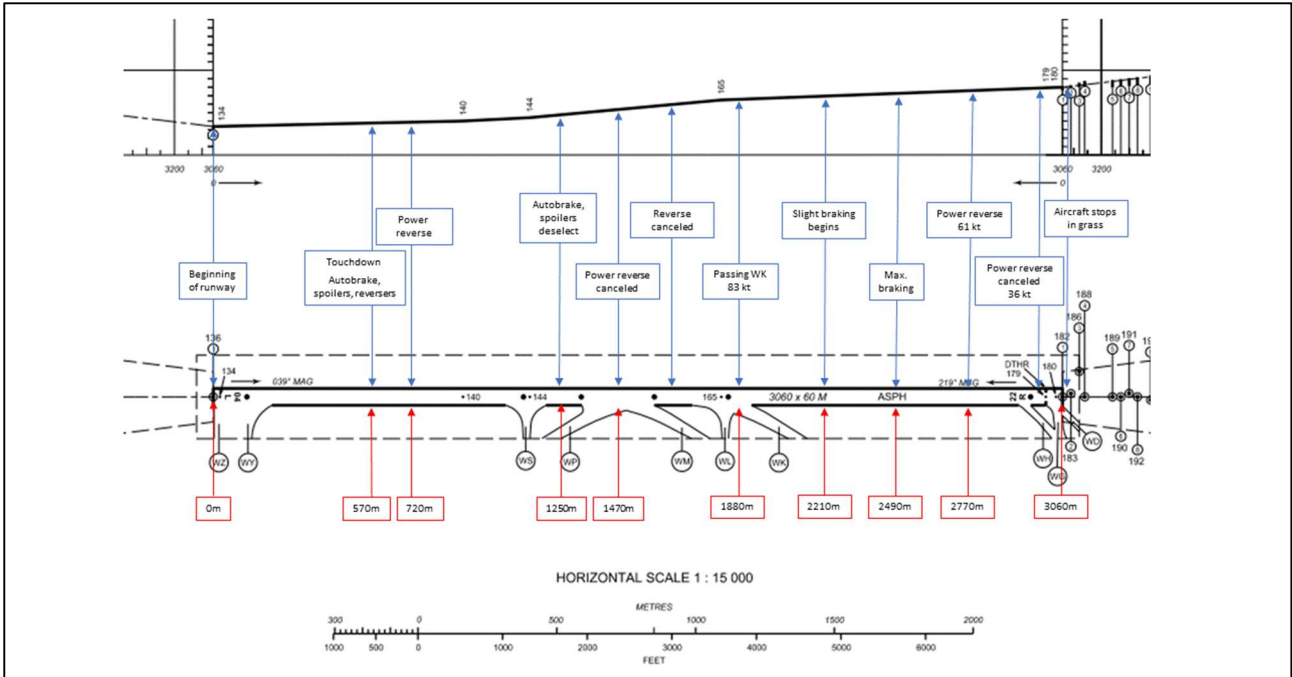
**Picture 1.** Graphic representation of the incident sequence. Distances are approximate and calculated from runway 04L threshold. (Basemap: ©ANS Finland Oy, overlays: SIAF)

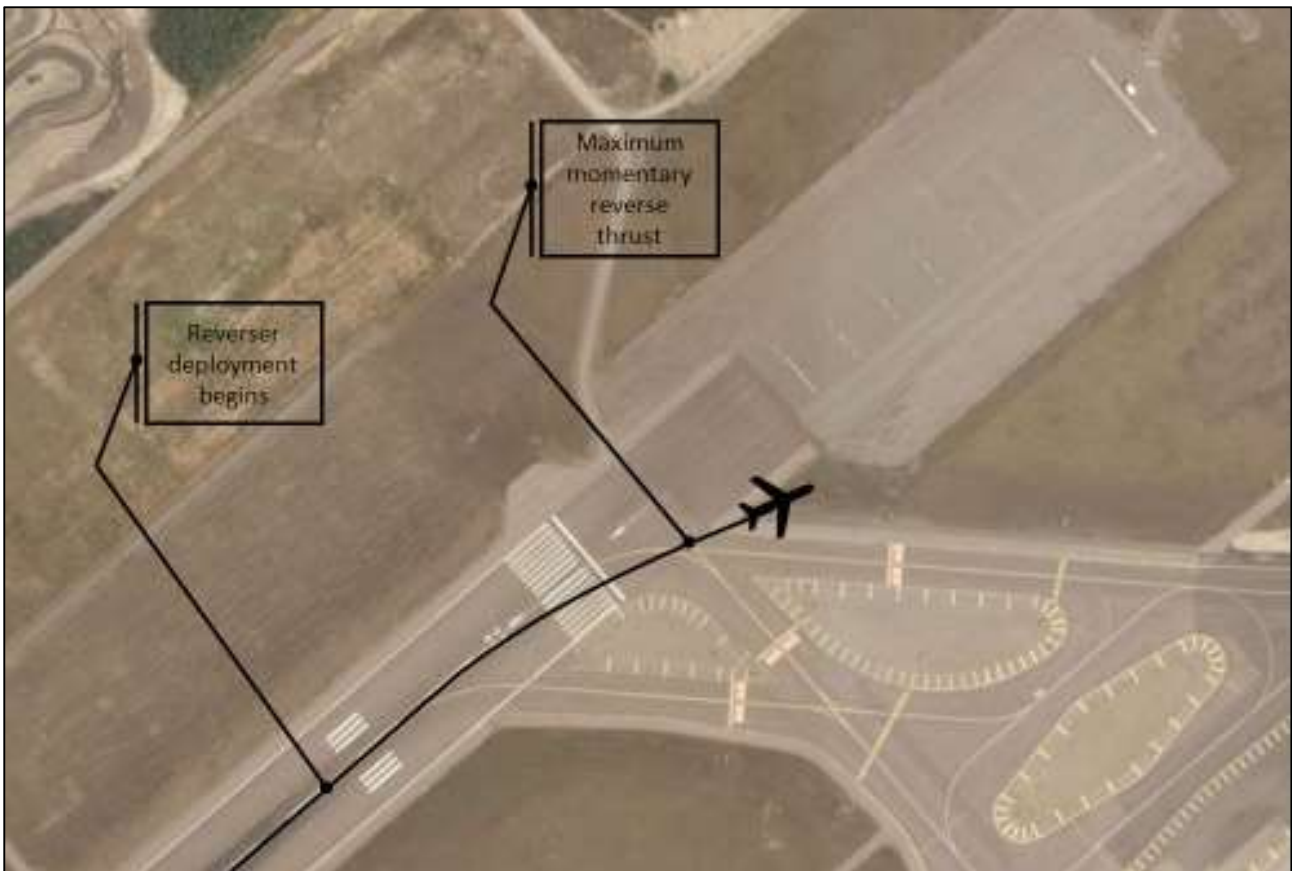
The tires impacted the runway light fixtures by the time aircraft heading had diverged approximately 20 degrees from runway 04L heading. Both nosewheels and three mainwheels came to rest on the grass while the fourth mainwheel remained on the paved area.

**Picture 2.** Thrust reverser deployment and final position of aircraft. (Plan view: Orthophoto ©National Land Survey of Finland 4/2018, overlays: SIAF)

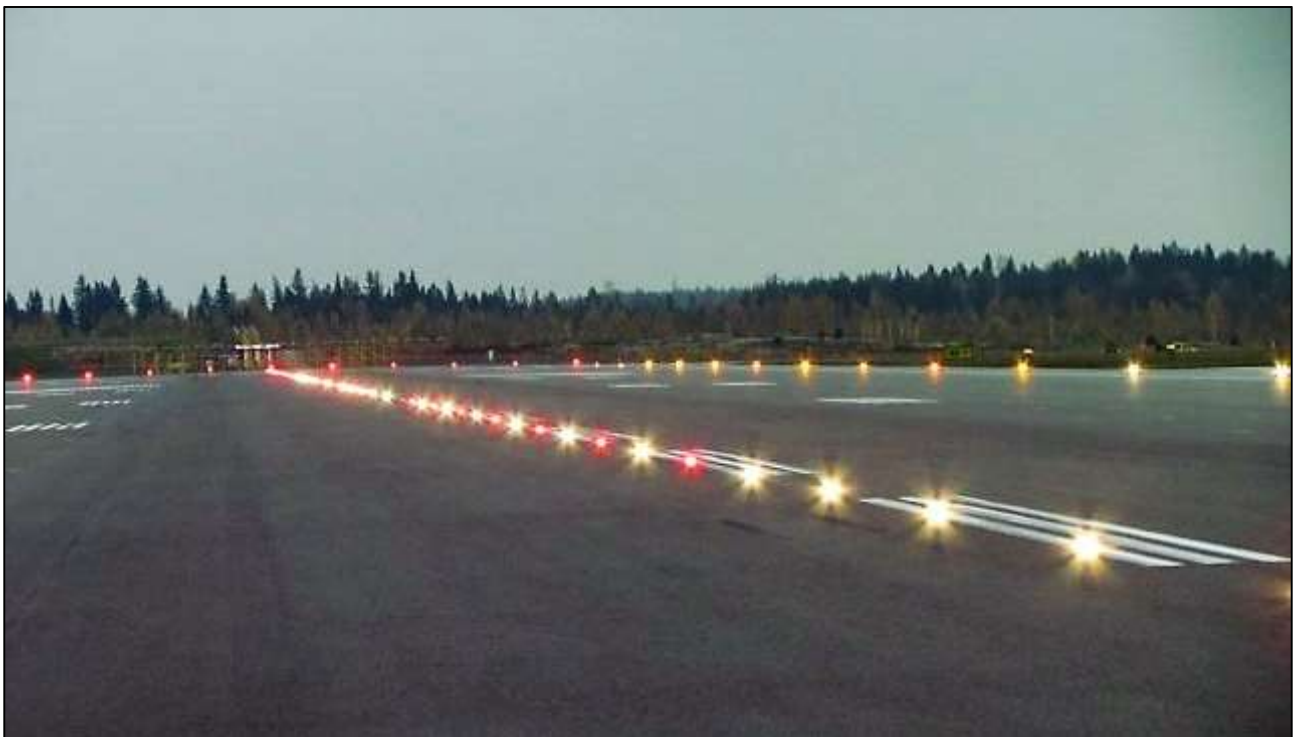
**Picture 3.** The final 900 m portion of the runway is indicated by alternating red and white centerline lights. (Photo: SIAF)

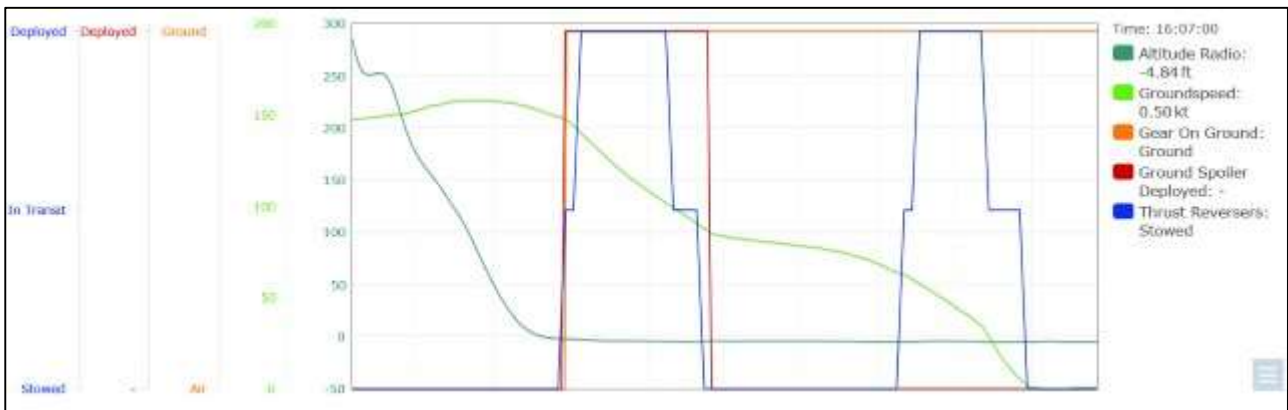
**Picture 4.** FDM data showing thrust reverser operation (blue), groundspeed (light green), and spoiler operation (red). (Source data: Norwegian Air Shuttle ASA)

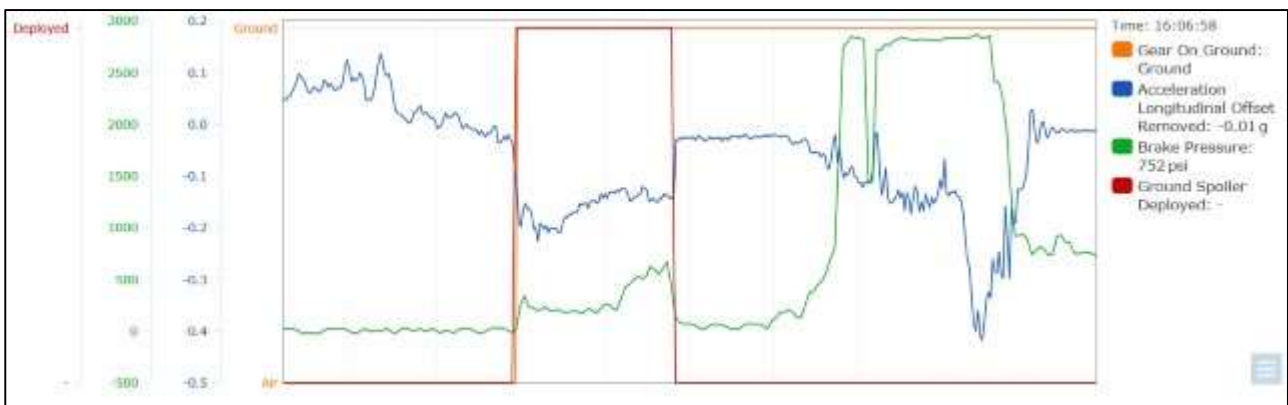
**Picture 5.** FDM data showing spoiler operation (red), longitudinal acceleration (blue), and brake pressure (green). (Source data: Norwegian Air Shuttle ASA)

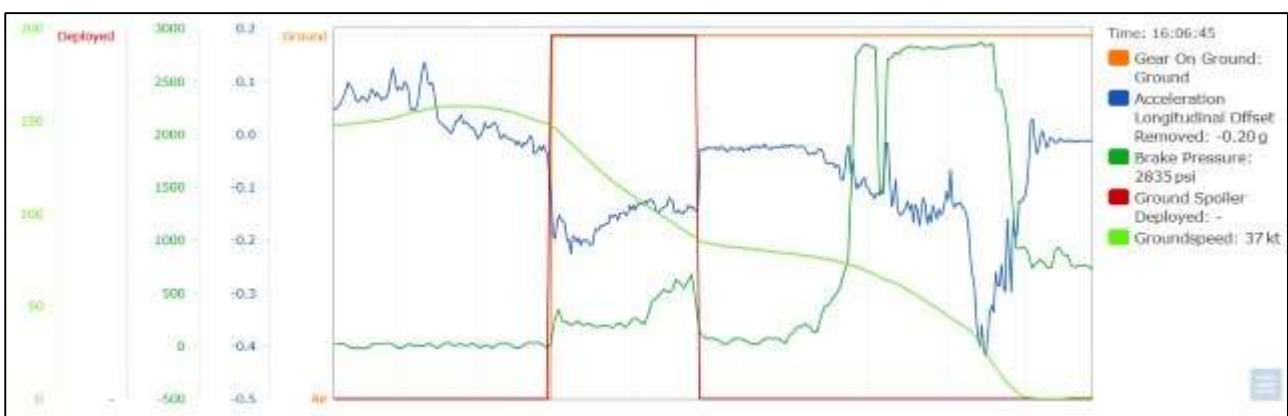
**Picture 6.** FDM data showing longitudinal acceleration (blue), brake pressure (dark green), groundspeed (light green) and spoiler operation (red). (Source data: Norwegian Air Shuttle ASA)
