Final report RL 2018:05e

Accident at Siljansnäs Airport, Dalarna County, on 30/06/2017 involving the aircraft OH-PHE of the model Piper PA-28-161, operated by Blue Skies Aviation Oy.

File no. L-71/17

9 March 2018

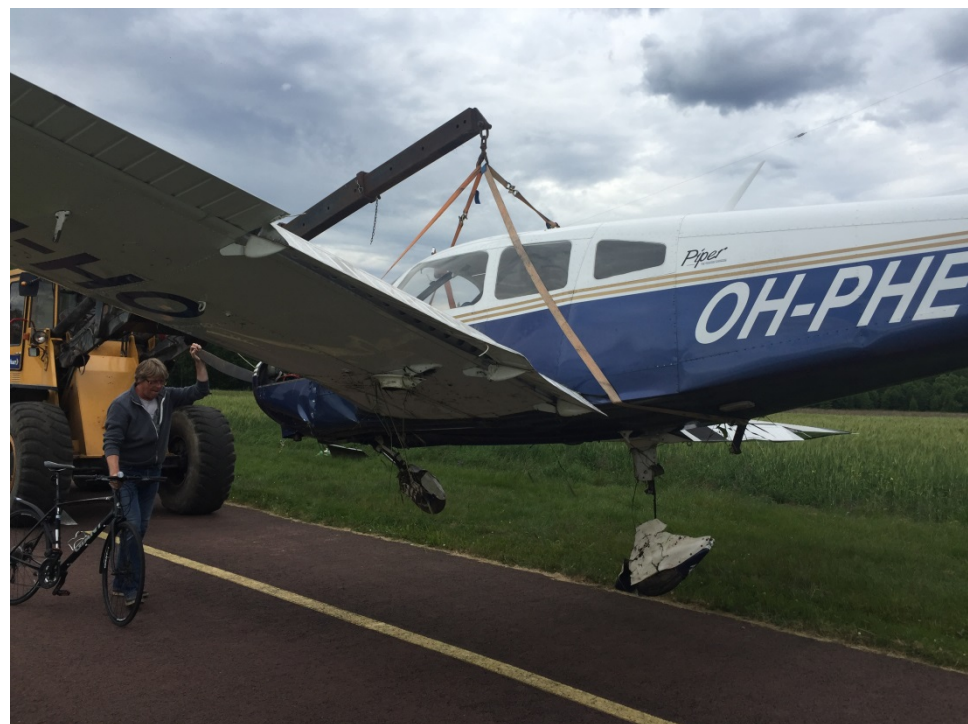
Substantially damaged.

Figure 1. Recovery of the aircraft. Photo: Alexander Sülberg.

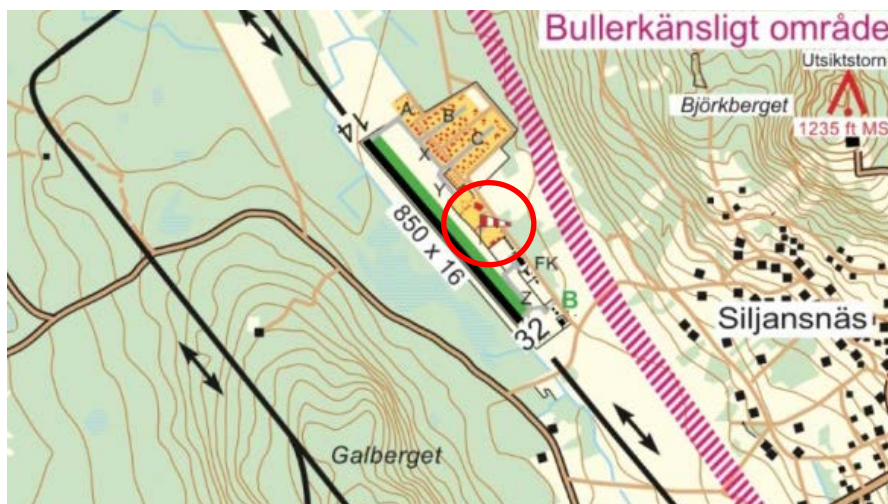
Figure 4. The airport with the windsock marked. Source: KSAB Svenska Flygfält.

- The assessment of the wind conditions might have been adversely affected by the fact that the airport's windsock stood on the lee side of a forest.
- There were no detailed instructions in the operator's manual regarding rejected take-off.
- During the latter part of the event, a wind shear might have contributed to the airspeed dropping.
- The manoeuvring towards obstacle clearance resulted in a banked turn, which at the low speed worsened the situation further.

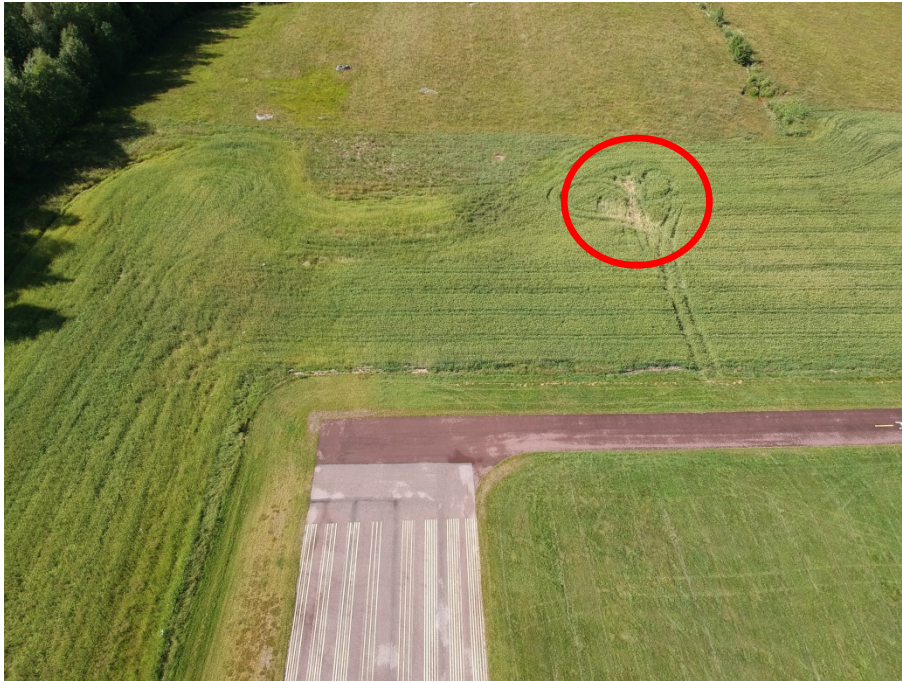
The aircraft stopped in a cornfield about 50 metres after the runway end and veered 90 degrees to the left in relation to the take-off direction (see Figures 5–6).

Figure 6. The aircraft's final position in the field marked with a red circle.

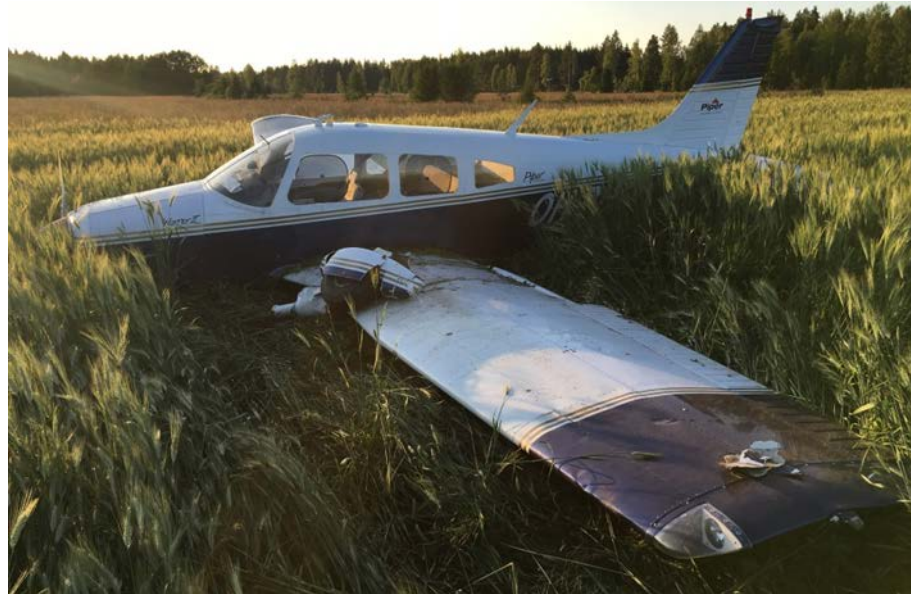
The aircraft had structural damage to the fuselage and wings with flaps and to the horizontal stabiliser. The engine and propeller were also damaged. The landing gear had extensive damage as these were torn from their attachments.

During the technical examination no faults were identified that could have been able to affect the sequence of events.

Figure 8. The aircraft at the accident site. Photo: Swedish Police.

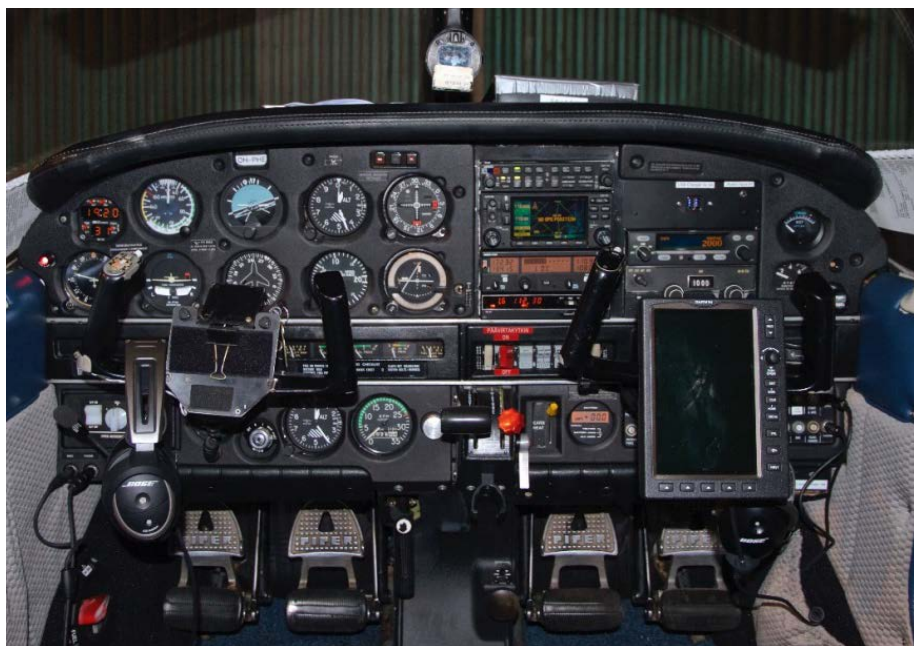
The instructor in the right front seat was injured in the chest by a GPS screen that was mounted on the right steering wheel (see Figure 9). The instructor was taken to hospital and was released from the hospital two days later.

There are no specific rules for the installation of equipment that can be mounted and removed without the use of tools.

Figure 9. The image shows the installed screen mounted on the right steering wheel. Photo: Peter Tähtinen.

On the instructor's side a GPS screen was mounted on the steering wheel, which caused bodily injuries upon impact. SHK opinion is that operators should perform a risk assessment for the installation of non-certified installations in aircraft.

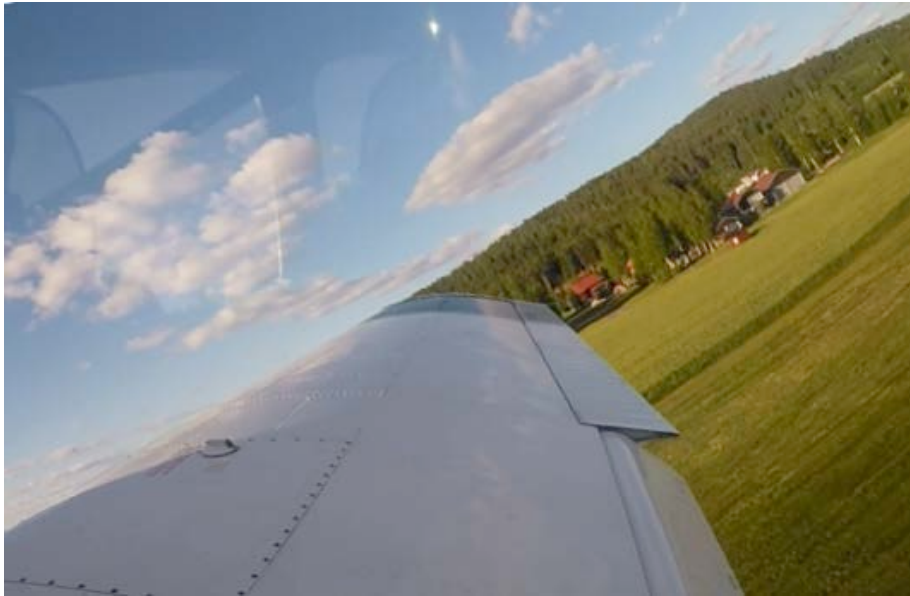
Figure 15 shows a screen dump from the GoPro video recording over the right wing when passing the threshold markings on the parallel grass runway. The wing has stalled at this point, whereafter the pitch angle has decreased and the aircraft descended and impacted in the field after the end of the runway.

Figure 15. Screen dump from GoPro film over the right wing of the aircraft during the event.
