Smoke in Cabin and Evacuation of Airliner at Turku Airport on December 3, 2017

L2017-06

SYNOPSIS

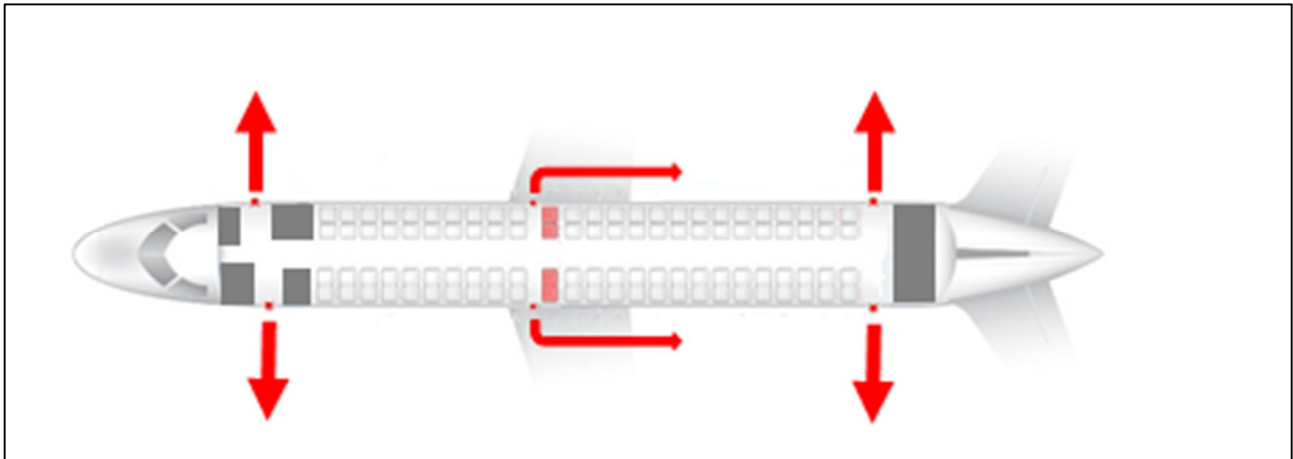
Figure 1. Emergency exits. The exits in the front and back have inflatable slides. Persons evacuating via the overwing exits should stay close to the fuselage and drop off the wing. (Image: SIAF, source data: Nordic Regional Airlines)

A good number of passengers who had exited onto the wings moved towards the wing tips while the instruction shows an evacuation route along the fuselage side. This route is illuminated with exterior lights all the way to the ground; however, illumination alone will not render the overwing routes as conspicuous and easy to use as the door slides. Jumping off the outer wings would increase the likelihood of an injury since the drop will be more than two meters and therefore higher than at the wing root. Since the cabin was found to be safe, the rescue crews prompted the passengers to reenter the airplane and evacuate via the slides. All these factors prolonged the evacuation.

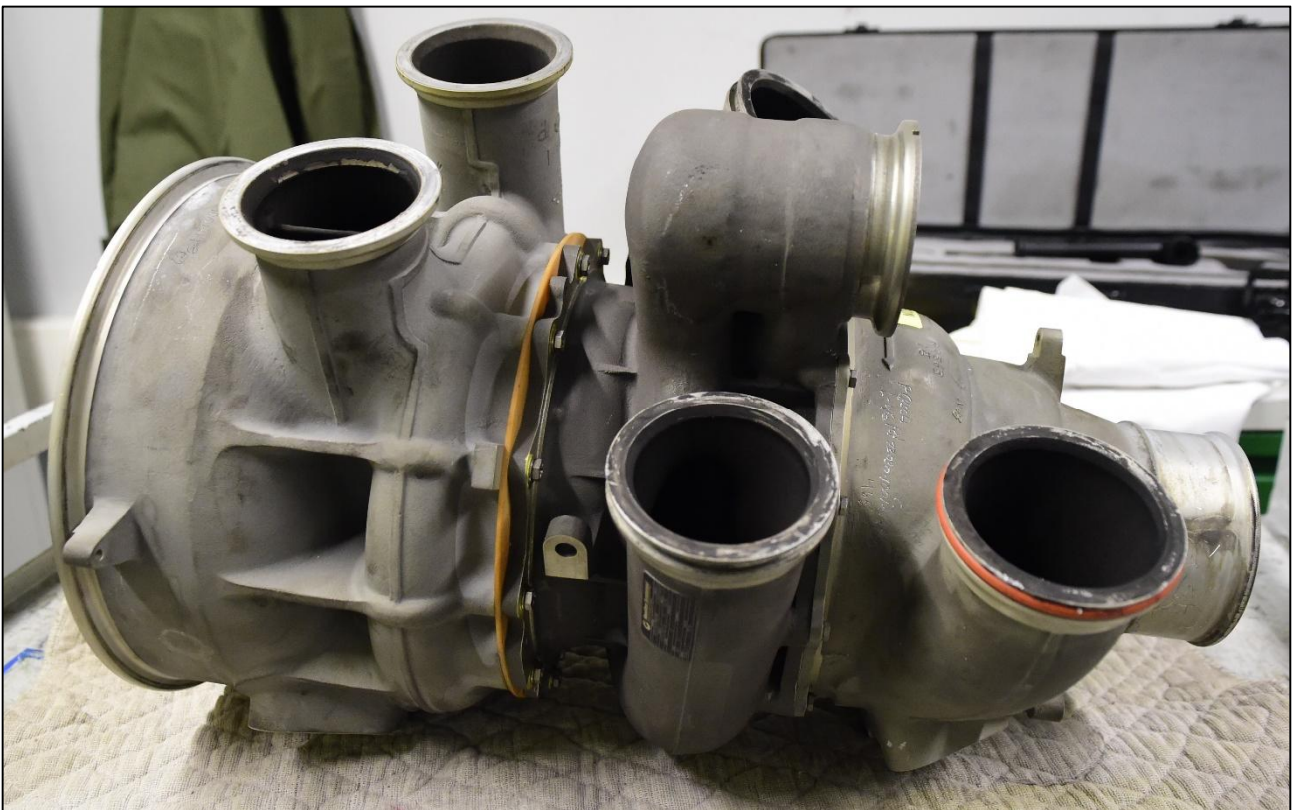
The ACM in the no. 1 air conditioning pack seized during the climb to the cruise altitude. The rotors rubbed against the fan shroud producing a bitter smell and whitish smoke. The ACM examination is described in paragraph 2.8.5.

Figure 4. The affected air cycle machine. (Photo: Nordic Regional Airlines)

The ACM was examined at the UTC Aerospace Systems laboratory in the Netherlands on January 11, 2018, under supervision of an SIAF representative. Various damage was observed in the unit during strip-down. The examination confirmed that the smoke and smell of smoke identified during the flight were caused by the rotating assemblies of the cooling fan, compressor and the two turbines (T1 and T2) contacting the fan shroud as a result of the failure of journal bearings. The examination was unable to determine conclusively which bearing had failed first. The examination of the fan shroud also revealed the presence of moist coffee grounds that had probably migrated from the sink in the forward galley.

During the repairs, the ACM was modified in accordance with the manufacturer's service bulletins to improve reliability and its part number was thereby changed to 100070-06. The modifications included the fitting of a new T1 turbine end shaft, new T2 turbine nozzle vanes and heavier-duty journal bearings.

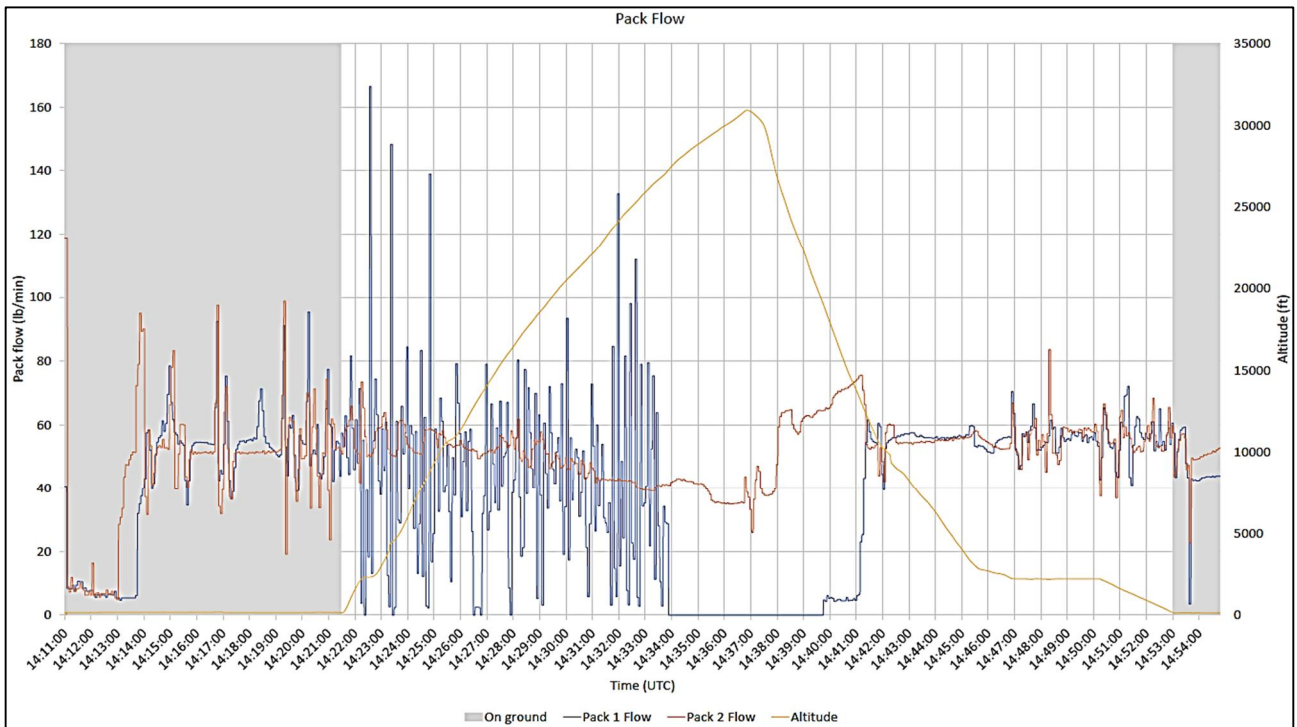
Figure 6. QAR data graph of air conditioning pack operation. The gray areas describe the airplane on the ground. The blue and orange traces represent, respectively, the no. 1 and the no. 2 pack flow (lb/min). The yellow trace represents altitude (ft). (Photo: Nordic Regional Airlines)

QAR data showed that the no. 1 air conditioning pack flow had oscillated significantly already during takeoff compared with the no. 2 pack flow and shut off completely at approximately 1634 h (figure 6). At the same time, the pack compressor outlet temperature began to rise to peak at approximately 1636 h (figure 7). The airplane had reached the maximum altitude (approximately 30,000 ft) when the outflow valve closed at 1637 h. The temperature dropped to reach a low level at 1638 h. The valve reopened at 1641 h, and the no. 1 pack flow was simultaneously restored to the level corresponding to the no. 2 pack flow. The temperature began to rise again at 1650 h.

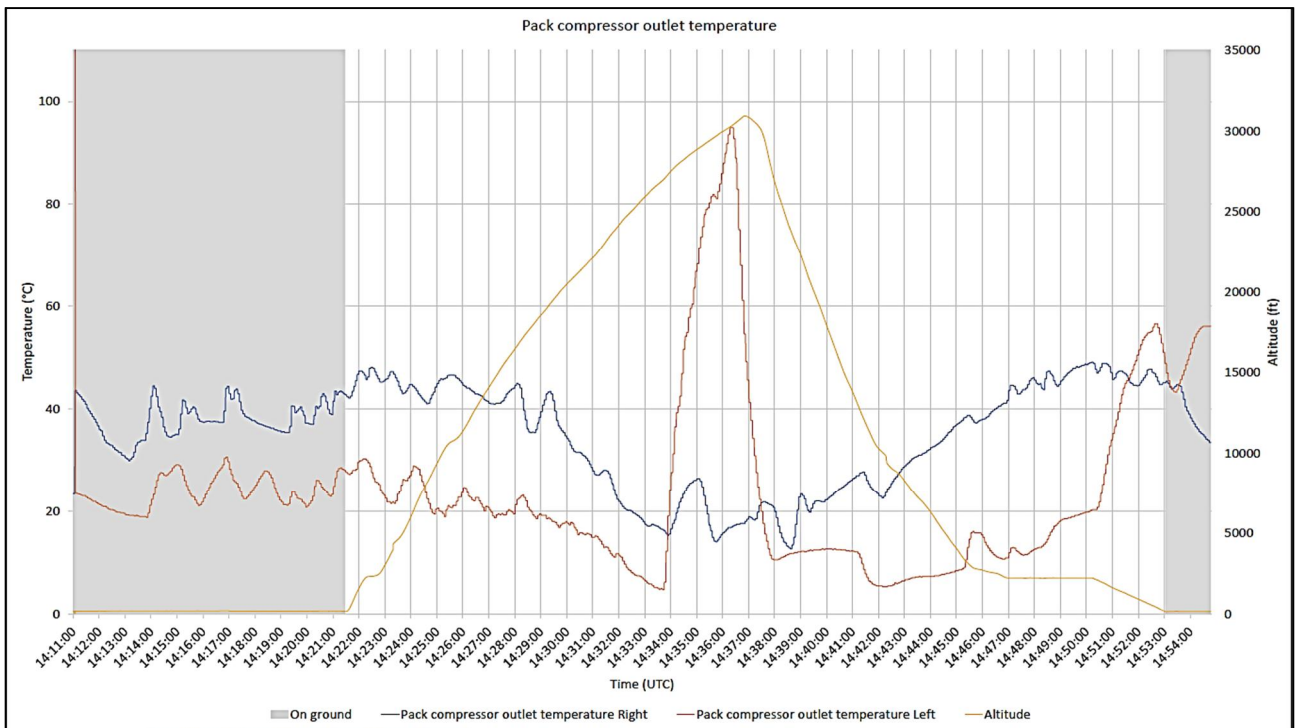
Figure 7. QAR data of air conditioning pack operation. The gray areas describe the airplane on the ground. The orange and blue traces represent, respectively, the no. 1 and the no. 2 pack compressor outlet temperature (°C). The yellow trace represents altitude (ft). (Photo: Nordic Regional Airlines)

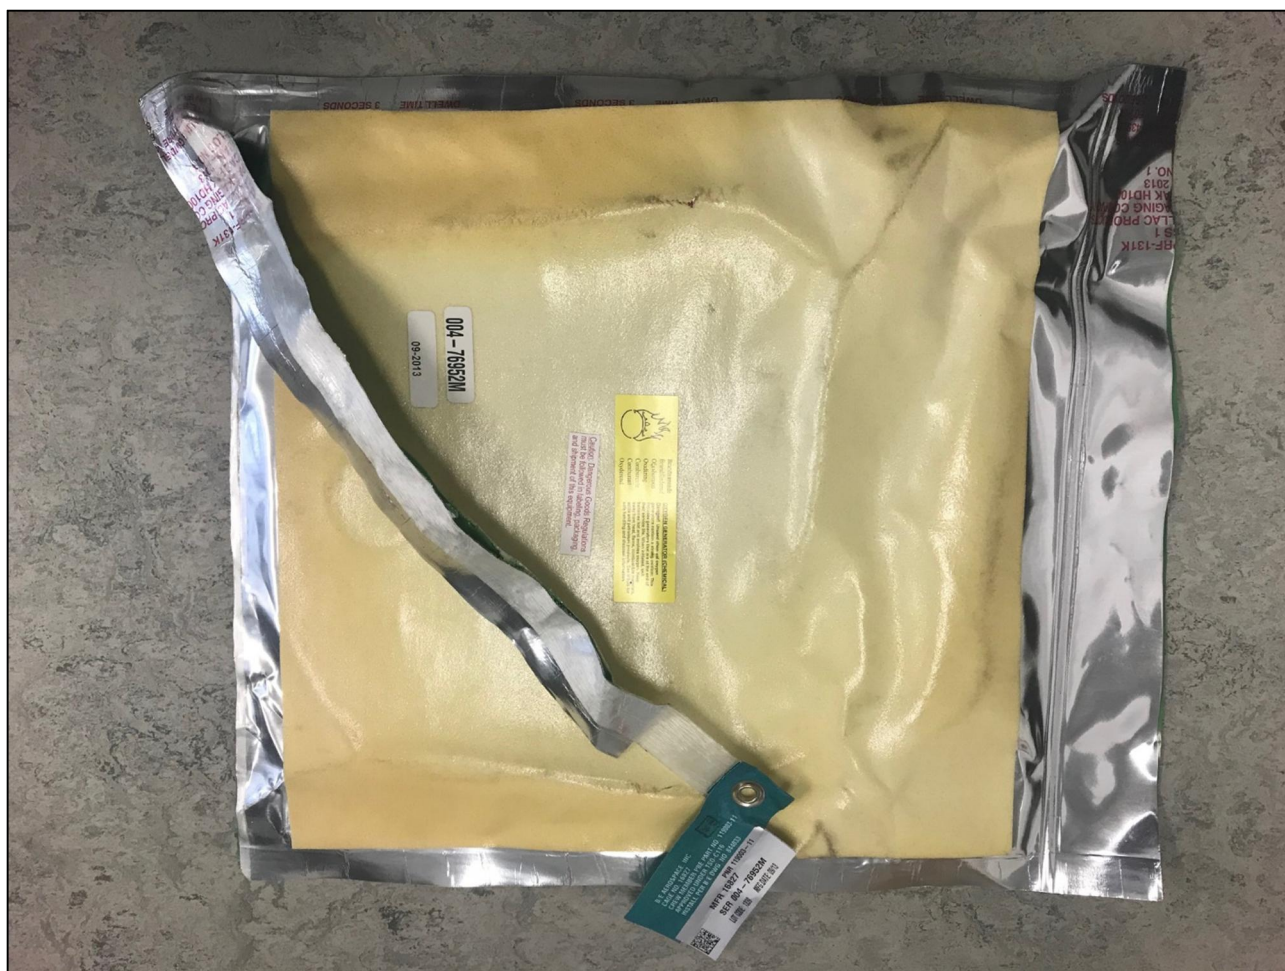
The opening mechanism of the PBE protective bags was examined using the repeated testing method. The tests showed that a pull of approximately 250 N was needed to open the bag from which the cabin crew member tried to extract the PBE. The spring scale used in the test indicated that a force of approximately 25 kp would therefore have been required. The test was conducted and the bag was opened by connecting the hook of the scale to a metal eyelet in the rip tag. In this way a force greater than would have been attainable manually could be exerted on the tag, and it was found that manual opening of the bag would have been extremely difficult. The eyelet detached from the reinforced tag during testing.

Figure 10. A protective breathing equipment bag. (Photo: SIAF)

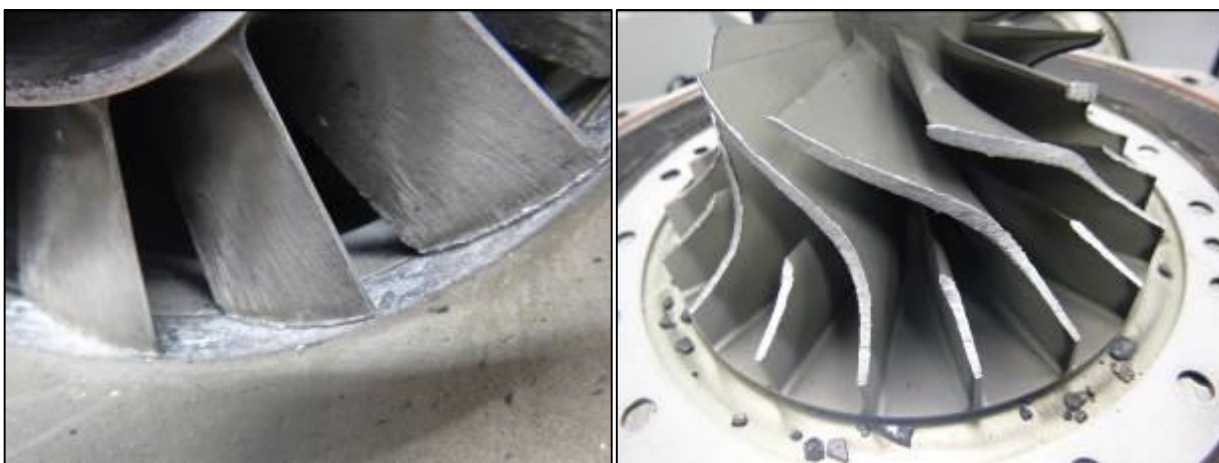
Figure 11. On the left, cooling fan blades showing signs of rubbing. On the right, similarly damaged T2 turbine blades. The T1 turbine exhibited similar damage. (Photos: Hamilton Sundstrand CSC Maastricht BV / UTC Aerospace Systems)

1. The rotating assemblies – i.e., the cooling fan, compressor and both turbines – of an ACM contacted the fan shroud as a result of the failure of journal bearings.

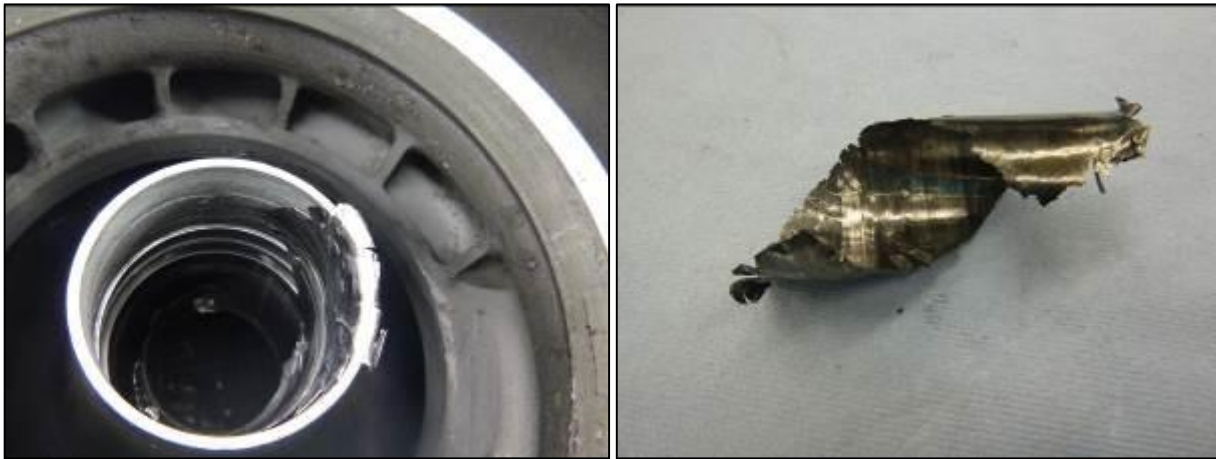
Figure 12. A failed journal bearing and associated damage. (Photos: Hamilton Sundstrand CSC Maastricht BV / UTC Aerospace Systems)
