Loss of Directional Control during Landing Roll at Turku Airport on October 25, 2017

SYNOPSIS

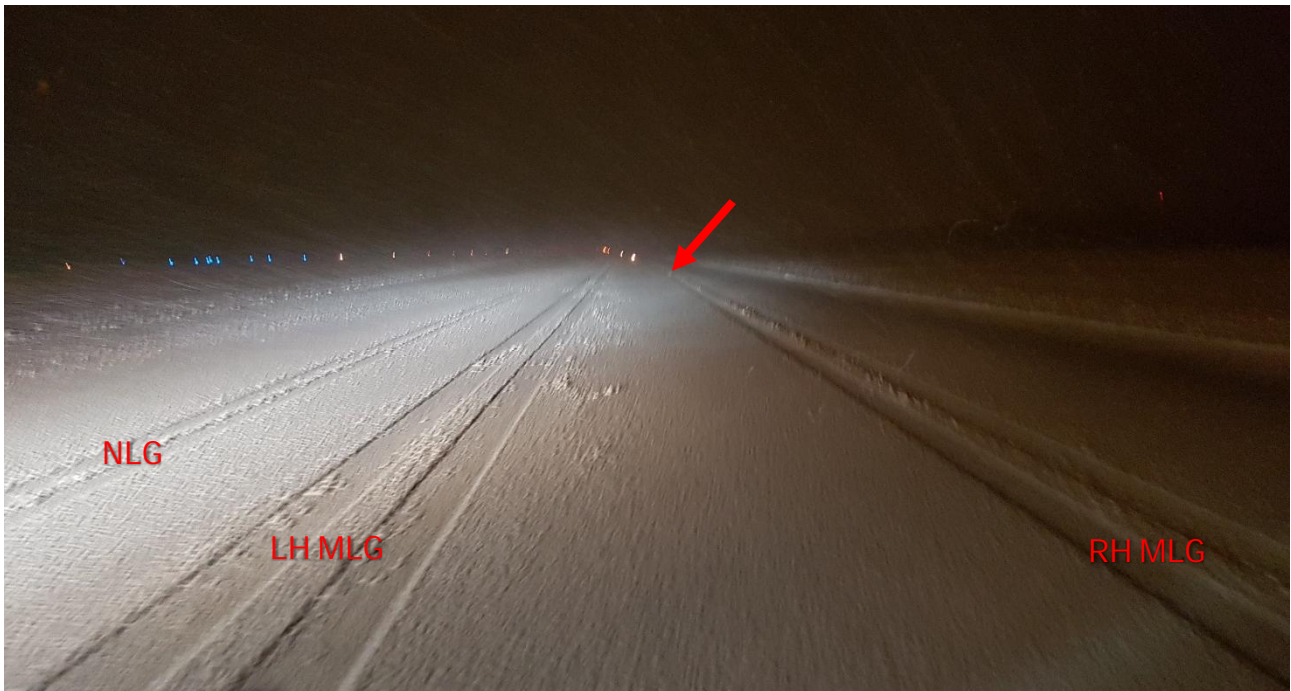
Figure 2. The tracks left by the left main (LH MLG), right main (RH MLG), and nose (NLG) landing gear as the skidding airplane was veering towards the runway edge lights, as seen approximately 35 min after landing. The red arrow shows the location of the first broken light. Intact lights are visible further down the runway in the center of the photo. (Photo: Finavia, annotations: SIAF)

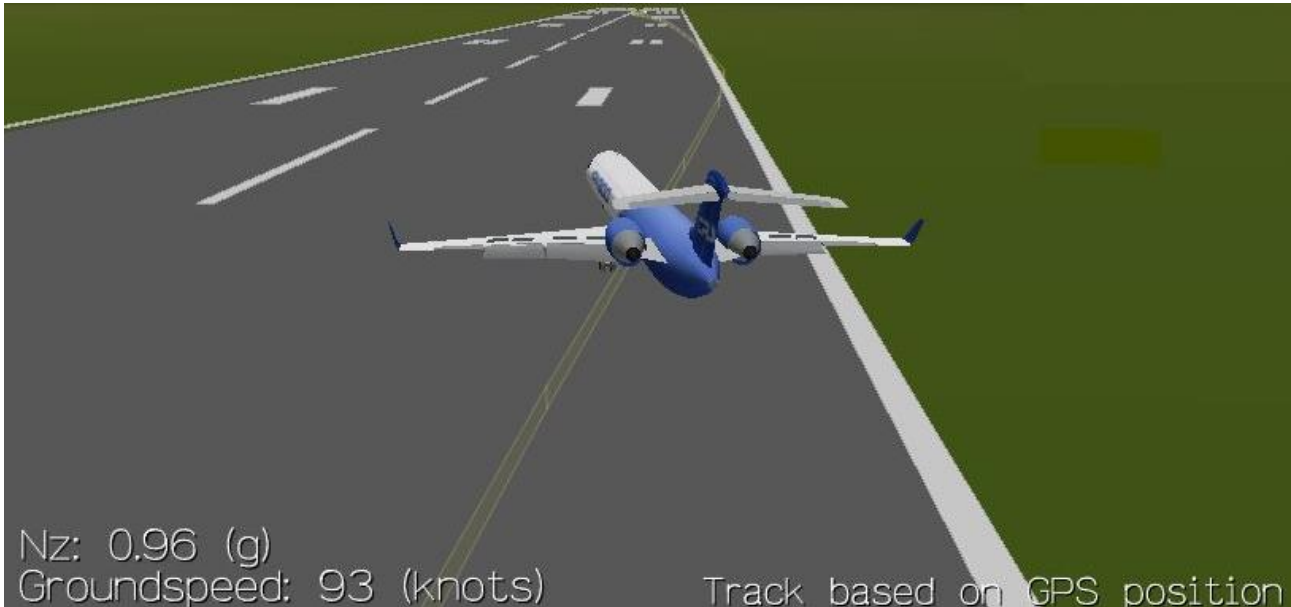
Figure 3. A snapshot from the flight data recorder -derived animation shows the skidding airplane veering off the runway. At this point, groundspeed is approximately 170 km/h, and the airplane tracks as indicated by the yellow line that is based on the locations of GPS points obtained from the recording. The actual paved area extends beyond the white runway edge line, but this is not shown in the picture. The tires did not leave the paved area. (Photo: Insight™ ProView)

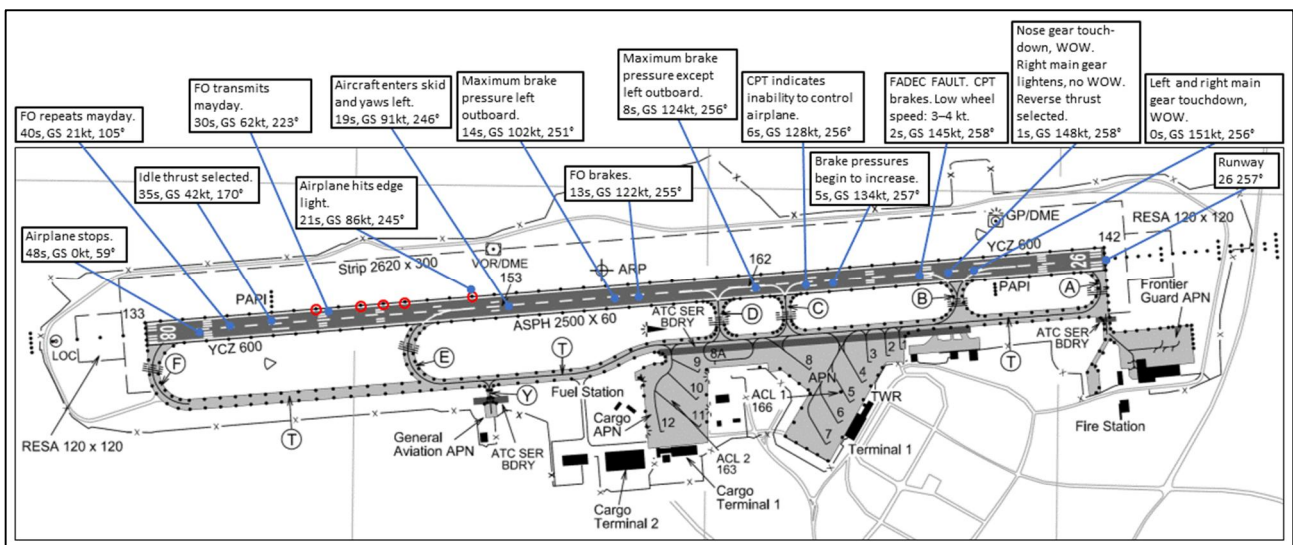
Figure 4. Significant events during the landing roll. The red circles indicate the broken runway edge lights. The bottom line(s) in each box indicates time from touchdown, groundspeed, and heading (WOW = weight on wheels, GS = groundspeed, CAPT = captain, FO = first officer). (Base map: ©ANS Finland Oy, overlays: SIAF)

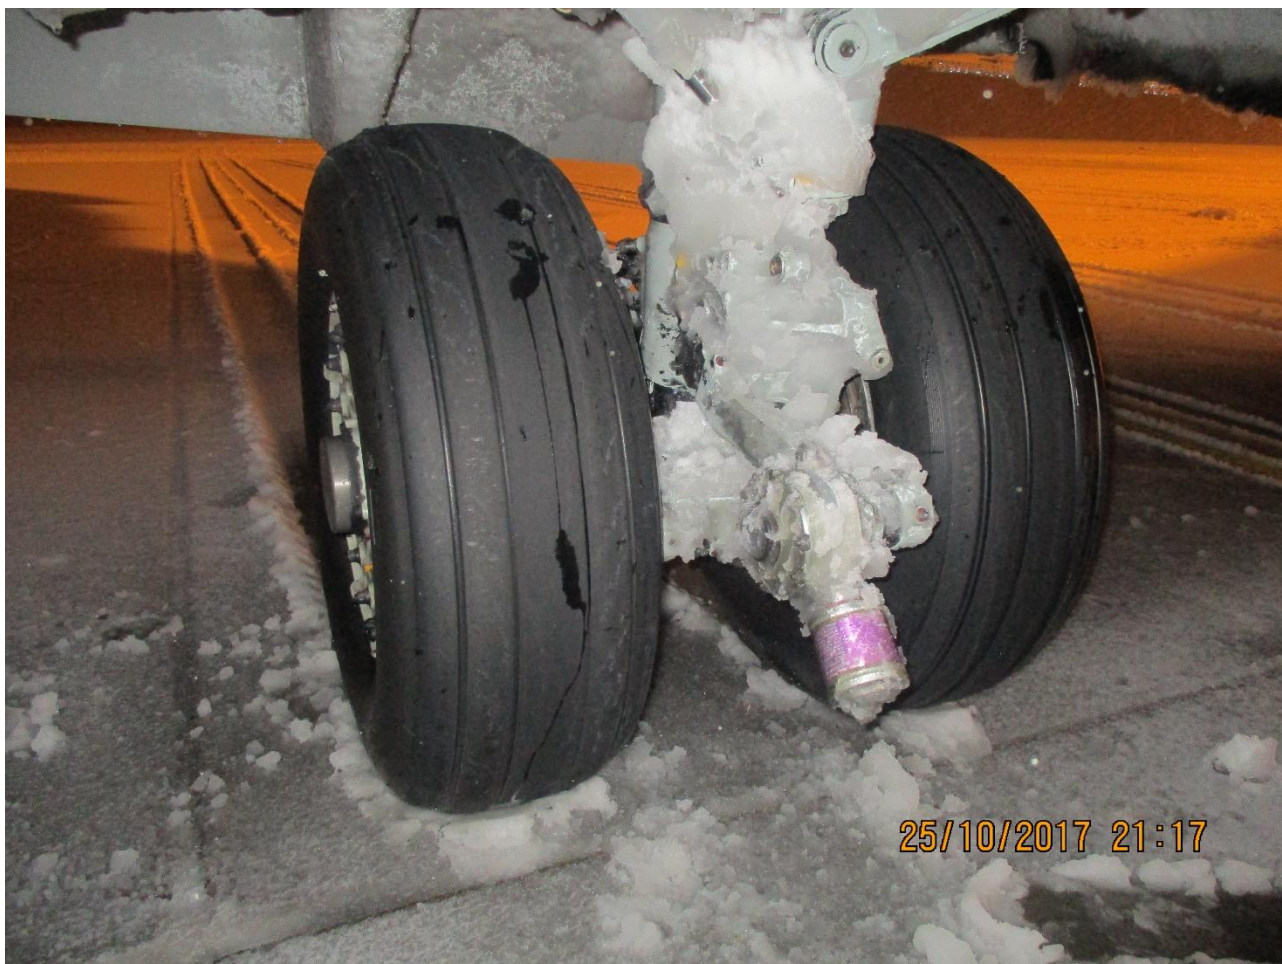
Figure 5. This close-up was taken on the apron approximately 50 min after landing. The airplane taxied into this position and stopped approximately 15 min after landing. No significant amount of fresh snow has fallen on the underwing areas, and by examining the track depth it can be estimated that the slush was over 10 mm deep at the time of the landing. Ground temperature expedited the transformation of snow into slush. (Photo: Police)

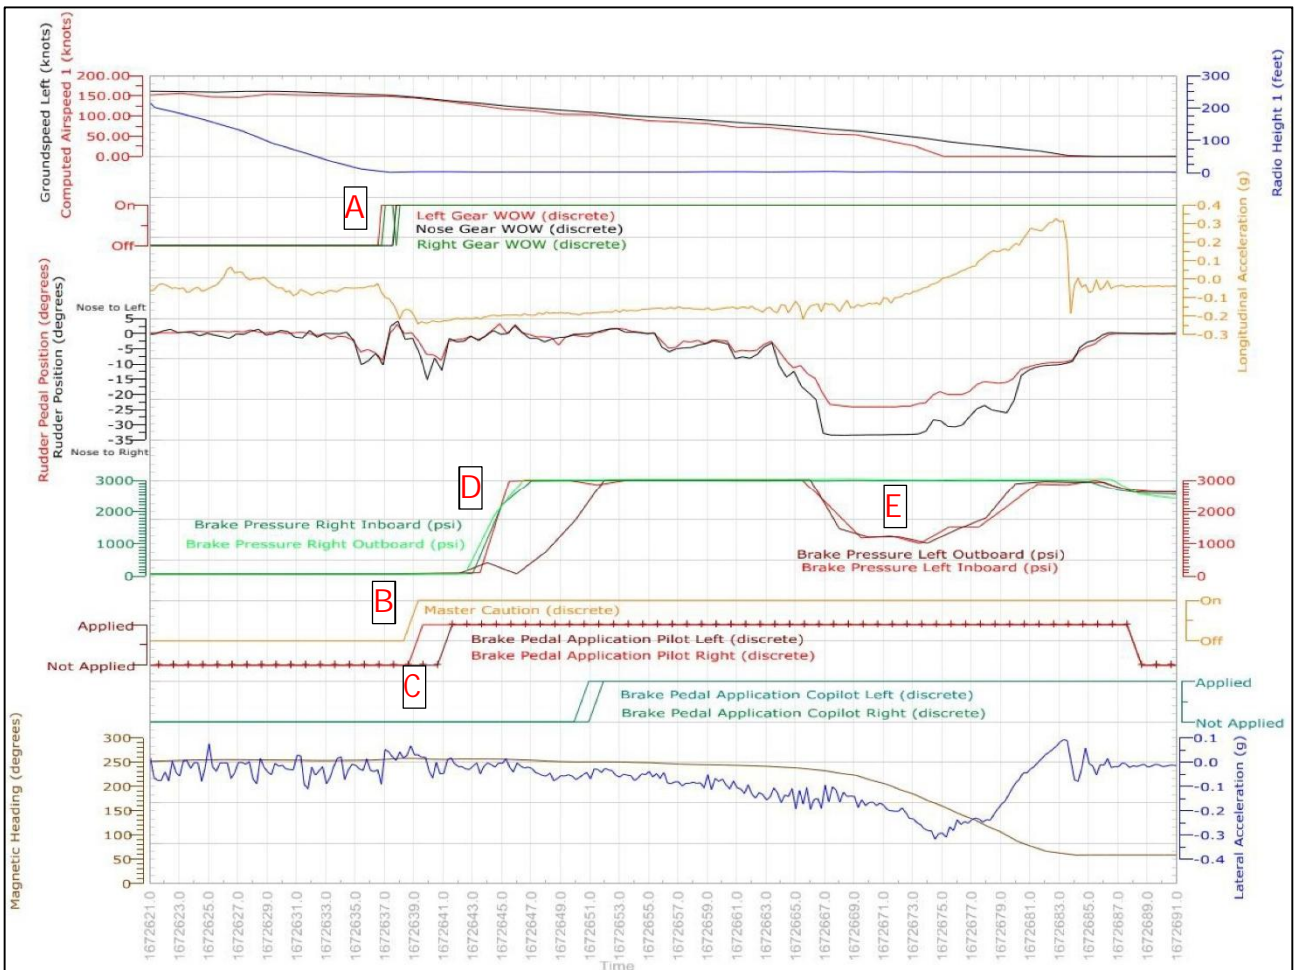
Approximately 1 s later, load on the right main gear lightened sufficiently for the logic to record "air." This condition lasted for 0.25 s (Figure 8, A). The tire did not necessarily rise off the runway, but the oleo extension (0.47 g) that followed the firm (1.95 g) landing may have reduced the load on the tire to such an extent that "air" was recorded. Nose gear touchdown occurred at the same time.

Manual brake pedal application (Figure 8, C) was recorded simultaneously with the master caution. Brake application is not shown in FDR graphs until brake pressure increases to 500–800 psi so light braking and even many normal brake applications remain unregistered. However, pressure in the brake units did not increase despite brake application (Figure 8, D) due to the operation of the touchdown protection logic that is designed to guard against wheel locking on touchdown. The logic prevents pressure increase in the brake units until wheel speed is over 35 kt or the WOW sensors record "ground" for more than 5 s. Brake pressure started to rise (Figure 8, D) after approximately 5 s from the first "ground" signal from the WOW sensors.

Figure 8. Flight data recorder parameters (Photo: FDR time history trace / Bombardier, overlays SIAF)

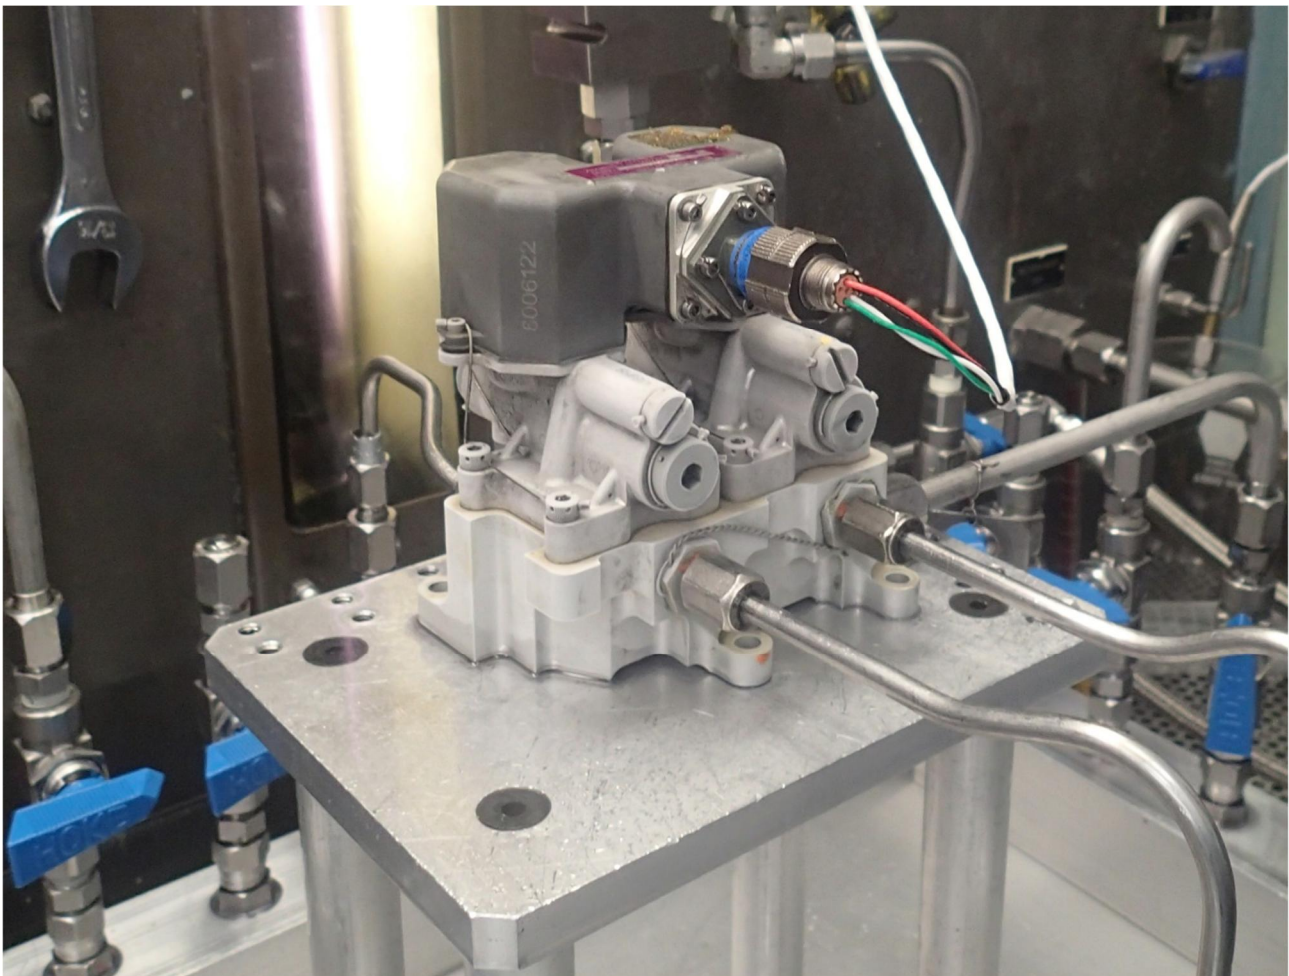
Figure 12. A cooled-down anti-skid control valve unit on the test stand (Photo: SIAF)

The ASCV tests showed no anomalies that could have contributed to the observed inconsistent performance of the brake unit on the left outboard wheel.

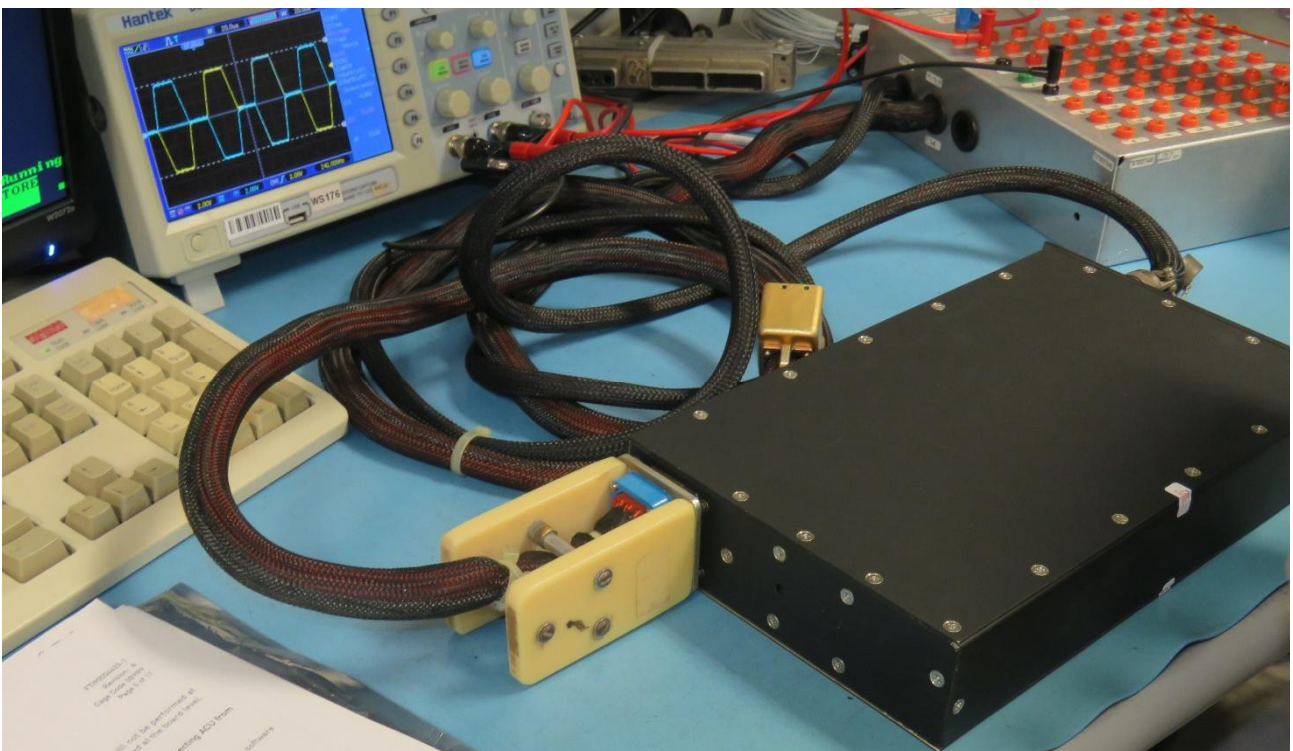
Figure 13. The anti-skid control unit under testing (Photo: Projects Unlimited Inc.)

The ASCU was subjected to functional validation that is done on returned or overhauled units. The validation plan calls for the sequential testing of the ASCU functions. These tests were repeated after temperature soaks at -40 °C and +70 °C. One failure occurred during the testing after the heat soak and was related to the test signal for the left outboard wheel brake. The anomaly was traced to a pin in the test connector that is only for ASCU test purposes and software uploads and updates and is not used on in-service aircraft. After cleaning the connector, the ASCU passed functional testing.

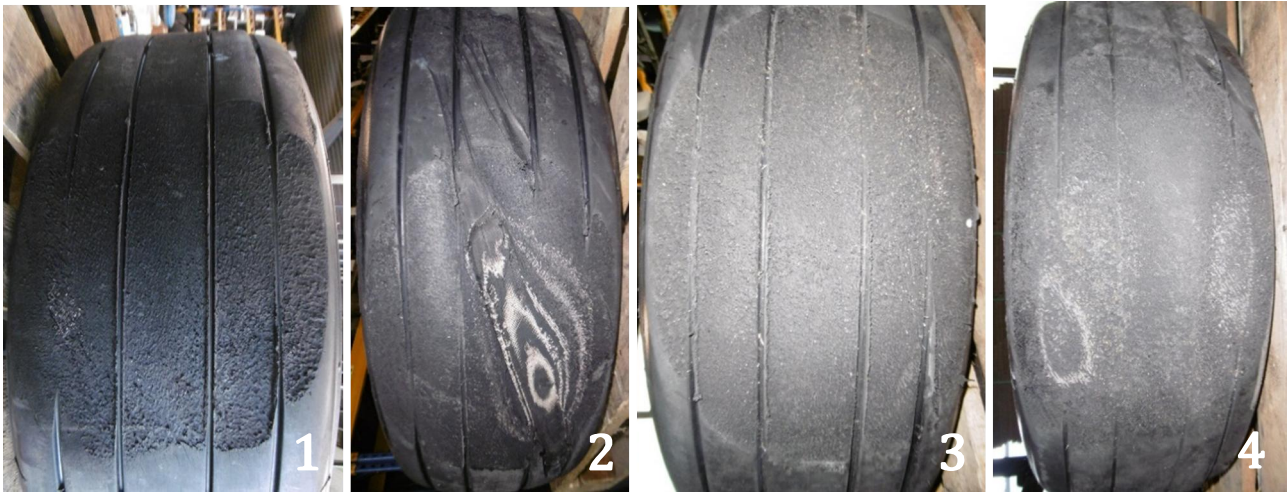
Figure 14. Damage to the mainwheel tires. The tires are arranged to correspond to their position on the airplane as seen from the rear. (Photos: CityJet)

Tracks on the runway and snow were used to determine the sequence in which the tires struck the runway lights. Tire #3 broke the first light, tire #2 struck the three next lights, and tire #4 contacted the fifth light.

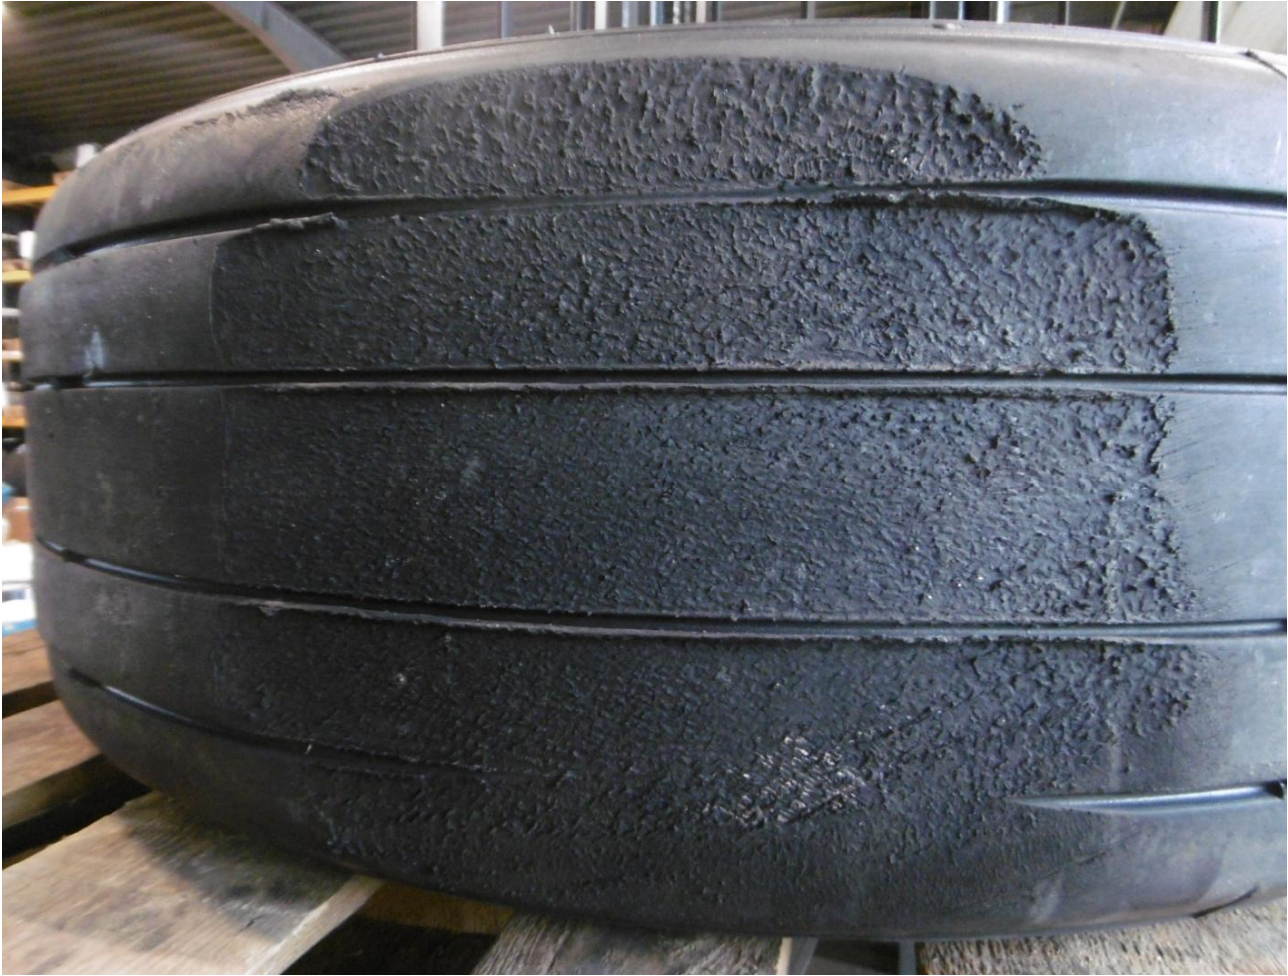
Figure 15. Mainwheel tire #1. Evidence of reverted rubber hydroplaning is apparent on the tread. The tire did not contact the runway edge lights. (Photo: CityJet)
