Ultralight Aircraft Accident at Tampere-Pirkkala Airport on July 31, 2019

FOREWORD

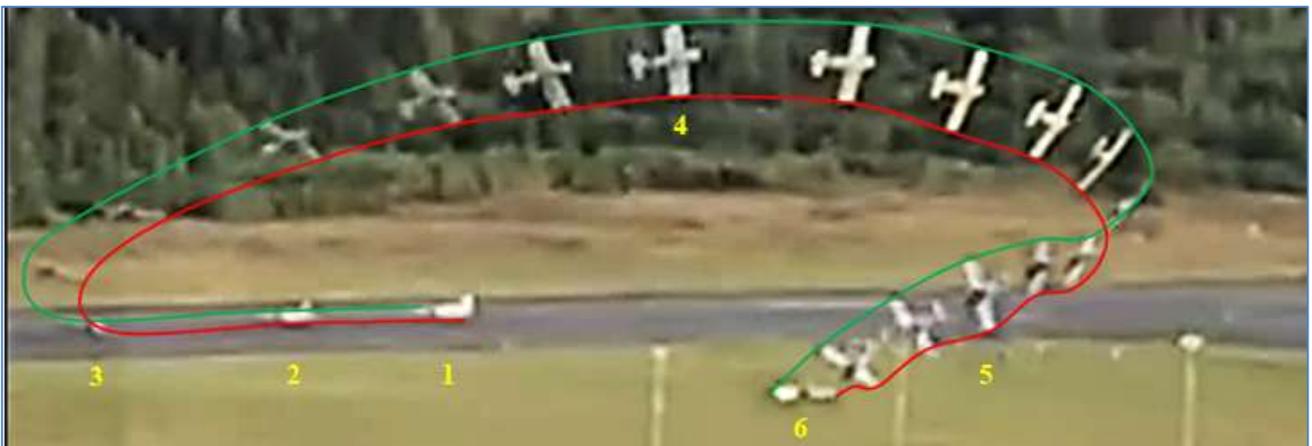
The student conducted normal preflight preparation in the presence of the instructor. After lining up on runway 06, he added power smoothly (1). Before rotation², the aircraft yawed abruptly about 45° left (2). Liftoff occurred just before the aircraft reached the edge of the paved surface (3). The aircraft became airborne at a high angle of attack³ and at a low airspeed. It continued flight in a left turn; the turn was initially unstabilized, and then became steeper, while the aircraft continued to climb.

Kuva 1. The aircraft's trajectory as derived from a video footage. The numbers refer to the text.
(Source: eyewitness material)

The aircraft continued in the left turn, and by the time it had turned about 180° and was flying almost parallel to the runway, the bank angle had attained about 70° to the left (4), and the aircraft was more than 50 m above ground level (AGL). It then began to descend, and the bank angle reduced. By the time the aircraft was at about 20 m AGL, it was banked left more than 30° and descending on an easterly heading, which meant that the heading change during the turn was about 330°. The aircraft then stalled to the left (5), and the sink rate increased significantly.

The aircraft impacted terrain left wing first. On impact, the bank angle was over 70°, and the aircraft was in about 45° nose down attitude. The engine operated at maximum power until impact (6). After the initial impact with the left wing, the aircraft rotated approximately 180° about the vertical axis, and the nose hit the ground. The aircraft then bounced, tail first, about 5 m and came to rest upright with the nose pointing towards the east. The airborne time was about 20 s. The aircraft was destroyed by the impact, and the student pilot sustained fatal injuries.

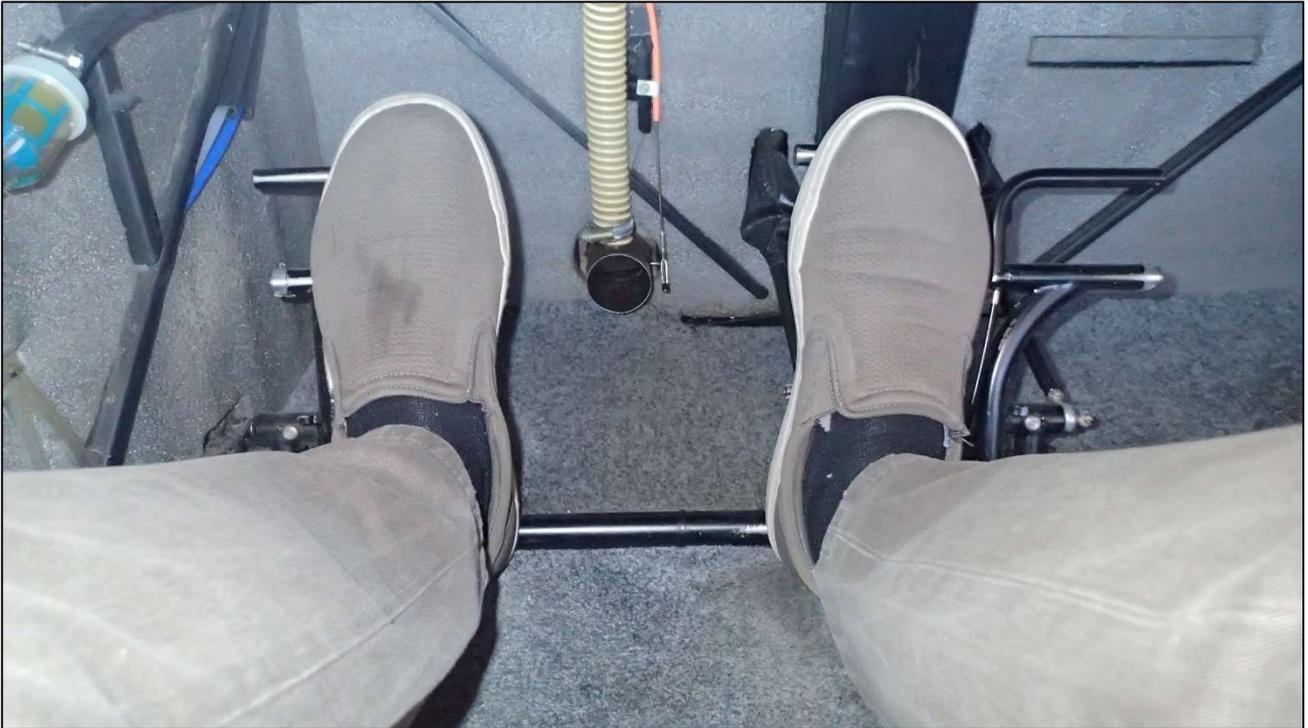
One characteristic of the accident aircraft type is significant propeller torque that causes left yaw on takeoff. The pilot should counter this tendency by the carefully timed application of the right pedal.

Kuva 2. Correctly positioned feet on a pedal assembly. Photo: SIAF

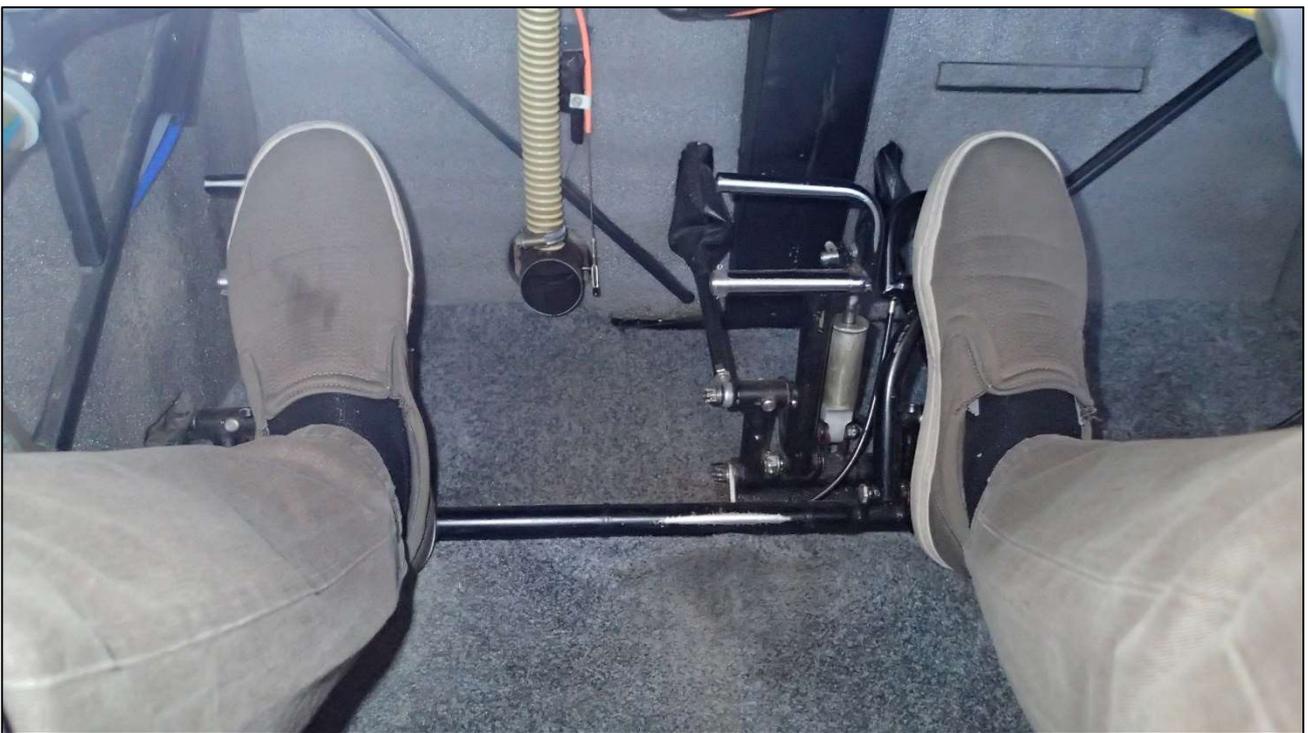
Kuva 3. Right foot positioned incorrectly. Photo: SIAF

A factor contributing to the abnormal rudder operation could have been an incorrect foot position made possible by the pedal configuration of the accident aircraft type. It is likely that the student was inadvertently resting his right foot on the left pedal of the copilot's (right) pedal assembly and applied pressure on this pedal. The aircraft manufacturer has designed a barrier that can be retrofitted between the pedal assemblies to prevent such a foot position⁸. However, since the associated service bulletin is non-mandatory, some aircraft owners elect not to implement it, although the modification would enhance safety, especially in aircraft that are used for training.

Conclusion: *The pedal assemblies are located very close to each other. This configuration is conducive to incorrect pedal application.*
