Accident Resulting in the Death of a Captain at Kittilä Airport on 4 January 2018

L2018-01

Investigation: L2018-01
Investigation report: 13/2018
ISBN: 978-951-836-528-3 (PDF)

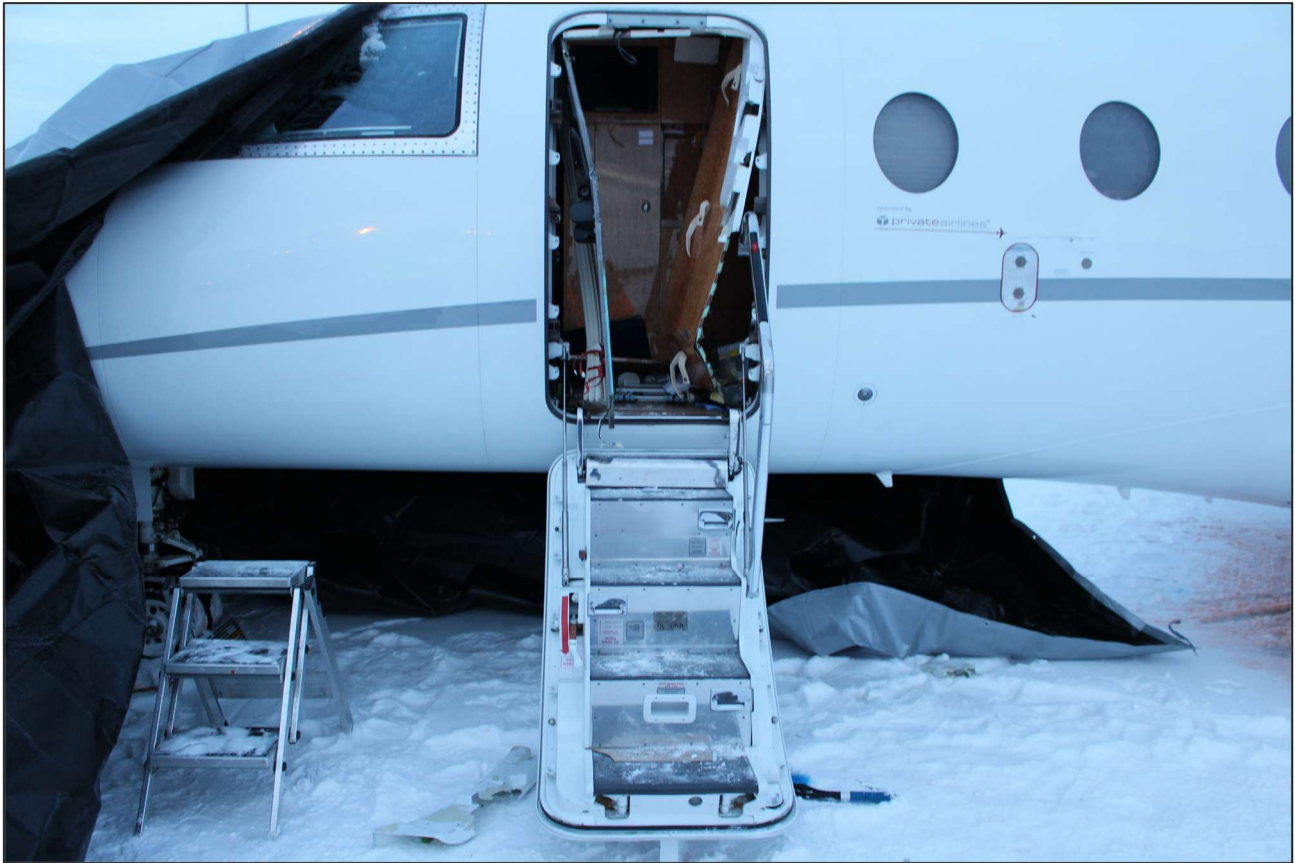
Image 1. Post-accident photo of the doorway. (Photo: SIAF)

The cabin sustained substantial damage. The cockpit's aft left bulkhead and the cabin's forward left bulkhead were nearly torn off, left hanging by only a few fastenings near the doorway. The airstairs' acoustic entry curtain and the extinguisher, flashlight and crash axe,

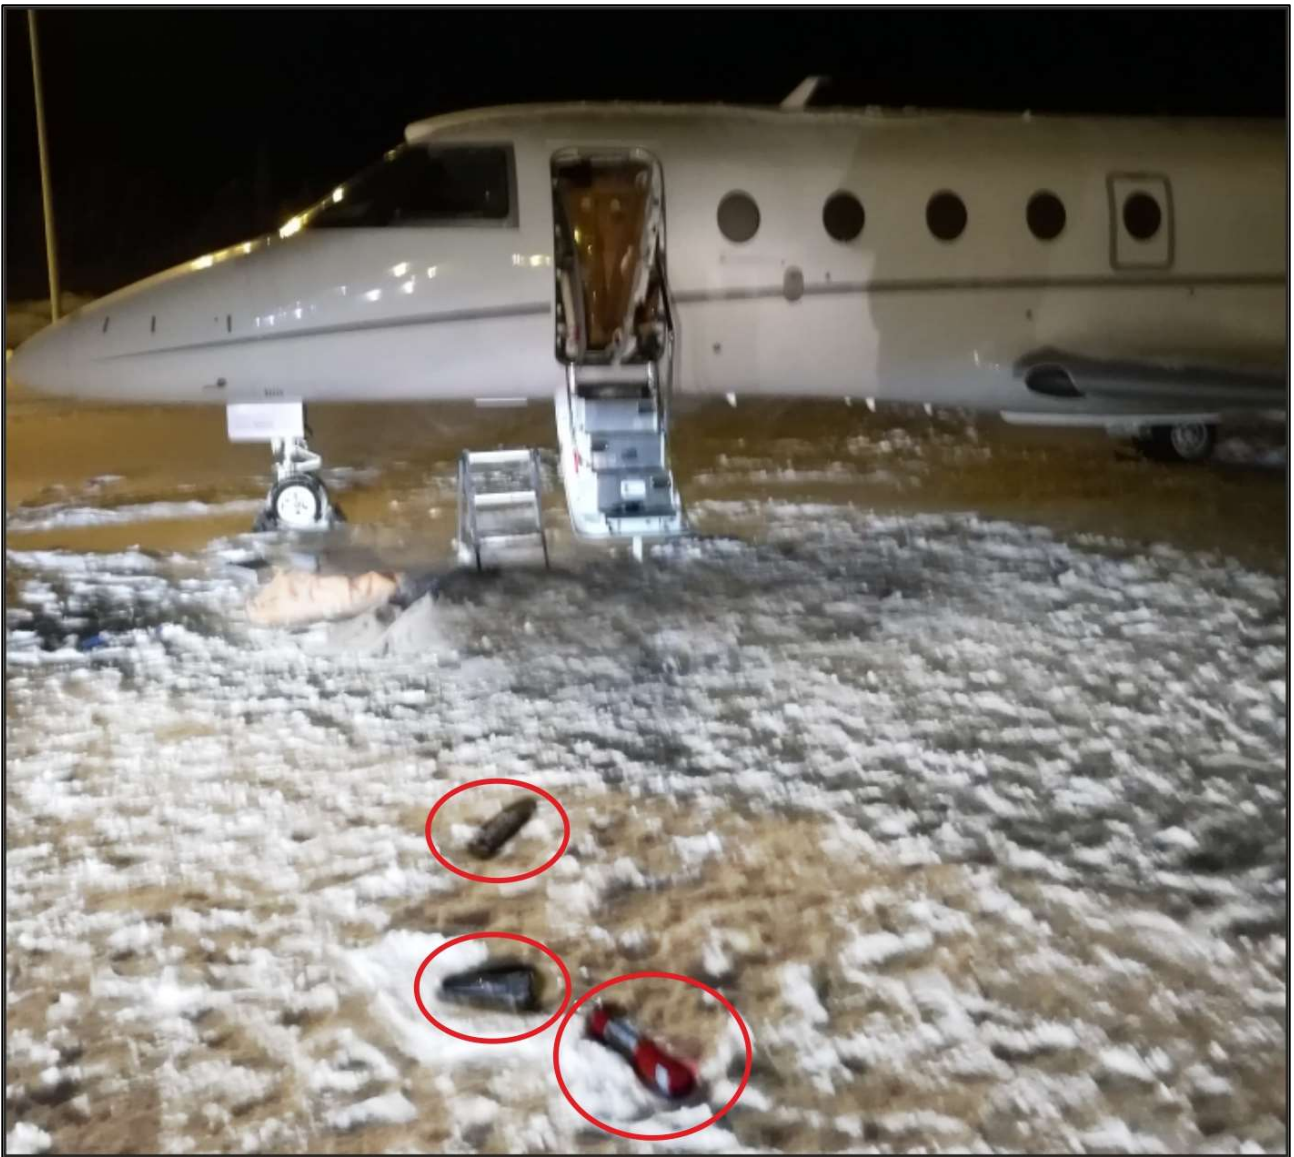
Image 2. In the forefront of the photo are the loose items ejected from inside. (Photo: Lapland Police Department)

which were fastened to the cockpit's aft bulkhead, came loose from their fastenings and were ejected out approximately 5 m from the door. When the front cabin bulkhead came loose, the tableware storage drawers on the bulkhead broke and the dishes were broken. Several cabin wall panels came loose from their lower fastenings. The cabinets in the aft cabin toilet had opened. The oxygen box in the headliner, closest to the door, had opened and two oxygen masks were hanging on their air hoses.

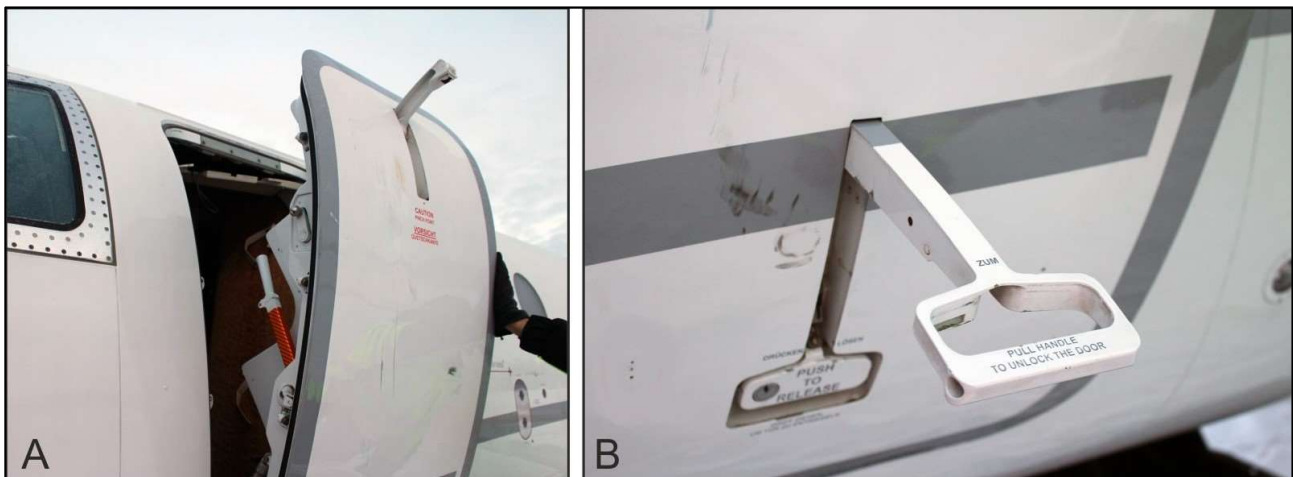
Image 3: 3A: The door in the process of opening, the ground support leg has come out.
3B: A close-up of the stirrup handle. Photo: SIAF

According to the co-pilot’s observations the captain had to use much more force than usual when he was opening the door. This difficulty was caused by the differential pressure between the cabin and the outside ambient pressure. During onsite testing, the door appeared to close and open normally once displaced wall panels that had come loose in the accident sequence were repositioned.

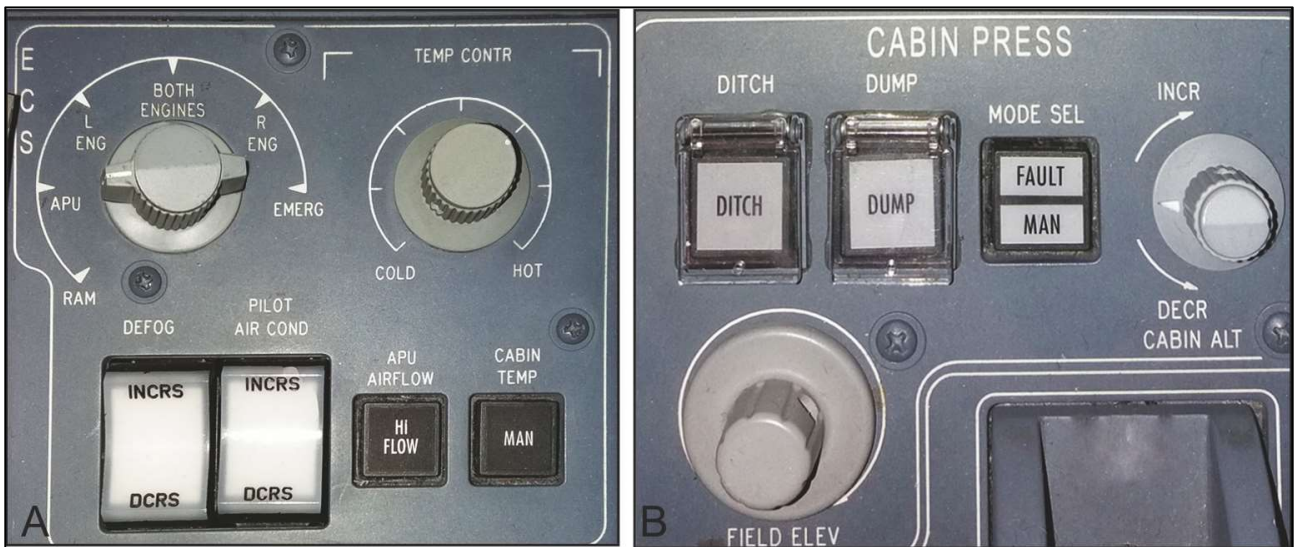
Image 4. 4A: The ECS control panel where the bleed air is selected to APU and the temperature control knob is turned to approximately the one o'clock position.
4B: The Cabin pressurisation control panel. (Photos: SIAF)

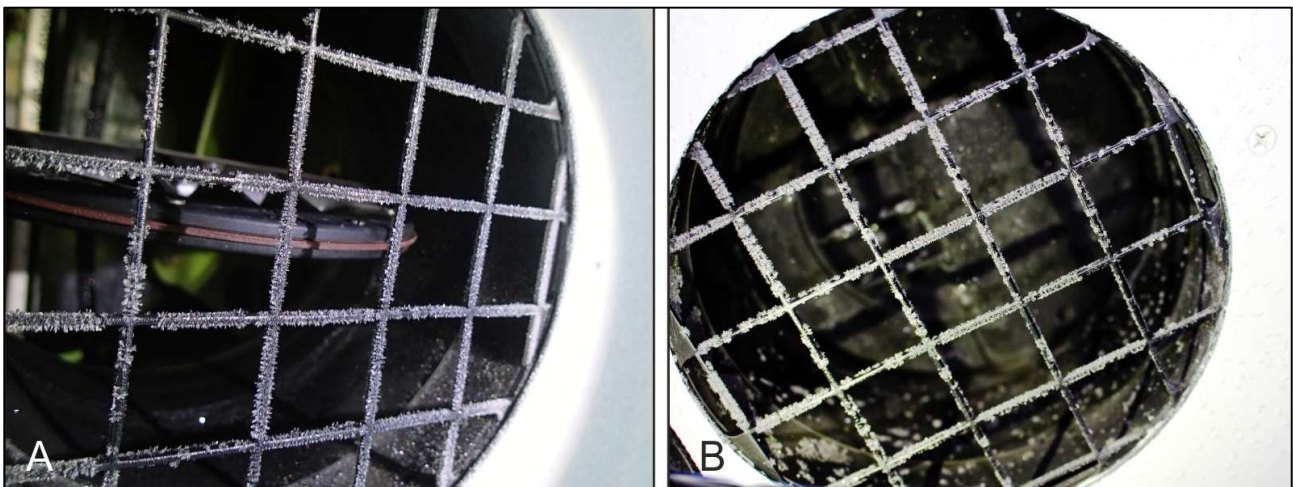
The outflow valve exhaust opening is positioned below the cockpit, on the right side of the front fuselage. The opening is protected by a metal grill and the actual valve is deeper inside the fuselage. According to the cold weather operating instructions the pilot must check the outflow valve during the walkaround check. It must be ascertained that no packed snow or ice has accumulated inside the valve. In Kittilä, in the conditions that prevailed at the time of the occurrence, this would have required the use of a flashlight or some other light source. According to the co-pilot’s statement the outflow valve was not checked visually at this stage. The outflow valve opened and closed normally during testing, and no snow or ice was detected. The aircraft was parked outside in sub-zero temperatures after the accident and before testing. This was done so as to preserve the conditions that prevailed at the time of the accident, so that a possibly frozen outflow valve could not have thawed in the meantime.

Image 5. 5A: Outflow valve open.
5B: Outflow valve closed. (Photos: SIAF)

- Failure to check the outflow valve may result in inadvertent cabin pressurisation when APU bleed air is ducted into the cabin while the door is closed.
- When operating in cold conditions, the instructions in the Cold Weather Operations Manual must be followed.

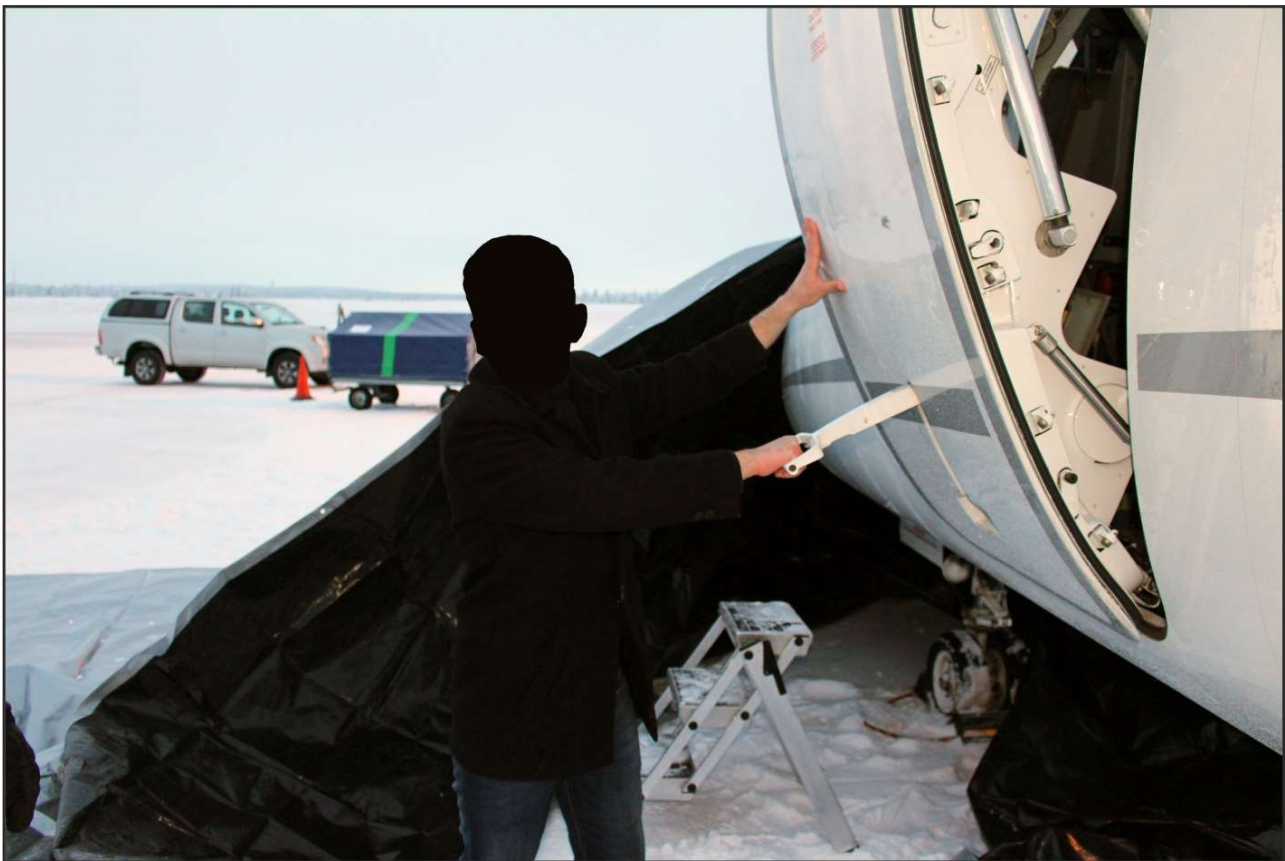
Image 7. Typical hand positions when opening the door. (Photo: SIAF)
