Incident on Helsinki-Vantaa Airport Runway 22L on January 18, 2019

Investigation: L2019-02
Investigation report 15/2019
ISBN: 978-951-836-562-7 (PDF)

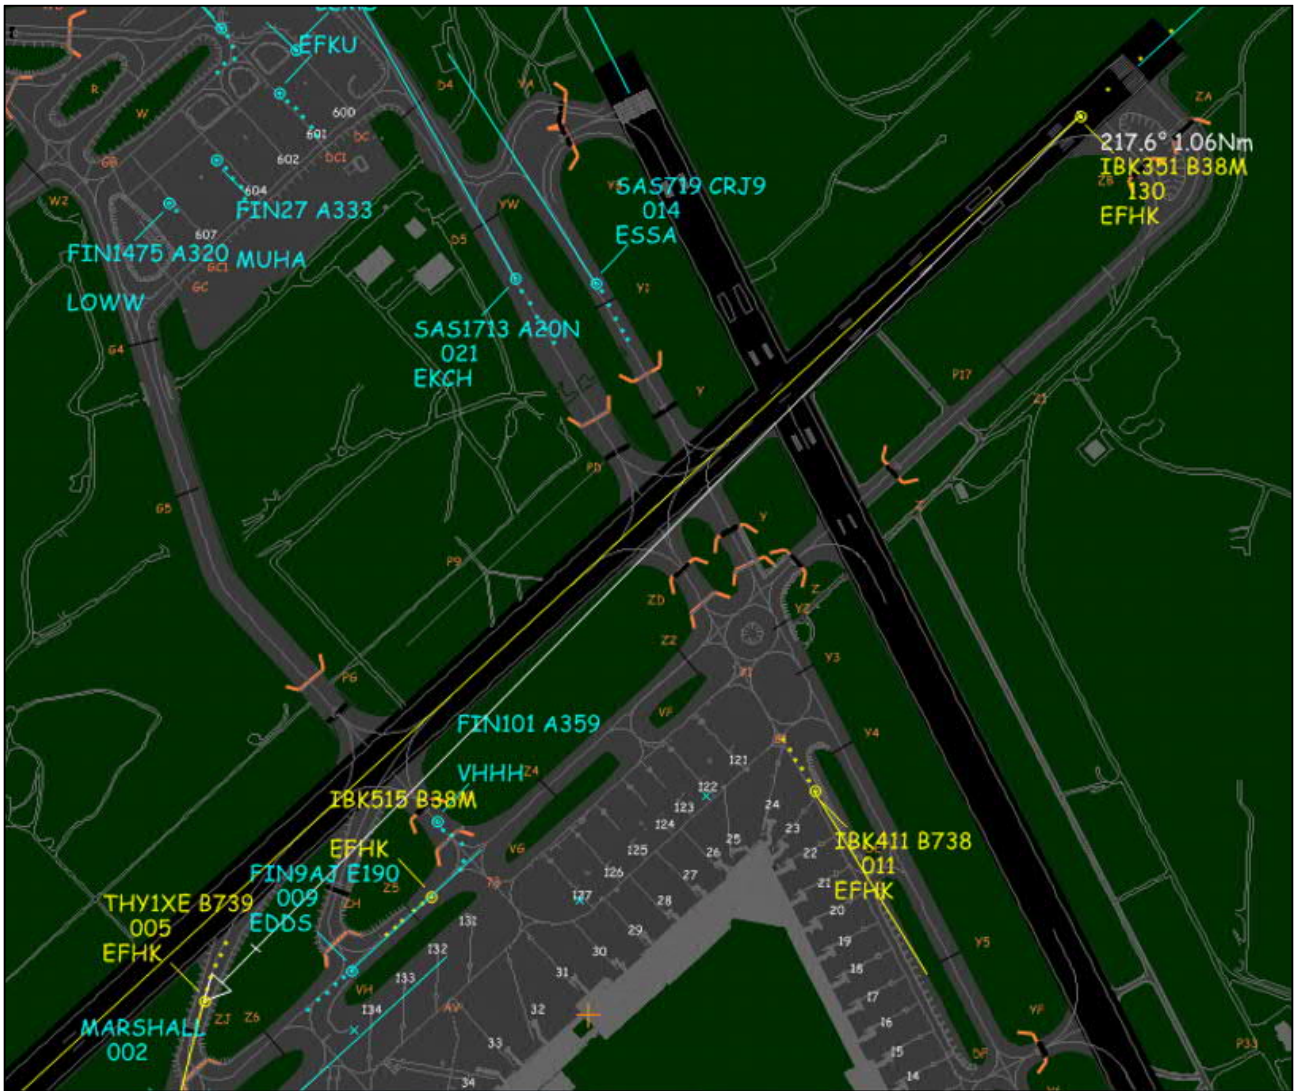
THY1XE had slowed down markedly during rollout and entered taxiway ZJ at approximately 9 kt. Speed subsequently reduced to approximately 4–5 kt on the taxiway. The controller told THY1XE to vacate the runway and contact ground control. By the time IBK351 was arriving over the threshold, THY1XE had vacated the 60 m wide runway and was entirely on the taxiway.⁵ Tower controllers monitored the situation but due to the slow speed were unable to positively determine whether the airplane was moving or not; the controller therefore concluded that the runway was still occupied and transmitted to IBK351, “go around, I say again, go around.” The controller used the phrase go around twice in the brief message.

⁵ Surface movement radar data reveals that the perpendicular distance between THY1XE and the runway edge was about two thirds of the runway width, i.e., approximately 40 m.

Figure 1. Rendition of the incident based on available data. In the upper right corner, IBK351 is practically above the threshold, while THY1XE is in the lower left corner, moving at a slow speed on the taxiway. The image does not represent the radar picture available to the controller at the time of the incident. (Source: ©ANS Finland)

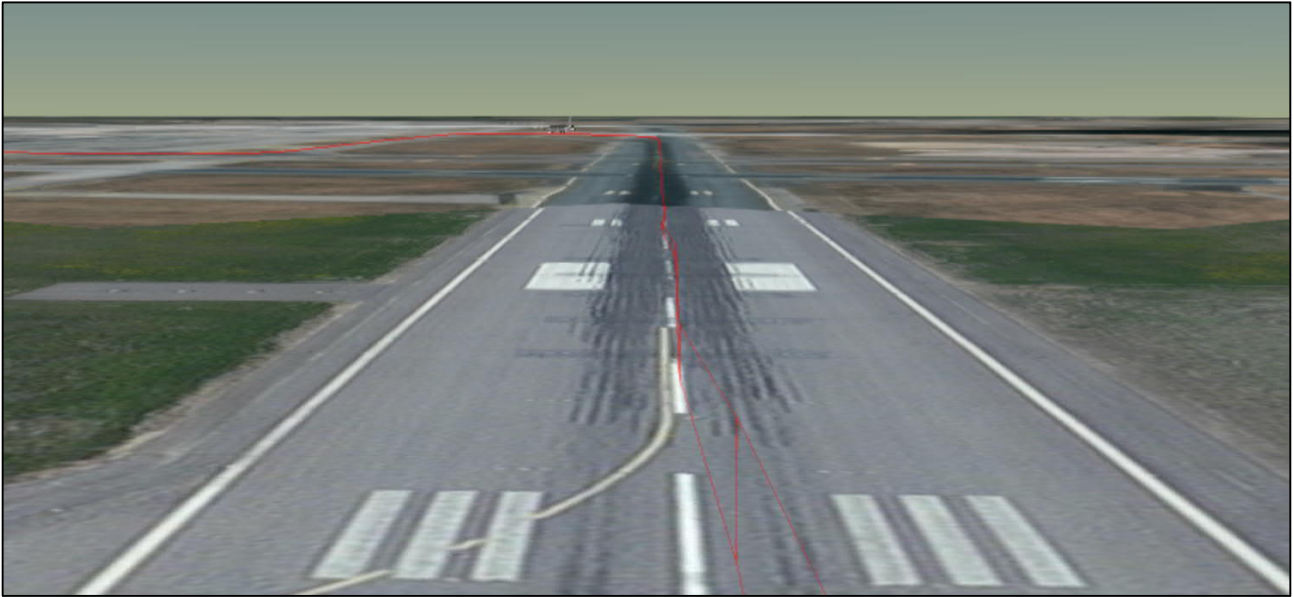
In the flight deck of IBK351, the entire go-around instruction consisting of the flight's call sign and the two-part message was masked by automated callouts that alerted the pilots of the passing of 50, 40, and 30 ft of altitude.

Figure 3. A reconstruction of the view from IBK351's flight deck at the moment of threshold crossing. THY1XE is in the distance off to the left side of the runway. The image does not correspond to the lighting conditions at the time of the incident due to software-related reasons. (Source: Flight IBK351 DFDR-data; Norwegian Air International)

ANS Finland pays attention to the way controllers speak during communication and the tone and volume of speech in the delivery of critical messages. The principles shall be clearly documented and observed during site-specific and other training. [2019-S62]

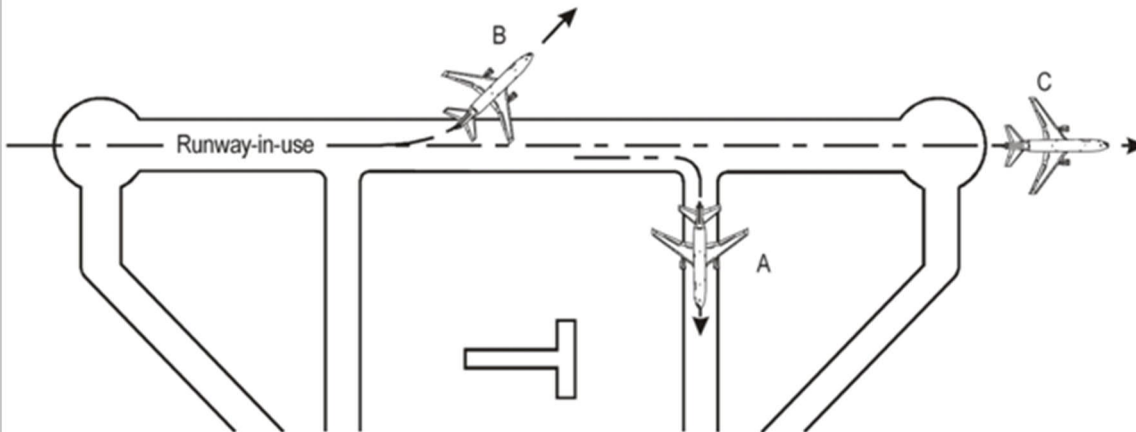
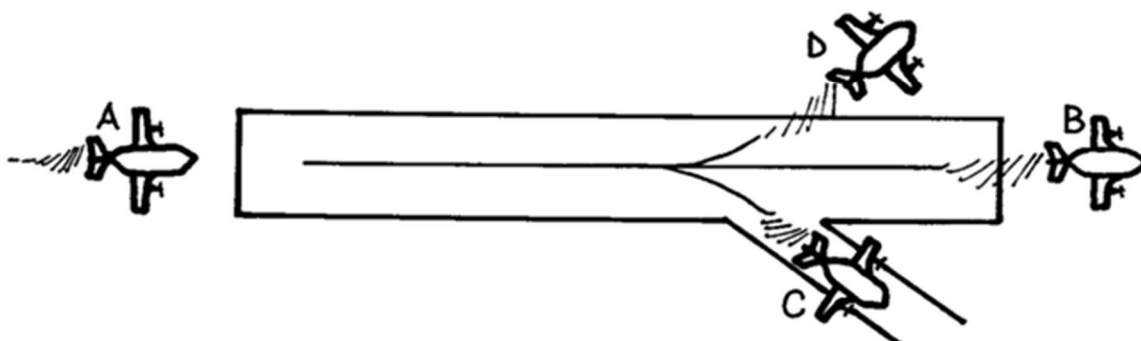
Figure 4. The ATCOH uses two figures to explain the conditions that shall exist when a runway is considered vacated. The upper figure comes from a foreign document and is found in paragraph 4.4. The lower figure, which is in paragraph 11.4.5, contains essentially the same information. The underlying notion in both figures is that the runway is vacated when the preceding landing aircraft has exited the runway. The 'wakes' in the lower figure indicate a moving airplane. (Figures: Air Traffic Control Officer's Handbook, ©ANS Finland)

Condition ii) uses two coordinating conjunctions (or and and) and discusses two aspects of runway operations: turnoff and crossing. The phrase "is in motion away from," that follows the conjunction and, can be interpreted to mean only the latter case (has crossed the runway and is in motion) or both (also: has turned off the runway after landing and is in motion). The latter interpretation is probably correct, because otherwise the text would contradict condition i), at least up to the 50-meter distance.

Since conditions i) and ii) are separated by a comma and conjunction or, it suffices that only one of the conditions is met in cases where reference is made to a preceding landed aircraft; in other words, the runway will be considered vacated after the aircraft has turned off the runway – that is, the rectangular area mentioned in the definition – and is also in motion away from the runway. The ATCOH uses two figures (Figure 4) to visualize the foregoing scenarios.

Traficom and ANS Finland launch a joint long-term risk analysis of potential hazards associated with landing clearances that are based on reasonable assurance. The analysis would look at challenges to the controllers, the potential consequences of non-executed go-around instructions, and other contingencies. The results would be used to revamp the existing procedures by eliminating the possibilities of inconsistent interpretations resulting from the way the conditions are prescribed in the present documents. [2019-S61]
