# Airliner Evacuation due to Smoke in the Cockpit at Helsinki-Vantaa Airport on 30 June, 2020

## **SYNOPSIS**

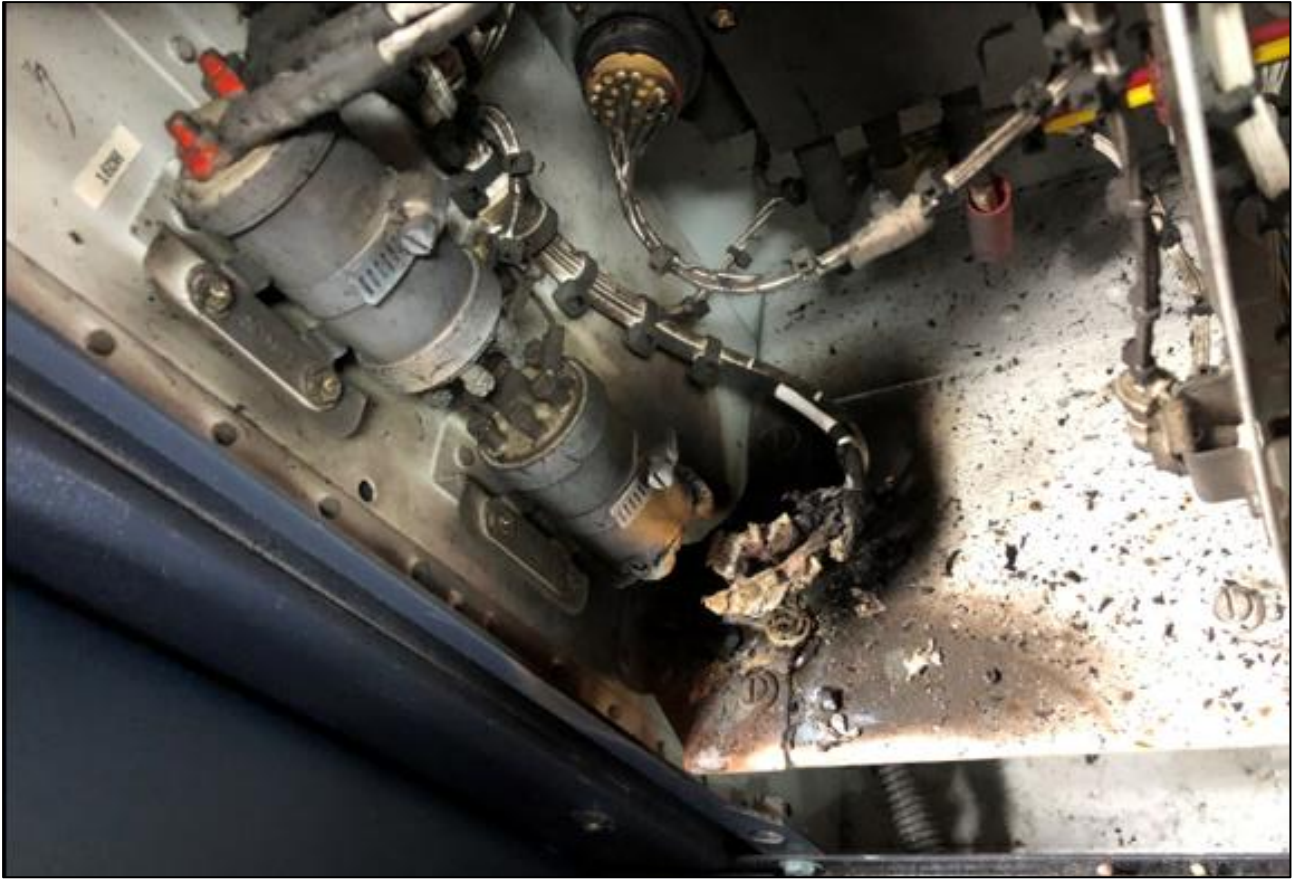
In the inspections conducted by the aircraft's maintenance organisation the propeller 1-3-5 anti-icing relay, position 18DH, proved to be the cause of the smoke. Its main moving contacts and the end of the relay had melted. The relay had experienced a fault 10 minutes after the anti-icing system was turned off. The fault caused the relay's contacts to overheat, which in turn damaged and partly melted the propeller control relay inside the avionics bay. There was abundant dust around the relay and wiring inside the avionics bay. Traces of burnt dust were also detected in the compartment above the burnt avionics bay.

The avionics bay is normally vacuumed and cleaned of dust and grime during more extensive periodic maintenance. Judging by the large amount of dust the cleaning had possibly been omitted, or poorly done, during the previous maintenance.

**Figure 4.** The burnt anti-icing system relay, the photo was taken before repairs. (Photo: Norra)

5. The smoke detected by the pilots and aircraft systems came from the faulty relay. Burning dust inside the avionics bay increased the smoke generation.

**Conclusion:** *Avionics bays are only opened during more extensive periodic maintenance, or when systems fail. Dust accumulation is not monitored. Excessive dust and grime speed up equipment overheating because of degraded cooling and strengthen a developing fire.*

The operator should, together with the aircraft manufacturer, add the type 101CC01A2 relay to the periodic inspection list and, possibly, consider it a HT time-monitored<sup>3</sup> component.

At the same time, it is suggested that the inspection period for cleaning the avionics bay be shortened to prevent possible dust accumulation.

The aircraft operator has implemented proactive action so as to prevent any similar occurrences. All of the company's ATR propeller anti-icing system relays will be measured and tested as per the manufacturer's instructions. Should any relay fail to meet the manufacturer's limits, it will be replaced. At the same time the avionics bays in which the relays reside will be vacuumed and cleaned.

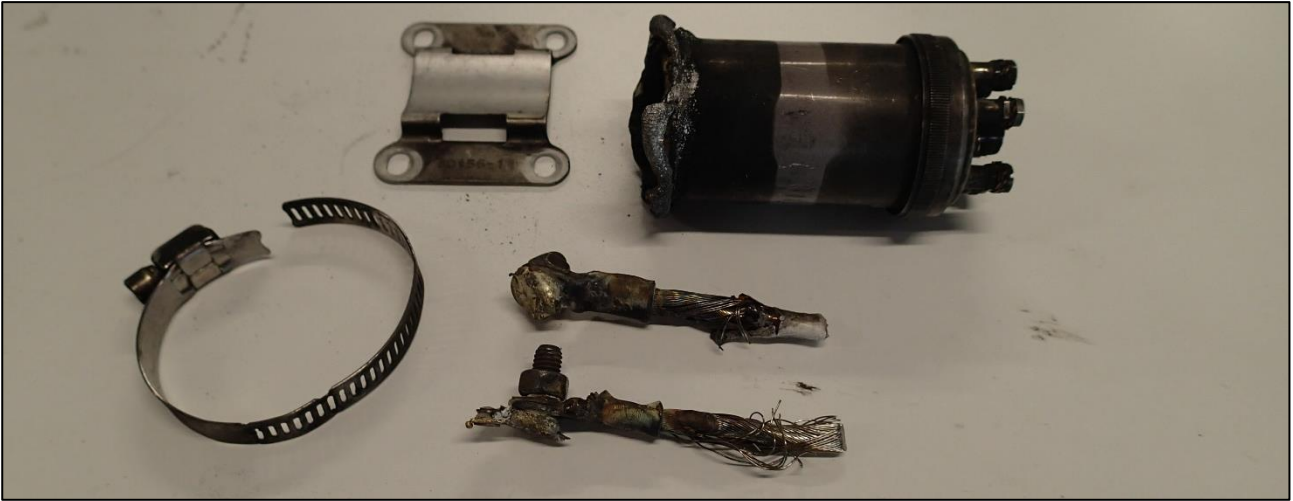
The preliminary investigation did not establish the cause of the failed relay. Its control wiring was intact and attached to the unit. The electrical wiring to the propellers had melted off of the relay. The contacts with which the wires are connected to the relay were still attached to the ends of the wires. The insulations in the propeller control relay had completely burnt on the side of the propeller electricity supply. The relay was partly disassembled but no clear indication of the cause of the fault was found inside it. The contact surfaces and the swivelling insulating plate had melted completely.

**Figure 5.** Parts of the relay. The end of the main moving contact had melted and contact surfaces 1 and 2 had loosened from the end. The main moving contact had completely melted. (Photo: SIA)

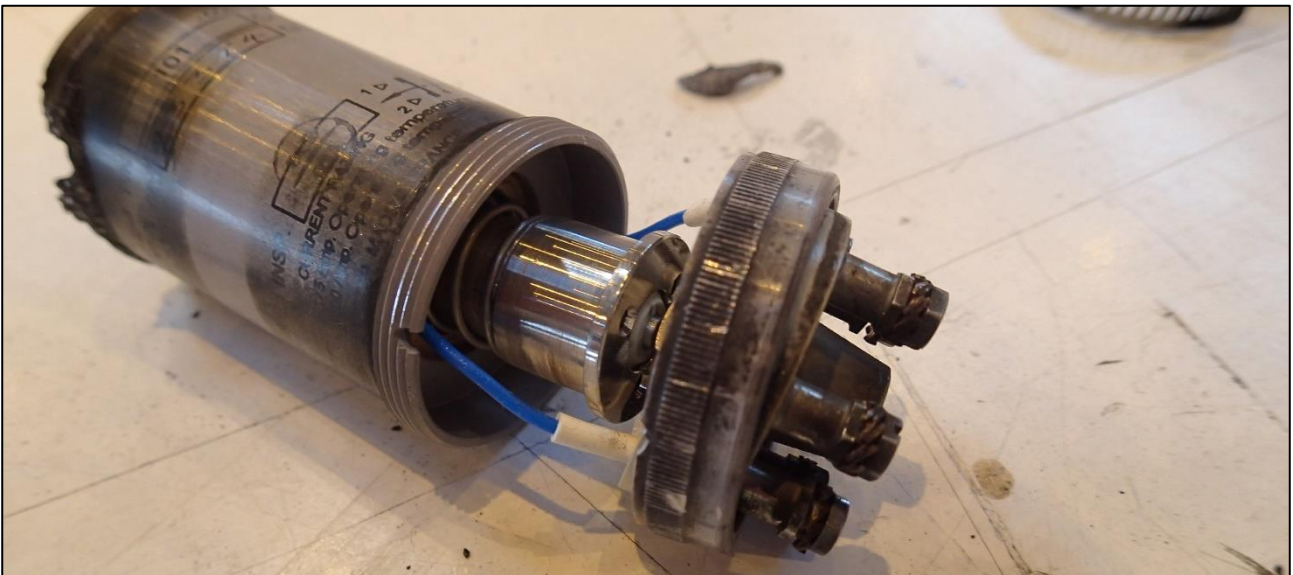
The end of the relay's control voltage and of the auxiliary contacts were intact. Similarly, the coil was intact and the trunnion moved freely inside it. Also, the spring which keeps the trunnion in its default (rest) position was intact.

**Figure 6.** The opened end of the relay's control voltage and auxiliary contacts. The trunnion and its spring are visible inside the relay. The blue wires connect contact points 3 and 4 to the coil. (Photo: SIA)

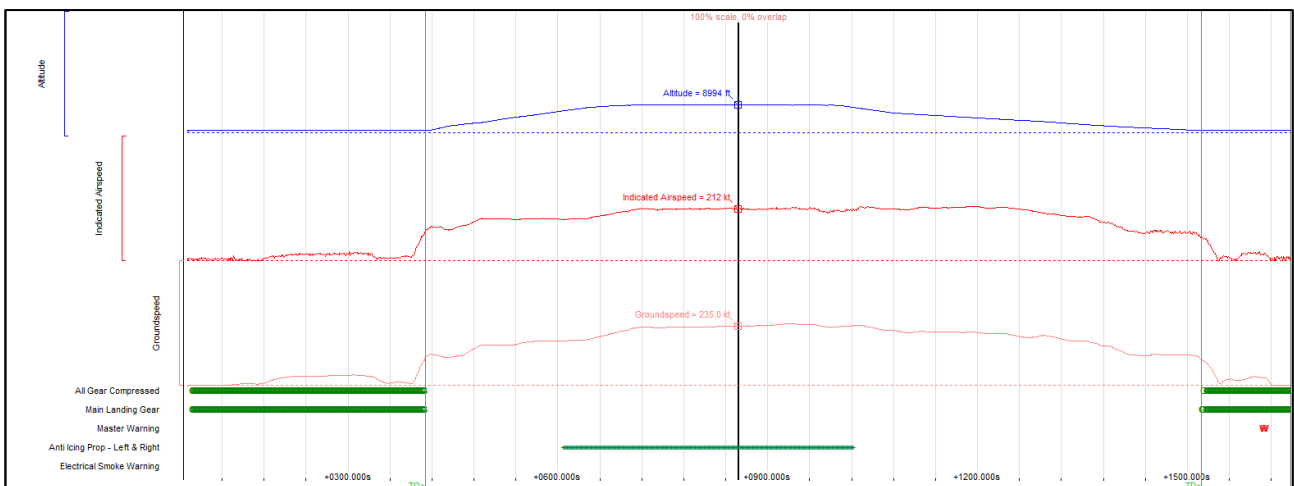
Propeller anti-icing was used on the occurrence flight. Anti-icing was turned on three minutes after take-off at 11:47. The system was turned off nine minutes before landing, at 11:54. While the aircraft was taxiing after landing, the MASTER WARNING activated at 12:04.

Figure 7. A graph compiled from the OH-ATG's flight data recorder information. (Image: Norra)
