Incident report

D 1/2001 Y,
Shortened Version

Bus Fires in Finland during 2001

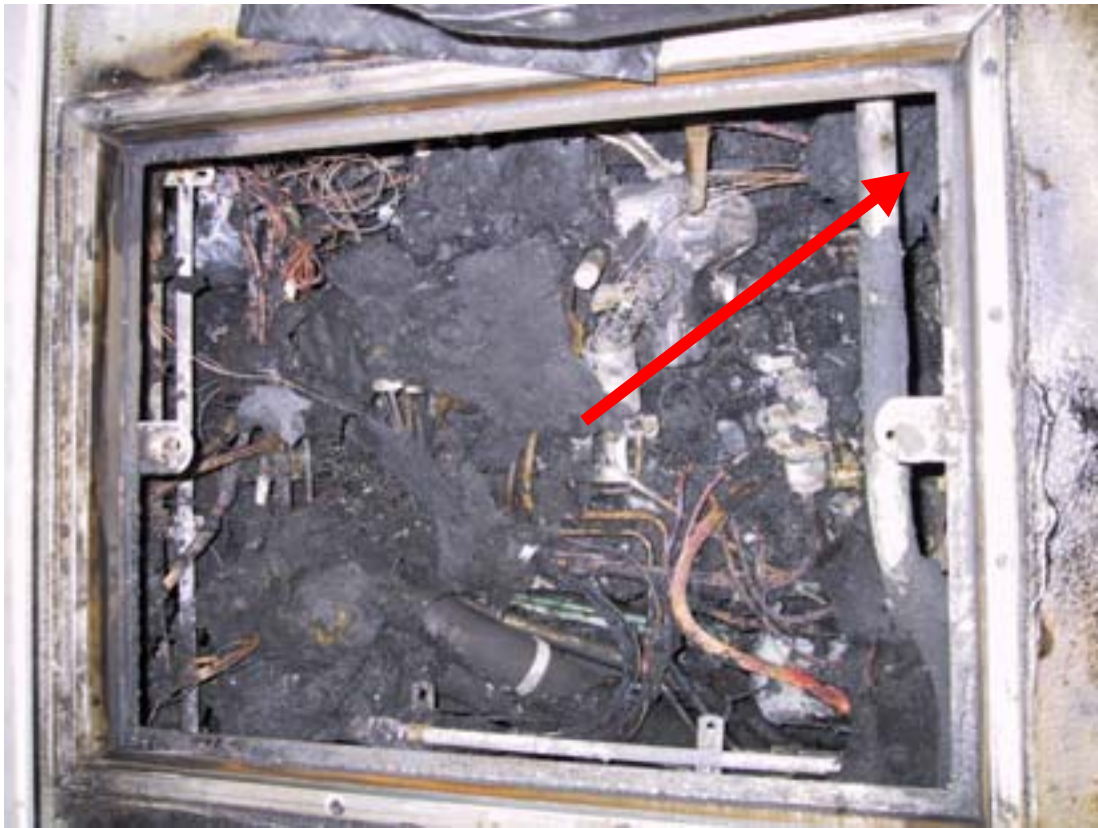
Of the repeated causes of fire that were found in the investigation of the year 2000 one was the abrasion of the battery cable against the hoist bracket of the engine. In 2001 there were still three fires caused by this. In the 2000 report this problem was clearly highlighted so it is surprising that this fault, which can quite easily be repaired, has not disappeared.

Figure 1. Typical damage after the abrasion of the battery cable against the hoist bracket of the engine (Volvo B10B). The arrow points to the location of the short circuit.

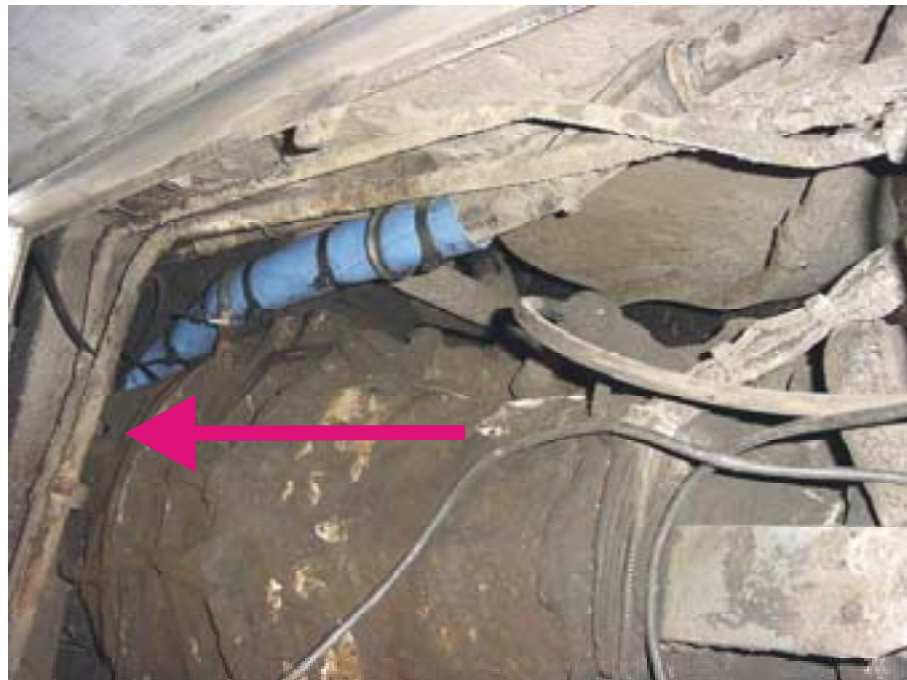
Figure 2. Protection and tightening of the battery cable at the repair shop. The wiring loom has been protected from abrasion with protective tubing and supported well. (Photo : Oy Pohjolan Liikenne Ab)

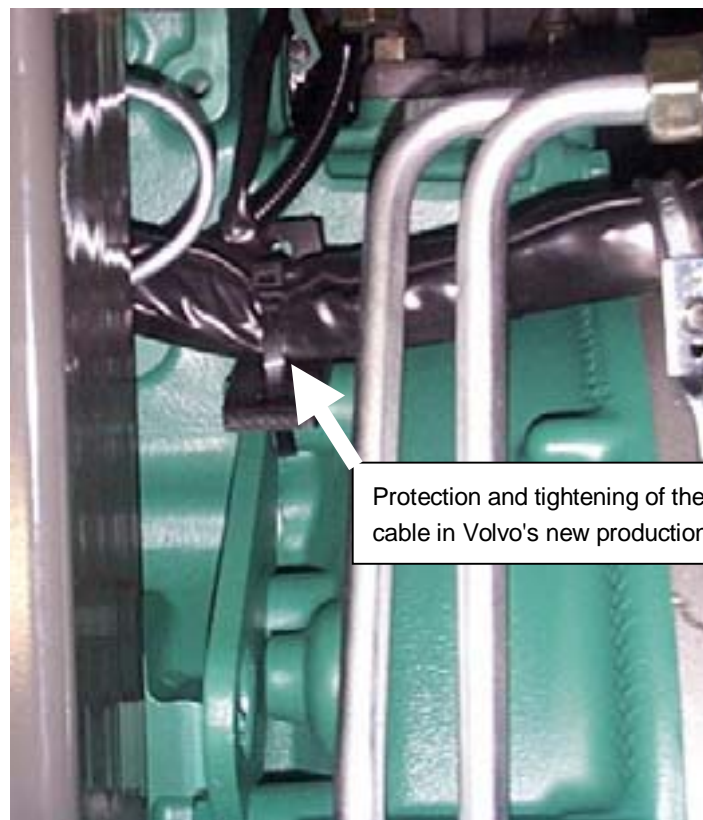
Protection and tightening of the battery cable in Volvo's new production.

Figure 3. The tightening of the cable in Volvo's new production. The hoist bracket is below the tightened cable. (Photo : Volvo Ab)
