Investigation report

A 1/2004 Y Abridged translation
of the original Finnish report

A head-on collision involving a heavy vehicle combination and a charter coach on highway 4 at Konginkangas near the town of Äänekoski, Finland on 19.3.2004

The vehicle combination: Road tractor REY-481 and full trailer PZU-497

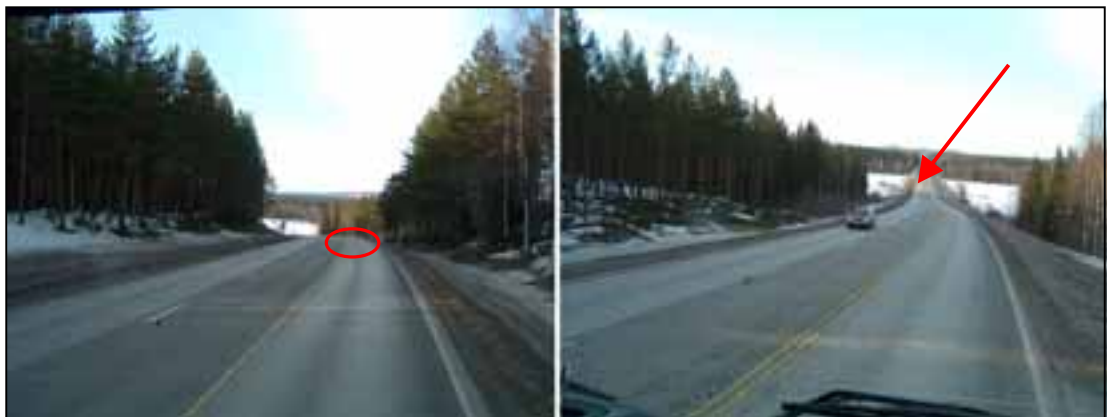
Figure 4. The curve and the hill. The circle indicates the place where the driver lost control of his vehicle and the arrow denotes the point of collision.

In the outermost lane of the curve, used by the full trailer combination, the pavement was visibly grooved and the lane was noticeably uneven.

The pavement of this section of the road was somewhat worn. As for grooves and smoothness, pursuant to the results of groove measurements taken on 3.4.2004, the surface was deemed partly good and partly satisfactory.

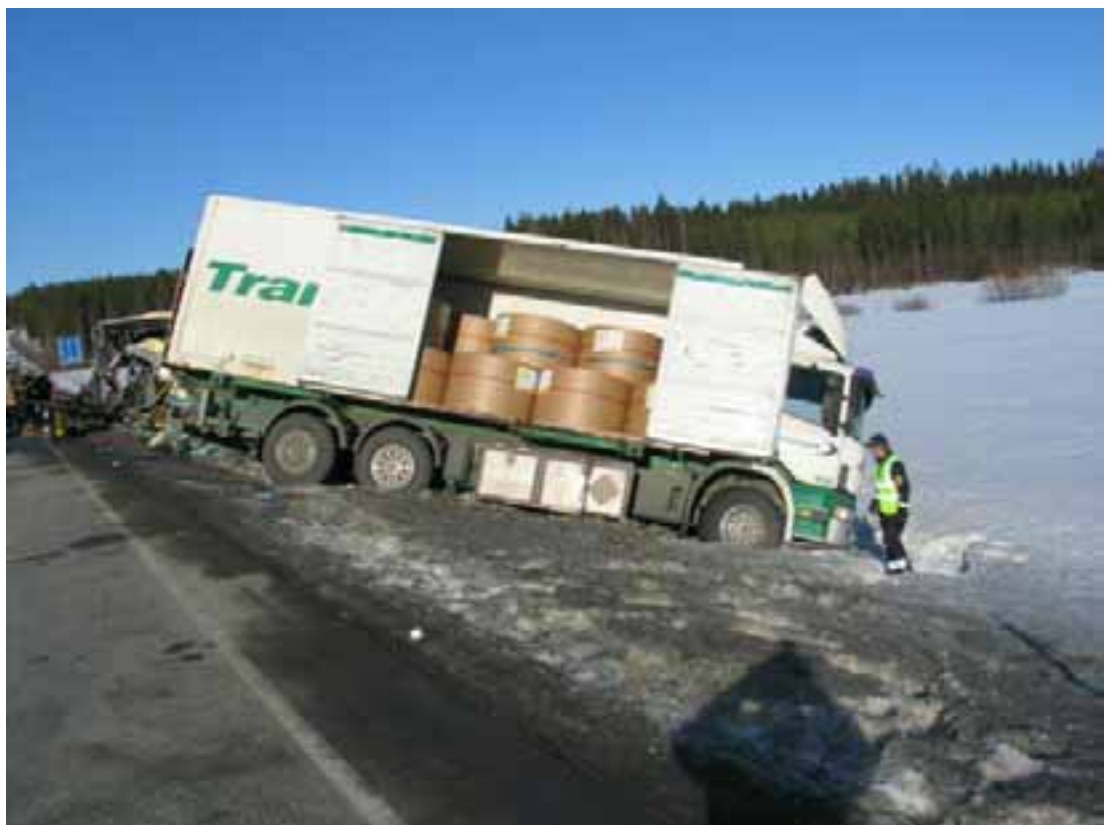
Figure 6. The tractor from the right.

The road tractor lay in the ditch approximately eight metres behind the coach, cabin forward. The rear of the tractor was at the edge of the asphalt. The front wall of the swap body was broken, pressed by the paper reels. The collision guards at the front of the swap body base had given way and as a result, the swap body had plunged forward. The paper reels had also bent the back wall of the cabin inwards.

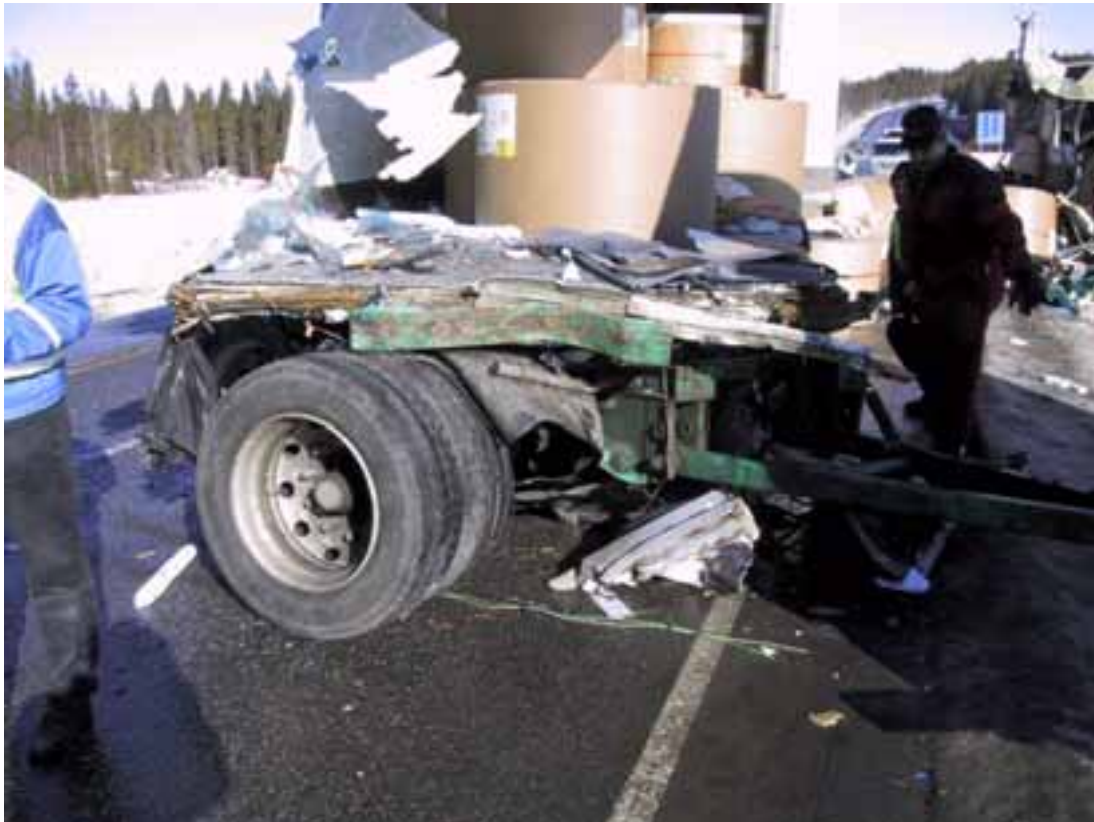
Figure 7. The trailer from the front.

The trailer was beside the coach in the coach's lane. The coupling between the trailer and the tractor had not disconnected. The front end of the drawbar was slightly bent to the left. The aluminium beams on the trailer's right hand side underride barrier had been bent and detached at the rear. The outermost right wheels on the rear bogie were packed with snow.

The front wall of the body was torn loose. Only a 35-90 cm high strip was still attached to the upper side of the front wall. The front part of the trailer's frame had impact marks. The front bogie's left wheels and tyres were badly damaged. The first axle was completely loose and the second one was partially loose. The frame of the front bogie was bent and the left splashguard had come loose and was stuck to the front of the coach. The vertical steel beams in the front corners of the body as well as the body sill of the left side doors had come loose. The right side wall was damaged for about 2 metres'

distance. Of the five door panels on the left hand side the first two had come loose and the remaining three had opened.

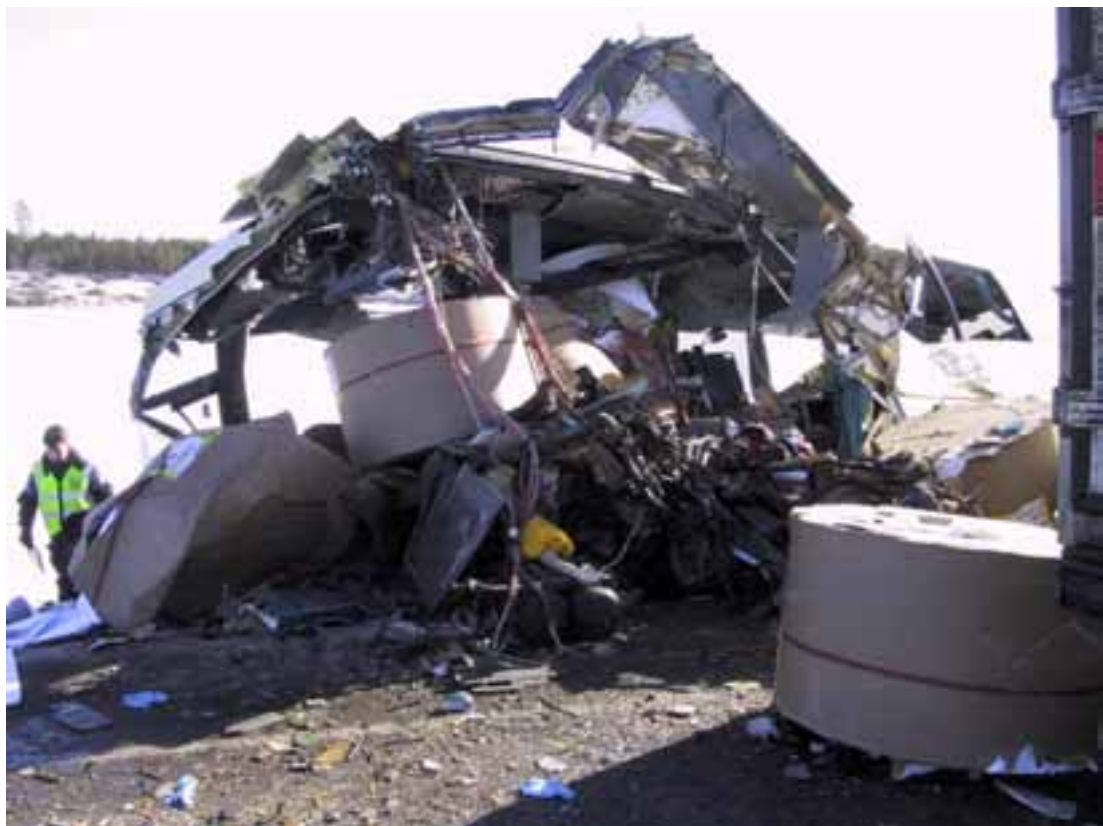
Figure 8. The coach from the front.

The frame structure was crushed all the way down to the front axle. The front axle had shifted rearwards and turned in such a way that the left front wheel was further back than the right wheel. The frame beams behind the front axle were badly damaged. The worst damage extended to the back wall of the front luggage compartment. The left front tyre deflated in the collision. The front floor was crushed for about a five metres' distance. The right hand side front wall had bulged outward all the way to the cabin compartment's middle door. The left side had completely split open for a distance of about five metres. Measuring from the frame beams the impact shortened the coach by 2.1 m on the left and 1.9 m on the right. Furthermore, on the left hand sidewall of the cabin compartment in front of the rear wheel there was an arched impact mark ca. 1.2 m long and 0.4 m high. The chassis was bent inwards and the outer side panel of the coach was torn at this spot.

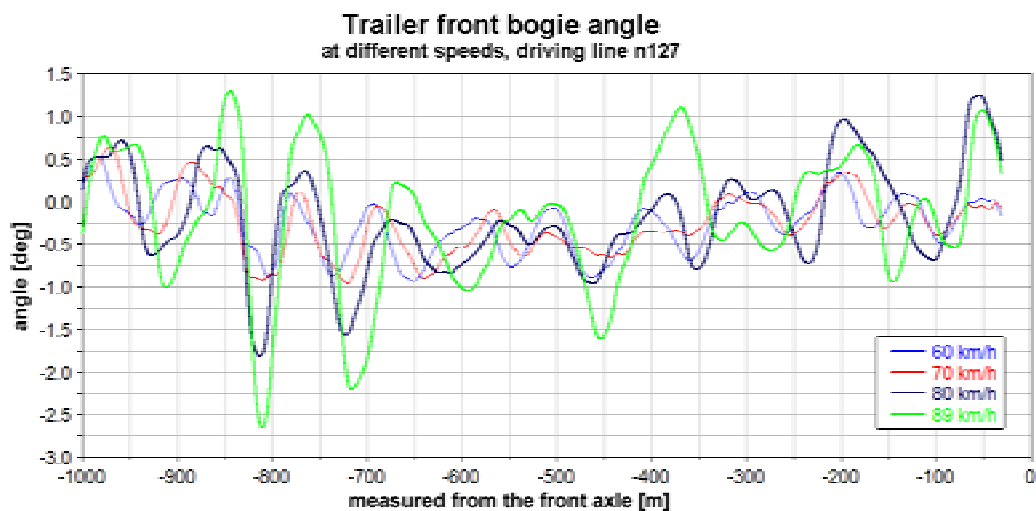
Figure 12. The angle of the trailer's front bogie in relation to the frame at different speeds. The plots clearly show how the trailer's oscillation grows in proportion to the increase in speed. On the driving line n127, the vehicle combination tracks on the left edge of its lane.

Judging by the results the trailer became increasingly unstable as speed increased; figure 12. The most noticeable change occurred when speed increased from 80 km/h to 89 km/h.

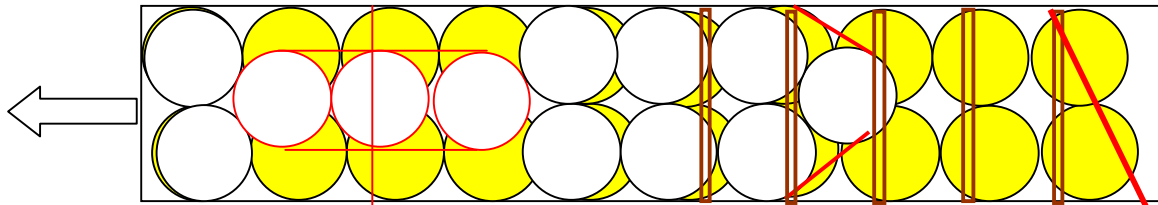
Figure 15. Load anchoring in the trailer viewed from above. The arrow indicates the trailer's heading. The yellow reels are at floor level and the white ones are on top of them.

ward movement of the last reel. The rated strength of the straps was 1 000 daN. In addition to the straps there were three perpendicular barriers resting on top of the reels securing them. No anchoring was in place to block forward forces.

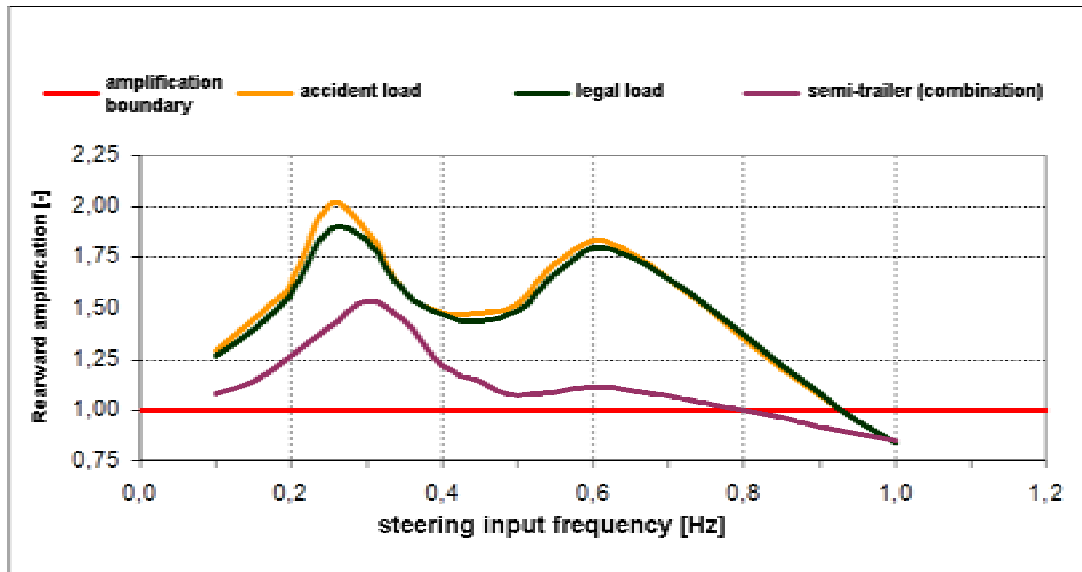
Figure 20. The effect of the load on Rearward Amplification. For the sake of comparison, the typical RA of a semi-trailer is also shown on the graph.

The simulation tested the effect of the load by comparing the Rearward Amplification (the definition of RA is in subpara 1.15.6) of a legally loaded tractor-trailer to that of one carrying an excessive load, such as the one involved in the accident. Figure 20 illustrates that a vehicle combination which is loaded similarly to the collided tractor-trailer displays higher RA, i.e. lower stability, compared to a legally loaded vehicle combination. At the steering input frequencies of 0.25 Hz and 0.6 Hz, the maximum RA grows by 6.5% and 2.0%, respectively.

An increase in RA as such does not result in an accident. However, the vehicle's rearward amplification strengthens, resulting in an increase in the risk of losing control if the driver makes a steer input at a critical steering input frequency in an unfavourable driving situation.

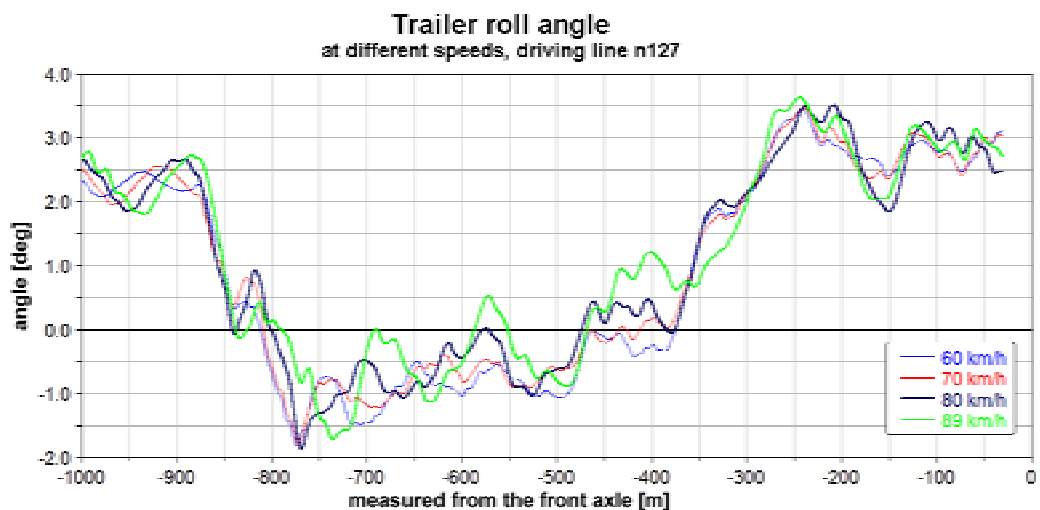
Figure 22. The trailer frame's roll angle at different speeds. Positive angle = roll to the right.

Figure 22 shows that the trailer's roll significantly increases as speed does.

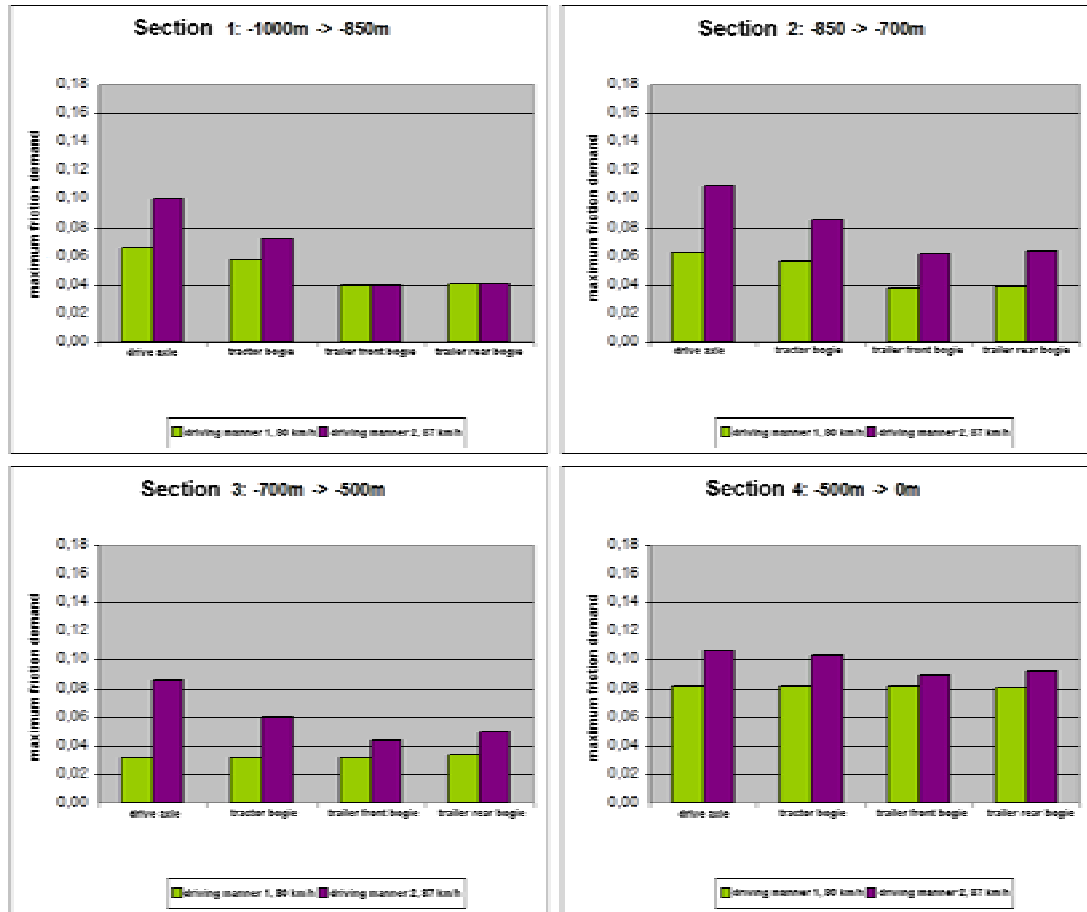
Figure 25. Summation of friction demand maxima in the centre of the lane on different road sections.

Based on simulation it can be stated that had the driver driven in the centre of the lane, no loss of control would have resulted at higher than 0.11 friction.
