Fire that resulted in the deaths of four people in a flat in Vuosaari, Helsinki on 9 December 2016

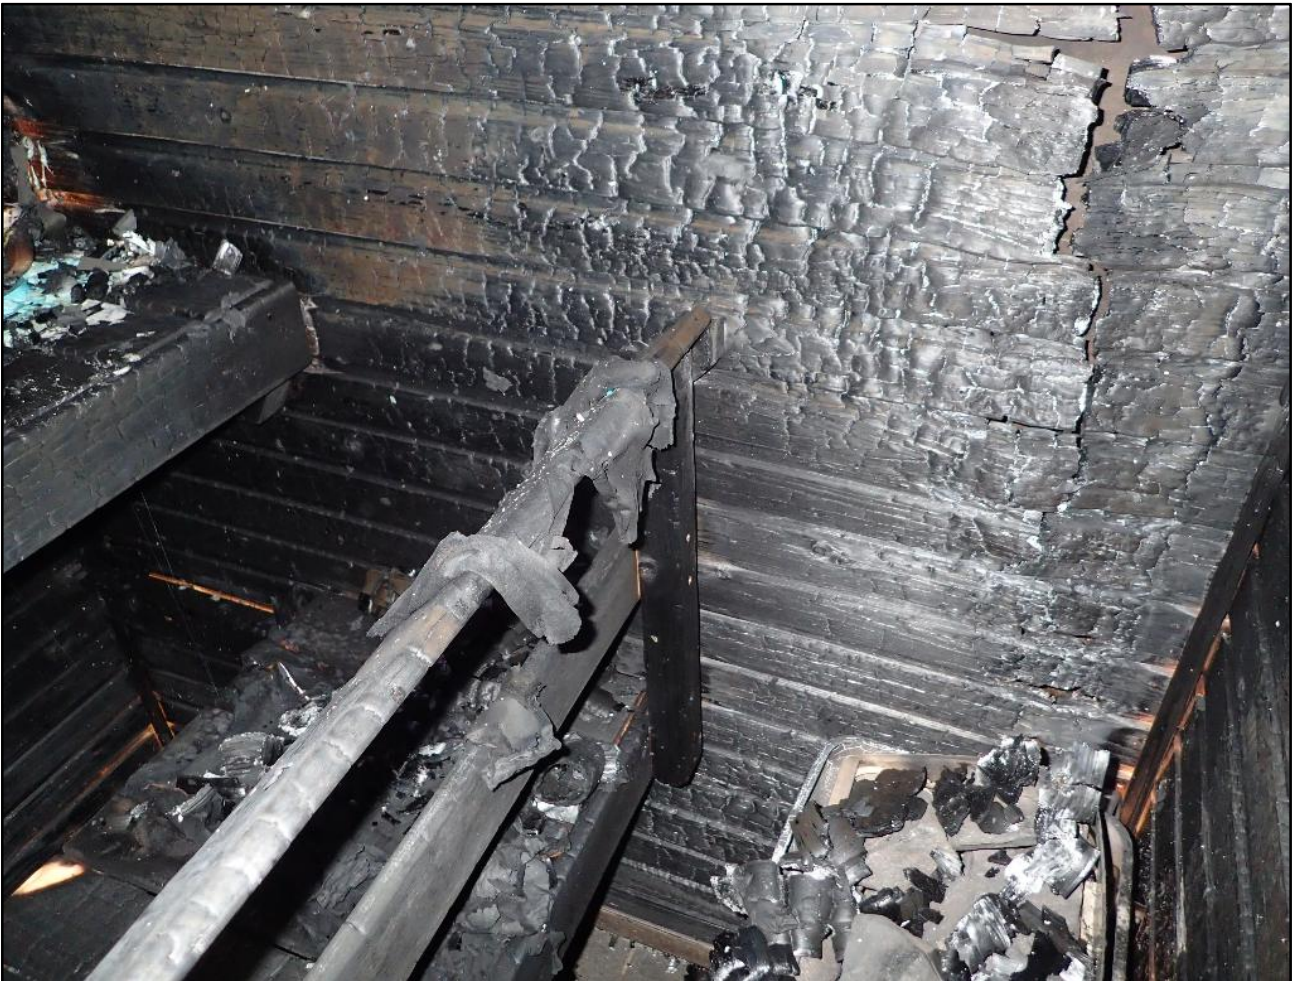
The sauna stove has likely been accidentally or purposefully activated already in the evening by turning the control knob to the timer preselection area. This means that the sauna stove has started heating only after the time set on the timer has elapsed; on the basis of the electricity consumption, this has been around 01:40. The cloths near the sauna stove ignited after reaching ignition temperature, and the burning cloths ignited the wooden floor panels. The

fire developed inside the sauna and formed combustible flue gases in the sauna and wash-room. At this point, the washroom door was closed. A hot water pipe on the washroom ceiling broke, and the water discharged from it limited the fire.

Kuva 1. There were clothes drying on the railings of the sauna stove and items were stored on the seats. The wall and ceiling panels in the sauna were charred during the fire and they partially burned through. (Photo: SIA)

It appears that the door between the washroom and hallway in the flat was half open when the smoke divers entered. The smoke divers did not find the fire immediately, since there were no large flames in the direction of the sauna. The fire had already died down and only a small simmer was found next to the sauna stove. After checking the rest of the flat, the smoke divers proceeded into the sauna and found small fire pockets on the panel wall behind the sauna stove and the burning and simmering clothes on the floor of the sauna. Only a small amount of water was required for the extinguishing. The window of the sauna was opened for ventilation, and at this time, it was observed that the inner glass pane was broken due to the heat. There were several pieces of clothing, shoes and nappies on the benches. The wooden parts of the sauna's inside walls were badly charred due to the powerful fire.

The suspended panel ceiling in the washroom was leaking water at high temperature, since the heat had burst open the hot water pipe. The floor drain was clogged by the crushed glass and fire residue, which caused water to flow over the washroom threshold and into the rest of the flat; there was 2–3 cm of water on the floor. The glass door between the sauna and washroom had broken into small pieces and all plastic parts in the washroom had melted and deformed. The water leak could not be stopped inside the flat; a serviceman was called and he used water shut-off valves located elsewhere. No fire detector was found inside the flat.

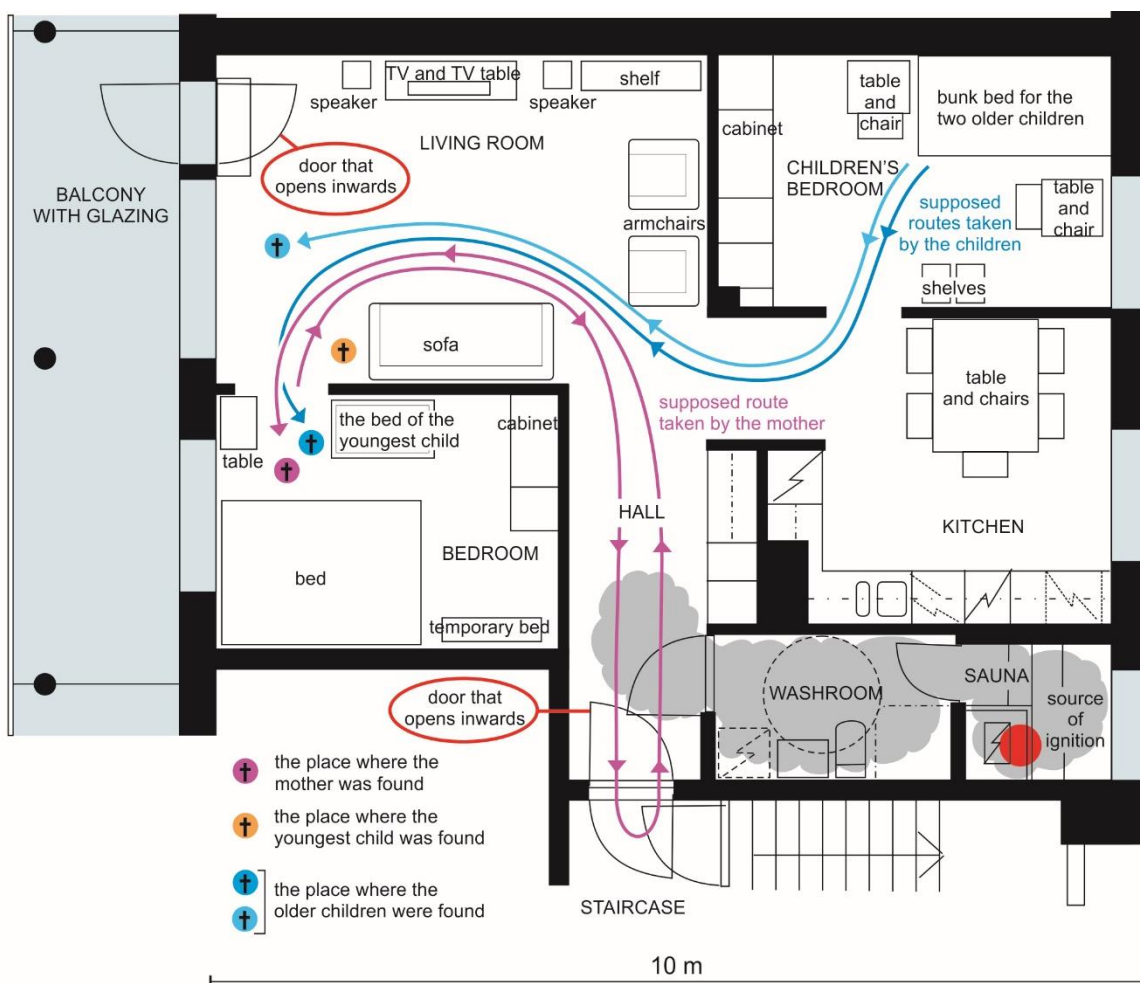
Kuva 4. Layout of the flat. Both doors leading out of the flat open inward. The supposed routes taken by those inside the flat are also marked in the image. (Photo: SIA)

There were two exit routes from the flat: one into the staircase and another into the balcony. Both exit routes had two doors, the inner ones of which opened inward. The fire classification for the outer door leading into the staircase was EI15. According to the father, the outer door had been found open on at least one occasion when he had returned from work.

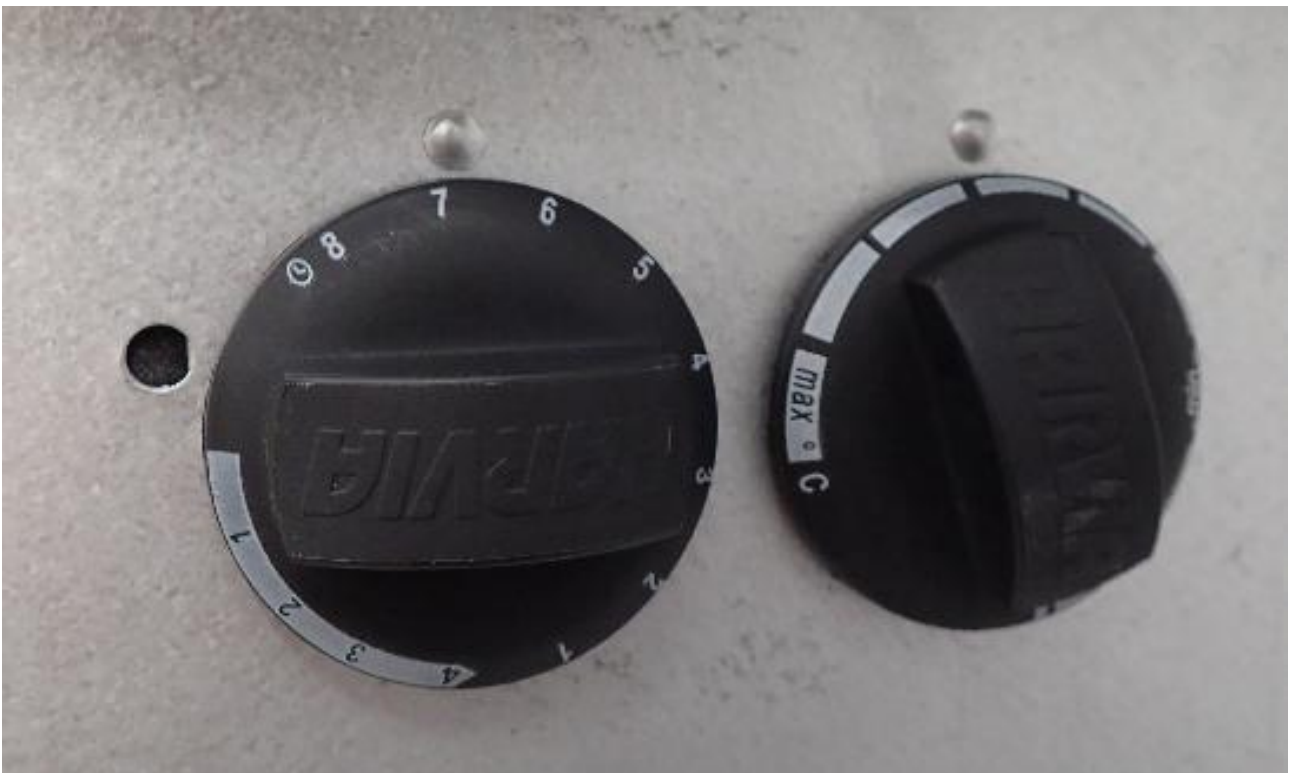
Kuva 5. Control knobs on a new sauna stove of the same make. The control knobs were in reverse order in the sauna stove of the flat where the accident occurred. The small hole on the left hand side of the photo is the reset button for the overheating protection. (Photo: SIA)

The sauna stove was equipped with overheating protection, i.e. a temperature limiter that disconnects the stove when it overheats. The overheating protection had been triggered during the accident. According to the operating instructions, the highest allowed temperature on the wall and ceiling surfaces of the sauna is +140°C.

⁹ The Safety Investigation Authority of Finland requested an estimate of the possible causes of the problem from the sauna stove manufacturer. The manufacturer stated that a technical explanation is not easy to find. The manufacturer considered the most likely alternative to be human error related to the turning of the control knob; it is possible that, when the problems occurred, the knob had been turned slightly too far, into the timer area. The manufacturer's opinion supports the understanding formed during the investigation that the operating logic of the control knobs on sauna stoves may easily cause mistakes or confusion.
