Investigation report

C 11/1997 M

**ms GRIMM, grounding outside port of Kotka, October 1,
1997**

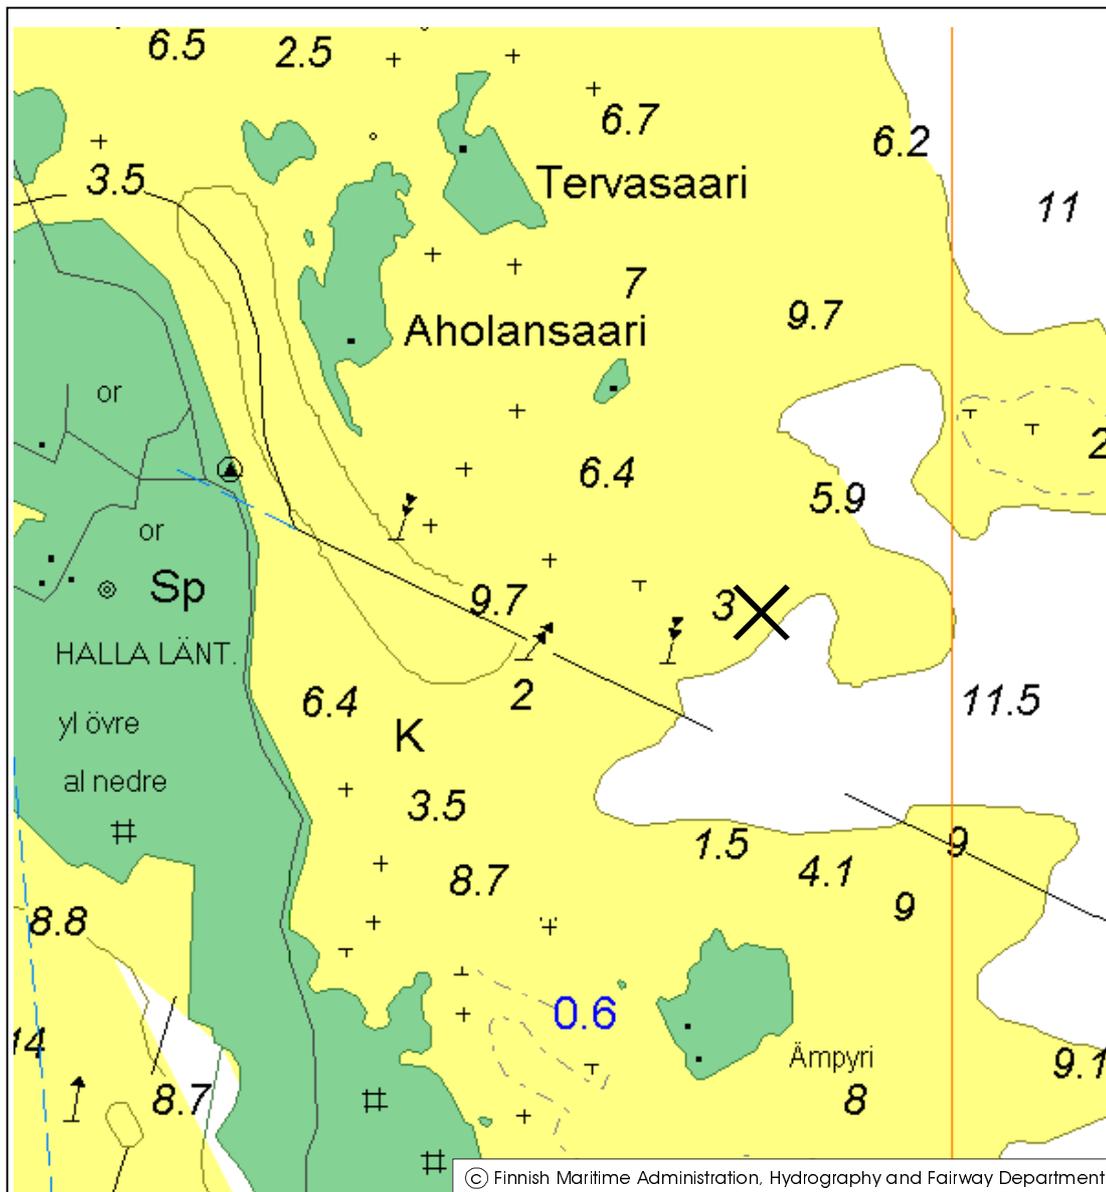
Figure 3. Halla port and grounding site of the GRIMM (marked with X)

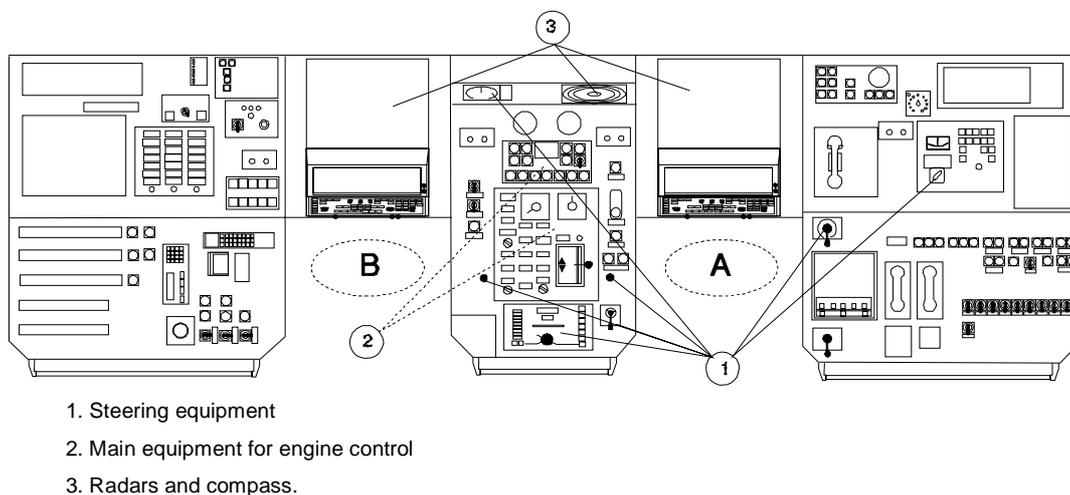
Work point A provides an efficient work point with regard to the steering and offers choice of various steering methods. The control unit for the rudder machine with the choice of the steering place and three different steering modes is within reach. The steering places are in the wings and in the middle of the bridge (Figure 4). The giving of engine controls was easier on the starboard side of the middle console, or at work point A. The engine control relay is close by within reach of the left arm. The engine control and rate of turn levers are almost next to one another and thus easily controllable at the same time.

Work point B offers the choice of only one steering mode, the NFU (Non Follow Up). The port side of the console is not designed for a work point for demanding steering. The speed can be adjusted at it by reaching slightly.

*Figure 4. Navigation and steering console on front wall of bridge.
A and B are work points for steering and navigation of the vessel.*

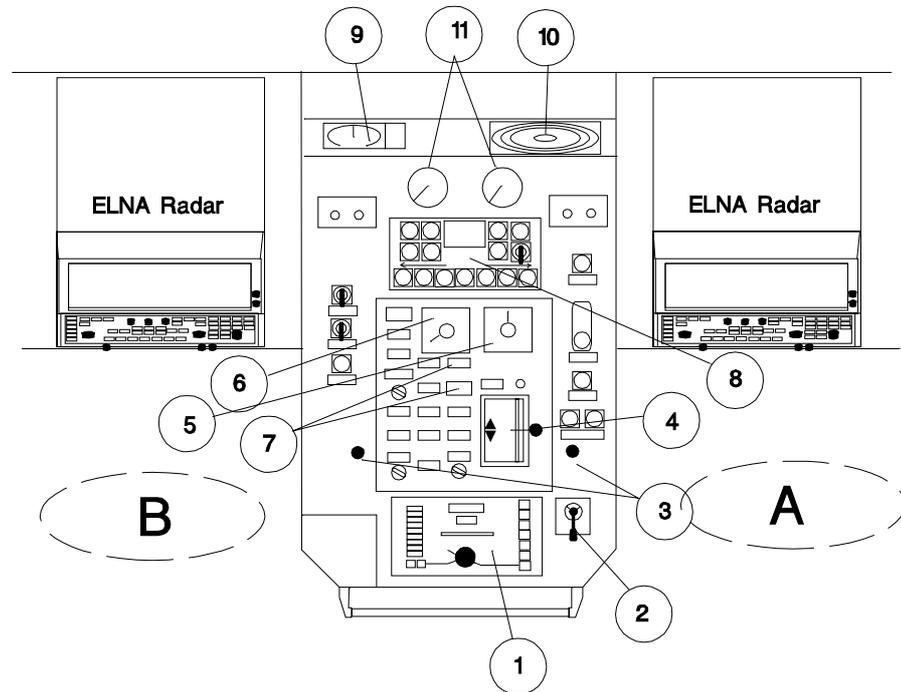
Figure 5a. Middle console of bridge and location of radars.

- The steering mode best suited for piloting is the ROT Tiller (Rate of Turn) in connection with the NAUTOPILOT D autopiloting system, located on the right edge of the middle steering console (equipment 2 in Figure 5a). The rate of turn can be selected steplessly between 0°/min – 35°/min. Zero stands for straight heading. The bridge has one ROT Tiller lever. Its use relieves the navigator for radar adjustment and provides the opportunity to concentrate on the radar image and the compass.

- There are four NFU (Non Follow Up) levers on the bridge. Two are located in the wings of the bridge and two in the middle console (Equipment 3 in Figure 5a). The NFU steering operates by changing the rudder angle while the lever is pressed. The rudder angle indicator must be monitored constantly in order to know the position of the rudder. When the lever is released, the rudder pumps stop. The rudder angle indicator is in the ceiling above the middle console which complicates the course keeping. The NFU steering is not suitable for course keeping if other tasks require simultaneous attention. The advantage of the NFU steering is its low price and easy installation. NFU is usually installed as an emergency steering because of its operational reliability.

The port steering place B provided the choice of only NFU steering (Equipment 3 in Figure 5a). The starboard steering place A offered all the steering systems of the vessel.

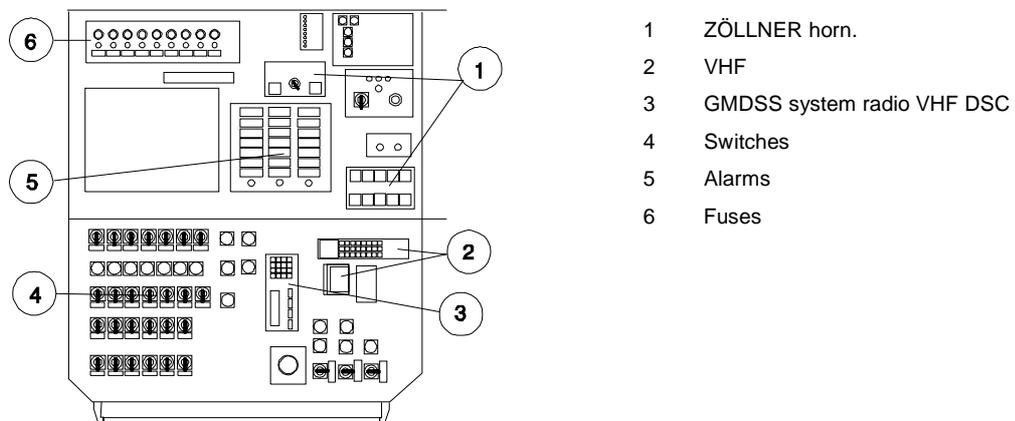
Figure 5b. Port console of front wall. It does not include anything important for piloting.

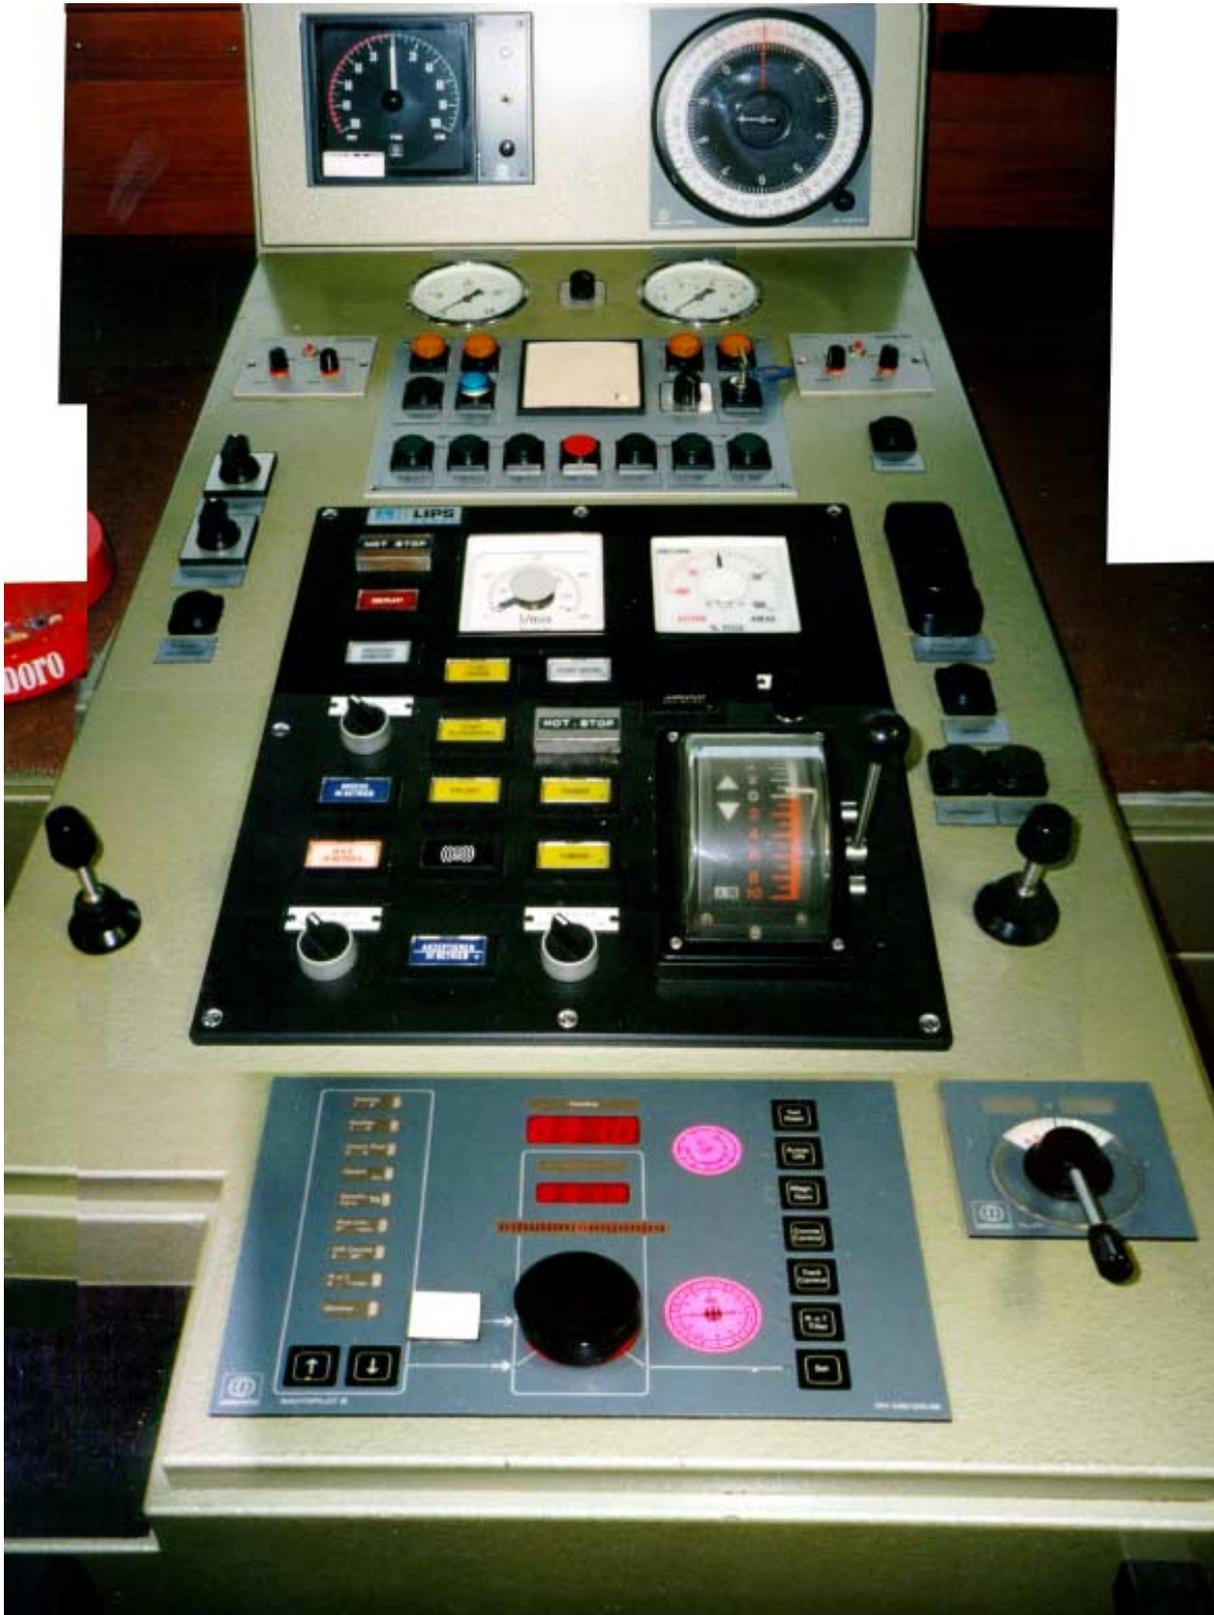
Figure 5c. Middle console of bridge of ms GRIMM. NFU lever used by the pilot is on the left edge.

The pilot stated had he had used a 10 cm long 'tiller' as the steering device. He called it a 'joystick'. The description fits the NFU lever used by the TENFJORD company manufacturing rudder machines. In the opinion of the pilot, the steering did not complicate the navigation. The speed remained during the entire passage at the slow ahead ordered by the pilot.

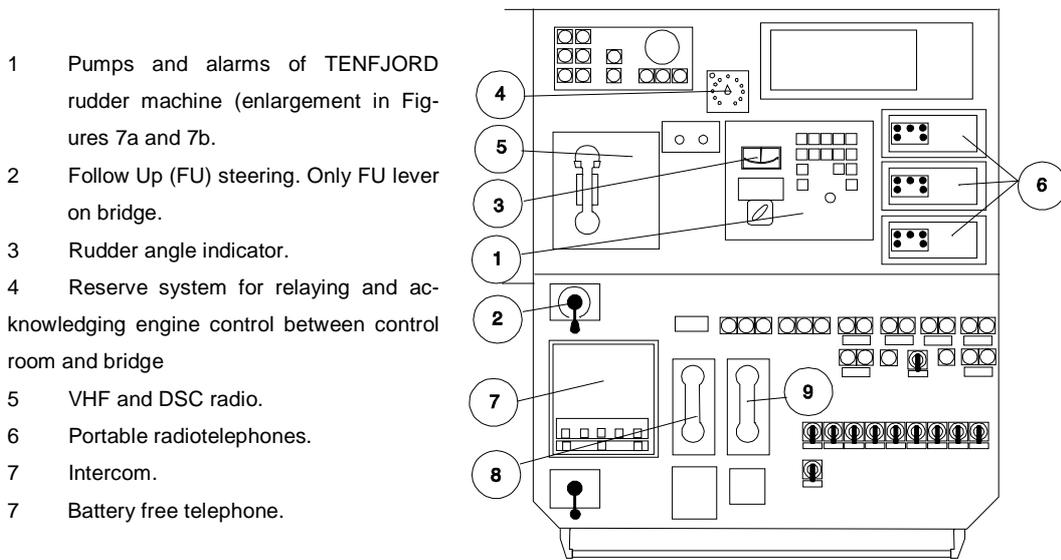
- The FU (Follow Up) steering is an ordinary steering device meant for the helmsman. It turns the rudder to the position where the lever is set (Equipment 2 in Figure 6a). The position of the rudder can be felt with the hand and there is no need to constantly monitor the rudder angle indicator. This would have made the steering easier and allowed the pilot to concentrate on the radar, the compass and the rate of turn indicator. The bridge only had one FU lever.

Figure 6a. Starboard console of front wall. Equipment most important for piloting include control unit for TENFJORD rudder machine (Eq.1) and FU steering (Eq.2). This console is operated from the starboard steering place A.

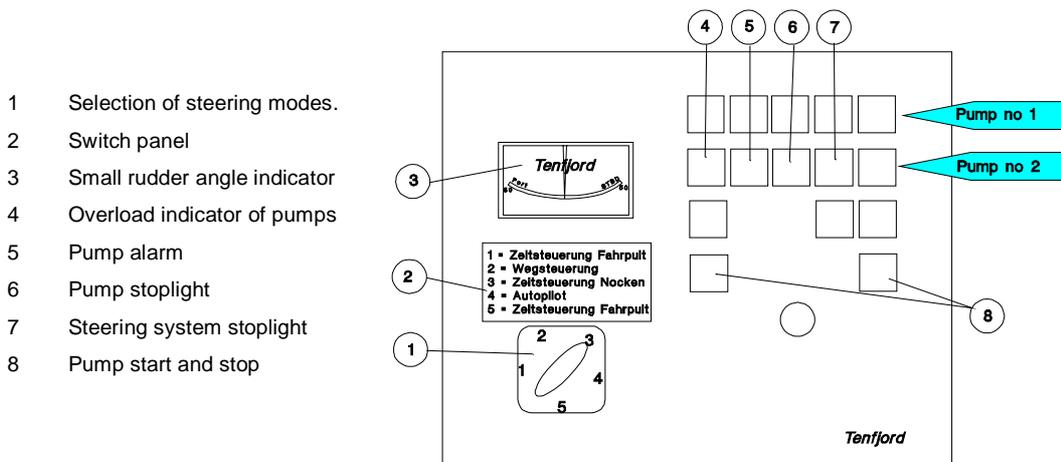
Selection of the steering method in the control panel of the TENFJORD rudder machine is a five position switch (Section 1 in Figure 7a). The panel explaining the positions of the switch in German is located above the switch (Figure 7a, Section 2). The translation of the texts is included in Table 1. The German terminology in the sign is not necessarily familiar to Finnish pilots. It is easy to make a mistake in the selection of the steering mode. The switch limits the choice of the right steering method. The switch may be in the wrong position at the critical moment. Instead of the switch, it is safer to change the mode with a pushbutton which is installed next to each steering lever or autopilot.

Figure 7a. Control panel of TENFJORD rudder machine in starboard console. Steering equipment selection with switch one. Translation of switch panel 2 in Table 1 below.

Table 1. Panel of steering equipment switch of ms GRIMM. It does not state which steering place (wing of bridge) positions 1 and 5 indicate.

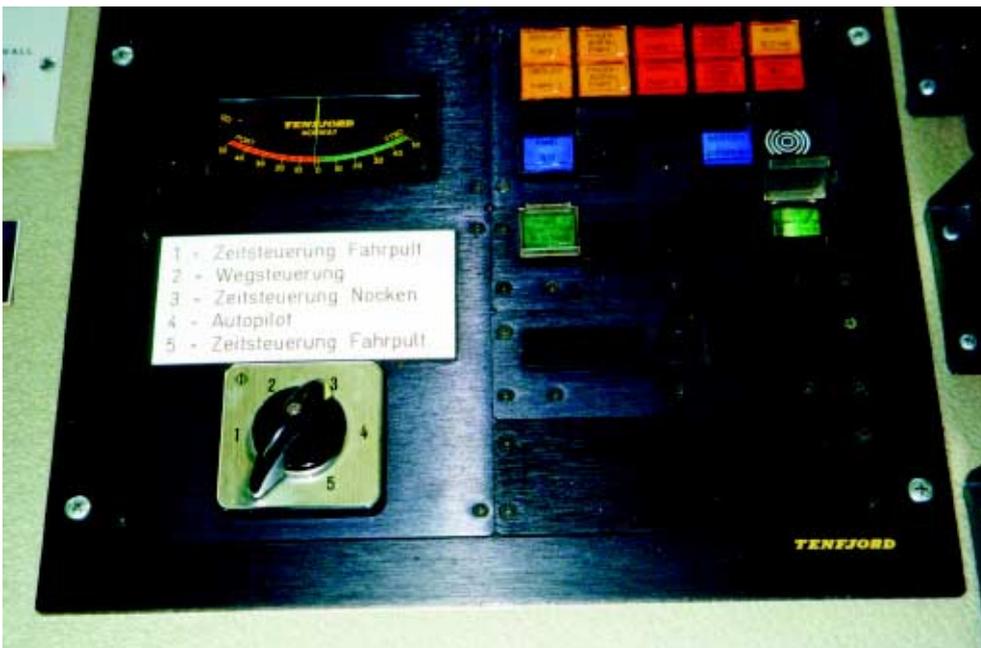
Figure 7b. Control panel of TENFJORD rudder machine.

The steering device was selected from the starboard steering place in the control unit of the TENFJORD rudder machine (Figures 6 and 7). The TENFJORD panel had a rudder angle indicator (Equipment 3 in Figure 7a and Figure 7b), but this was very small so it is probable that the indicator in the ceiling (Figures 8b and 2) had to be resorted to for piloting.

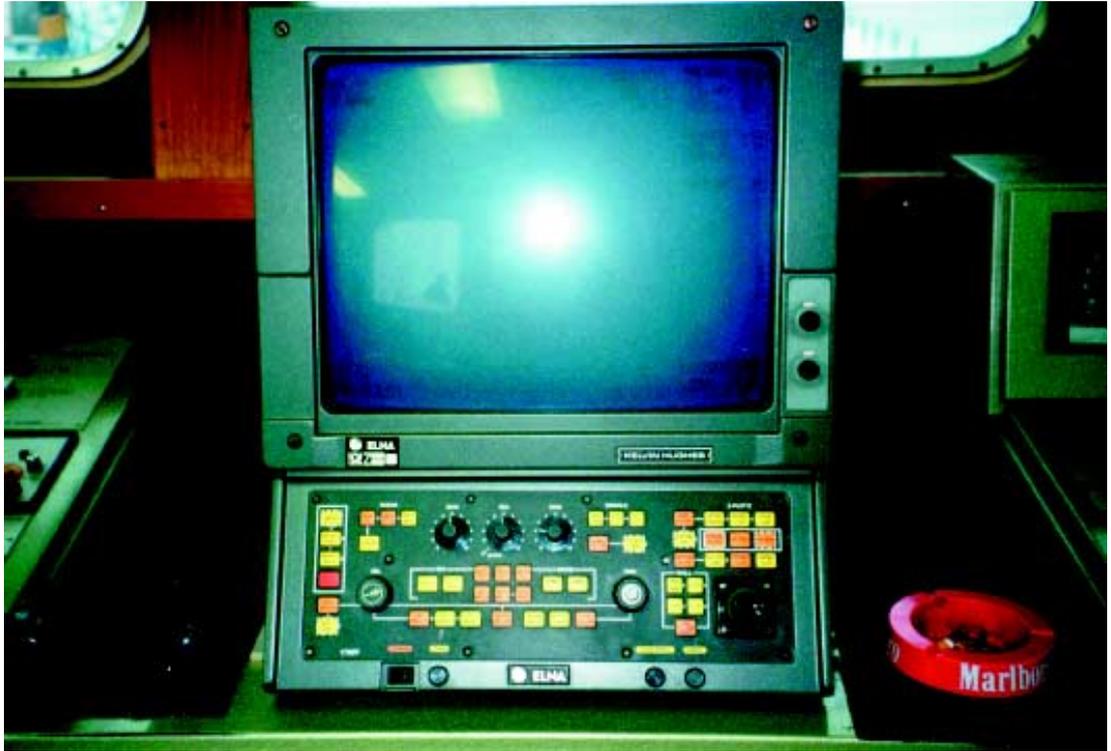
Tuning, Sea Clutter and Rain Clutter. These may not be combined in the installation² (Figure 8a). The radars of the GRIMM fulfilled these requirements.

Figure 8a. Easy to use ELNA radar of ms GRIMM.

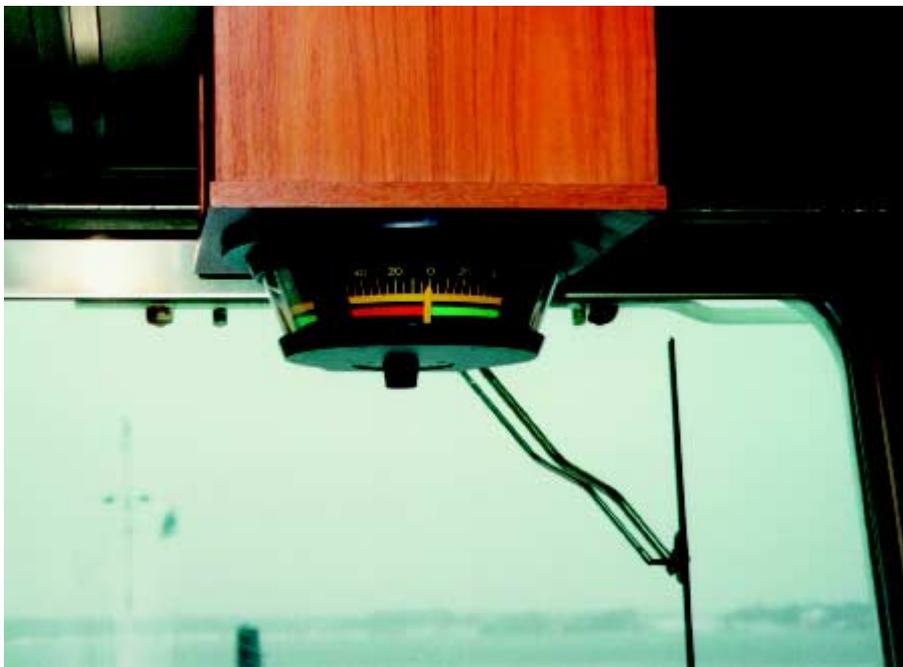
The only clearly observed rudder angle indicator was a round gauge in the ceiling, which contained the rudder angle indicator to the back and to both sides (Figure 8b). During steering, the eyes have to be raised in a disturbing way. The periscope of the magnetic compass was located in the ceiling next to the rudder angle indicator.

Figure 8b. Rudder angle indicator in ceiling of bridge (Location also seen in Figure 2).

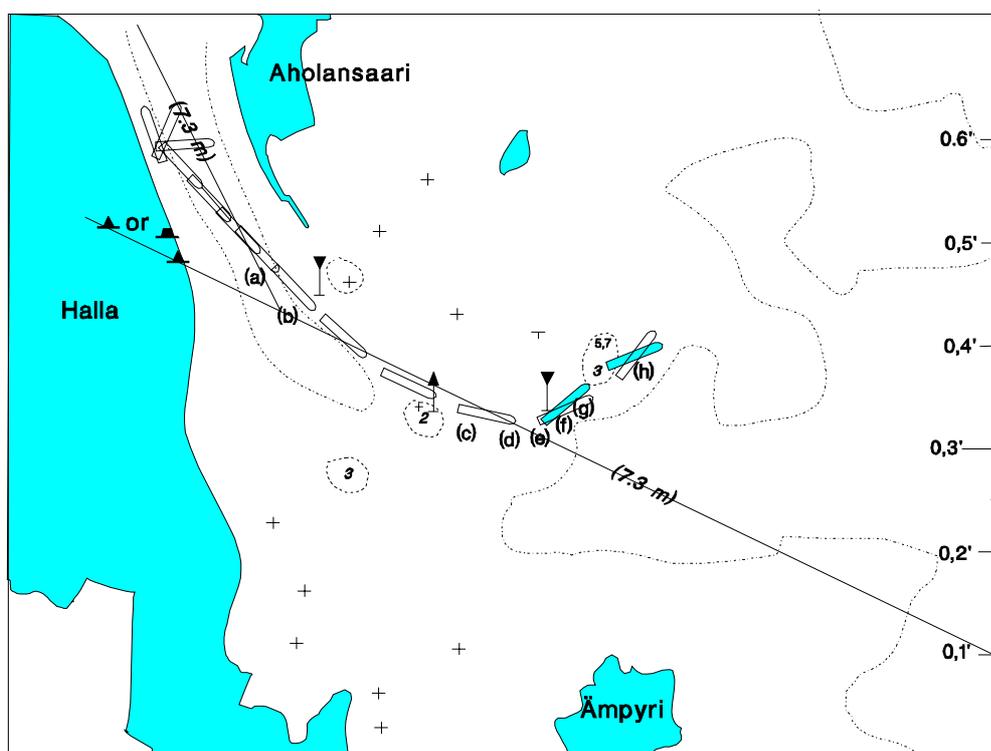
The reconstruction of the piloting situation, accident voyage and grounding was conducted by simulation on a desktop machine which was compared to the witness statements about the various phases of the voyage. The information from the witness statements presented in Table 2 was used in the simulation. As can be seen from the table, all witness statements cannot be made to coincide simultaneously. In sections (a), (b) and (d) the statements contradict the simulation presented in Figure 9.

Figure 9. Departure of the GRIMM from Halla according to witness statements and simulation. White symbols describe passage in simulator and shaded symbols describe witness statements when conflicting with the simulation at the time of the grounding since the rudder of the GRIMM was more efficient than the rudder of the simulator. There is no data on which way the GRIMM turned in the harbour.

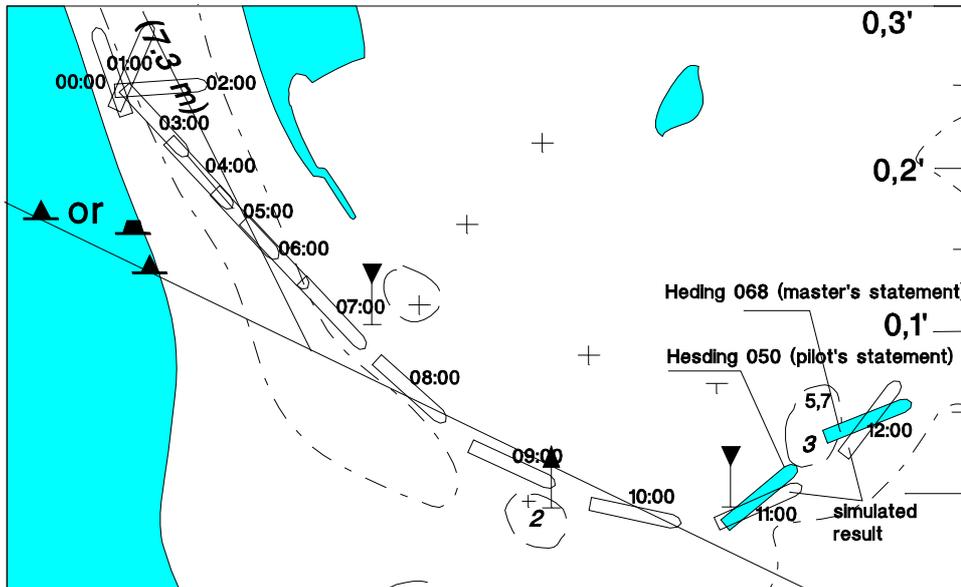
Figure 10. Simulated accident drive. Times are from simulator clock. Simulation begins when the ship is already one shiplength from the pier. It takes about 1-2 minutes, which means that the time from the pier to the grounding was about 13-14 minutes.
