Joint Norwegian/Finnish
Marine Casualty Report
May 2001

MARINE CASUALTY REPORT

On the cargo ship *ULSUND* - LHNW - which went down off Lista, Norway on 27 February 1998 and whose entire crew of 7 lost their lives in the casualty.

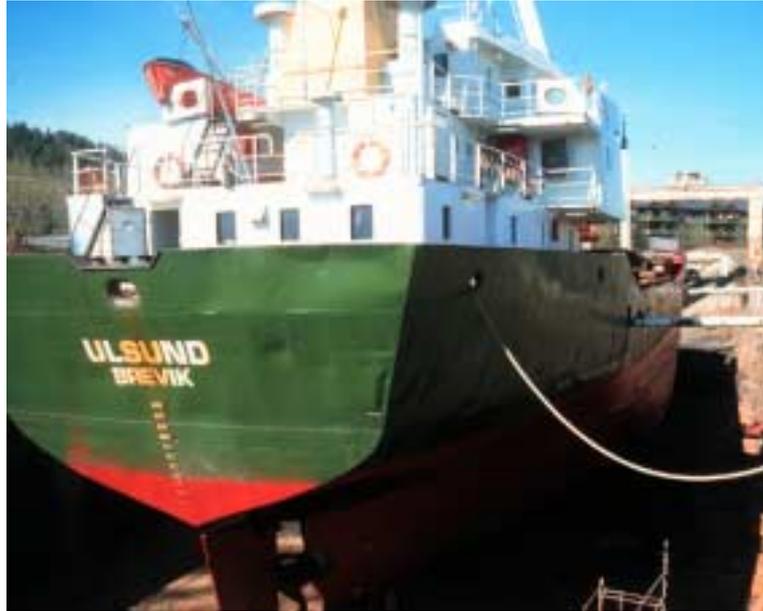
Fig. 1: Ulsund in dry dock at Porsgrunn, July 1997 (B. Cederberg)

Mr Kittelsen explained that while the ship was in dock he inspected the outside of the hull, which looked good, and that the wharf employees announced that steel hull was in good condition.

Mr Kittelsen explained that, at the instructions of the Norwegian Ship Control, the ship was then the subject of various repairs, including the removal and inspection of the propeller axle, the replacement of bilge plates on the port side, the installation of new anodes, and the sand-blasting and painting of the bottom of the vessel.

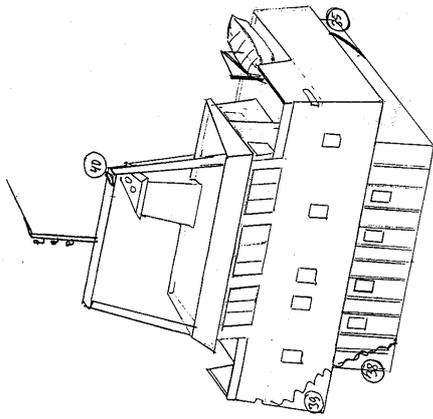
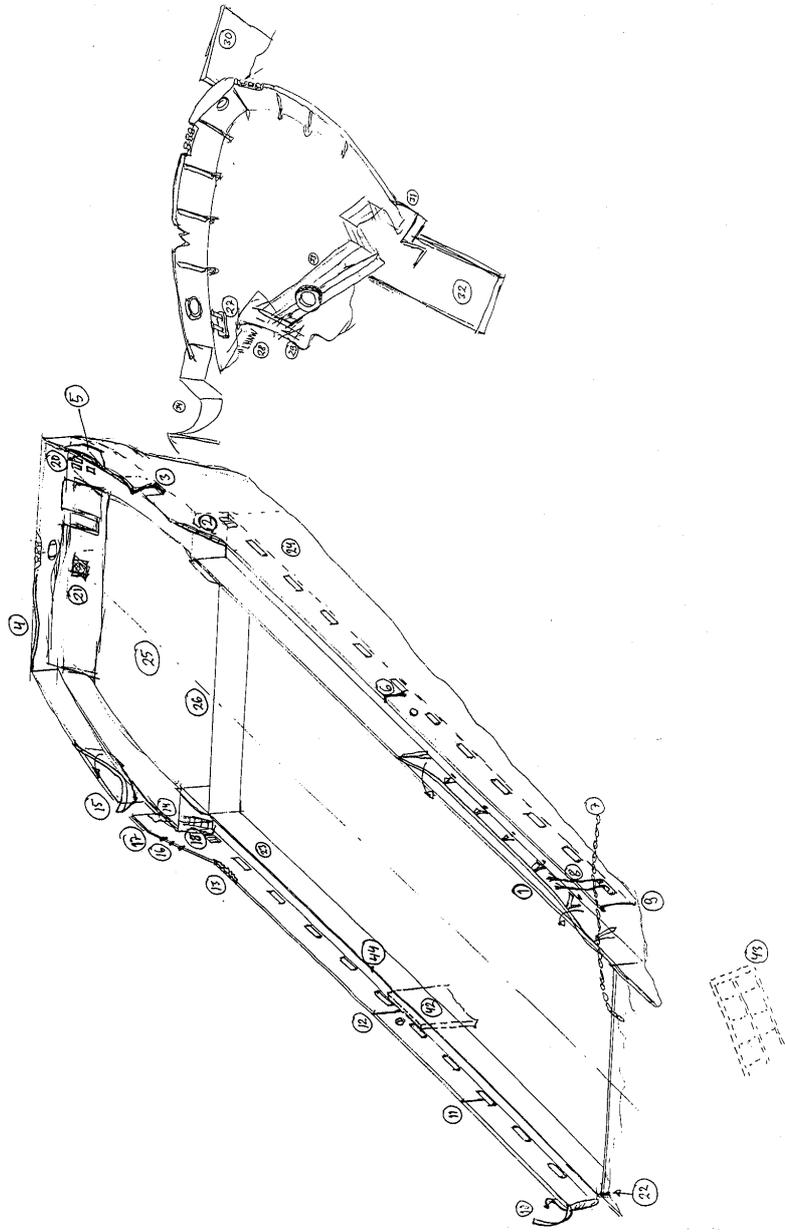
Fig. 7: Sketch of the wreck, made from the observations of the ROV-video. (J.Klawer)

It is believed that crack formations can be observed on the port side of the hull. It should be noted, however, that the side of the hull cannot be seen due to mud. It is possible to see crack formations in the starboard bulwark on the main deck, in scuppers no. 7 and no. 8, and in scupper no. 5 on the port bulwark. The numbering of these scuppers is from the stern.

m/s ULSUND, kartläggning av skador på fartyget, enligt videofilm från vraket

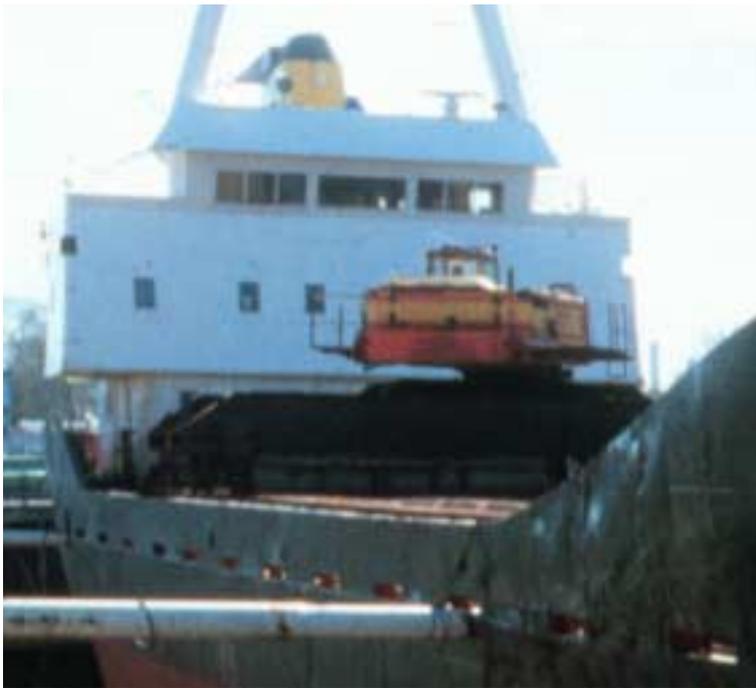
Fig. 8: Åkerman excavator, July 1997. (B Cederberg)

- The Åkermann was according to the loading document dated: 17.03.98, secured in a position over the lowest loading area in the hold – forward of the cargo hold mid section. Details regarding the securing of the excavator are given in Enclosure 1B. According to the loading documents and our findings, the Åkermann was not secured in a position in front of or aft of the cargo-hold, which is normal during transport in open waters. In both these positions at the end of the rail for the excavator/ramp, special locking devices/brackets are welded in order to secure the excavator/ramp in a proper manner.

- The Åkermann is not found in an area of approximately 150 m. radius from centre of the cargo hold. Several of our findings conclude that the excavator had a main role in the disaster. We have not surveyed the area from the position of distress to the location of the wreck. If the excavator/ramp and the excavator itself were separated during the accident, this could result in two positions for such equipment.

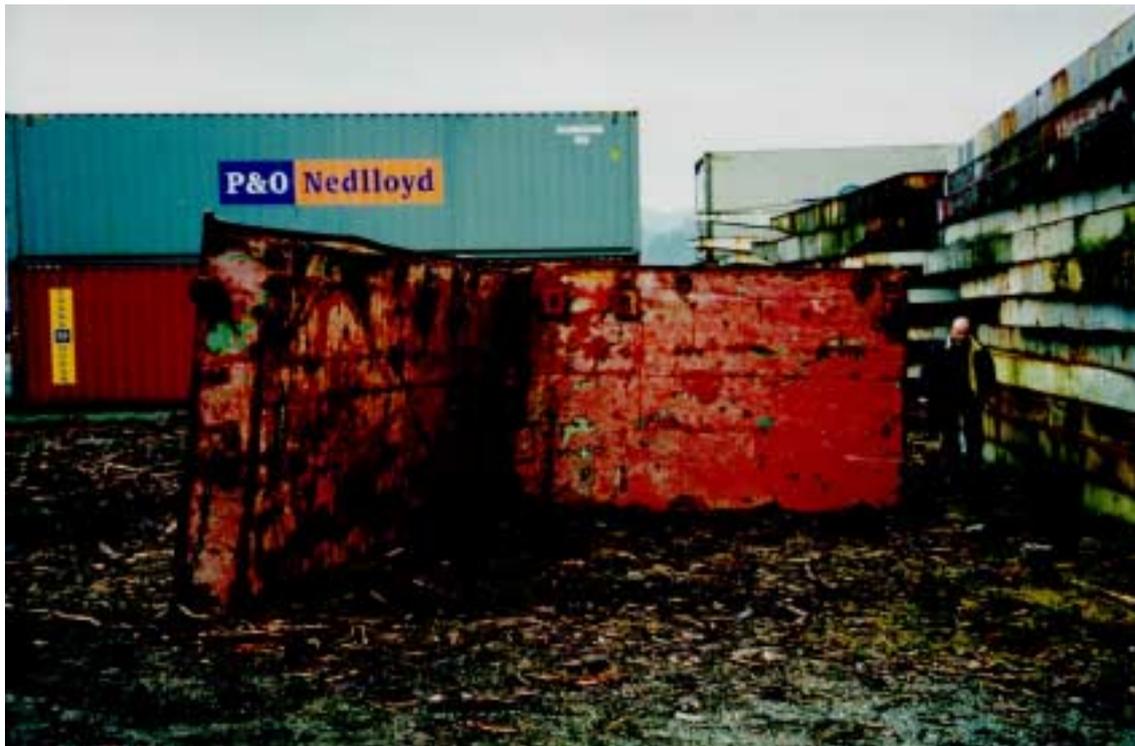
Fig. 9: The bent hatch cover section, April 2000, in Farsund. (AIB Finland)

The hatch cover has been bent into almost 90 degrees angle. There are no traces of any outside hit on the bended part. The bending force has come from the end/ends of the hatch cover. The inward bended hatch coaming on port side on the same frame supports this point of view.

There is a triangular hole in the hatch cover, the size of it is 35cm in length, 12cm wide in other end and 1-2cm in the other end. This is a trace of something sharp and can be thought to be from a hit by excavator's grab.

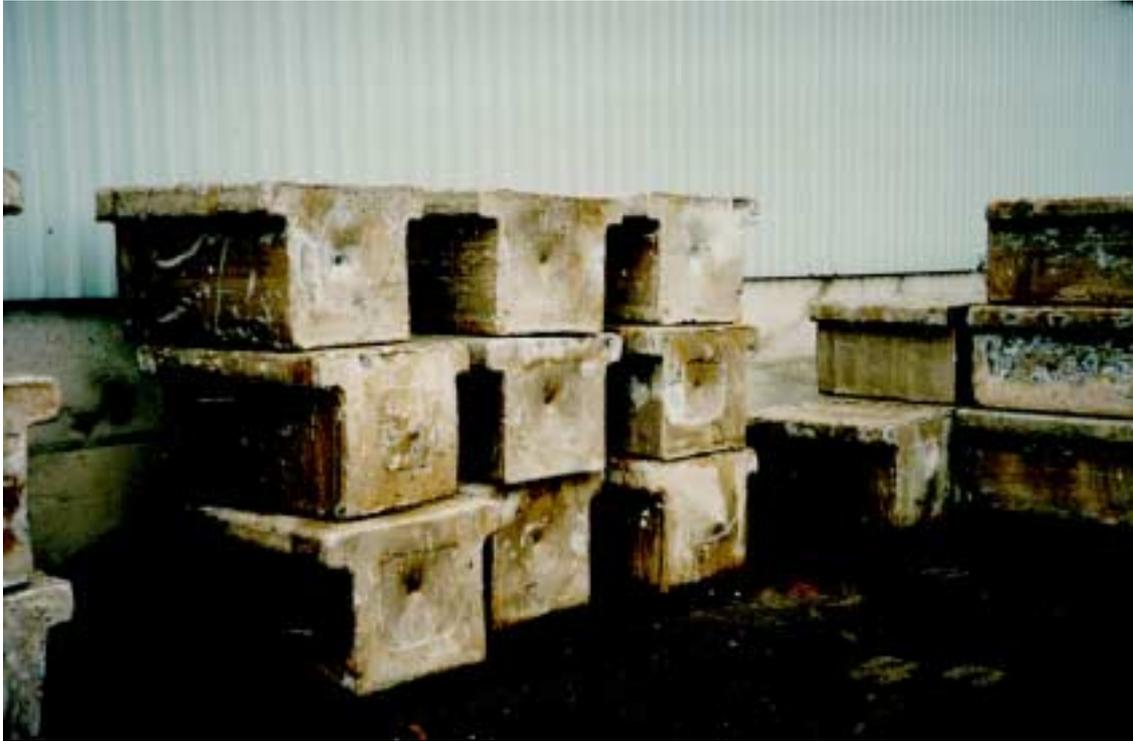
Fig. 11: Aluminium T-bars, discharged from Ulsund's wreck. (AIB Finland)

The ship was carrying 24043 MT aluminium on its casualty voyage, loaded in St. Petersburg. The cargo consisted of "T bars" forward in the hold and "Pack" amidships and aft in the hold.

The impressions gained from observations of the cargo hold of the wreck of ULSUND, made by mini-submarine and video camera (ROV), are that the cargo was well stowed on the casualty voyage. There are thus no grounds for claiming that a shifting of the load could be the reason for the casualty (the ULSUND wreck lies on a fairly even keel, with almost no list, at a depth of approx. 310 metres).

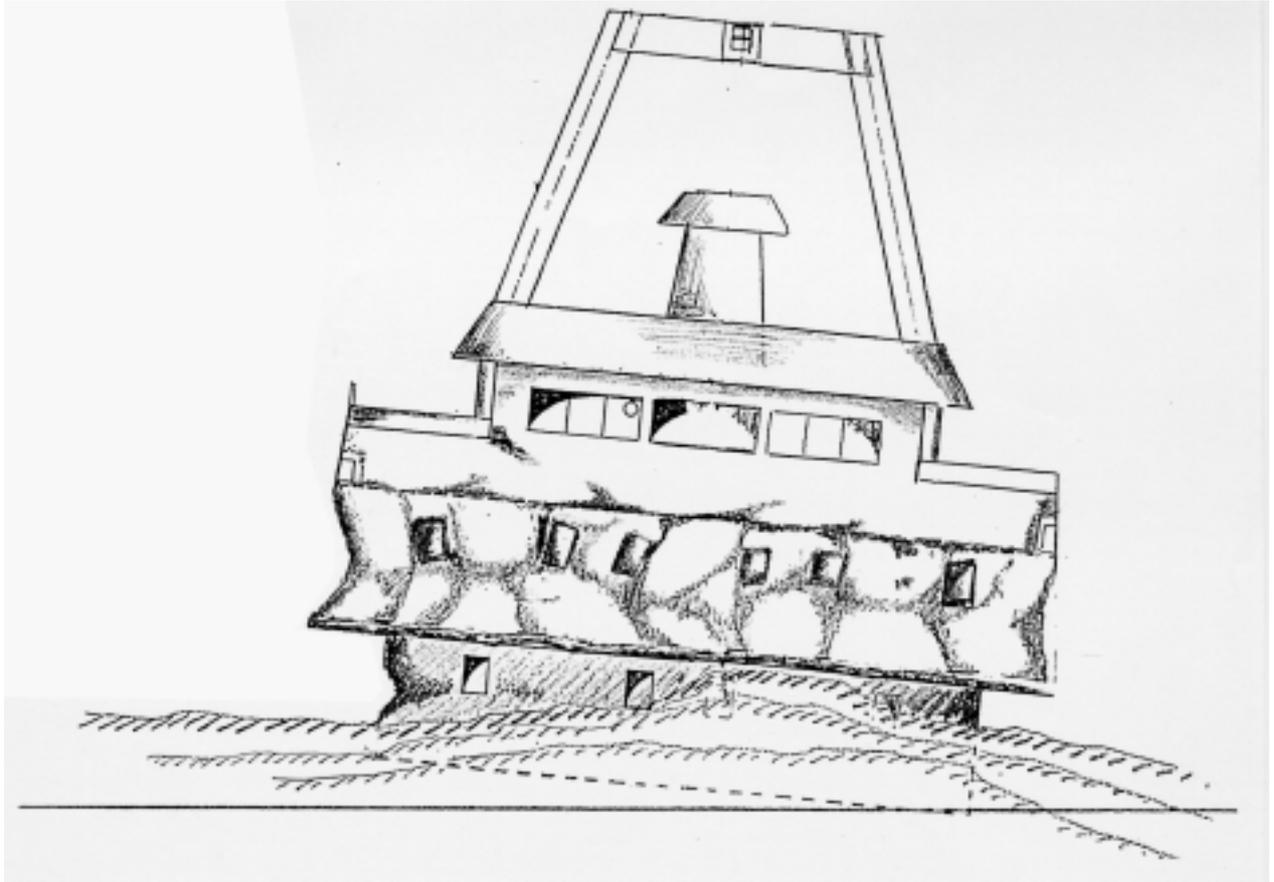
Fig. 17: Sketch of Ulsund's superstructure (Dacon company)

The superstructure has got indents by external force and is lying on the seabed port side of the hull.
