Investigation report

B 2/2000 M

**ms FINNFELLOW, grounding near Överö in Aland, April 2,
2000**

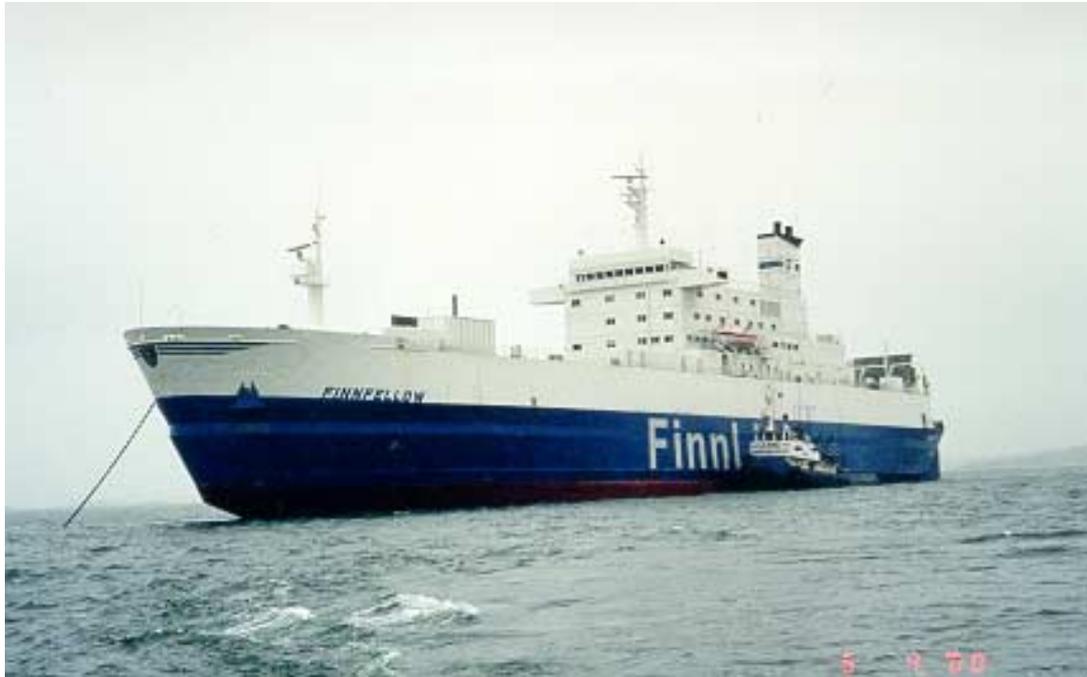
Figure 1. ms FINNFELLOW after refloating on 5 April 2000.

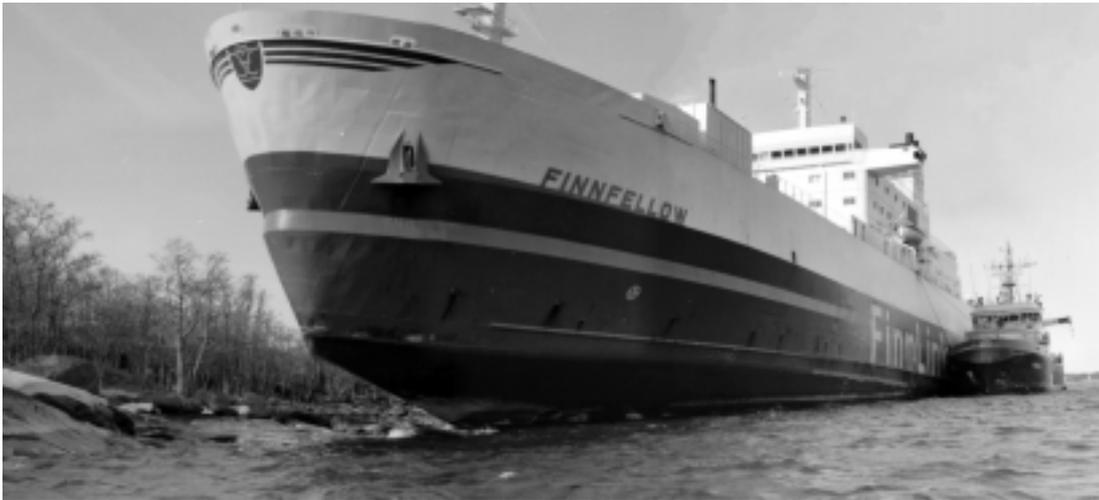
Figure 5. ms FINNFELLOW aground on the shore of Bockholmen.

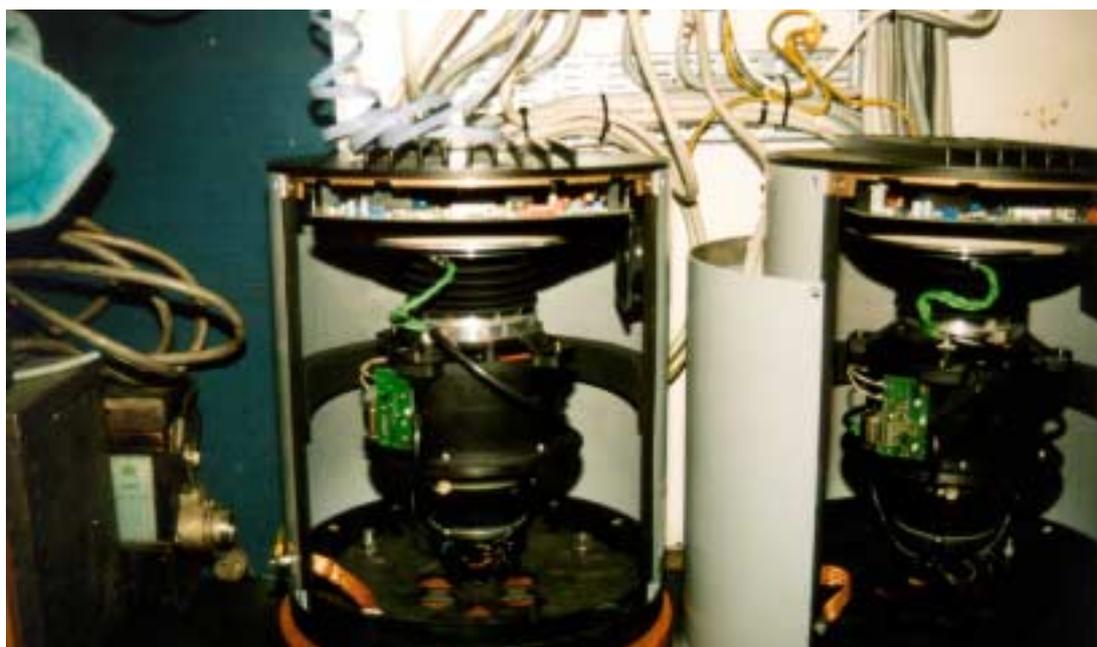
On the FINNFELLOW, the STEP signal containing heading information was relayed to the radars, the ANS recording system and the NACOS autopilot. The corrected wiring and connection drawing of the FINNFELLOW's navigation system is shown in Appendix 3. The documentation for the gyro system held on board the vessel did not correspond to the actual gyro system's installation.

Figure 12. The Finnfellow's compass installation photographed during testing on the dock after the grounding. The coiled signal cable is visible behind gyrocompass number 1 on the left.

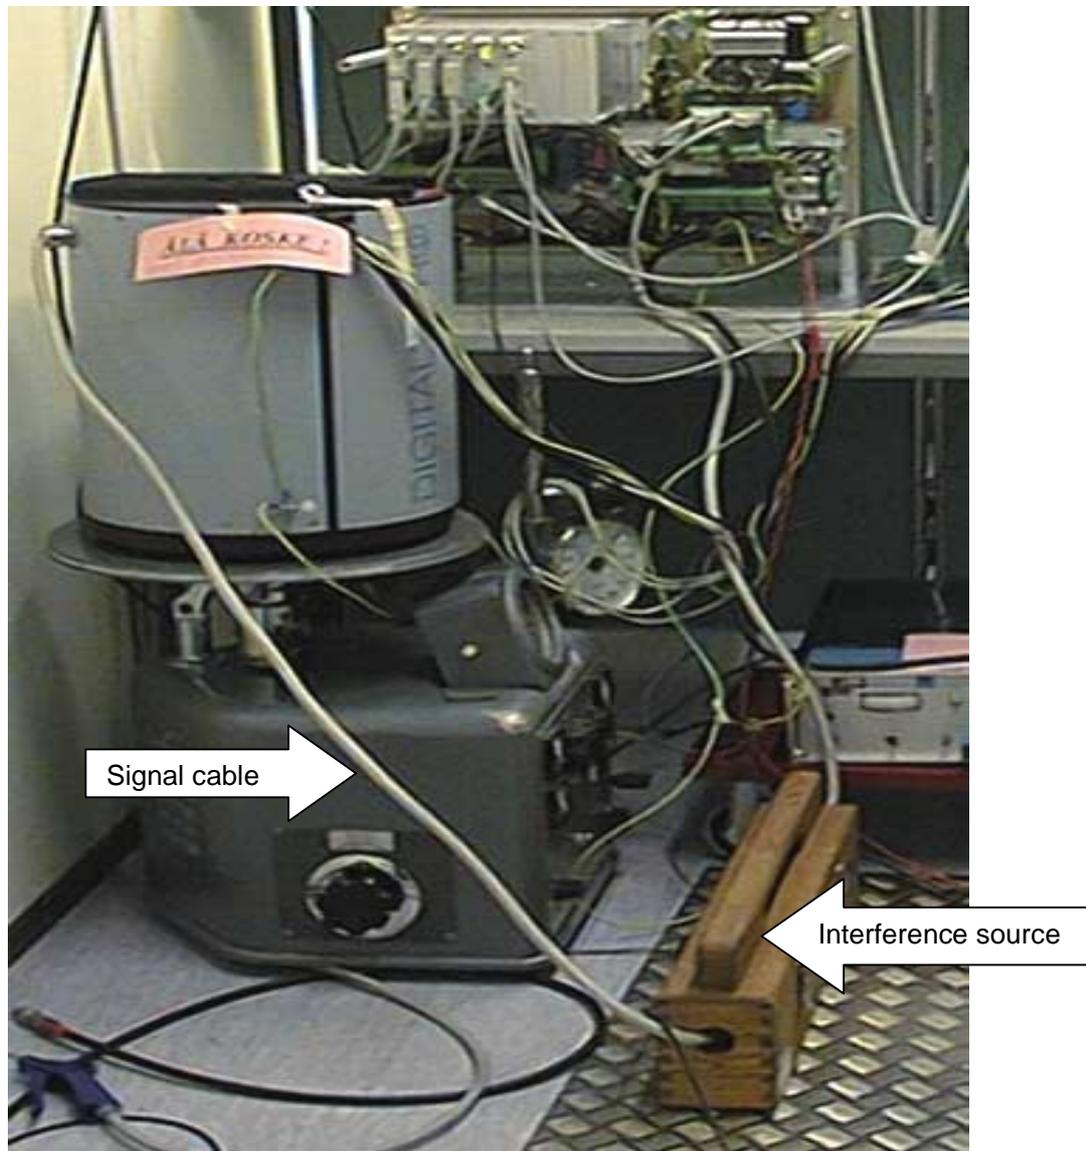
In the installation on the ship, it is possible that the interference passed to the compass system through the cabling.

Figure 14. Gyro compass undergoing radio interference testing. The interference was directed at the shielded signal cable between the gyrocompass and the central unit.

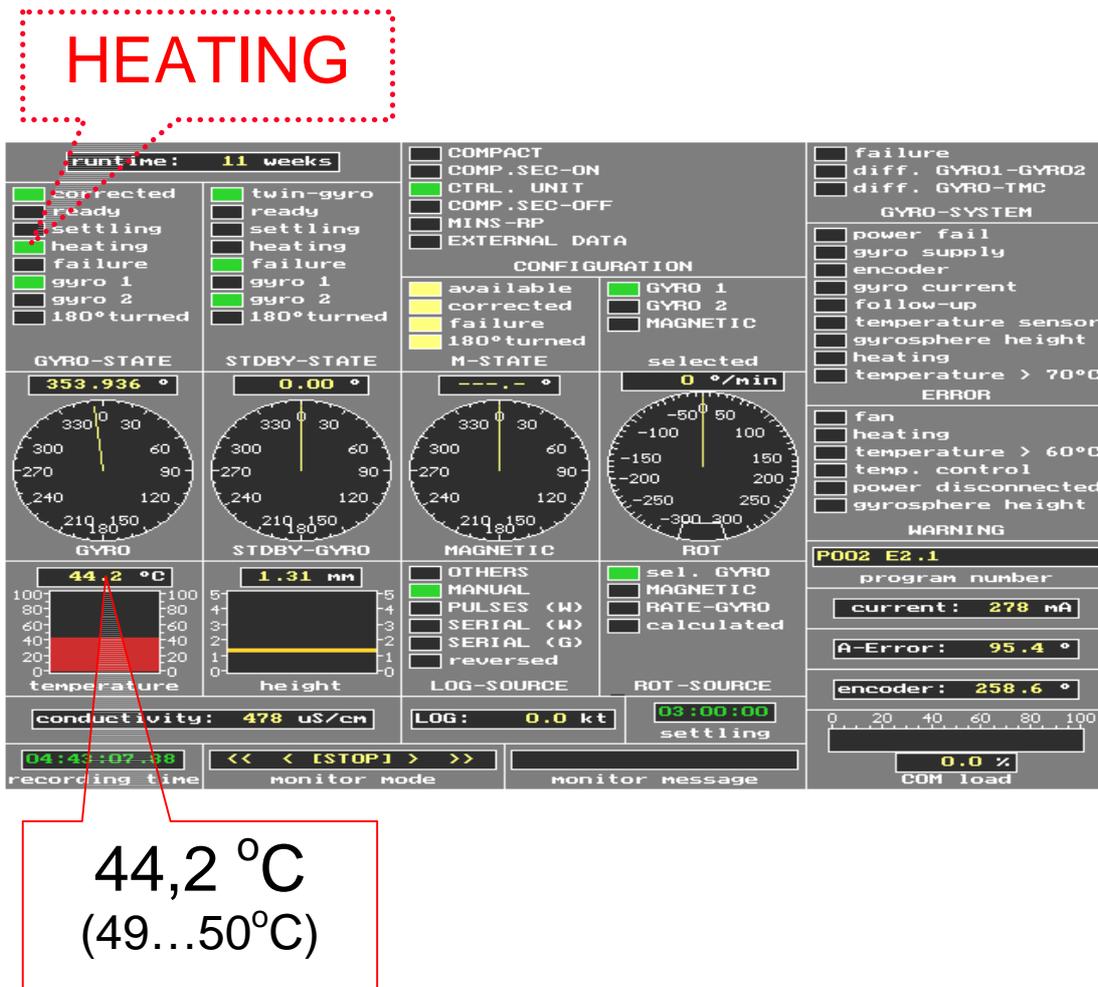
Figure 15. HEATING status caused by external interference as displayed on the Anschütz maintenance terminal screen.

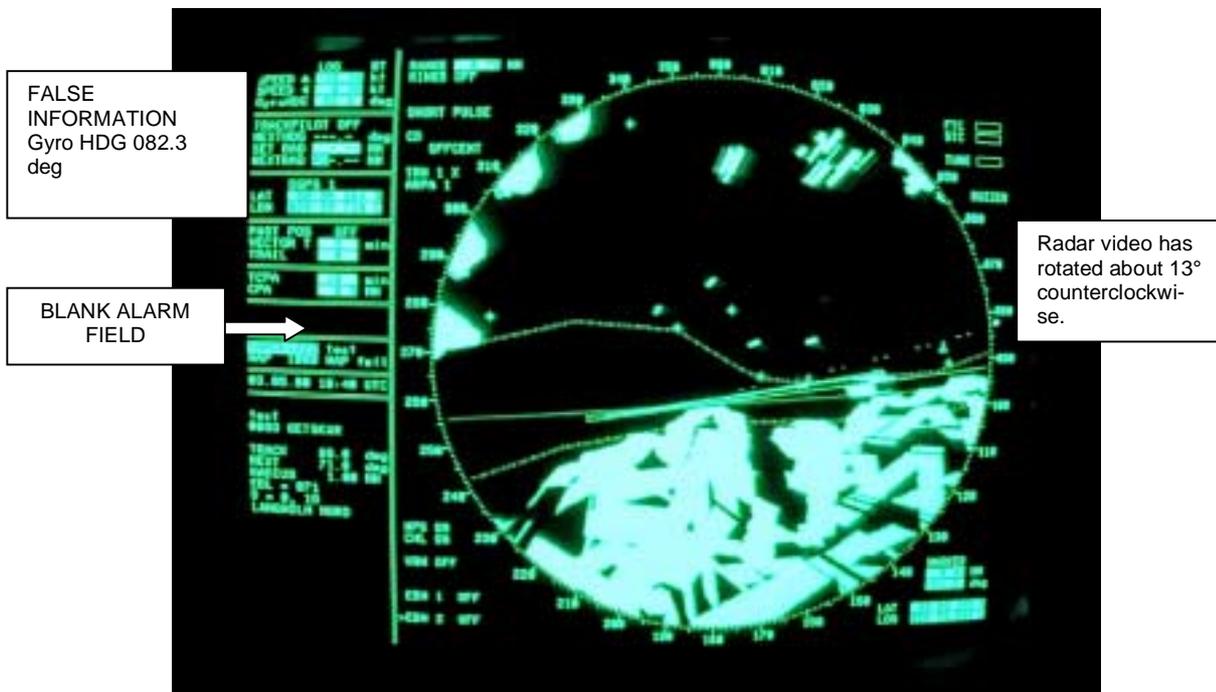
Figure 23. 45 seconds after the jamming of the compass. Time of the picture corresponds to 02:31:47 (UTC 23:31:47). Error can be seen clearly.

In Figure 23 the heading error is easily detectable 45 seconds after the gyro jammed because the shallow water contour clearly overlaps the land echoes. The reason for the error was not visible on the autopilot display in Figure 24.

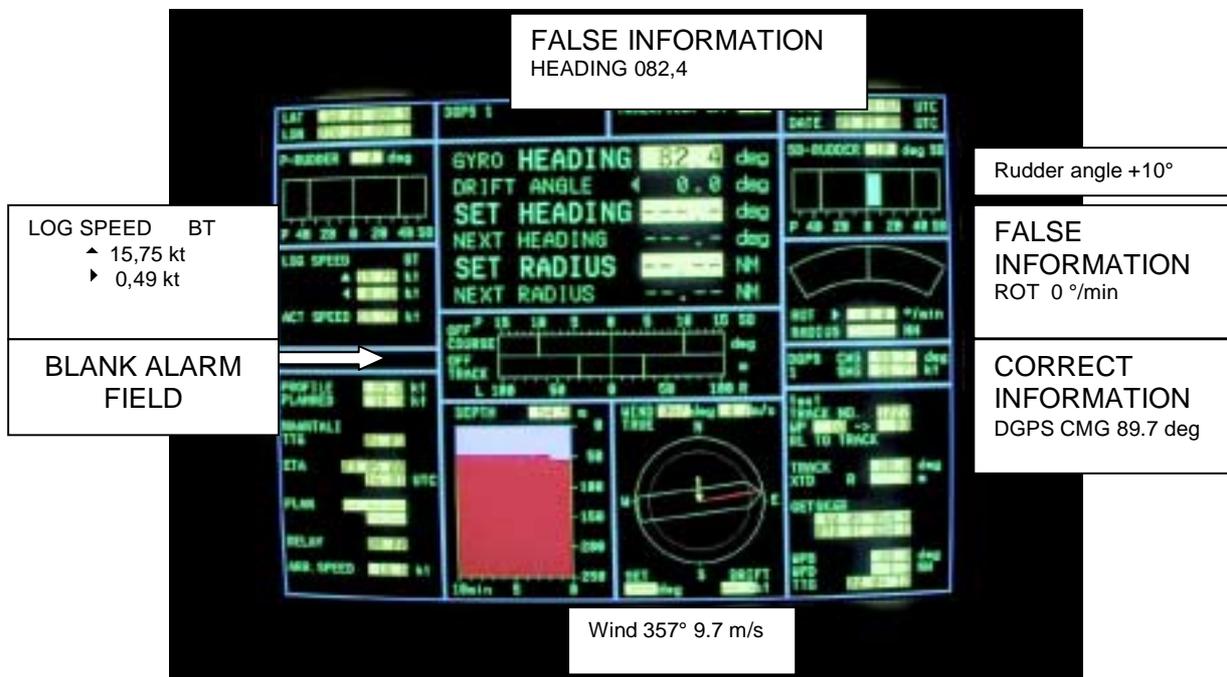
Figure 24. 45 seconds after the jamming of the compass. The picture corresponds to radar image 23.

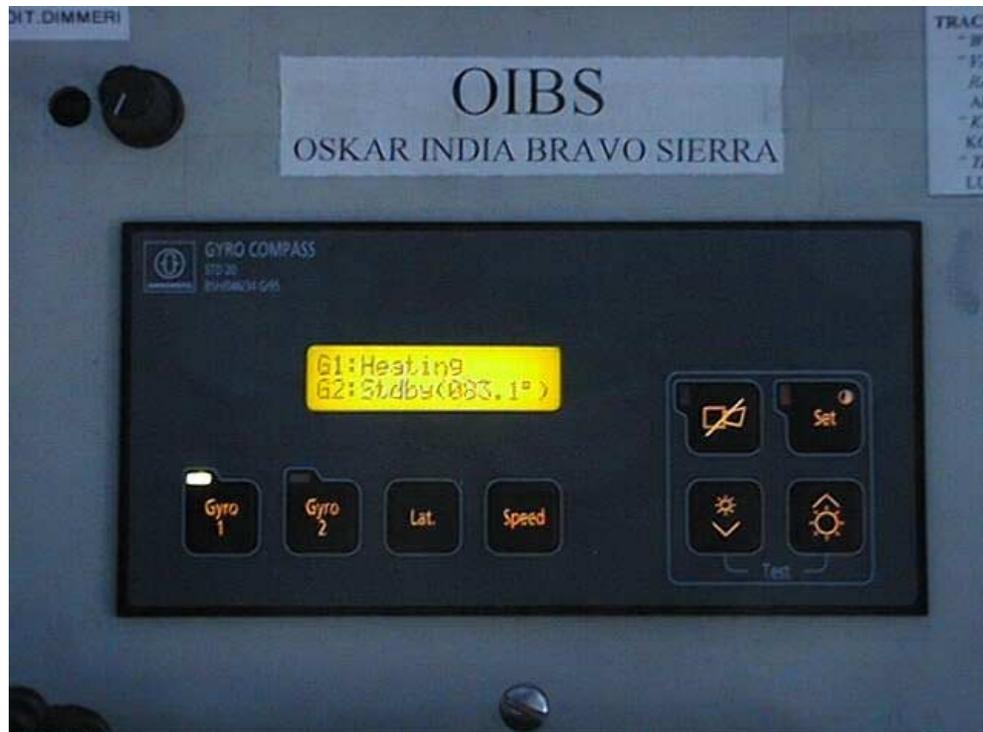
Figure 26. Gyro control panel on the FINNFELLOW. In the situation pictured here, the operative gyro is in the HEATING status and the second gyro (in stand-by status) shows the correct readings.

The control panel for the gyrocompasses is located in the FINNFELLOW's steering console under the NCC screen (Figure 3). Figure 26 shows the control panel in a situation where the active gyro is in the HEATING status and the second gyro (in stand-by status) is giving the correct reading. The control panel is only used if there is a gyro alarm. The HEATING status did not produce an alarm.

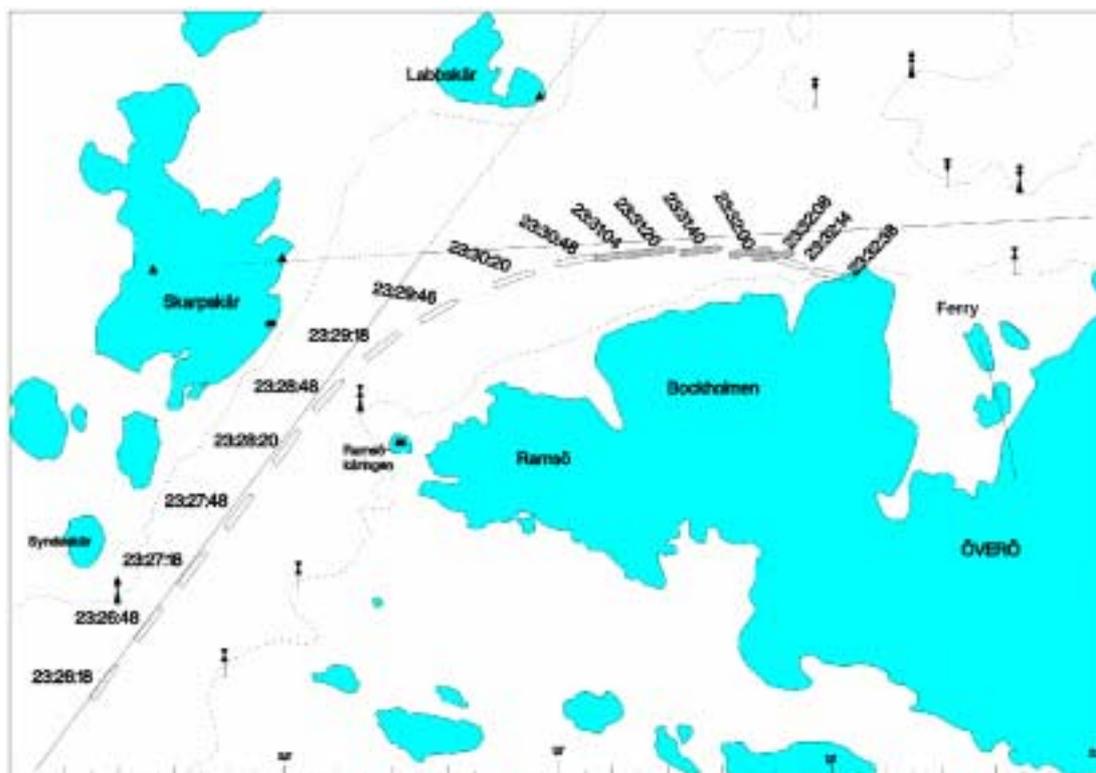
Figure 27. Data recorded by the ANS during the Skarpskär turn. The compass heading was jammed between 23:31:02 and 23:32:08.

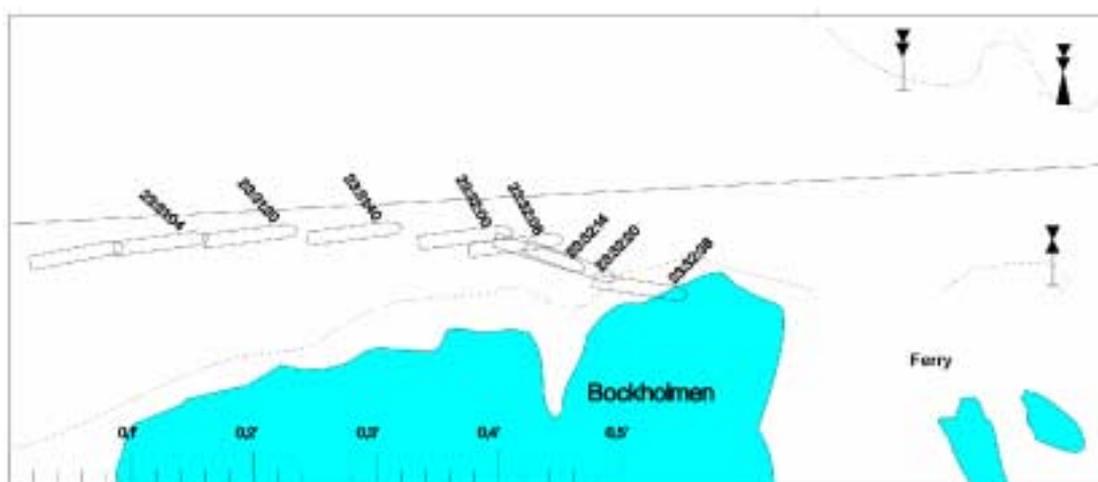
The ANS screen presented the end of the turn as shown in Figure 28 (see also Figure 25). The radar heading line pointed to heading 82.5° and the radar vector (COG) showed a drift to starboard. These readings were misleading.

Figure 28. ANS recording became distorted when the compass ceased to operate. The ship symbols between 23:31:02 and 23:32:08 do not show the true heading of the vessel.

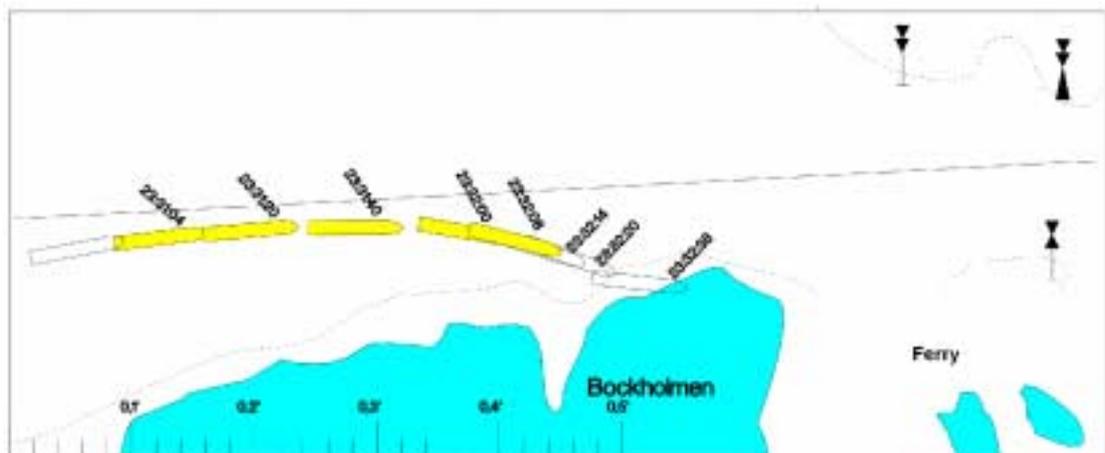
The true situation of the vessel was not shown on any display. The actual turn is reconstructed in Figure 30. Simulco Oy determined the true headings for the time interval when the signal output was jammed¹⁵. Reconstruction of the track was executed so that the vessel symbols were turned to the actual headings with regard to the centre point of the vessel. The shaded symbols in Figure 30 were turned according to the corrected heading definition. Had the compass functioned correctly, this is how the ANS recording would have looked.

Figure 30. The grounding shown with the reconstructed true compass headings. The shaded vessel symbols show the actual passage where the compass heading was jammed.

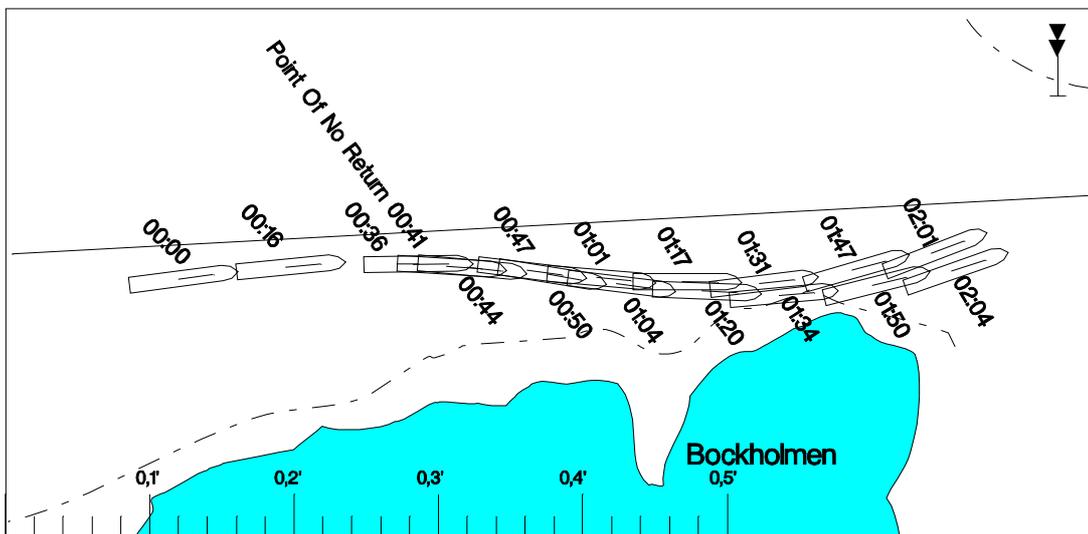
Corrective manoeuvre analysed in the simulator. Avoidance manoeuvres were performed in the simulator to determine how much time there was to react to the fault situation. Figure 31 shows the situation where the rudder was turned hard to port 44 seconds after the compass jammed.

Figure 31. The time of the jamming of the compass has been marked with zero in the picture. The simulated avoidance manoeuvre began at 00:44 but this was slightly too late. The rudder must be turned to port about three seconds earlier. The 'point of no return' is 41 seconds after the jamming of the compass.
