APPENDIX 2

**RECONSTRUCTION OF MOTION TRACK OF M/S FINNFELLOW
BEFORE GROUNDING ON APRIL 2, 2000**

**MS FINNFELLOW GROUNDING IN ÅLAND ON APRIL 2, 2000
 FINAL DRAFT OF INVESTIGATION BOARD REPORT**

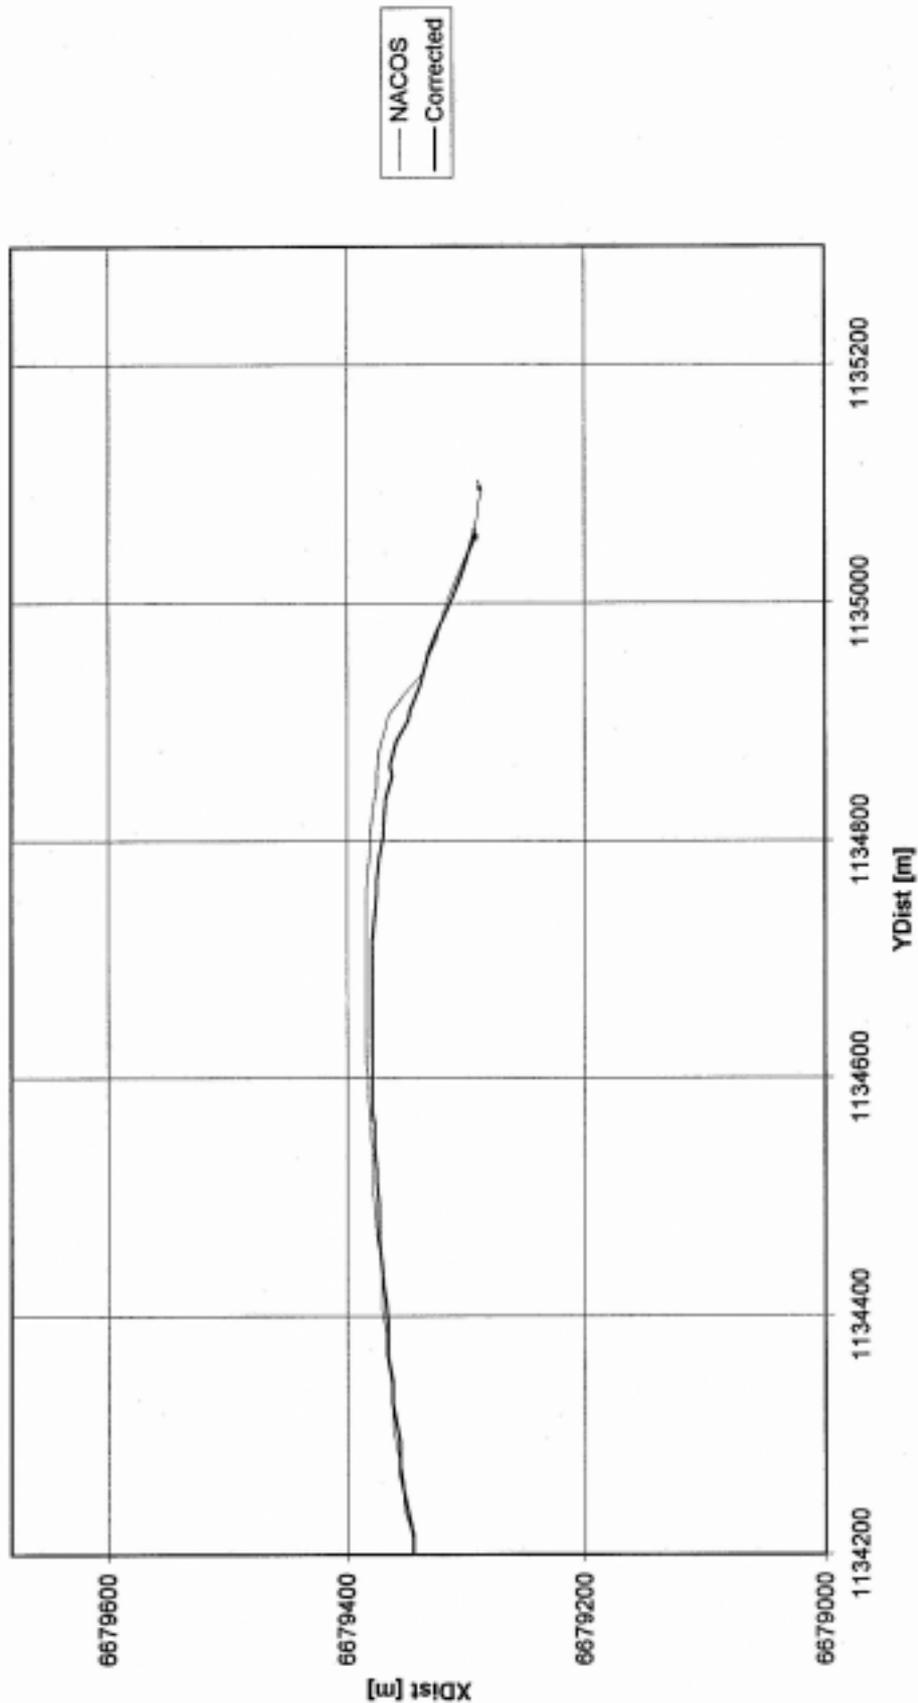
Position

The track of the midship was calculated on the basis of the information recorded by the ANS Blackbox application (page 4) and with the help of the track, the course and speed over ground of the midship (pages 5 and 6).

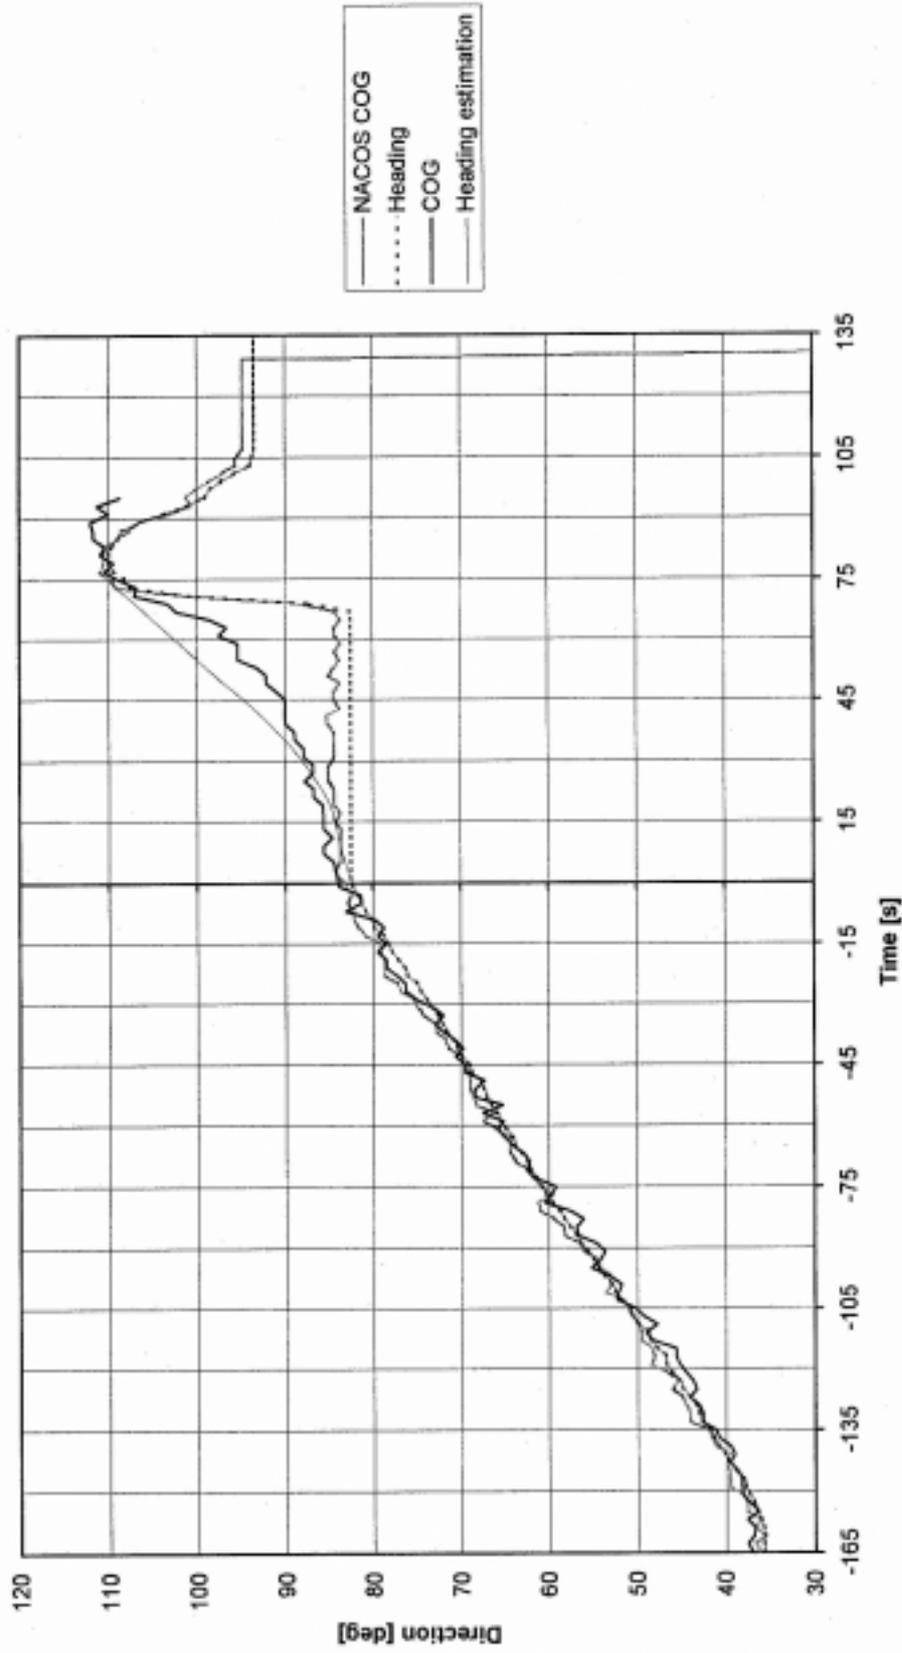
Heading and COG

The estimated probable heading of the vessel during the compass malfunction is presented on page 5. The estimation is based on multiple simulations.

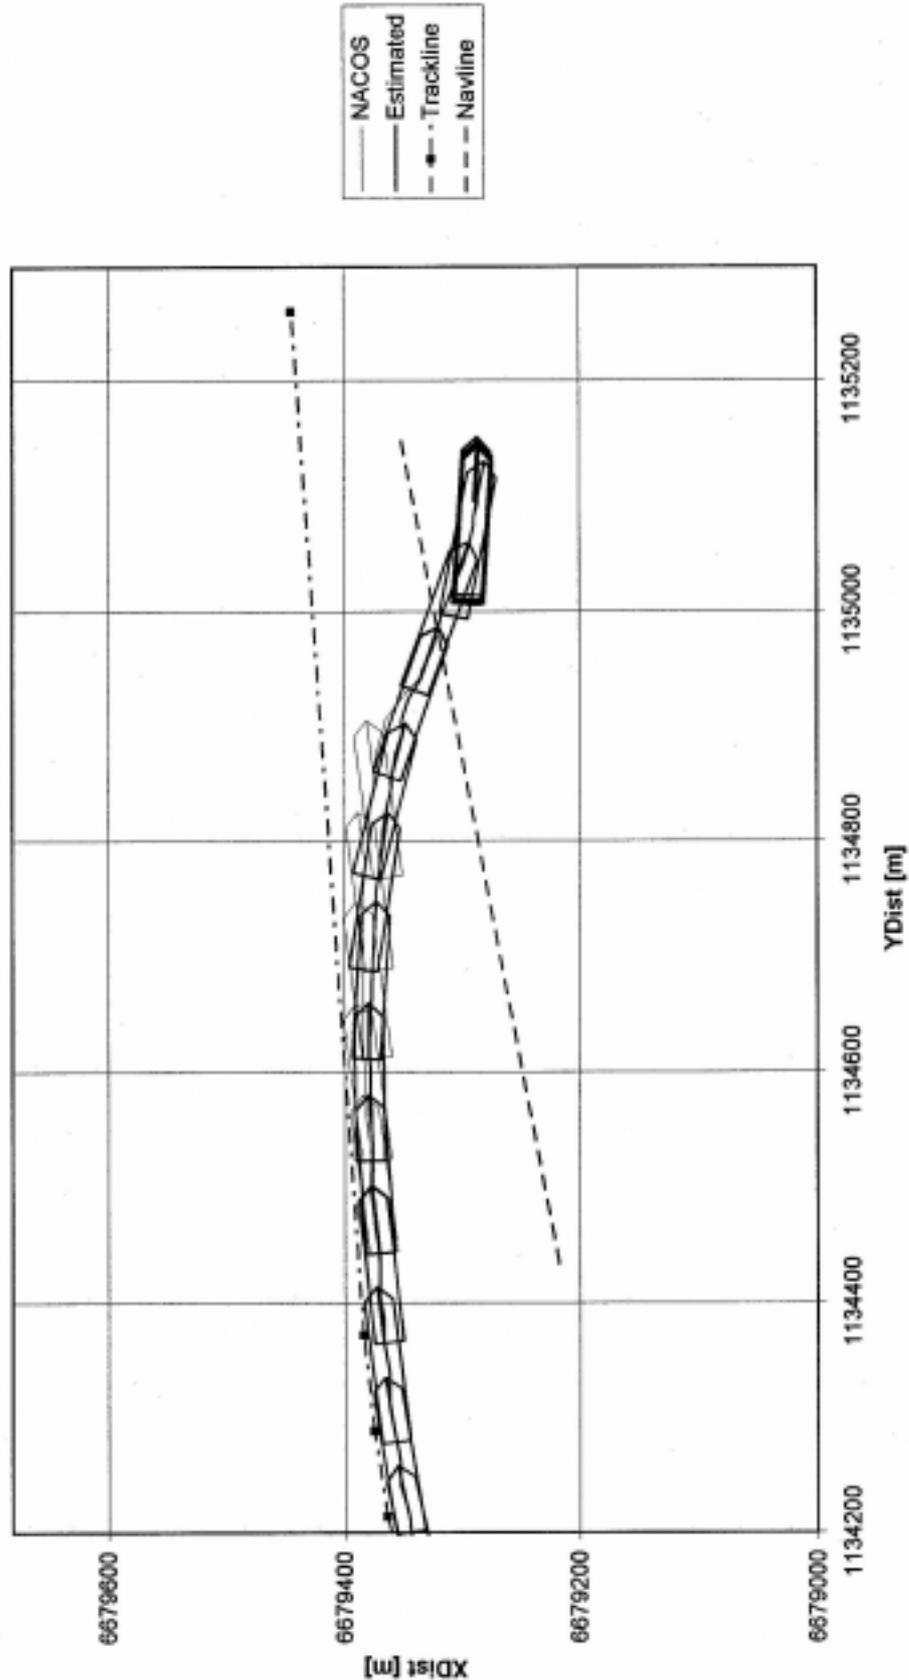
Track

The corrected track is presented on page 7 together with the original recording by the ANS Blackbox application. In addition, a SimBox-compatible recording database was created of the calculated data making it possible to reevaluate the accident situation in the ship handling simulator.

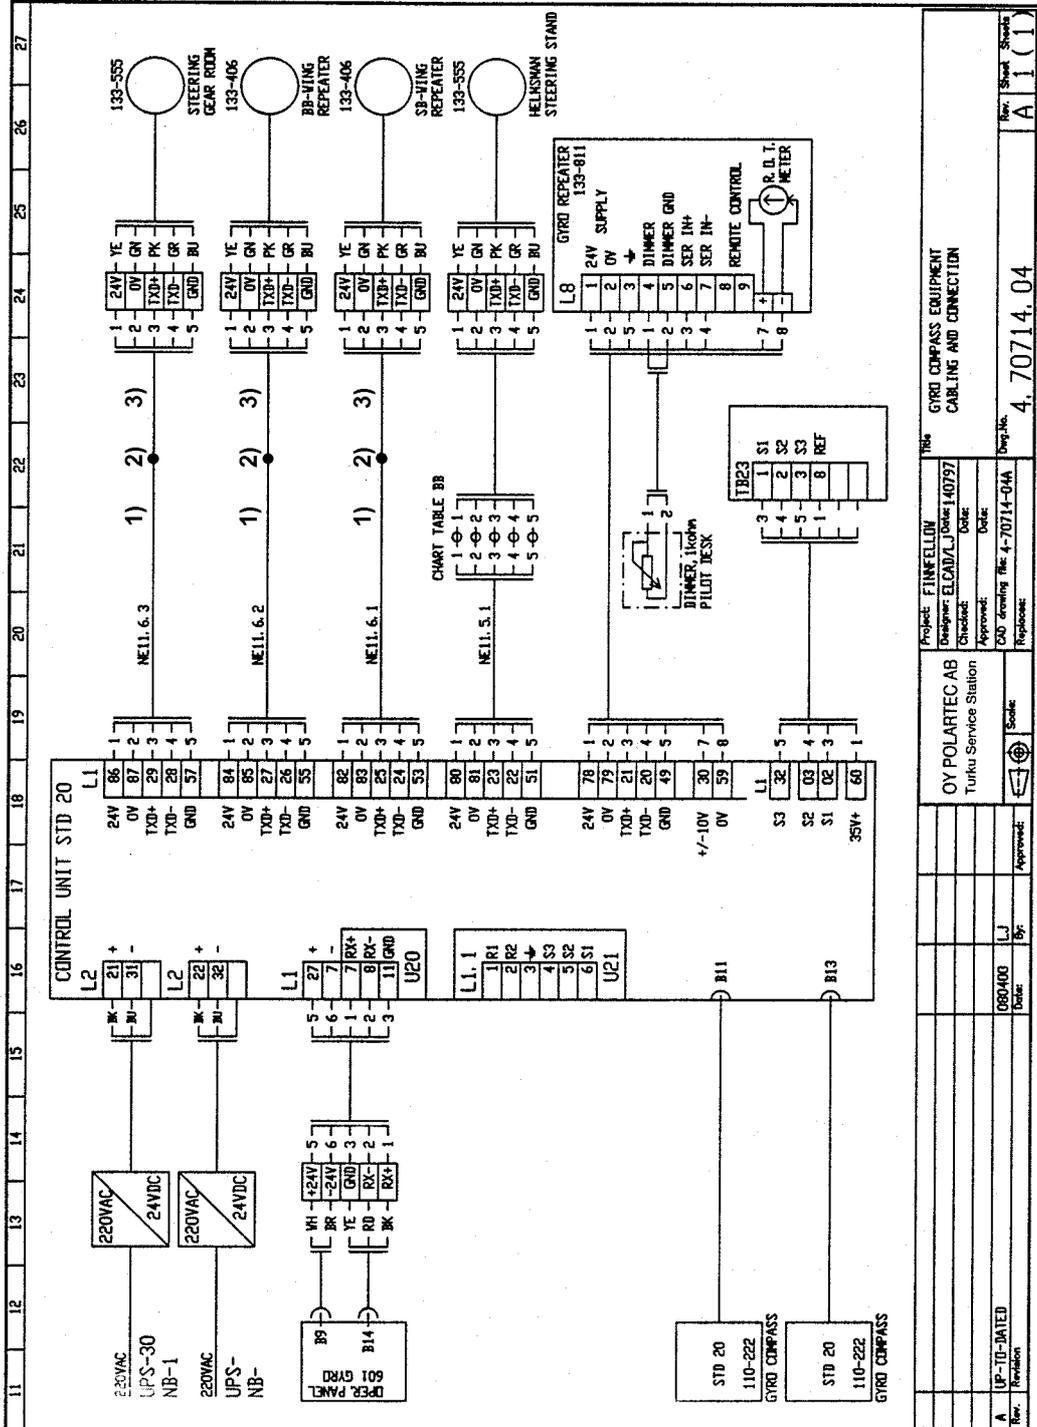
- 1) Cable with disturbance protection
- 2) Joint
- 3) Cable without disturbance protection

The gyrosystem has not been connected by course bus, as shown in the wiring diagrams, but by step signal only.
