## Investigation report

C 12/2001 M

**ms IRAN SARBAZ, emergency situation off Uusikaupunki,  
November 1, 2001**

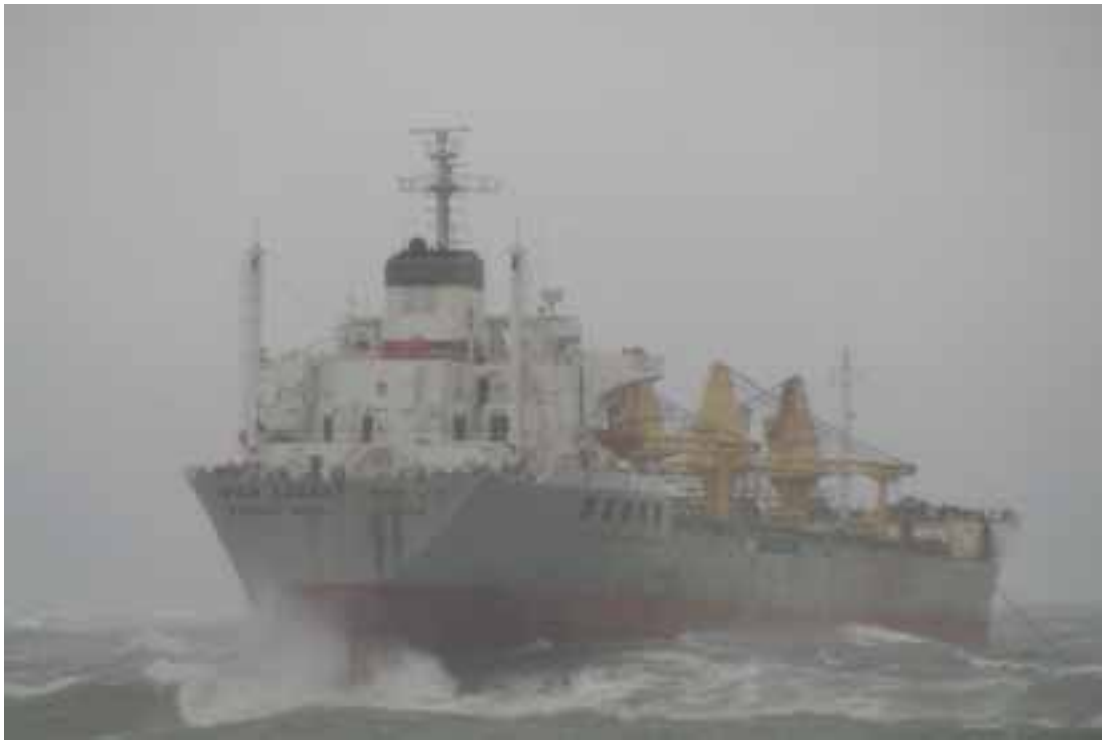
*Figure 1. Ms IRAN SARBAZ at anchor in the storm on November 1, 2001 outside Iso-kari. (Photo by The Finnish Coast Guard)*

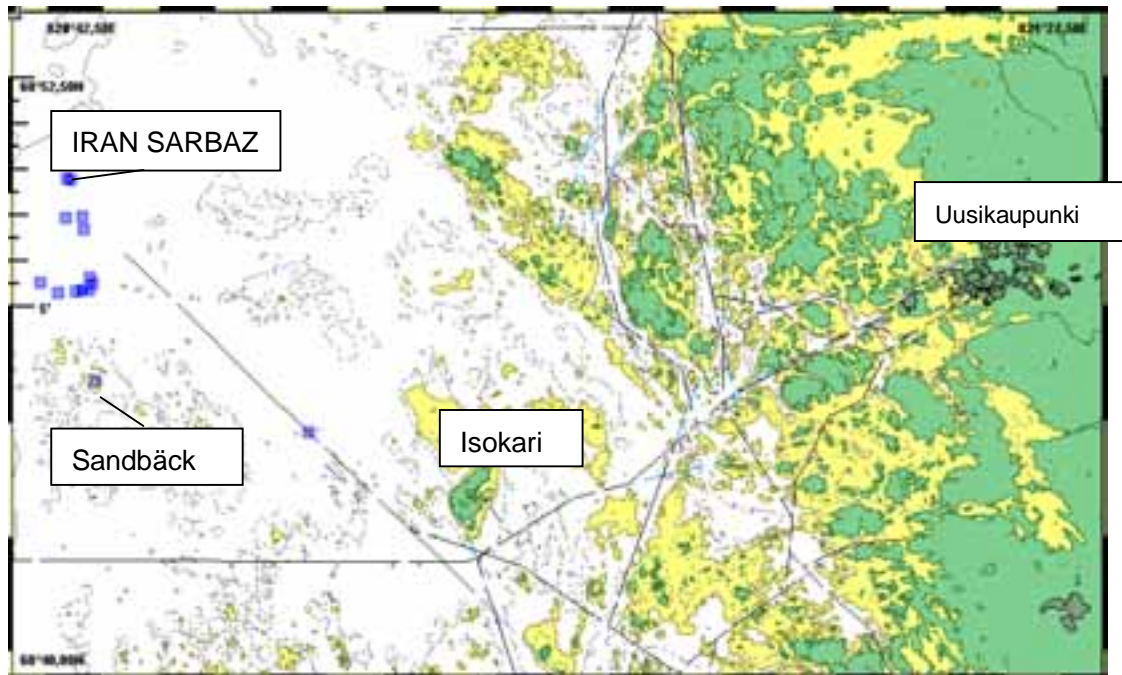
Figure 2. The IRAN SARBAZ anchored north of the Sandbäck light on October 31 at 18.30.

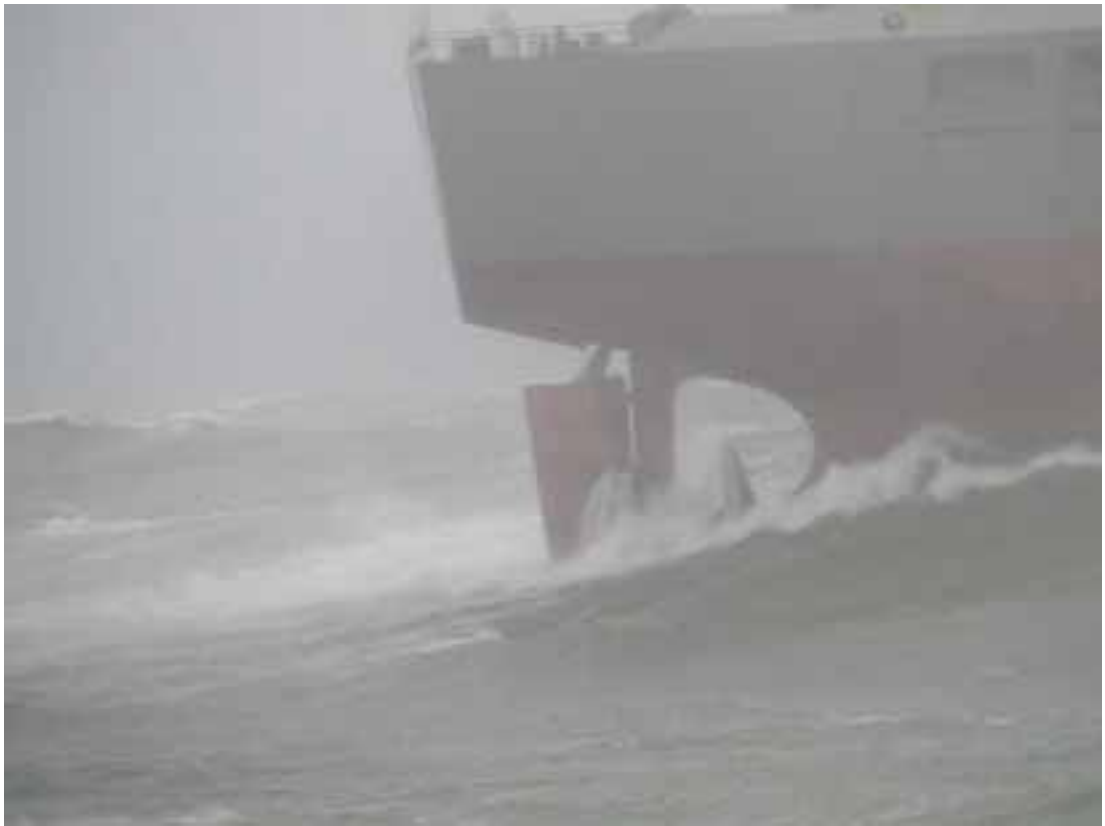
*Figure 3. Ms IRAN SARBAZ at anchor. The propeller is half visible. (Photo by The Finnish Coast Guard)*

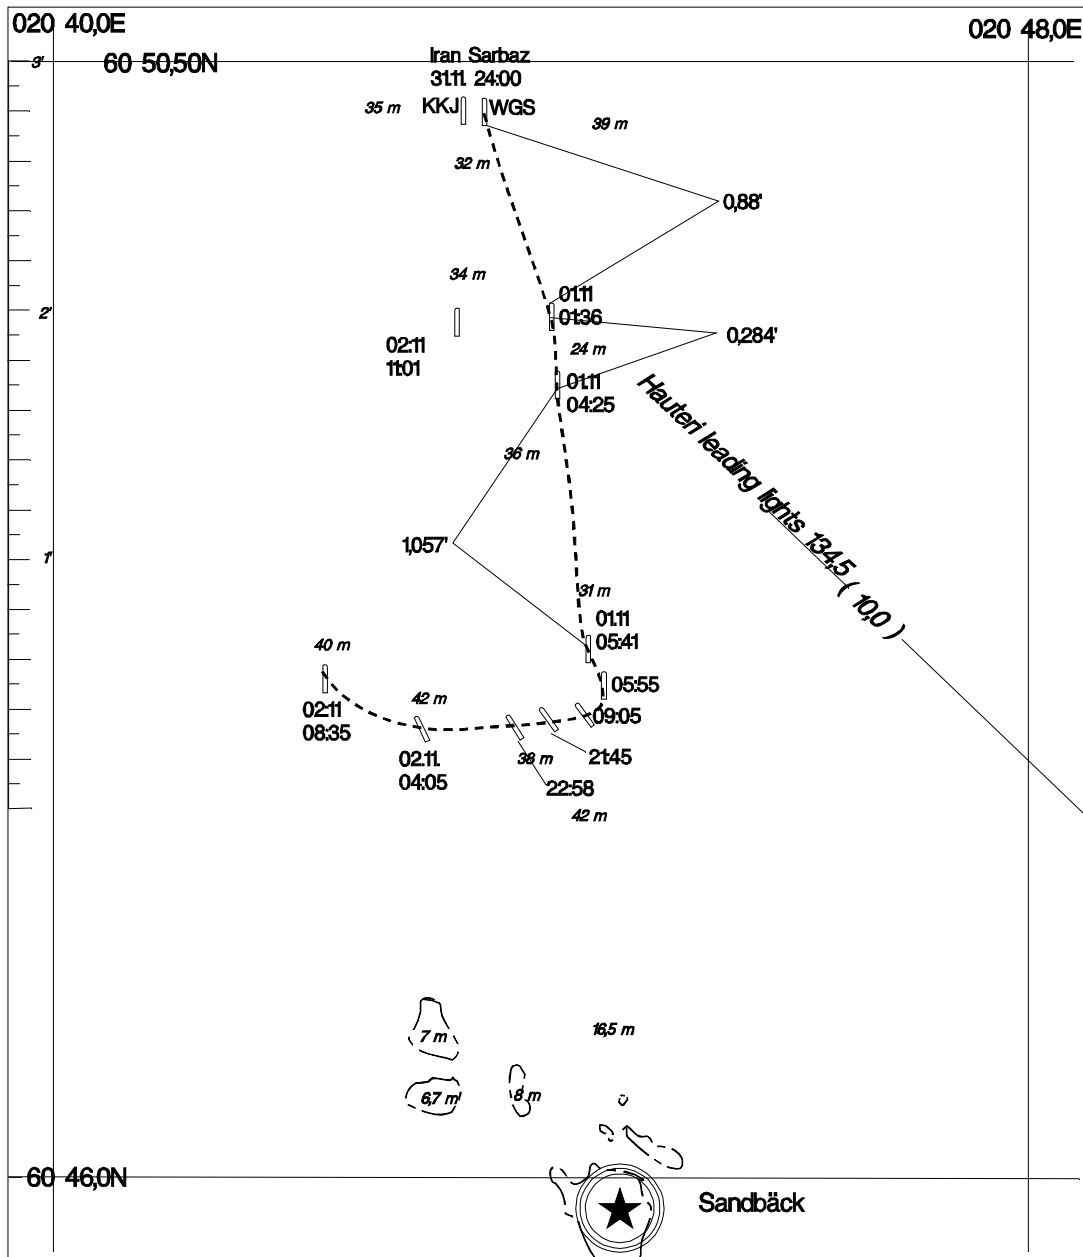
Figure 4. IRAN SARBAZ dropped anchor at 18.30 on October 31, 2001. The anchoring location was logged at 24.00. The chart is drawn in the Finnish National Grid Co-ordinate System (KKJ) and the symbols KKJ and WGS refer to the position of the vessel depending on which system is used for marking the position given by the GPS device.

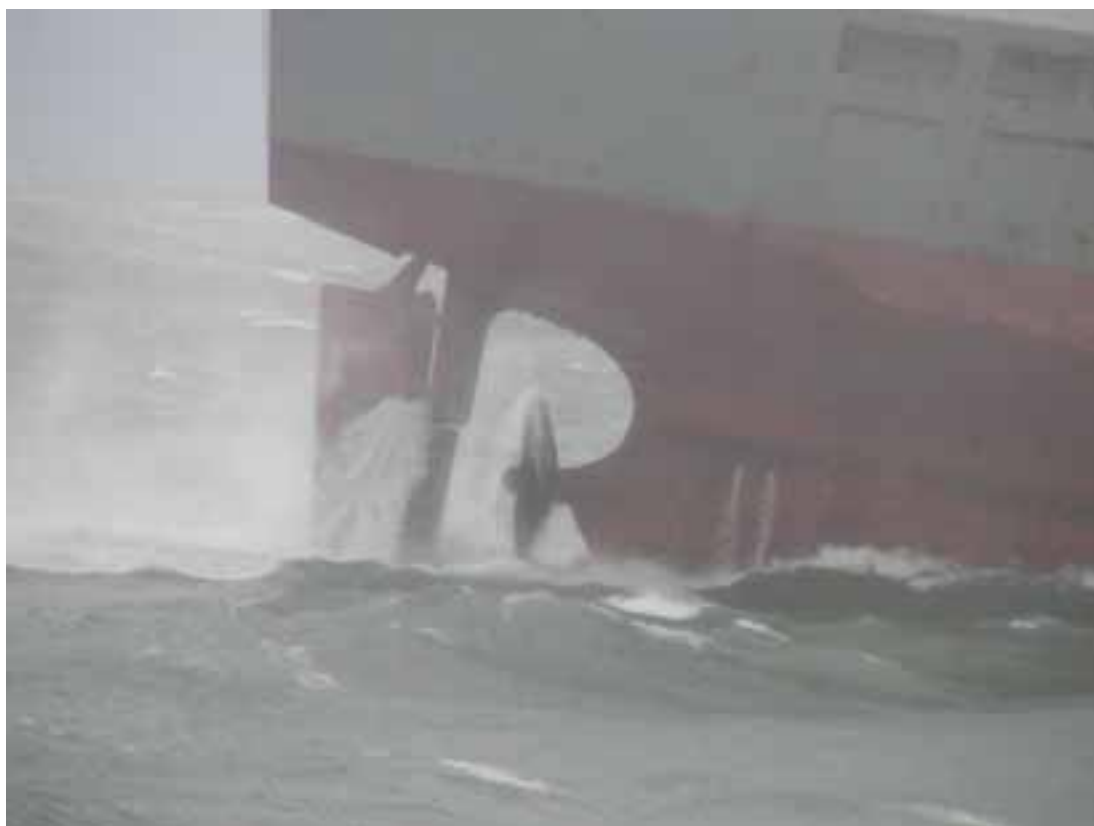
The following table with data from the ship's log and the engine log on the watch conditions between 04 - 08 focus on the external conditions in the ship's log and on the fluctuating rpm of the main engine in the engine log. Due to the high seas, the propeller was exposed at times which caused the engine to race and violent jumps to the rpm. The dumping of ballast had weakened the efficiency of the propeller.

Figure 5. IRAN SARBAZ at anchor in the waves. The propeller was fully exposed at times. The rudder was turned to port. (Photo by the Finnish Coast Guard)
