Investigation report

C 13/2001 M

MS TRADEN, incident caused by cargo shift in the Atlantic, October 19, 2001

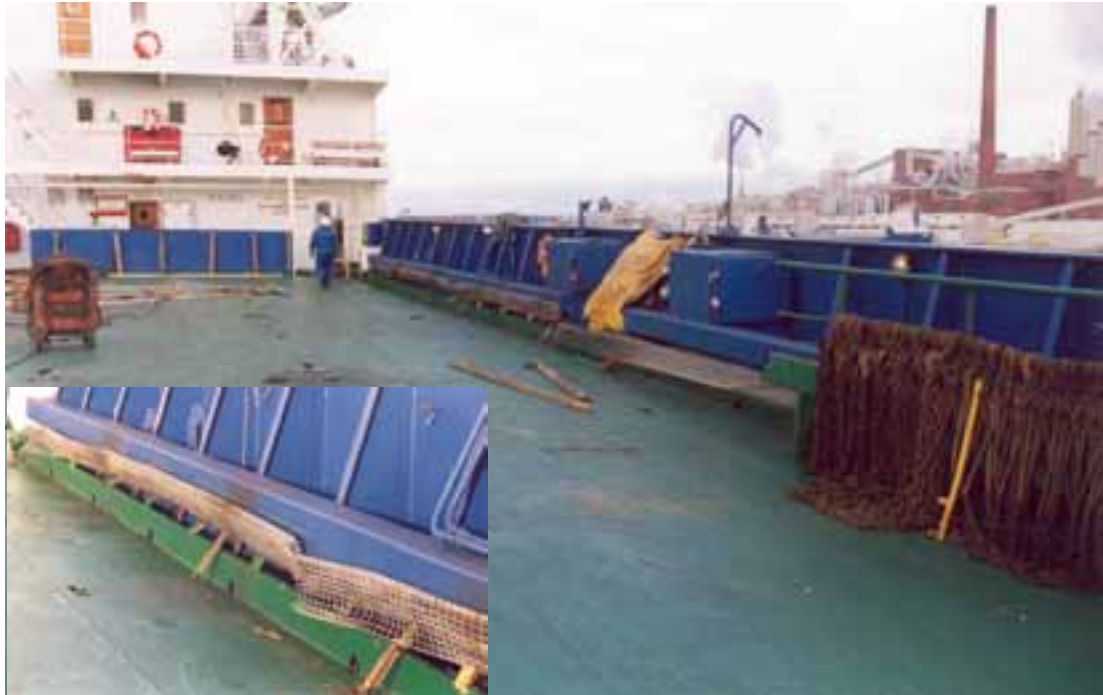
According to observations carried out in Kotka, major structural damages occurred to the cowbridge on the weather deck and structures on the main deck, Figure 14. Also the D-rings on the weather deck, which were used to secure containers with chains to the deck, were torn, Figure 15. The D-rings on the weather deck were in very poor condition and they were replaced with new ones. Received photos indicate also that the welding joints were quite thin. Fastenings of the renewed D-rings were made clearly thicker.

Figure 14. The damaged cowbridge on TRADEN's weather deck.

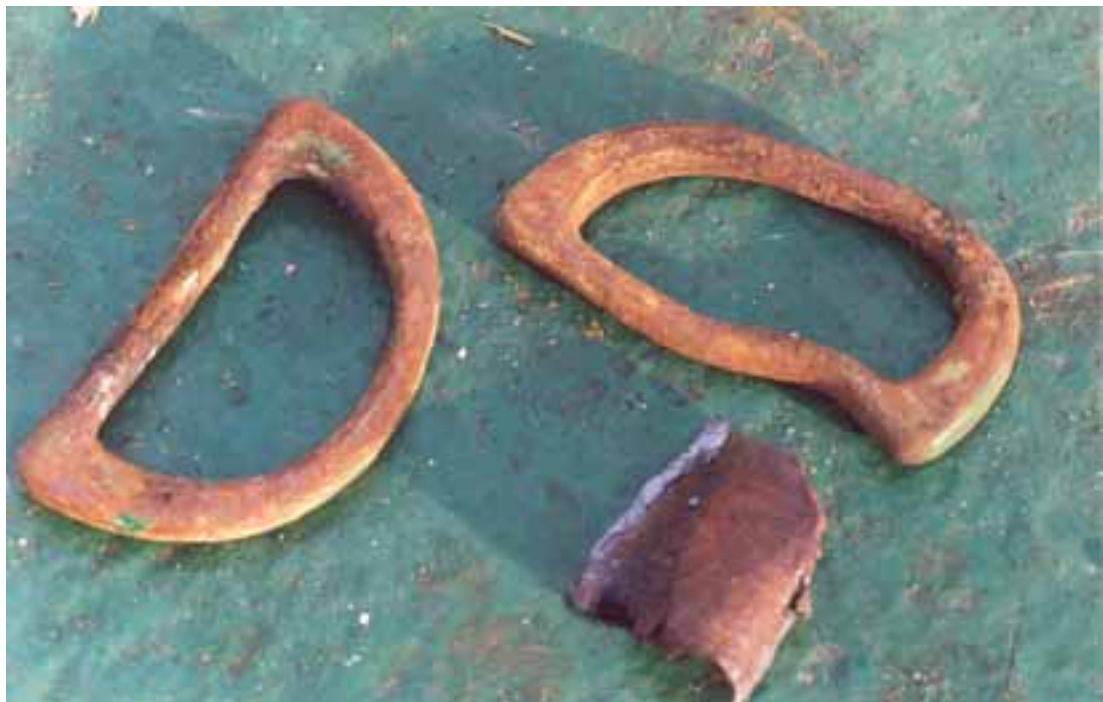
Figure 15. D-rings in poor condition on TRADEN's weather deck.

Stevedores loaded the ship and ship's personnel fastened the cargo. Ship's crew had also fastened containers loaded at Haifa and Valencia. Containers on the weather deck were stowed on planks and fastened with chains to the deck. It can be deduced from damages of the ship's weather deck that the deck fastenings were torn from the deck and caused the loosening of the cargo. Material thickness of fastenings was essentially smaller than the thickness of the new D-rings welded in Kotka, Figure 15.

The D-rings used to secure containers were rather worn. The welding joints had possibly also been eroded during the course of time. The D-rings had broken at locations of welding joints. It is clear that the D-rings were insufficient in strength for securing normal cargo in storm conditions. It is not possible to estimate their breaking strength, but the D-rings were renovated essentially stronger.

Within the investigation it was observed that deck fastenings of the D-rings on the weather deck had weakened, which might explain the loosening of containers.

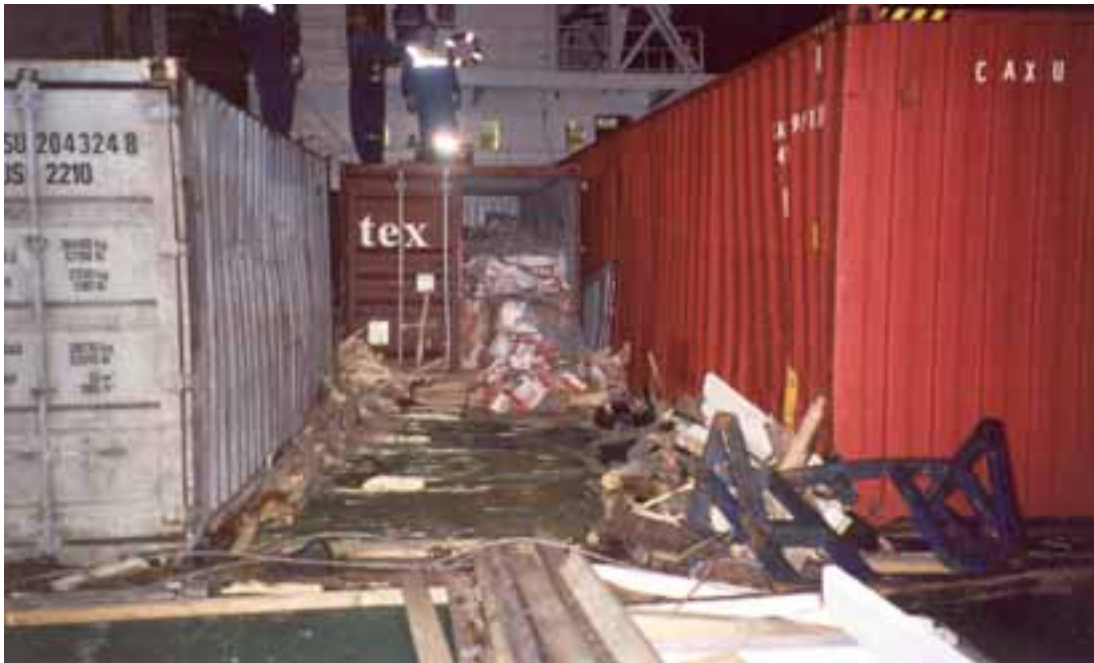
Figure 16. Damaged containers on the weather deck.

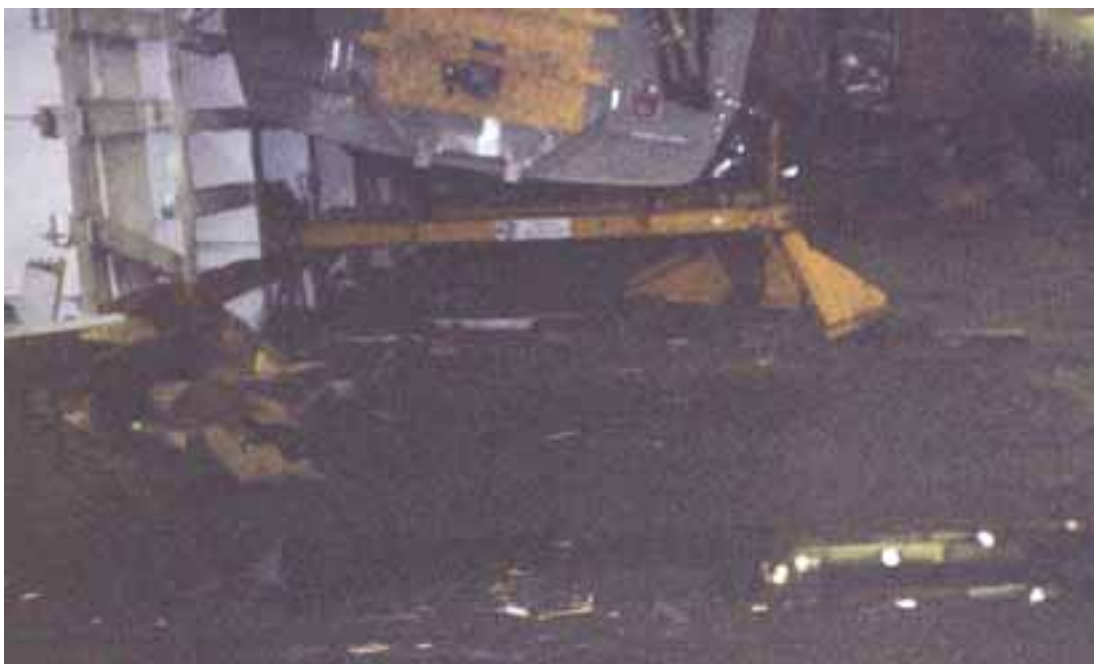
Containers got loose on the weather deck and main deck, and Pendolino railway carriages stowed on the main deck. Cargo damages are not investigated in other respects than from the weight shifting point of view. The examination focused on forces acting on cargo and lashing. Figure 16 shows damaged containers on the weather deck, and Figure 17 shows one railway carriage and a collapsed trestle.

Figure 17. Railway carriage on the main deck and collapsed trestles.

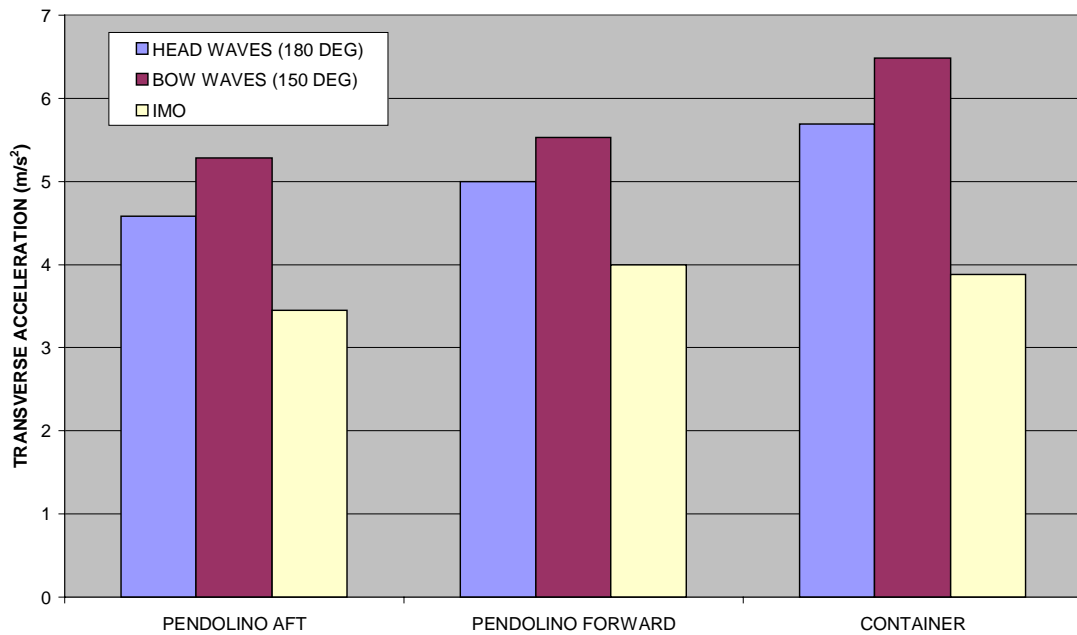
Figure 18. Maximum transverse accelerations and the IMO accelerations.

It can be observed from the results that the IMO accelerations were exceeded clearly in transverse and vertical directions and moderately in the longitudinal direction.

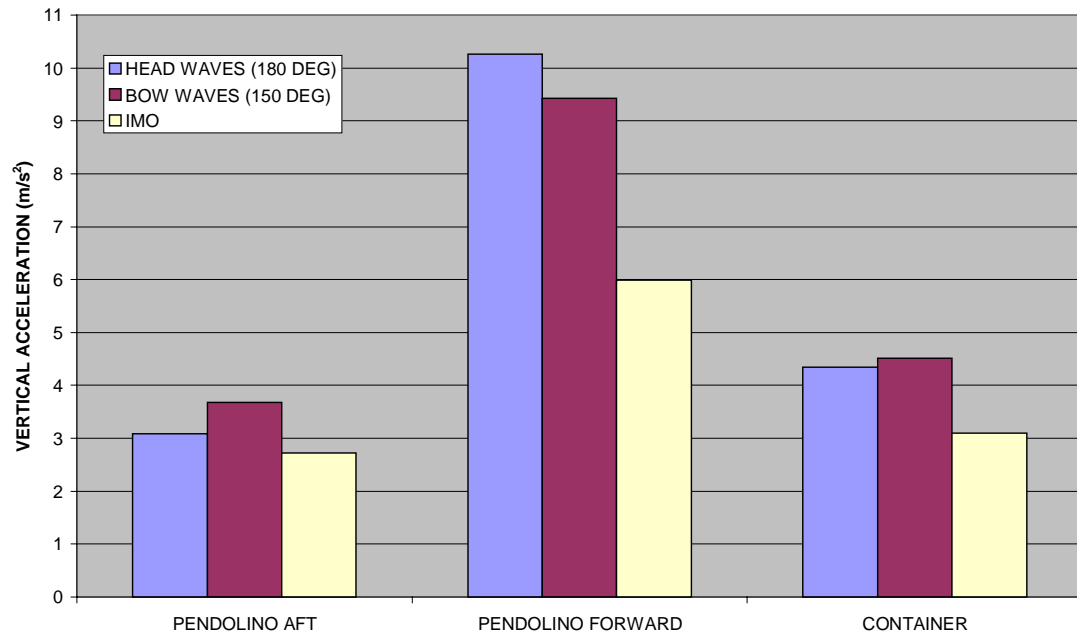
Figure 19. Maximum vertical accelerations and the IMO accelerations.

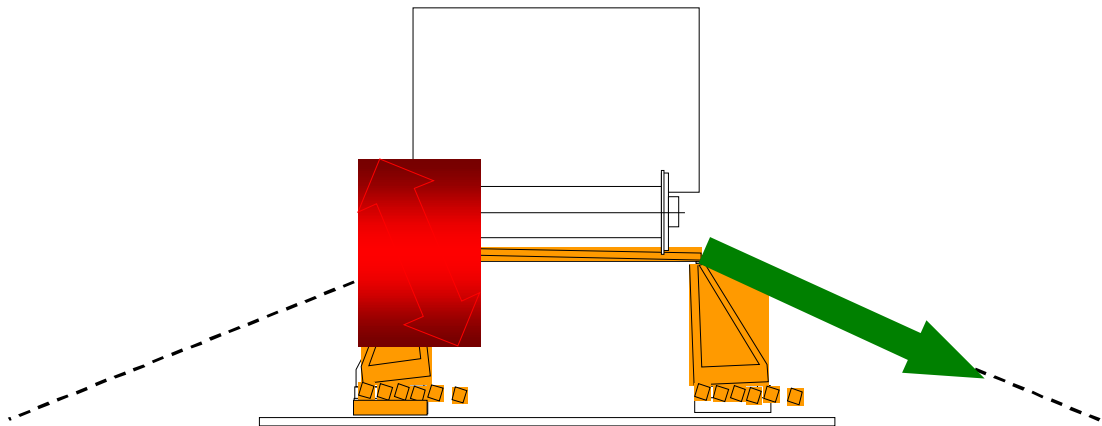
The mechanism of collapsing of a trestle is shown in Figure 21. The red arrow marked in the figure shows the lacking binding direction where the cargo unit is nearly free to move, when simultaneously a small additional force stretches the other binding.

Figure 21. Collapsing mechanism of the trestle.

It is possible to examine the behaviour of the trestles in physical terms by using accelerations experienced by the ship. The total accelerations at the bow were according to the calculations of the order of magnitude of g , and at midship approximately $0.5 g$. This implies that the force caused by a Pendolino carriage on lashing chains would be approximately the amount of its own weight added by a geometry coefficient according to the installation angle. Flexibility of a chain was measured to estimate if a trestle would detach from the deck. It is of the order of magnitude 6 tonnes / %. Thus, if a Pendolino is held stationary for example with 8 lashing chains, in rolling motion each chain will experience a force, which is sufficient to lengthen about 3 m chain with 30 millimetres. It is obvious that a trestle or the end experiencing lift will raise out of the deck, and nothing will prevent any more the parts of the beam stack. Translations will occur gradually until there is nothing left under the trestle's leg, and it can move freely and collapse.

The mechanism of loosening of the Pendolinos has probably been such that the stretching of a trestle has been associated with a gradual movement of a trestle's leg in the outward direction. The form of the trestle's leg has contributed to this together with the fact the trestle's lower end was not secured. The wooden beams under the trestles have obviously given loose, and their friction against the deck was not sufficient to prevent the cargo shift. If the beams have been wet, this has further advanced the escape of a trestle's leg sideways.
