## **Vesiliikenneonnettomuuksia ja vaaratilanteita Waterborne accidents and incidents**

MS ANTARES, MOB lifeboat falling into the sea in the port of Uusikaupunki,  
FINLAND, July 5, 2001

## **Investigation report**

C 6/2001 M  
Jnr. 397A/01

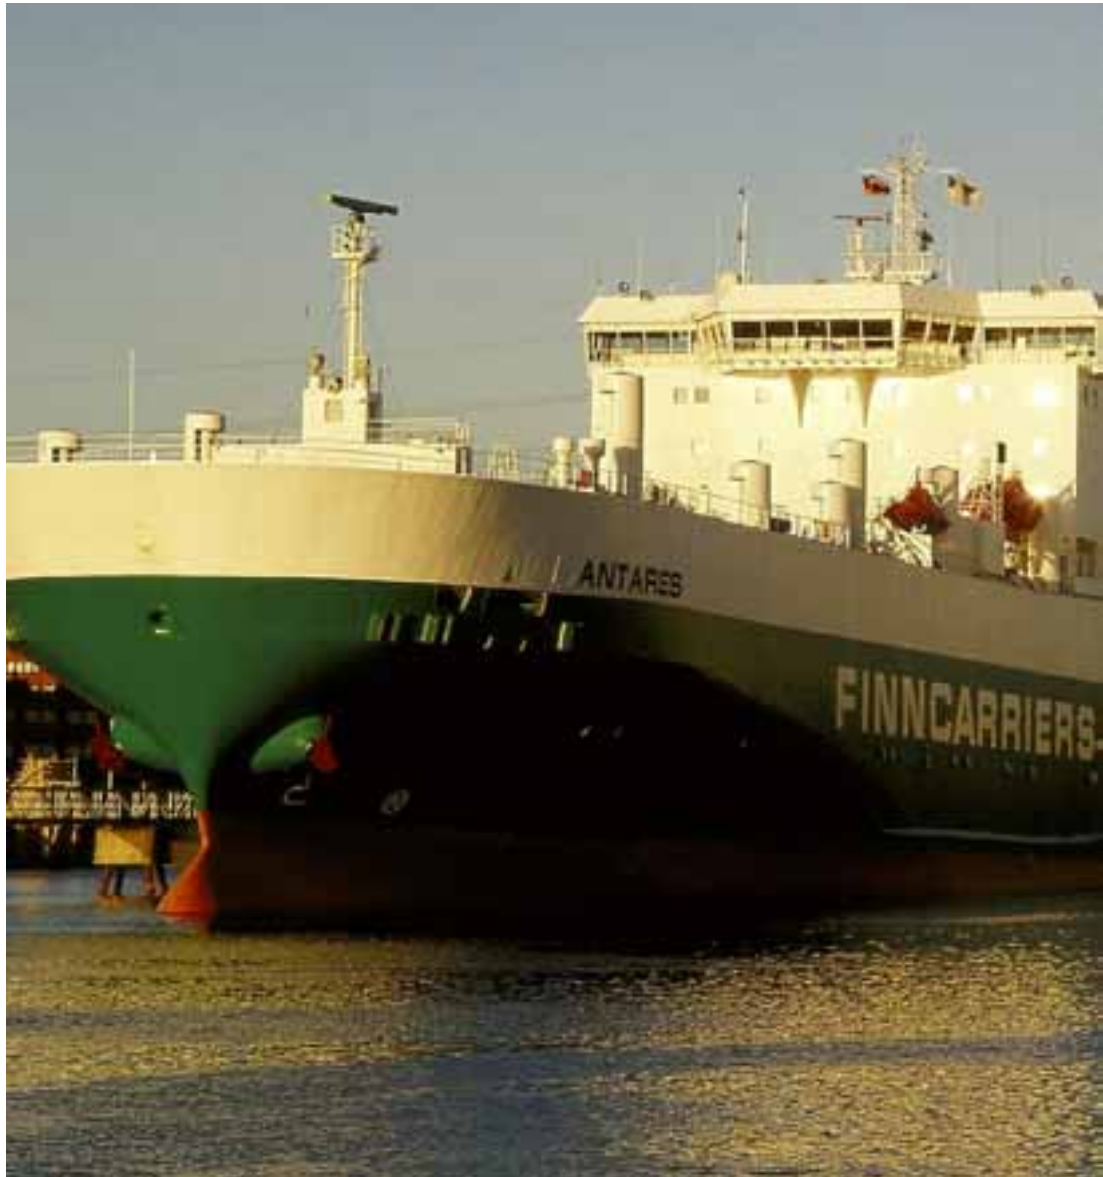
Figure 1. MV ANTARES, the MOB boat in its station (© Finnlines Ltd).

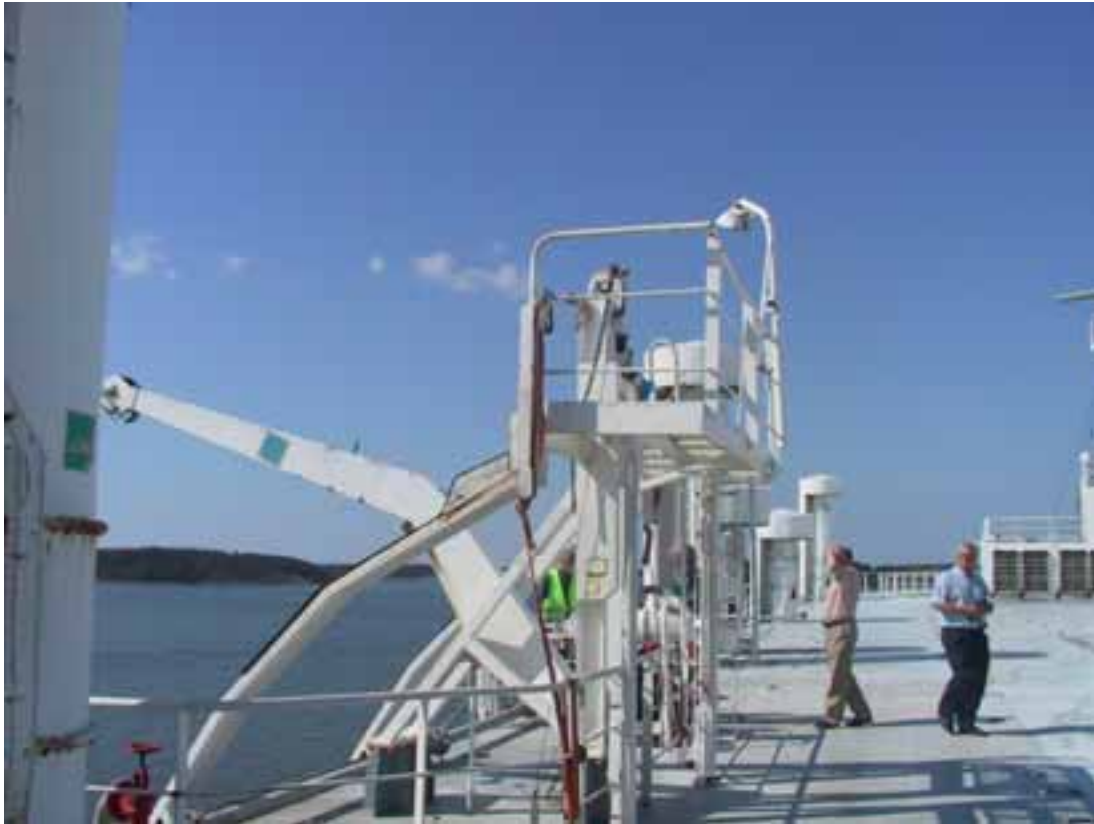
Figure 2. The rigging station for the MOB boat.

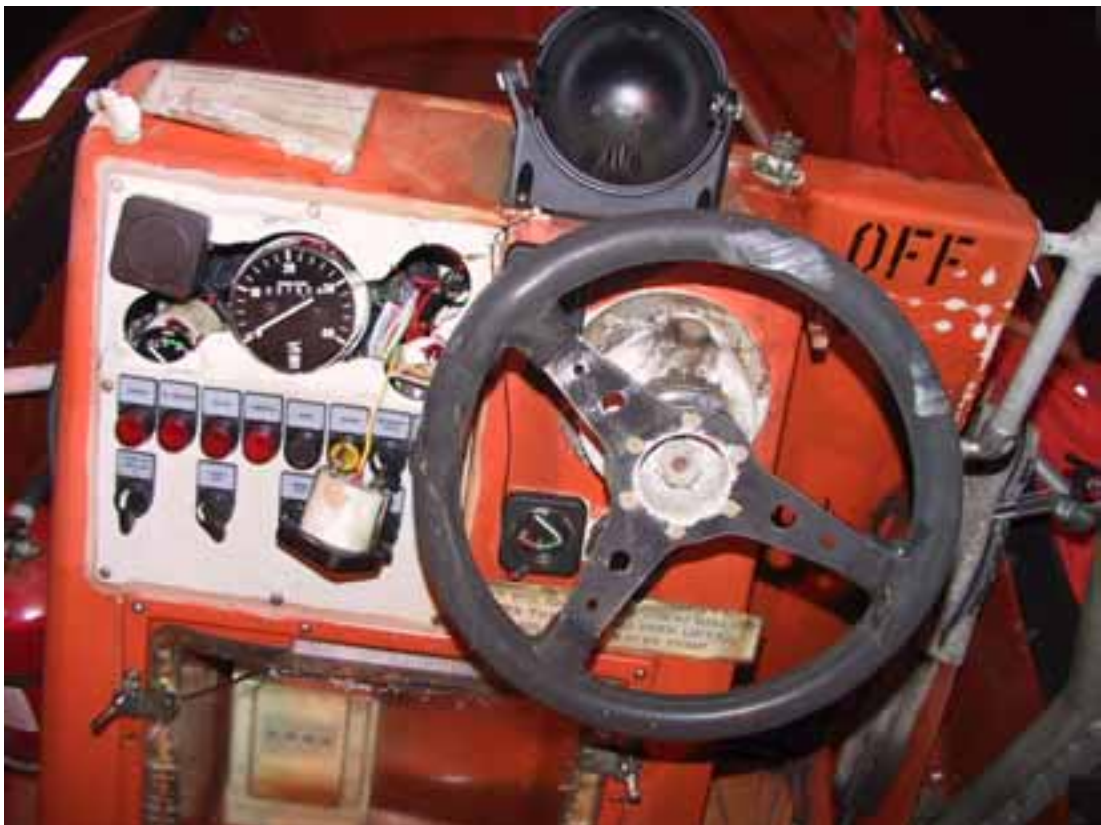
The MOB boat's hull and equipment were badly damaged.

Figure 3. The damaged boat's steering pulpit.

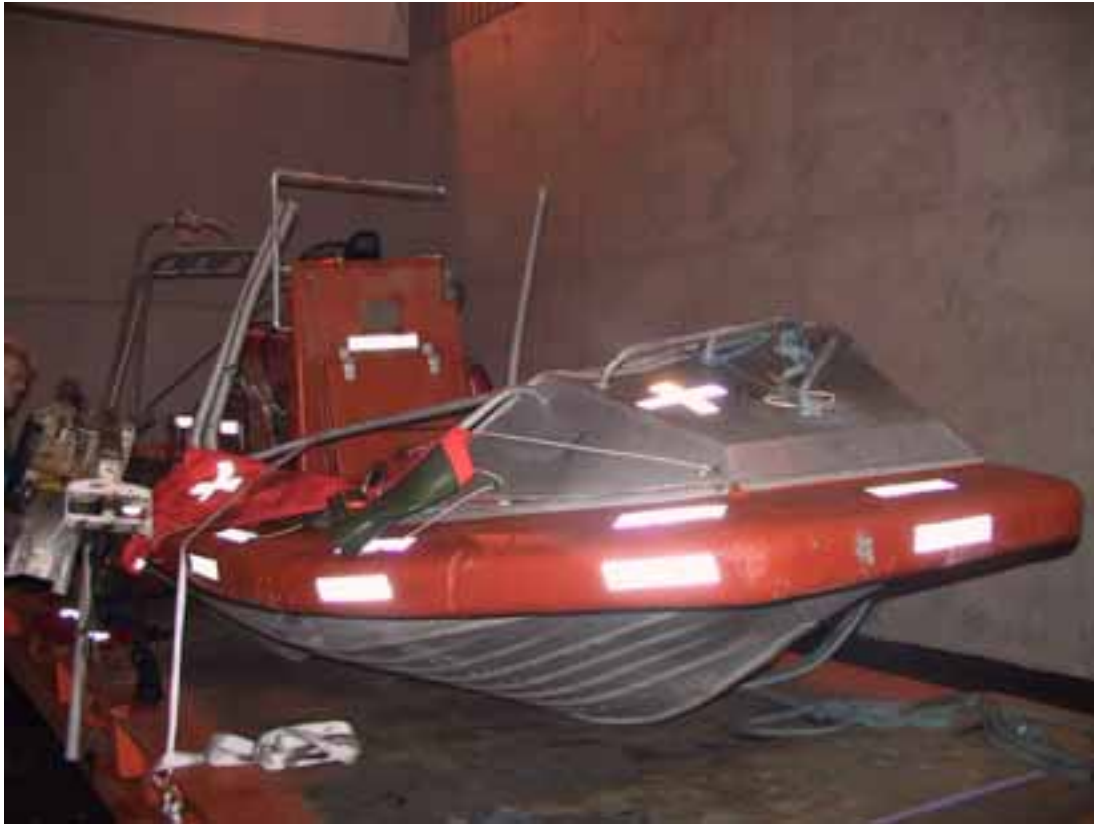
Figure 4. The MOB boat after the accident.

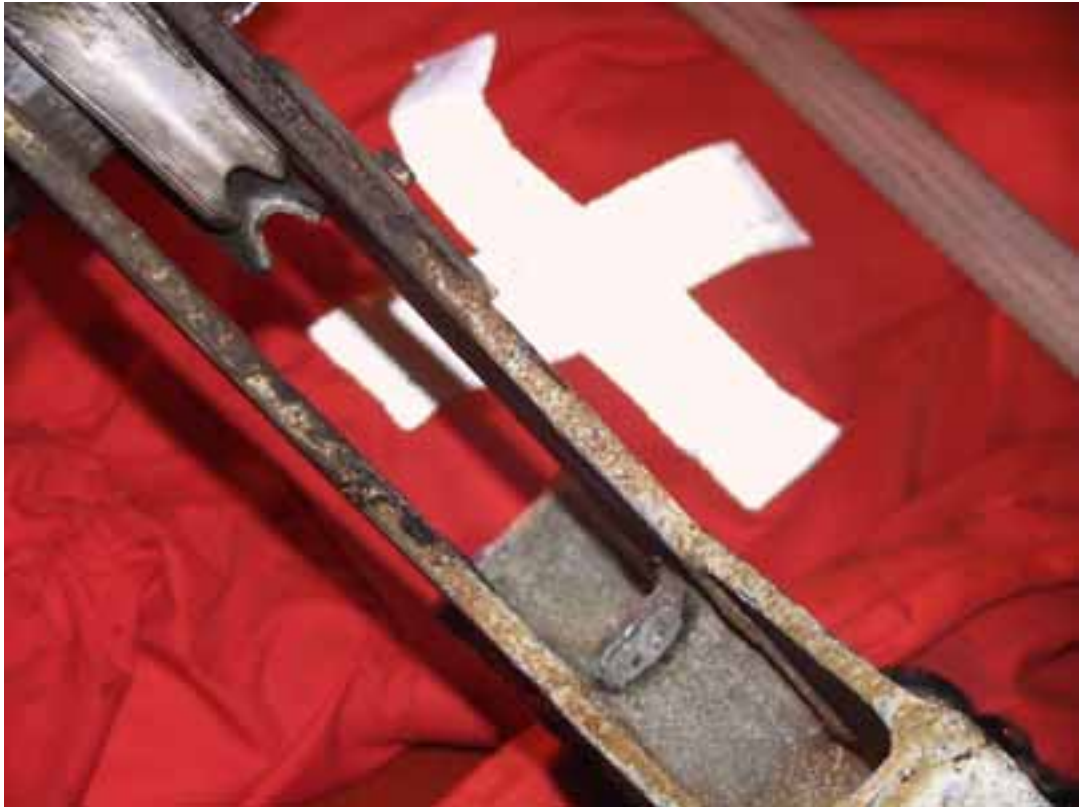
Figure 6. The position of the fall wire's eye and talurite and the guide hole for the wire.

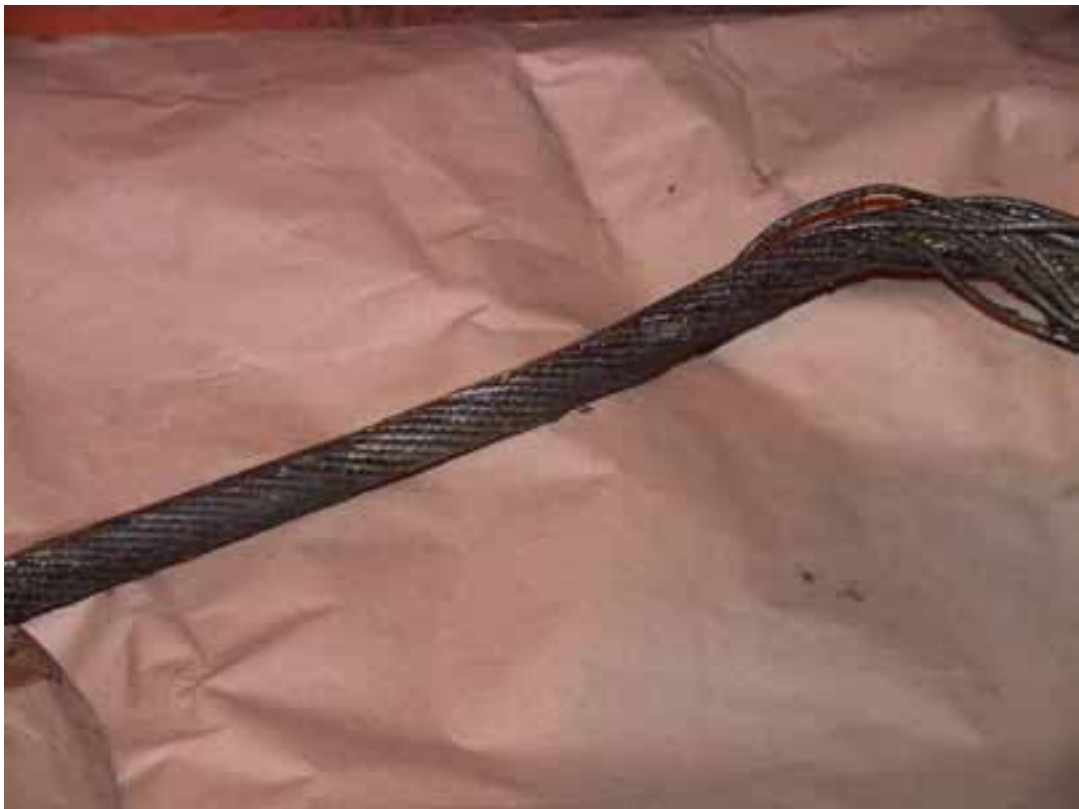
Figure 7. The fall wire; in the middle part there can be seen traces of the talurite clamp (mechanical splice).

The talurit splice of the fall wire to the MOB boat failed in the accident: it exploded under lifting conditions. This happened either as a result of a fault in the splicing process, or because it had been subjected to external stress or an outside force during its use prior to the accident.

1. On sample 1 the evenness of the ends of the strands of the frayed end of the wire indicates that the wire has not broken by stretching. There were no markings left by tools in these strands either. Additionally the lighter-coloured areas indicate that the talurite would have been attached there.
2. In the guide tube of the life boat's fastening system and on the cable wire there are remainders of metal from the talurite.

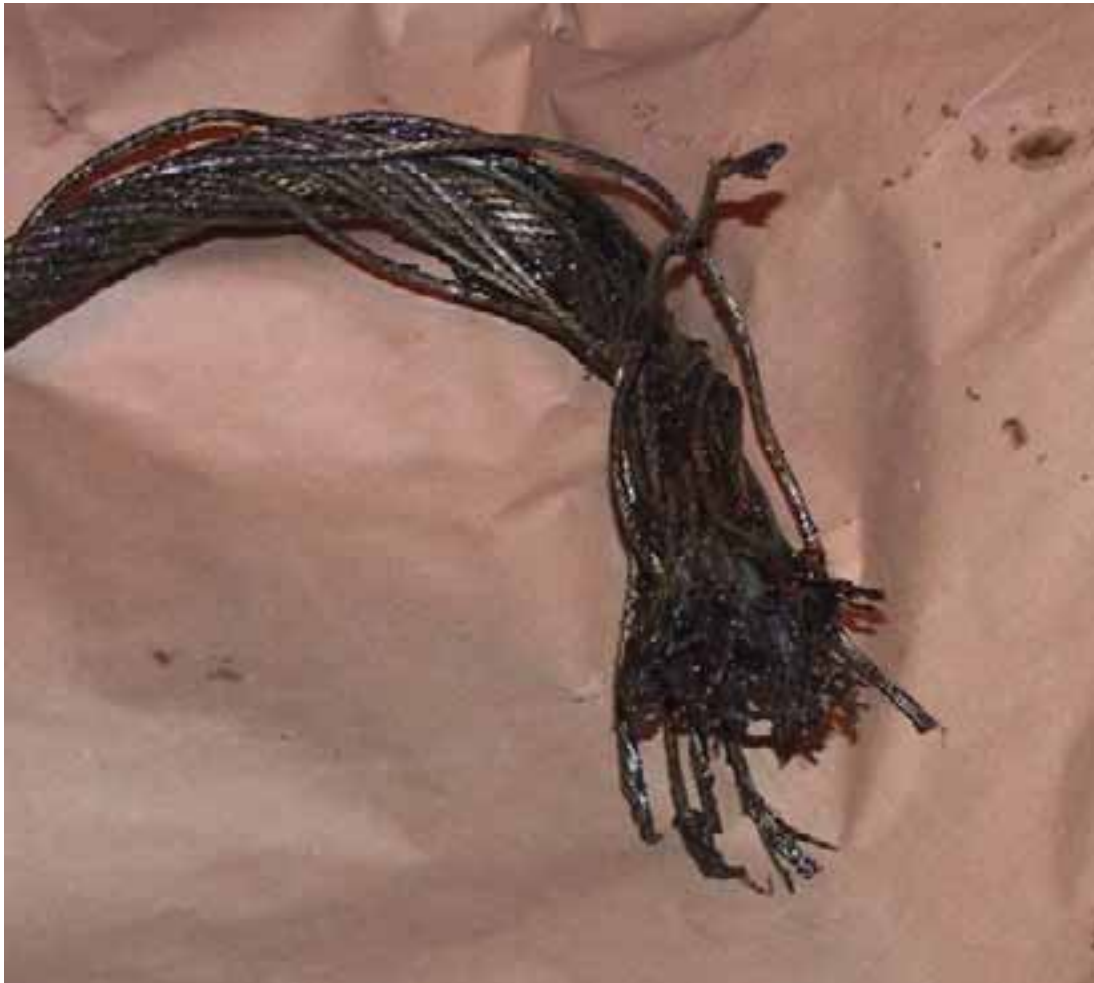
Figure 8. The ends of the strands of the fall wire are not stretched, instead they are even.

1. One end of the cable wire of sample 1 is frayed. The ends of the strands of the frayed end are not stretched instead they are even. The ends of the strands are blackened and oxidised. In the ends of the strands there are no markings that suit to be left by tools. At distances 2 cm and 30 cm from the frayed end there are lighter-coloured areas, their width is 5 cm. These markings fit by their type and approximately by their size to be caused by an object like for example the same sized talurite which was performed as a reference specimen.
