Investigation report

C 2/2002 M

**MS CITY OF SUNDERLAND, grounding off Hanko,
January 1, 2002**

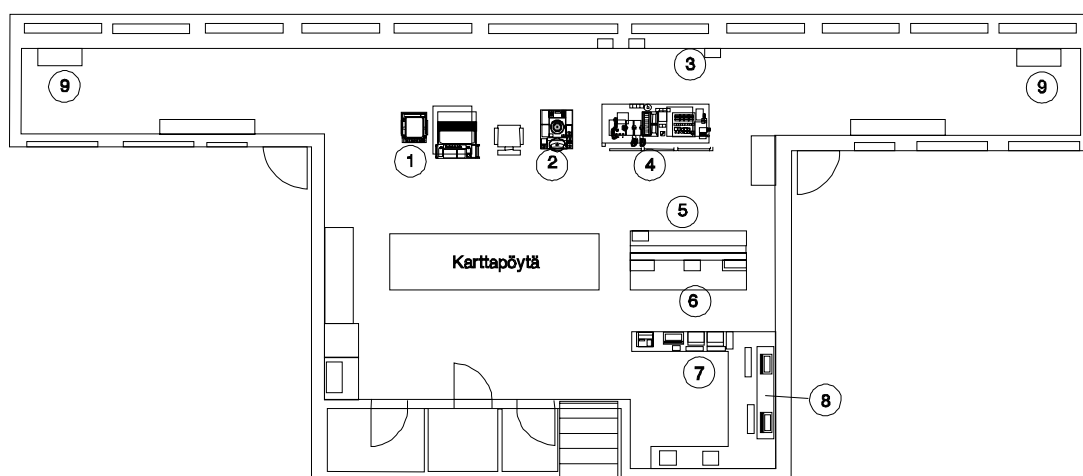
The CITY OF SUNDERLAND's cockpit was rather outdated. There was no dedicated navigation and steering point for pilotage. The radars had been installed far from the engine controls and the VHF telephone.

Figure 2. Cockpit arrangement of the CITY OF SUNDERLAND.

The scattered positioning of the bridge equipment prevented efficient positioning and steering of the vessel. The bridge arrangement was not conducive to good pilotage. The equipment was up to the required specification.

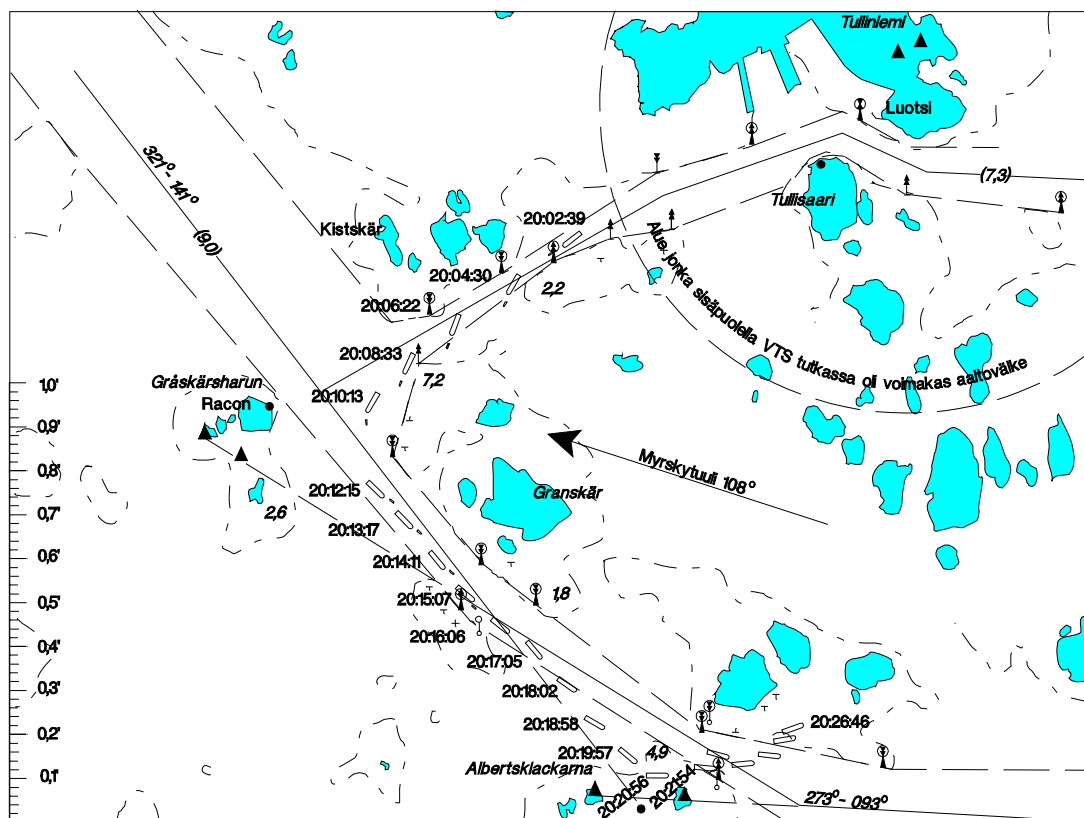
Figure 10. The CITY OF SUNDERLAND's passage according to VTS tracking.

There is an adjustment error in the VTS image. The image of the VTS radar video has to be moved about 90 metres to heading 150° on the chart. The vessel's position is shown in figure 10 to an accuracy of about two shipwidths.

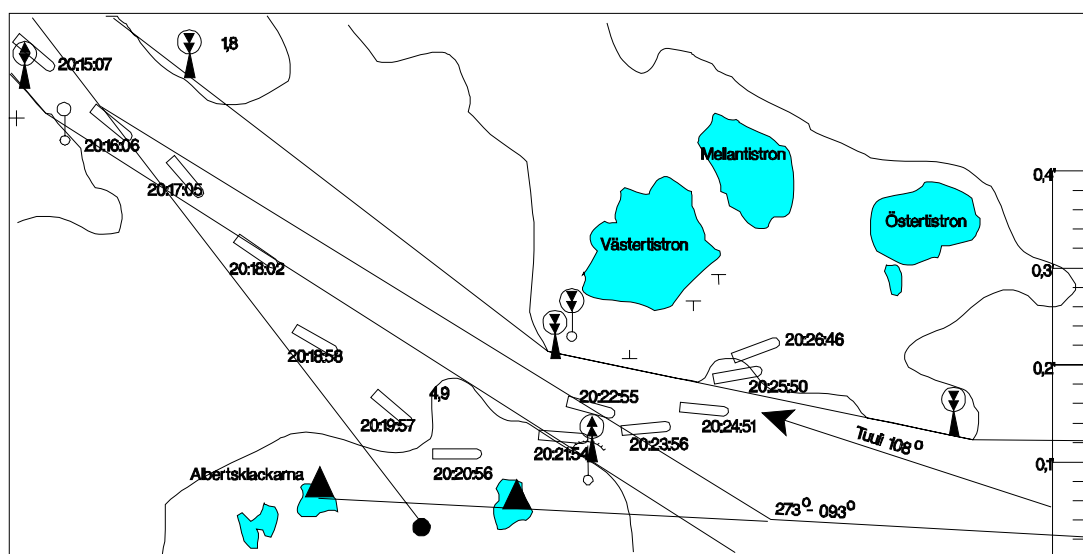
Figure 11. The CITY OF SUNDERLAND's passage before the grounding.

After the tug was released, the CITY OF SUNDERLAND started to drift off the fairway. The main cause of this was the sea clutter on the radar. The tug's radar antenna was low down, so the sea clutter did not affect her radar as badly as that of the CITY OF SUNDERLAND. The fairway was more visible from the tug, and she could pull the CITY OF SUNDERLAND in the right direction. Several factors played a part in causing the vessel to drift off the fairway: the unexpectedly large drift angle after the release of the tug, the poor radar image, and the non-existent visibility.

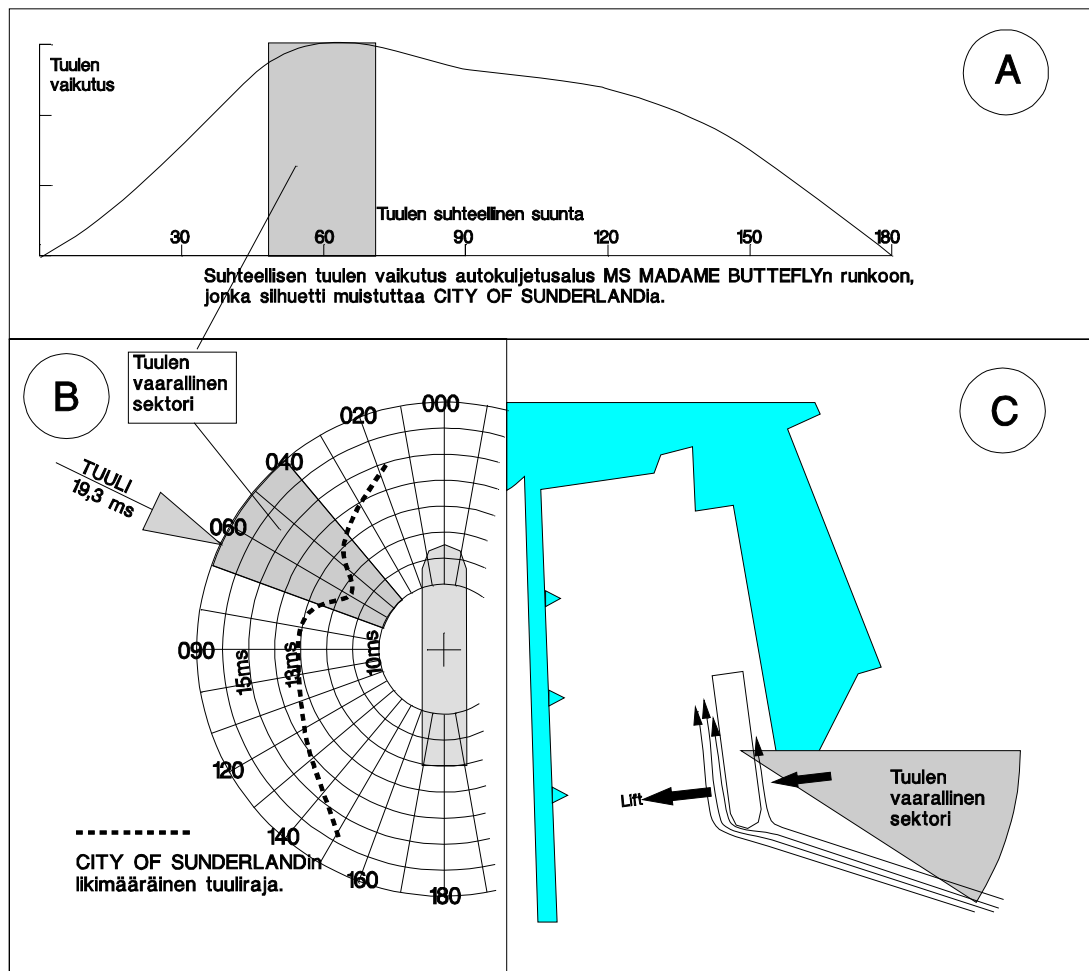
The vessel's PILOT CARD indicated that the bow propeller could not manage if the wind coming directly on beam exceeded 13 m/s. If the wind comes at about 60° off the bow of the vessel, a strong lift is created on the leeward side of the hull, which causes more drift than the wind directly on beam. The direction of the wind when the CITY OF SUNDERLAND was berthed was the worst possible (figure 12). The vessel had a wind force table (table 8), where the wind on beam is correct but the force of a head wind coming at 45° is too small. The relative hazardous wind direction was not indicated.

Figure 12. Estimated wind limit for the CITY OF SUNDERLAND based on the PILOT CARD and on the general wind limit definitions²⁵. The wind limit was exceeded.

The wind limit for the vessel had clearly been exceeded, according to the information on the vessel. The wind direction was the worst possible, because it was blowing directly through the strait between Tulliniemi and Tullisaari. The master explained in the Maritime Declaration session that: "The pilot knows the conditions of the harbour best, and that he considers the opinions of the pilot when making a decision". The pilot said that: "Ships had been brought in under similar conditions before". By "similar conditions", the pilot apparently meant that this referred to the use of a tug. He proposed that a tug be requested and the master agreed.

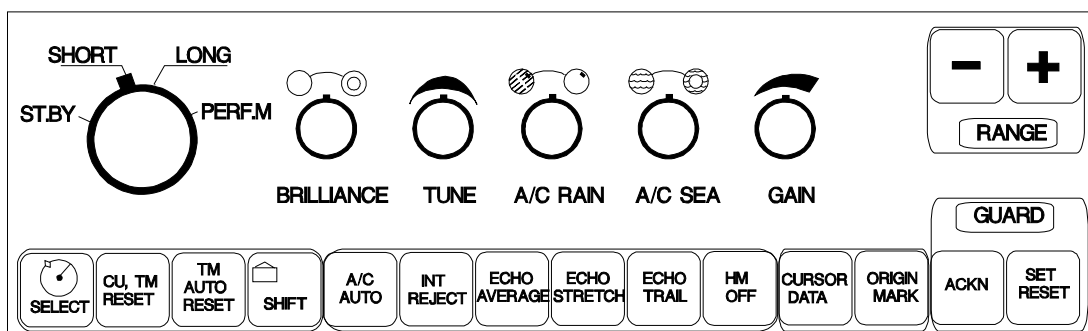
Figure 14. Control panel of the CITY OF SUNDERLAND's main radar. The panel is clear and easy to use.

The radar's adjustments were good ergonomically. Its image could be adjusted using the TUNE, A/C SEA (clutter reduction) and GAIN controls. These controls were arranged logically on the control panel so that they were not on top of each other. The radar had a 3 cm transmitter in accordance with the regulations, which is not the best possible wavelength if there is sea clutter on the radar. According to the information available, there was no technical malfunction of the radar itself (figure 15).

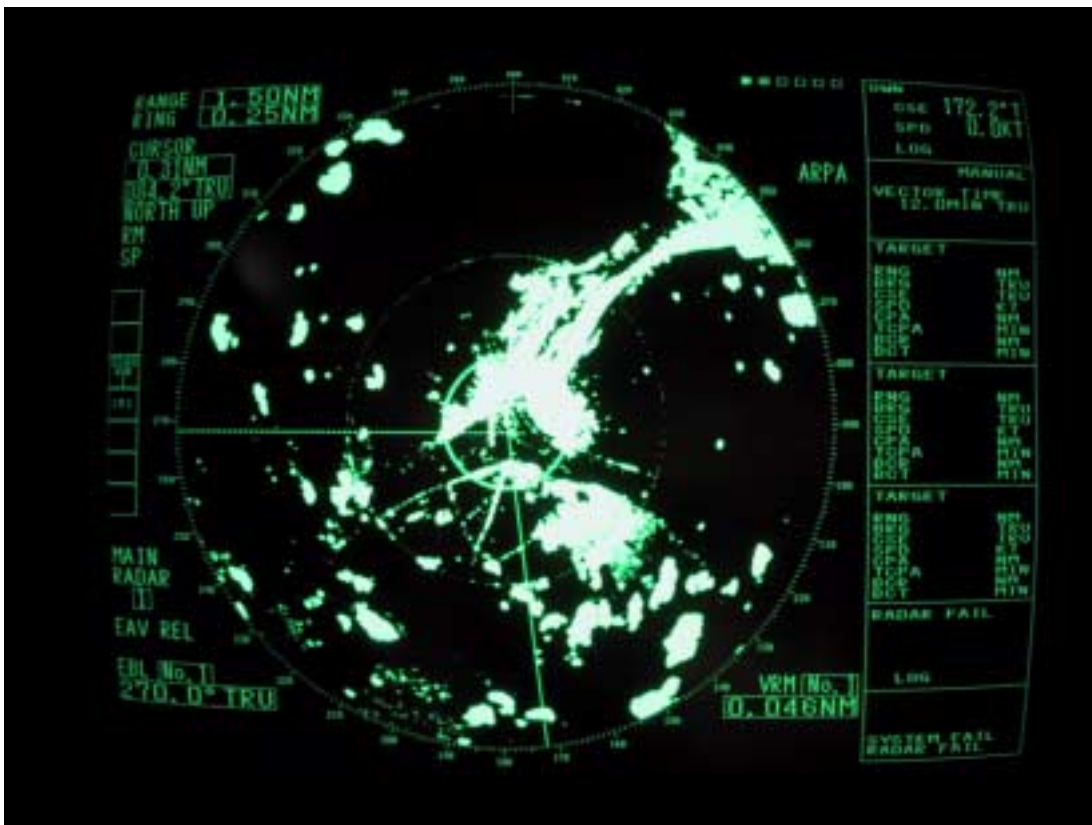
Figure 15. Image of the CITY OF SUNDERLAND's main radar at berth after the accident.

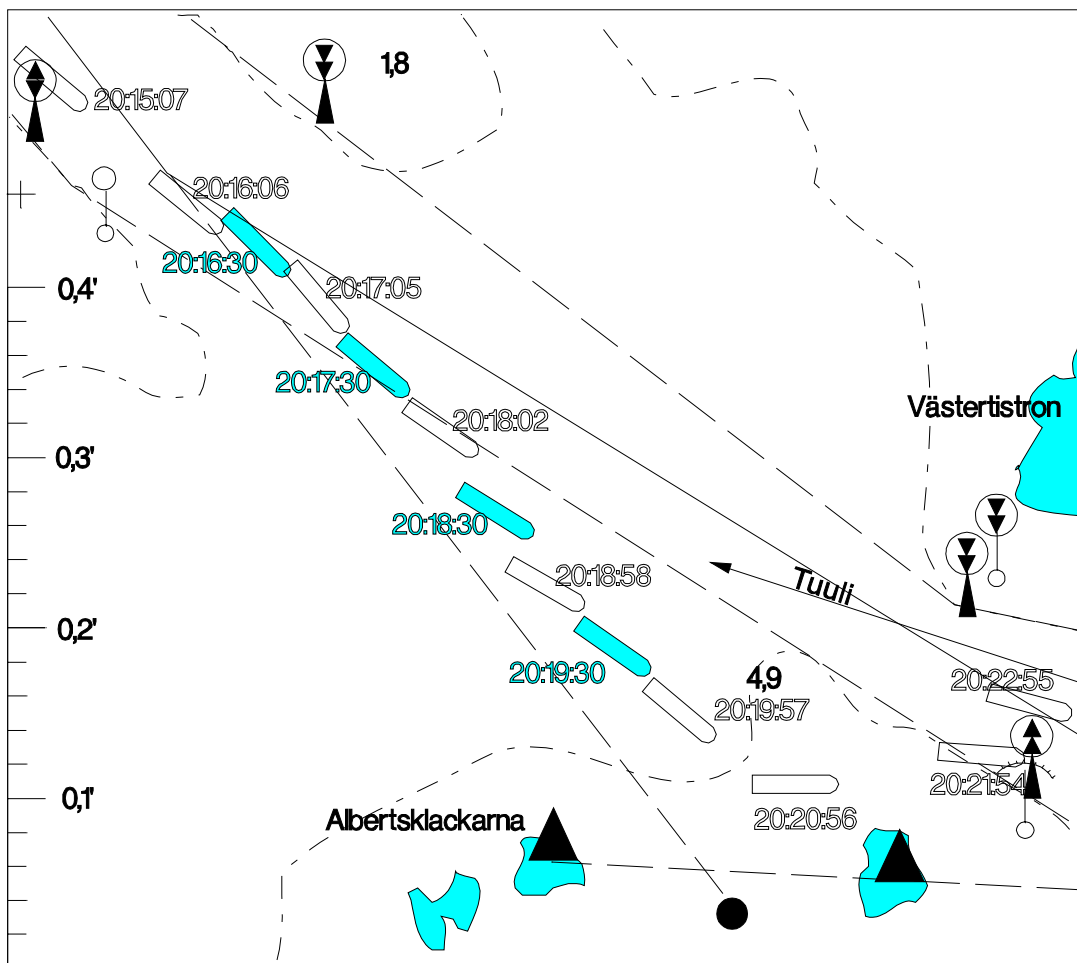
Figure 17. The compass heading used by the CITY OF SUNDERLAND indicates that it was difficult to determine the drift because of the poor radar image.

The drift angle of the vessel varied between 10° and 20° . The radar targets ahead easily give the wrong impression of the fairway markings if the radar image is poor. The poor radar image deprived the pilot of his last chance of determining the correct heading. The vessel's compass heading was 10° - 15° too much to starboard. The vessel's direction agreed with the given line, but the drift was greater than expected.
