Casualty Investigation Report CA 75

**Grounding of Isle of Man registered vessel City of Sunderland
at the Port of Hanko, Finland on the 1st January 2002**

Isle of Man Government Marine Administration

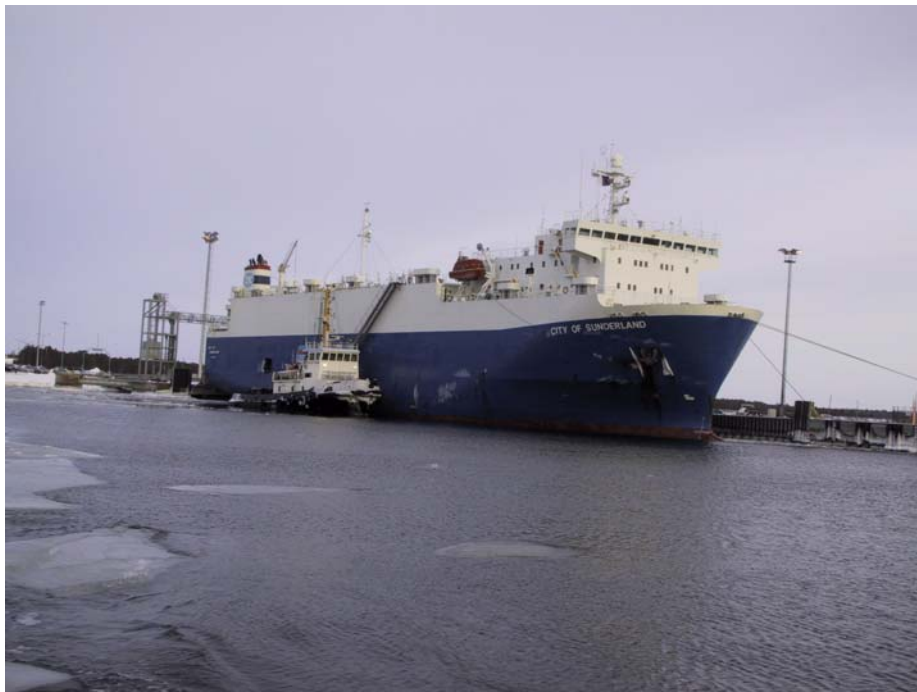
Picture No.1

“City of Sunderland” berthed at No. 2 Ro-Ro Berth Hanko after refloating

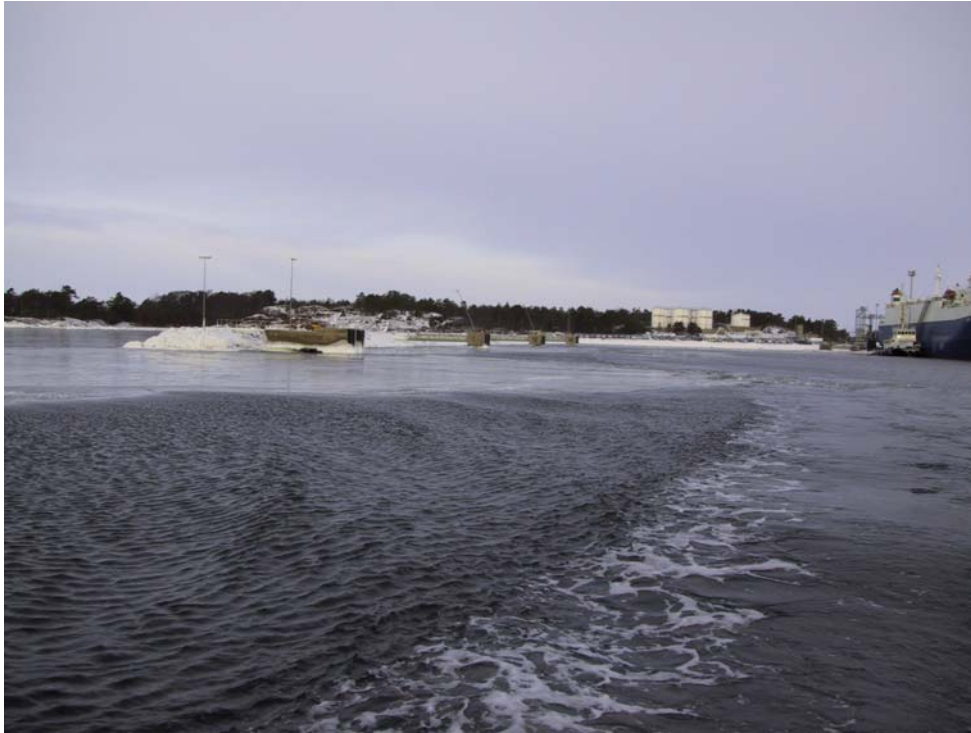
Picture No.2

Shows the Western Jetty where the “City of Sunderland” landed eventually across the Dock from the intended Ro-Ro Berth No.2

- 4.22. The ship was forced onto the Western Jetty and pinned there by the severe weather conditions. The starboard bow landed on the middle dolphin. There was 50 metres or more of the ship overlapping the inner dolphin and the ship was lying at angle to the jetty. The Master told the pilot he would require another tug before any further attempt was made to manoeuvre the ship onto the Ro-Ro berth. The Pilot advised the Master another tug could be ordered from Helsinki, but it would take up to 6 or 7 hours to arrive. Meanwhile the tug “Ajax” was being made fast forward, the Deck CPO confirmed this fact at 1842 hours. The Master was unhappy about the ship’s angled position as she lay on the jetty, this fact was confirmed by the Chief Officer from aft. He requested the Master to move the ship forward to avoid any further damage on the dolphin. As the Master attempted to manoeuvre the ship forwards on the main engine the Pilot had the tug “Ajax” pull the ship forward. However, the Pilot’s intention was to pull the ship off the berth, and take it out to the anchorage via the main channel. The Master’s actions were to manoeuvre his ship sufficiently forward with the sole intention of providing a safe place for the ship to lie and await the second tug. The Pilot was of the opinion that the ship would be damaged if it remained on the jetty. It appears the Pilot never discussed or told the Master his intention to return to the anchorage, or sought his agreement to leave the port. The “City of Sunderland” has apparently stayed on this jetty previously to wait for a tug. The Pilot ordered the Master to provide the engine movements as the tug “Ajax” attempted to pull the ship off the jetty and up into the wind. The strength of the wind again proved too much, the Pilot was forced into the decision to turn the ship to starboard and proceed down the secondary channel via Granskarharun and Albertsklackarna to the anchorage area.

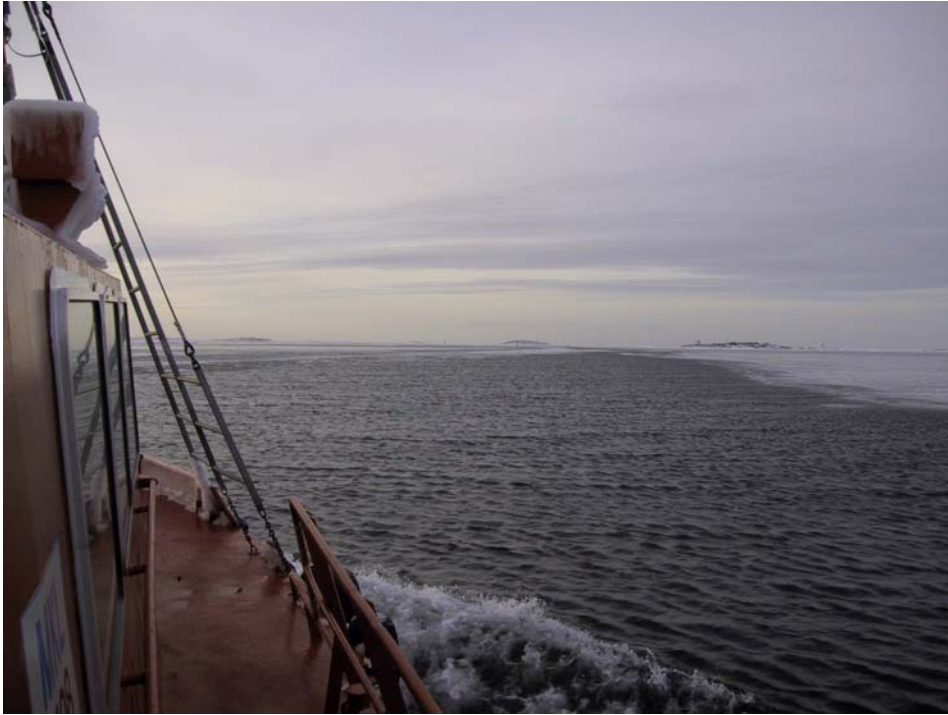
Picture No.3

Depicts the westerly course of the secondary channel from the Western Jetty to Granskarsharun in the distance

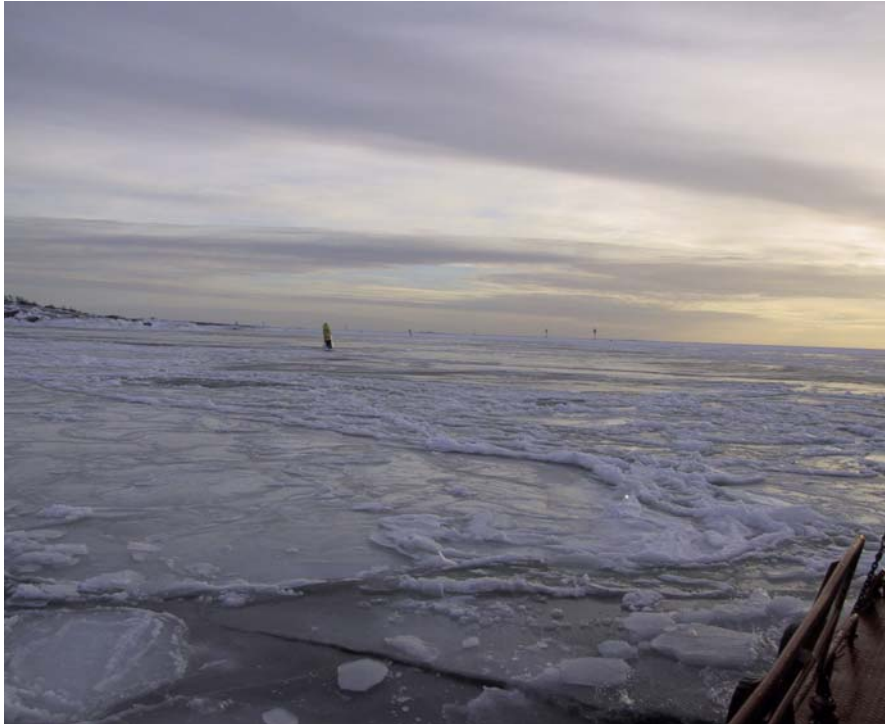
Picture No.4

Depicts the south easterly course from Granskarsharun to Albertsklackarna

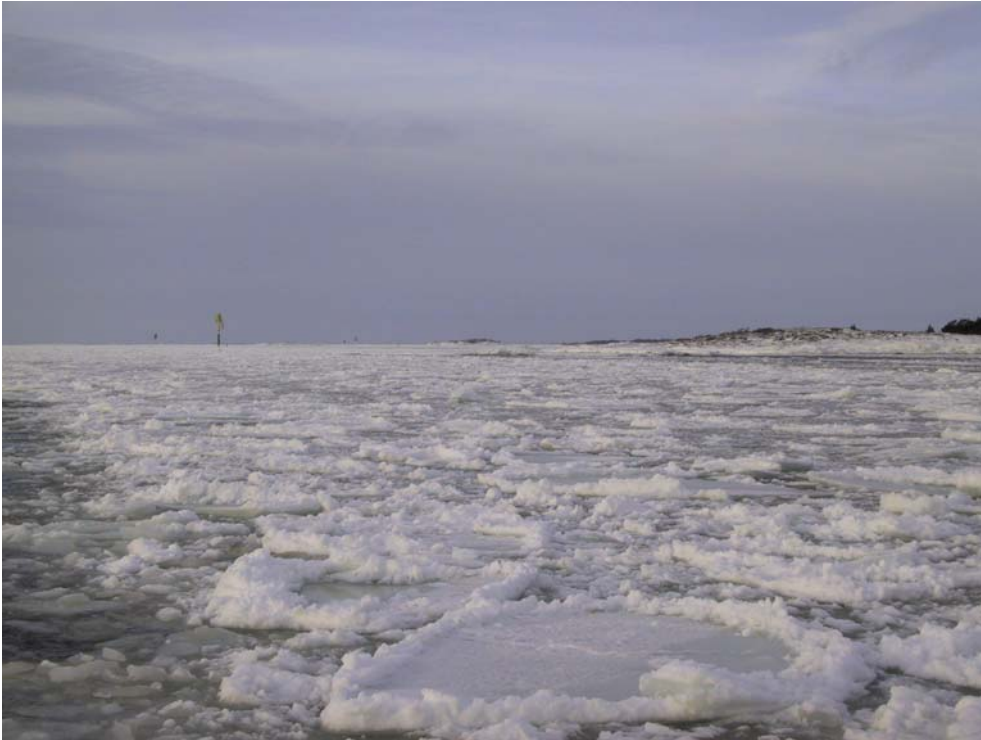
Picture No.5

Depicts the beacon lying close to the south west of Vastertistron Island and the area close to the south of the island where the City of Sunderland grounded

- 4.31. The lack of recorded ship's positions on the south easterly heading makes it difficult to identify the actual buoy which was picked out by the tug's searchlight. However, given the close proximity of the time of grounding to the time the tug was let go, the probable identity of this buoy is the north cardinal mark positioned on the north eastern edge of the Albertsklackarna group of islands. It has not been determined whether this beacon was ever correctly identified.

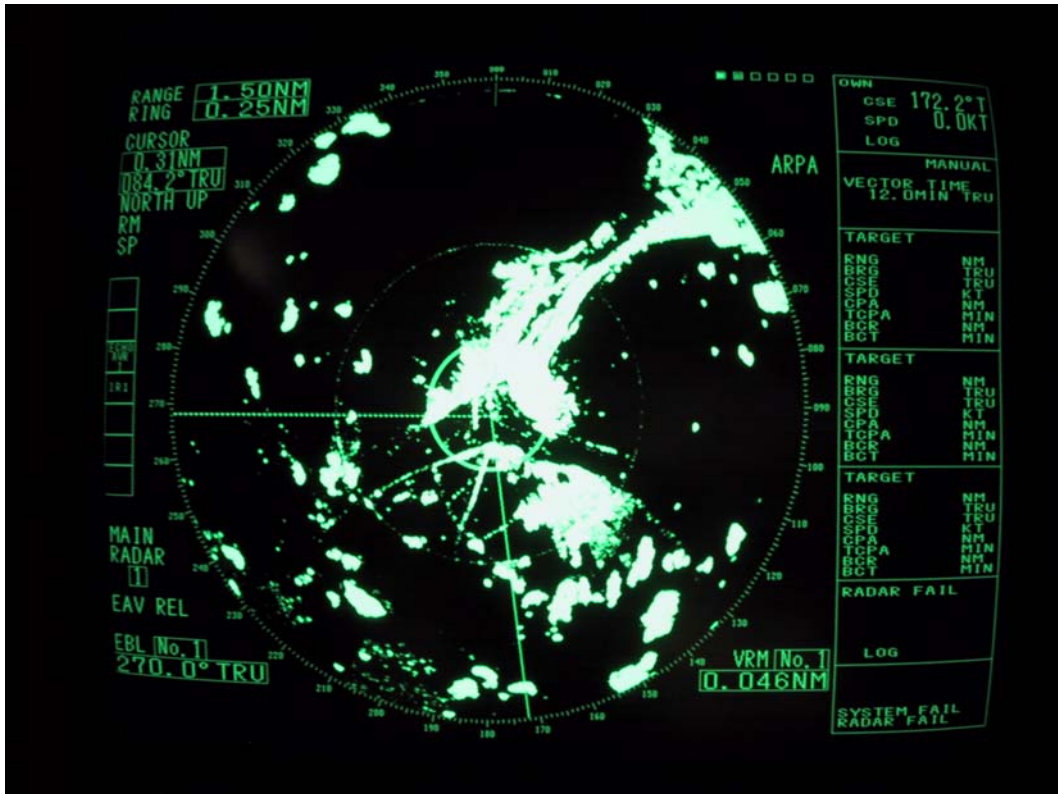
Picture No.6

View of radar picture covering the area from the berth at Hanko to Vastertristron

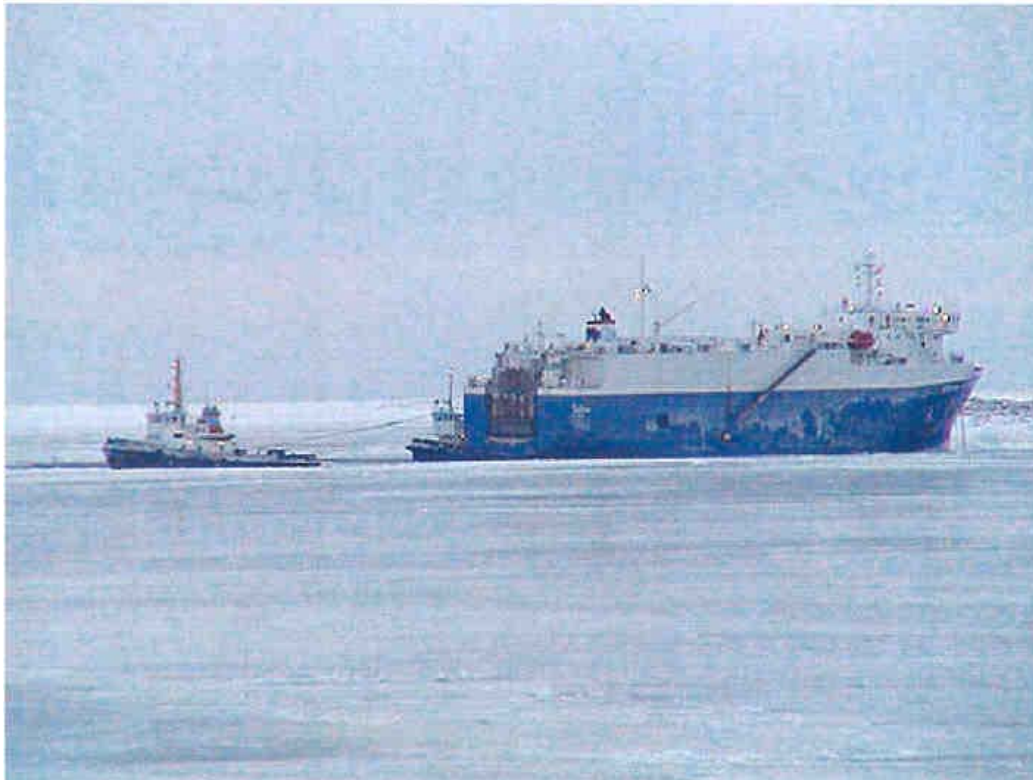
Picture No.7

- 4.34. Damage was sustained to the underside of No.1 Fuel Oil Tank (P) frames 105 to 109, No.1 Double Bottom Tank (P) & (S) frames 70 to 90, No.2 Double Bottom Tank (P), No.2 Fuel Oil Tank (P) frames 39 to 54, Engine Room Oil Tanks on the port side in way of frames 17 to 28. A number of cracks were found in the areas of hull indents mentioned above, cracks were also discovered on the propeller blades. The resulting grounding caused no apparent oil pollution or environmental damage to the area.

“City of Sunderland” preparing to be re-floated with the assistance of tugs at Vastertistron Island

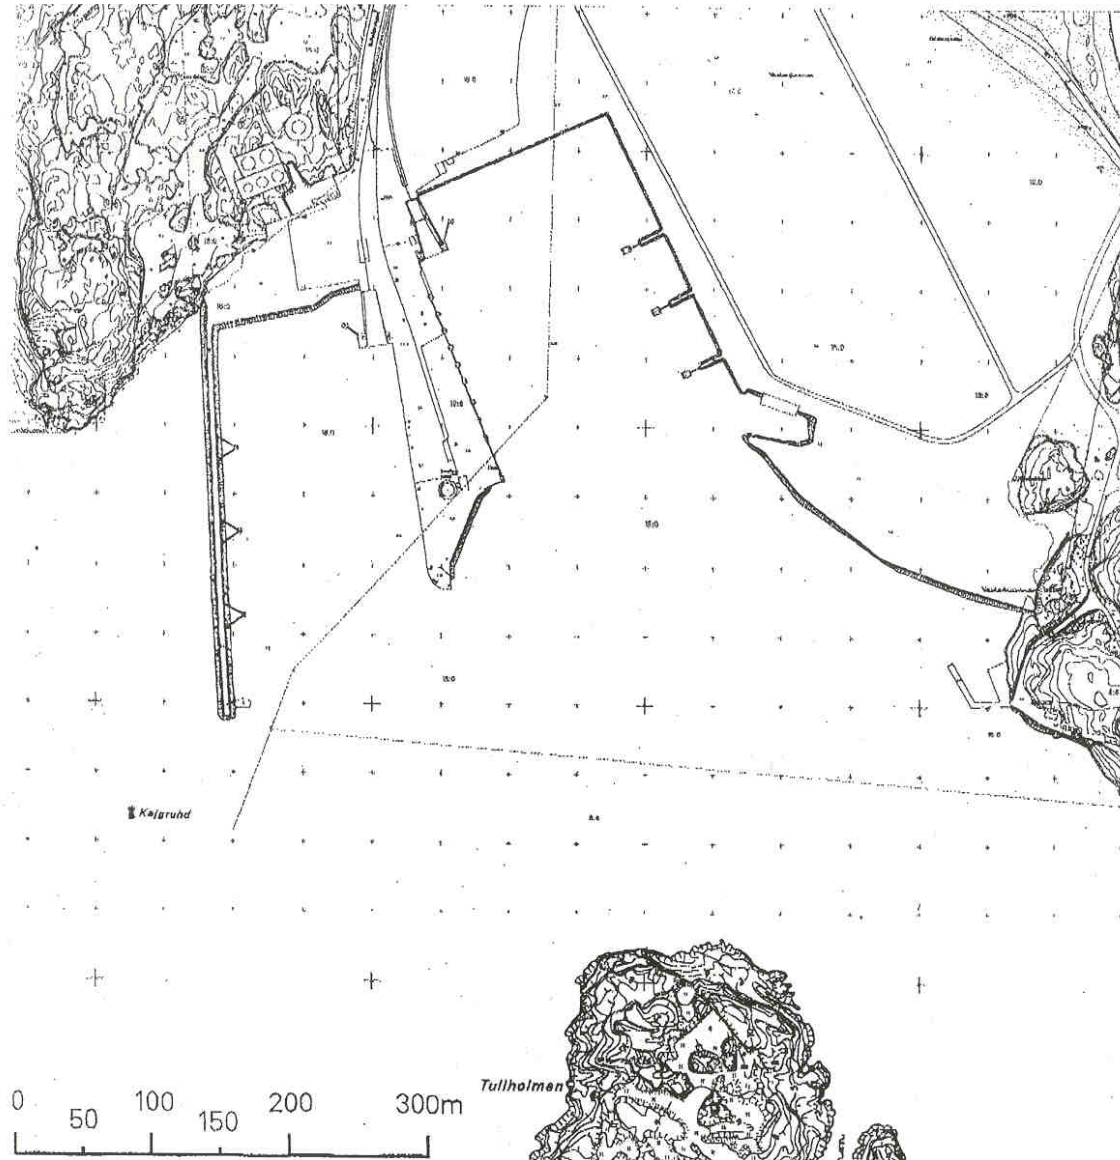
Appendix I

Plan view of Hanko Outer Harbour shows Ro-Ro Berths and Western Jetty

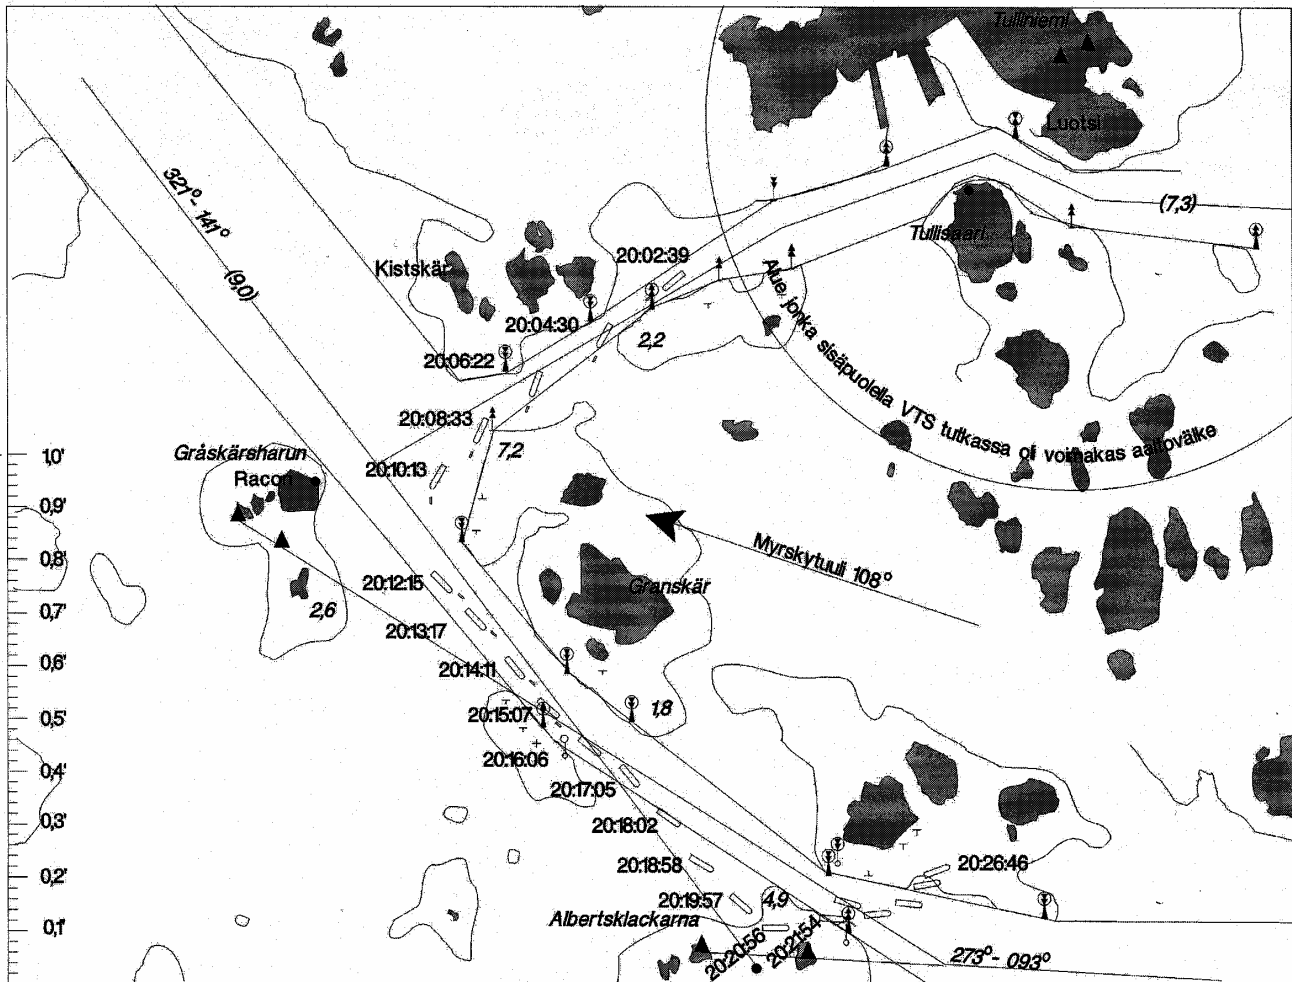
Appendix II

A section from a Finnish chart representing the Approaches to Hango.
The "City of Sunderland's" track has been recorded from an unknown source west of the Western Jetty to the position of grounding south-east of Vastertiströn Island
