Investigation report

B 1/2004 M

M/V FINNCLIPPER, grounding off Kapellskär 20.01.2004

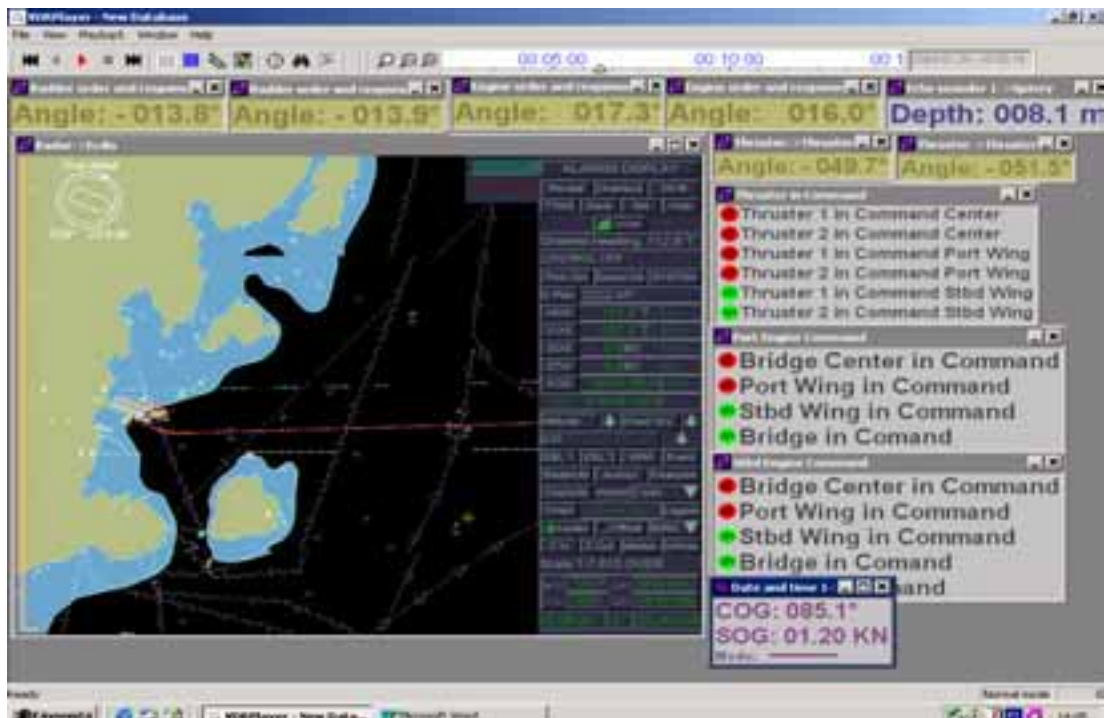
The Chief officer entered the bridge at 02.06 when the ship was already moving. Chief officer informed master that the stern was coming closer to the pier and master made correction alignment to the right by the rudder. This is how it was continued until the stern had passed the piers edge. After this the master changed his steering position in the middle of the bridge, the rudder being in the middle, the main propellers output 23 % forward and he didn't activate the bow thrusters in the middle cockpit steering position.

VDR Image 4. Time 02:06:05 rudders are 14° to port and the bow thrusters output 50 % to port. Ships stern is coming closer to the pier.

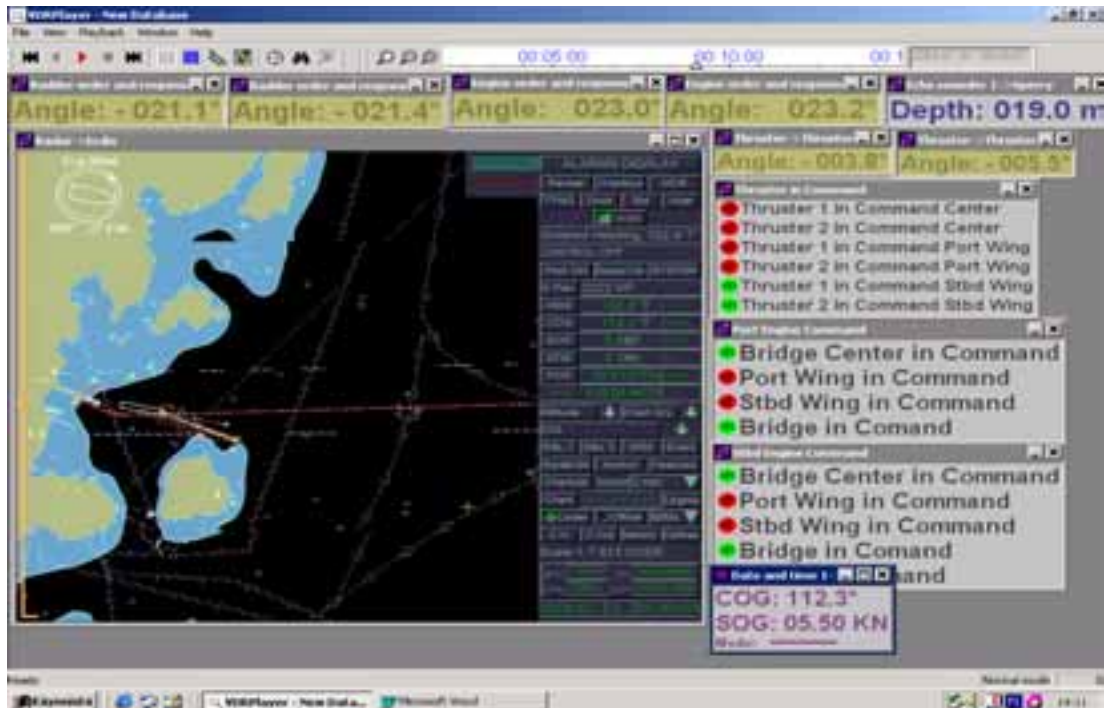
VDR Image 7. Time 02:08:50 rudders are 21° to port. The manoeuvring is done from the centre console. But the bow thrusters control is still activated on starboard bridge wing. Predictor on the ECDIS display shows that the vessel is running aground.

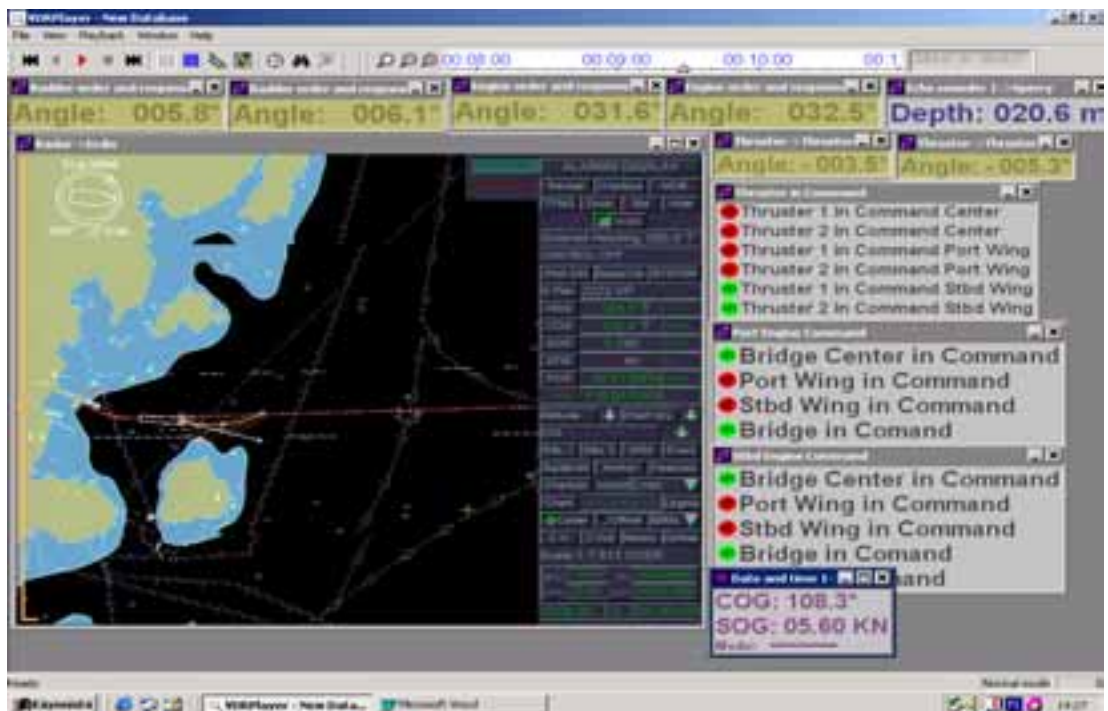
As per VDR recording the "Predictor" did point the vessel to drift towards the buoy north of the Kapellskärs skäret. Neither the Master nor the Chief officer did monitor the "Predictor"s display. The passage was resumed with similar propeller blade-and rudder adjustments, bow thrusters being in zero position. About 02.09 Master turned the rudder about 20° to the left leaving the other means of steering as they were. The vessel was continuing the drift due to lack of steering efforts towards to the before mentioned buoy. When the stern was coming closer to the buoy 02.09.50 master increased the propellers output to 32 % and turned rudder 15° to the starboard in order to avoid the stern to collide on the buoy. The vessels sterns sb-side collision bar did collide on the buoy at 02.10.30 and there after the vessel run on the ground located on the north eastern side of the island. The vessel run over the ground and the vessels bottom was damaged in the entire length.

VDR Image 8. Time 02:09:20 rudders are 6° to starboard and the propeller output is 32 % ahead. Ships speed over ground is 5.6 knots. Heading line and the predictor shows for a while that the ship is clear from the ground.

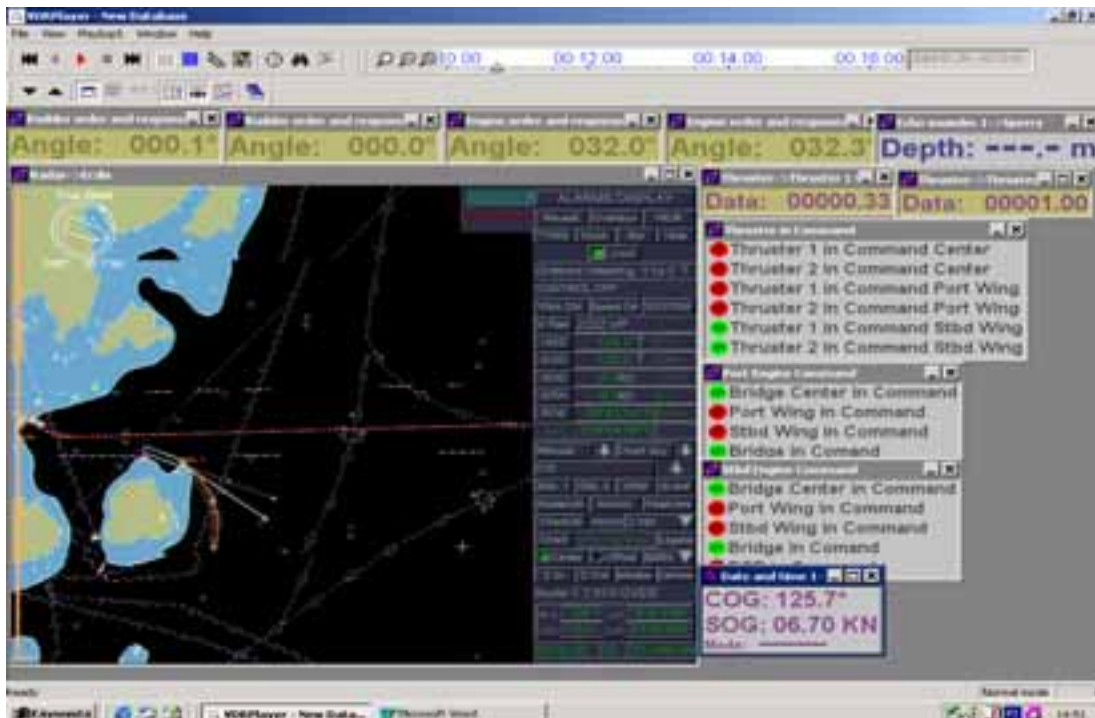
VDR Image 10. Time 02:10:42 grounding. Echo sounder without reading.

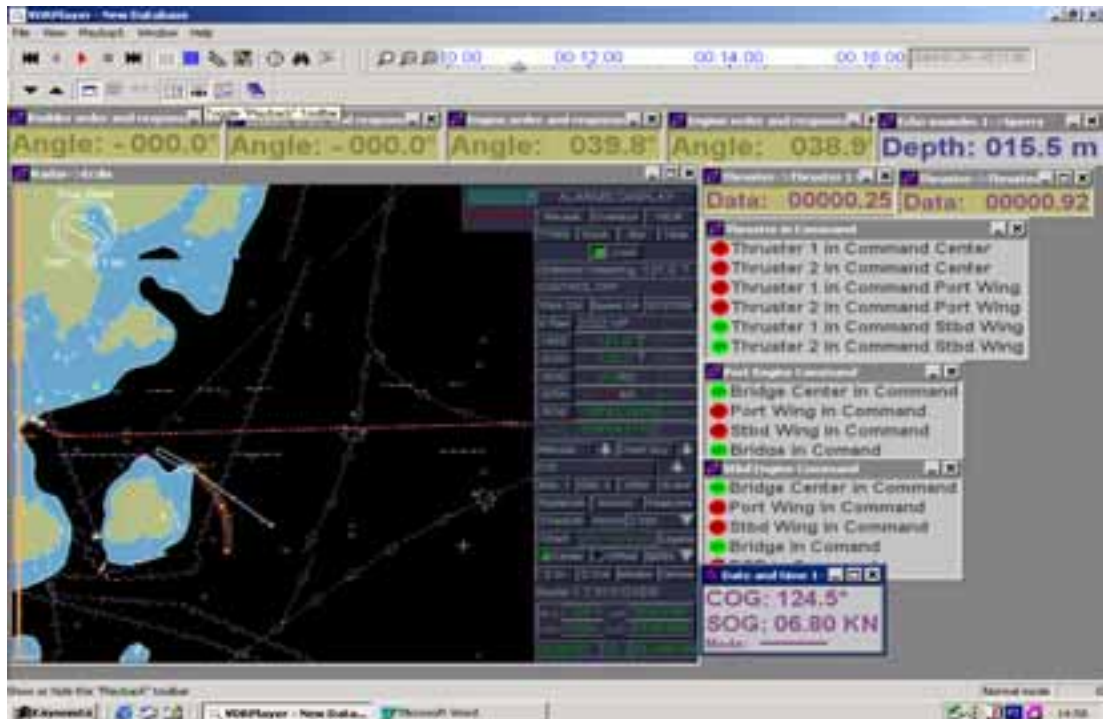
VDR Image 11. Time 02:11:00 echo sounder reading is 15.5 meter. Head of the ship is over the ground.

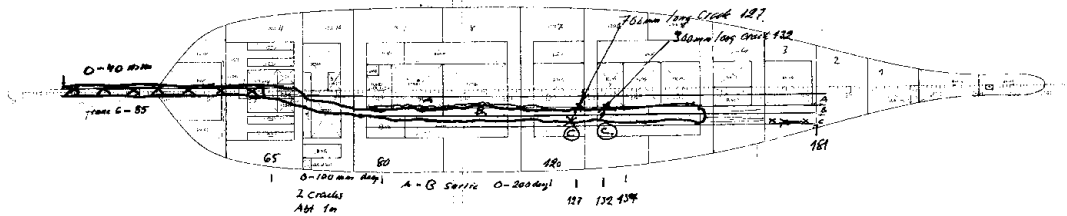
Figure 9. A rough description of ship's damages.

In the area between frames 10–60 in the stern was 1,2 m wide and 4–10 cm deep dent. In the ballast tank 20, lubrication waste oil tank 41, diesel oil drain tank 40 and heavy fuel oil drain tank 40 were leaks.

Between frames 59–170 in the mid ship was 3–5 m wide and 0–40 cm deep dent. In the heavy fuel oil overflow tank 60D, bilge tank 60SB, heavy fuel oil tank 60C, 70C, diesel oil 80C, heavy fuel oil tanks 90 and 100 C there were leaks.

In the ballast tanks BW 60SB, BW 80SB and BW 90B there were leaks.

Void spaces 4–10 were filled by water and got dirty by heavy fuel oil and diesel oil due to broken jumper frames and pipe tunnel inner frames. Ballast pipes and connections to the tanks were broken off. The remote sounding systems in the tanks were in electric short cut and the sensors were filled by water. Engine alarm- and remote sounding system was broken. All electric cables were totally damaged in the void spaces which were filled by water. The remote controlled valve control devices of the ballast- and fuel oil pipes were damaged by water. The guide rails of the forward sb-elevator were bent. All the piping insulations were totally damaged in the spaces which were filled by water. Part of the fuel oil and air pipes were damaged.

About 137 tons of steel were used to repairs and repairing expenses were about 2,5 M €. In addition the vessel was out of traffic 6 weeks.

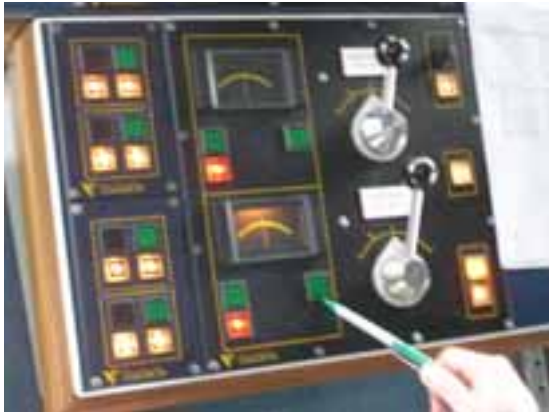
Upon the chief officer had entered the bridge, he went to right wing to check that the stern will be clear off the jetty. Meanwhile Master changed to steer the vessel from the centre cockpit but did not activate the thrusters there and the chief mate did not notice that the thrusters were still activated in the right wing. Vessel drifted south towards the shallow.

Image 11. The pen is pointing the activating "In Command" button.

7. Communication to the stern was cut in too early stage, which caused that the chief officer had to focus on the lookout to stern.
8. The Master changed to steer in the centre cockpit and forgot to activate the bow thrusters in the centre cockpit. Neither did the chief officer notice this when being in lookout duty.

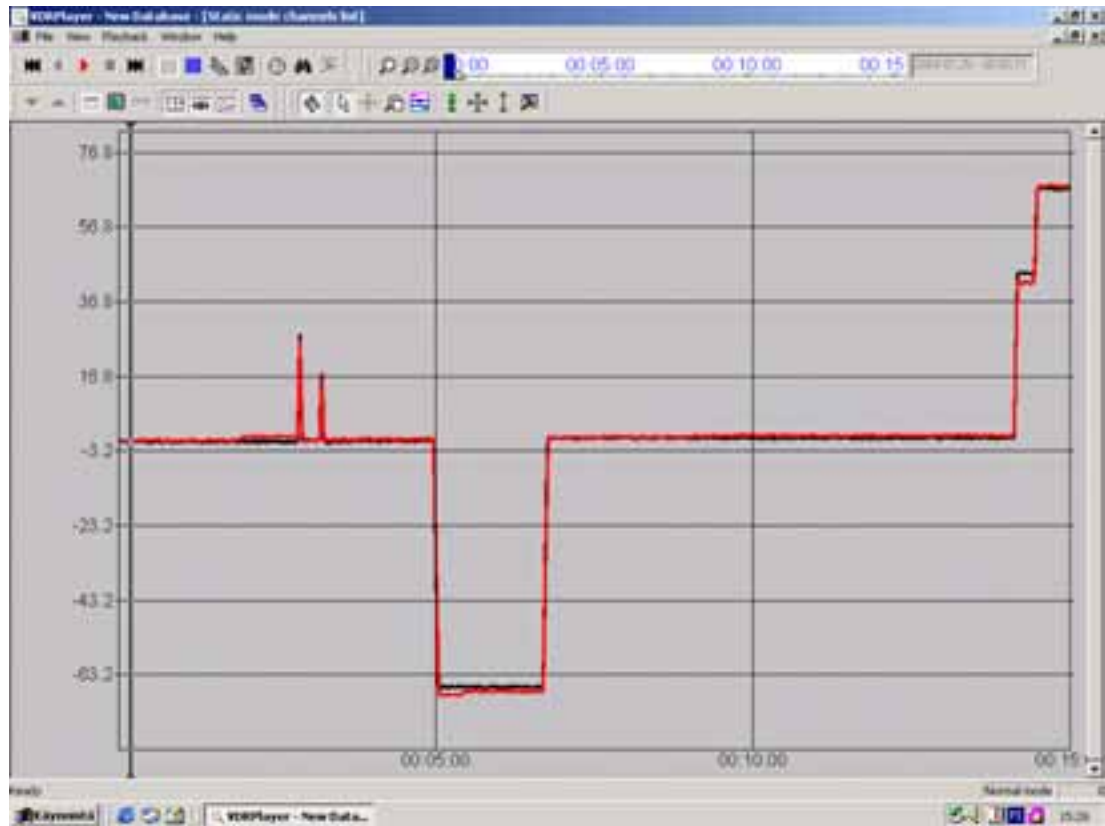
Image 12. VDR recording of the use of bow thrusters.
