Investigation report

B 7/2004 M

Ms SUPERFAST VII, grounding off Hanko on 12.11.2004

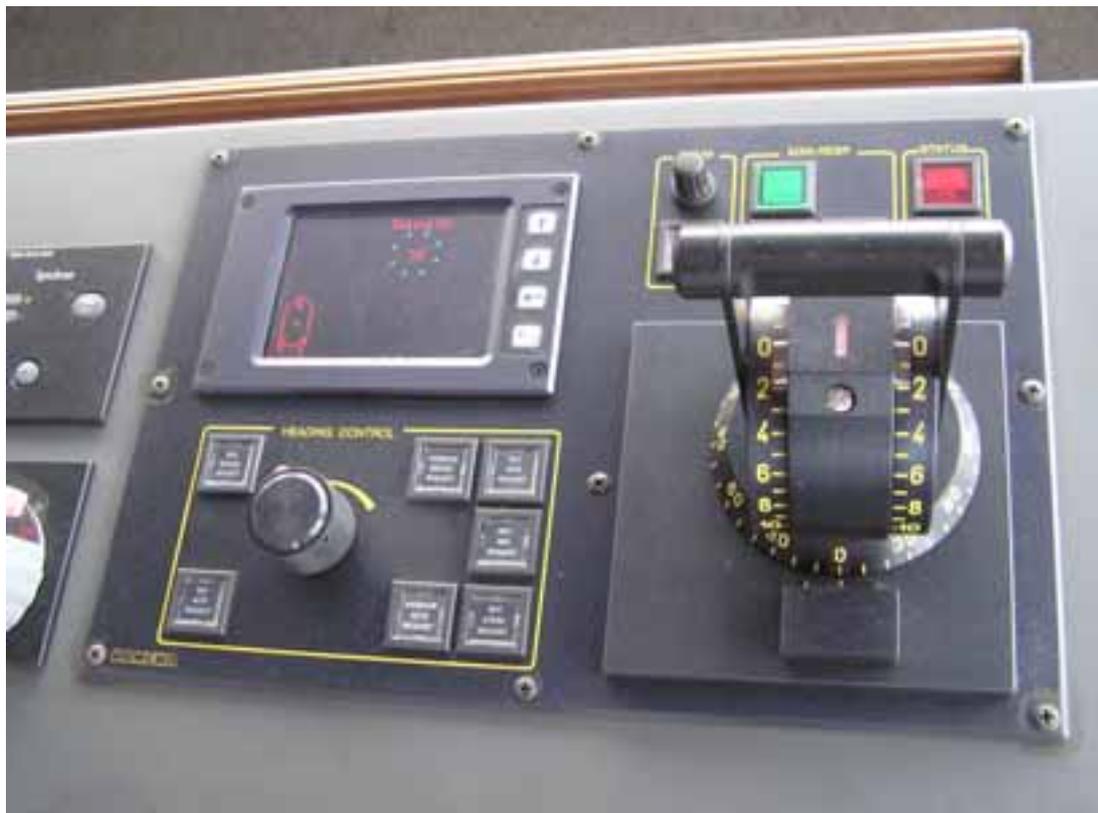
In harbour manoeuvring, six different steering levers have to be handled. There are two control levers for each of the main propellers, the rudders and the thrusters. The KaMeWa JOYSTICK combines the control of all propellers and rudders to one lever and one turn knob. (Figure 9). The lever is turned in the direction in which the joint force of the steering equipment is directed. The round Heading Control knob turns the vessel in the direction desired. The Pivot Point can be placed in the bow or stern of the vessel or midships. In harbour manoeuvring, with a low speed, the pivot point is set midships. The KaMeWa Joystick is a very good steering mode in high winds, because it makes it possible to concentrate on the electronic chart in addition to steering. The Joystick operates the propellers separately so that when turning, the rudder stern of the reversing propeller goes automatically midships and the rudder behind the propeller rotating ahead turns inwards. The JOYSTICK was not used before the accident, nor was there any company instruction on its use.

Figure 9. The KaMeWa Joystick, efficient for harbour manoeuvring.

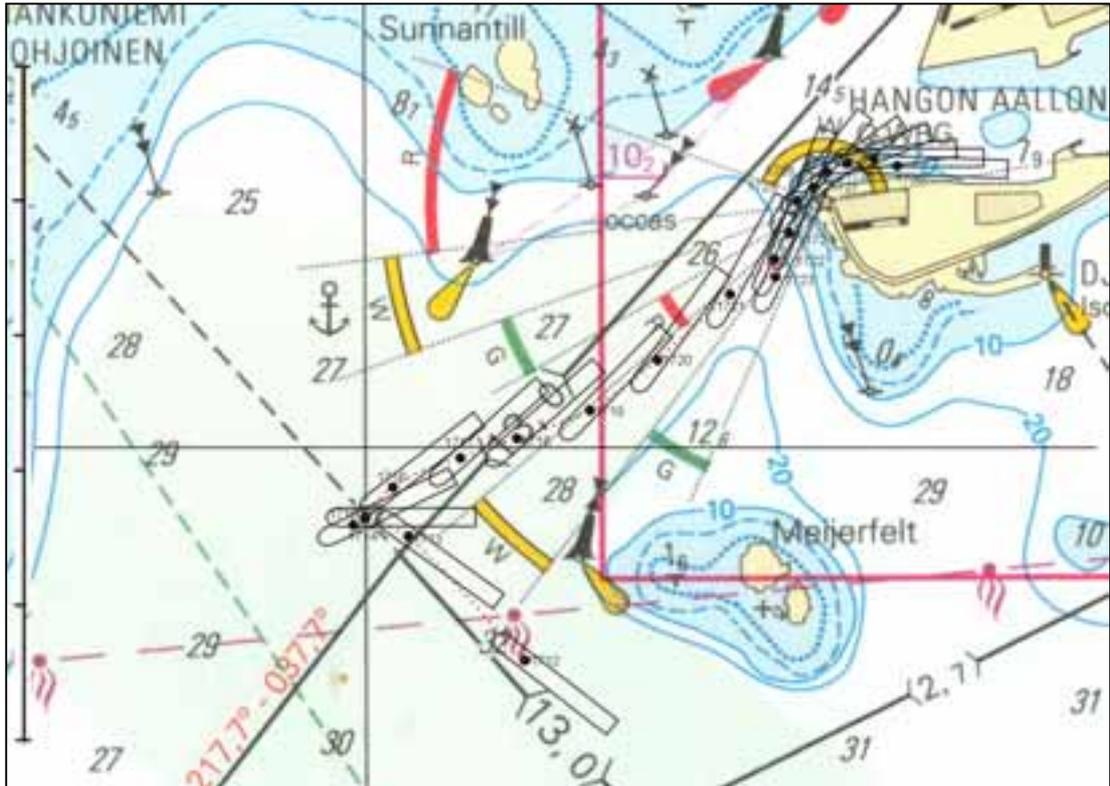
Figure 12. The track of reversing the SUPERFAST VII

The view of the investigators on the track is in Figure 12, which has been traced on the basis of the above information.

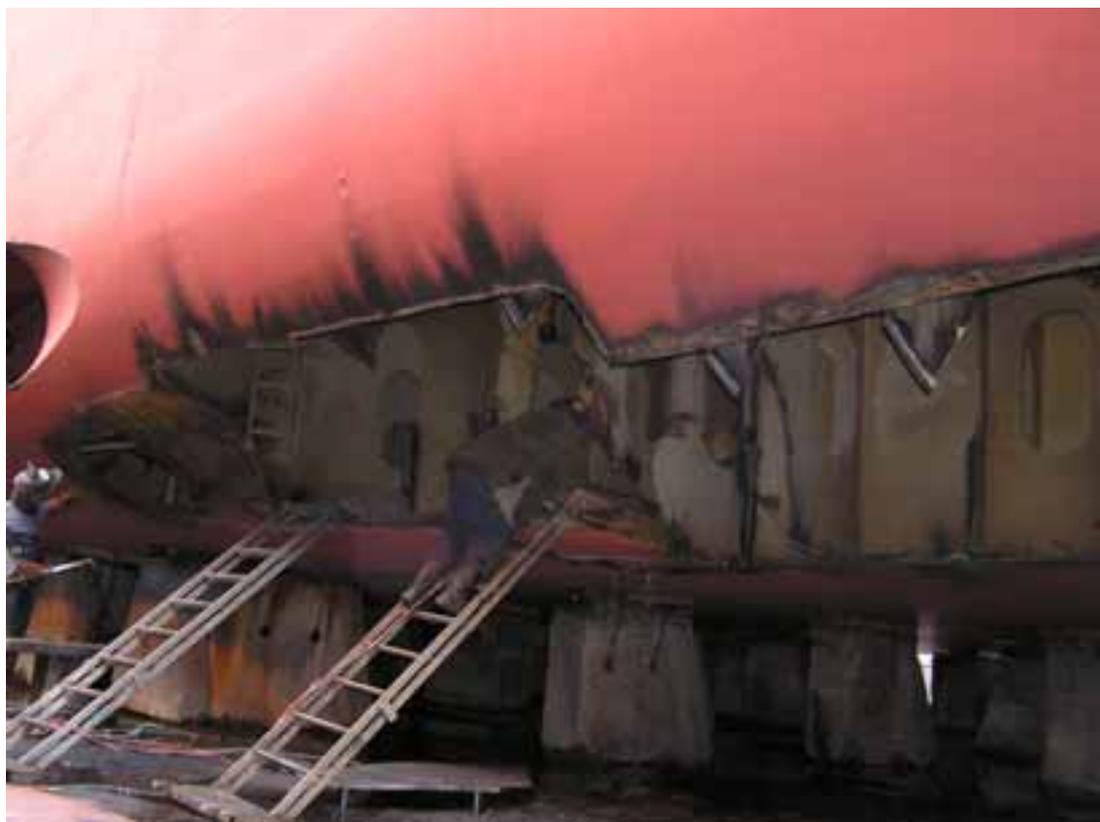
Figure 13. Part of the damaged section cut off portside of the stern of the vessel.

Void space 609 below the engine room had a rupture on portside between frames No. 73 and 85. The engine room had a rupture of about 15 cm above the tank top. There were dents for a length of several indicators and the bb bilge keel was damaged in the stern for 3.4 indicators. About 14 tons of steel were used for the repairs and the costs were approximately 200,000 €. The vessel was out of traffic for about two weeks.

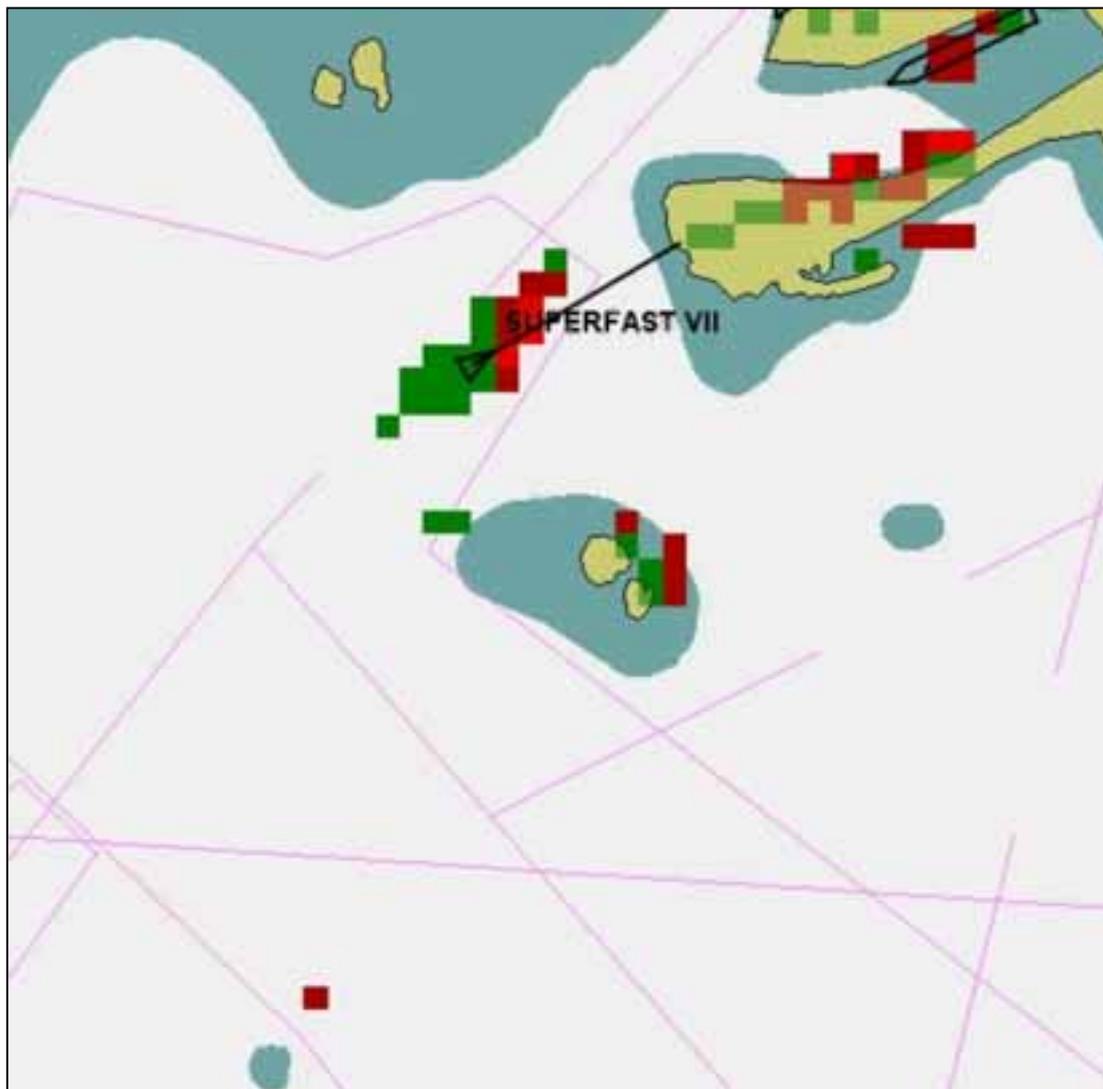
The supervision area of the Helsinki VTS is divided into three sectors and Hanko port belongs to sector 3 of the Helsinki VTS. The VTS did not have a reason to react to the movements of the SUPERFAST VII before its grounding, because the vessel was in scheduled traffic and it was steered by its permanent master and an experienced pilot.

Figure 14. A cut from the VTS recording shows how difficult it is by means of it to monitor close situations in the port area.

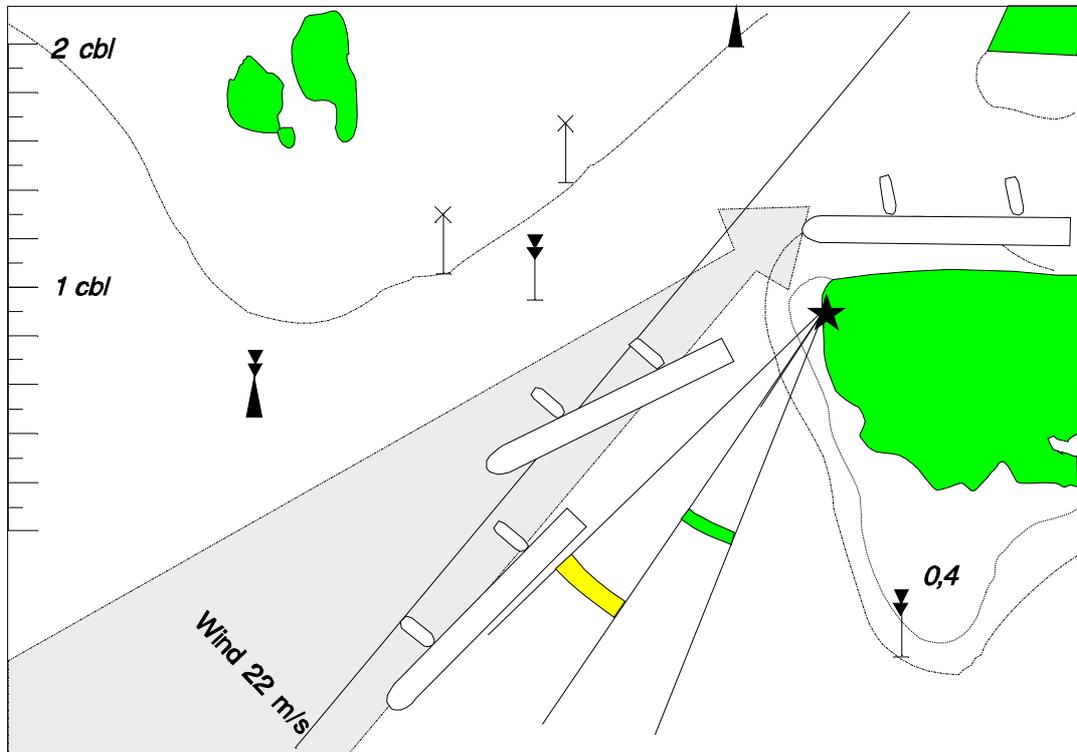
Figure 15. The approach plan of the master. It was the purpose of the master to keep the wind directly from the bow during the reversing. The beacon and its facade light were the visual guidance marks when reversing. The figure is an estimate of the Investigation Board.

The wind direction was approximately 230°, but wind direction always varies in gusts. In Figure 15, the variation of wind direction has been estimated at ± 10 degrees, but it may have been bigger. On the basis of the Tulliniemi wind gauge, the strength of the wind gusts was 5 m/s at 16:00. The Staff Captain estimated the gusts at about 7 m/s and the pilot 2 m/s. In a high wind, the strength varies about 5 m/s, but it is difficult to see this visually from the wind gauge. It is very difficult to keep the bow of the vessel in an exact direction in a wind with heavy gusts. The gusts vary more quickly than the power of the bow thrusters can be changed.

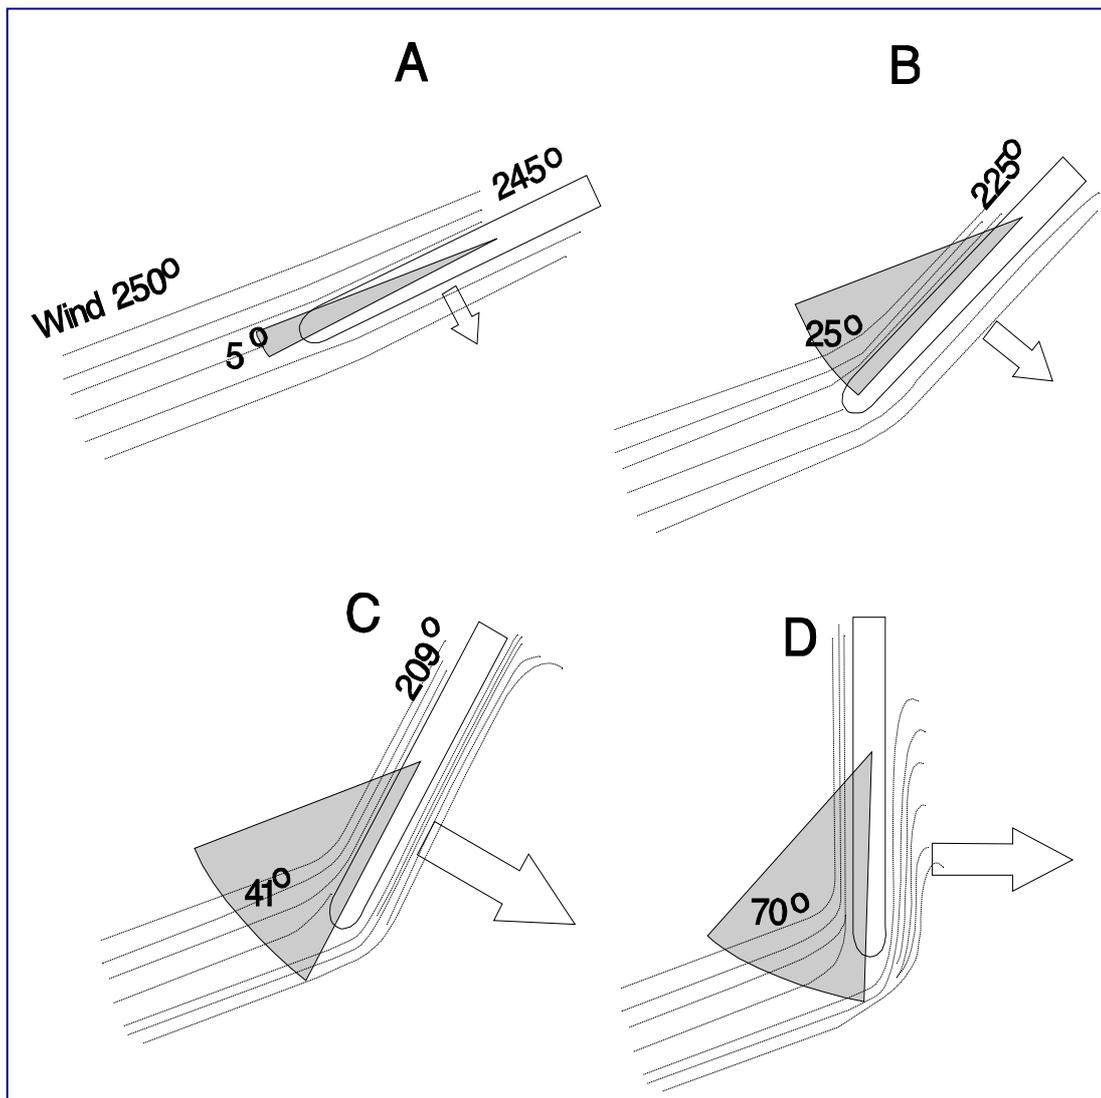
Figure 16. The wind forms a lift on the side protected by the hull. The lift of a relative wind is at its greatest at about 50 degrees from the bow. The situations A-C describe the SUPERFAST VII. Situation D was not realised. The buoyancy decreases with wind angles exceeding 60°.

When the tugboats fastened, the heading of the vessel was about 245° (Figure 16, A). The wind was 5° from the bow. The vessel turned so that the master could see the beacon. The heading was 225° when the vessel had crossed the fairway line (Figure 16, B). The wind was 25° from the bow and it turned portside of the hull of the vessel creating a lift. The lift and the turning torque caused by the wind increased. Near the end of the quay, the heading of the vessel was about 209° and the wind was 41° from starboard (Figure 16, C). The lift created by the wind was strong. The turn ended in direction 201°.

When the relative direction of the wind is over 60°, turbulence begins to form in the lee side of the hull and the buoyancy caused by the wind decreases (Figures 16 D and 17). This phenomenon has the greatest effect on passenger ships and trailer ferries.
