Investigation report

C 1/2005 M

M/S PAULINE RUSS, grounding in Hanko Port 20.01.2005

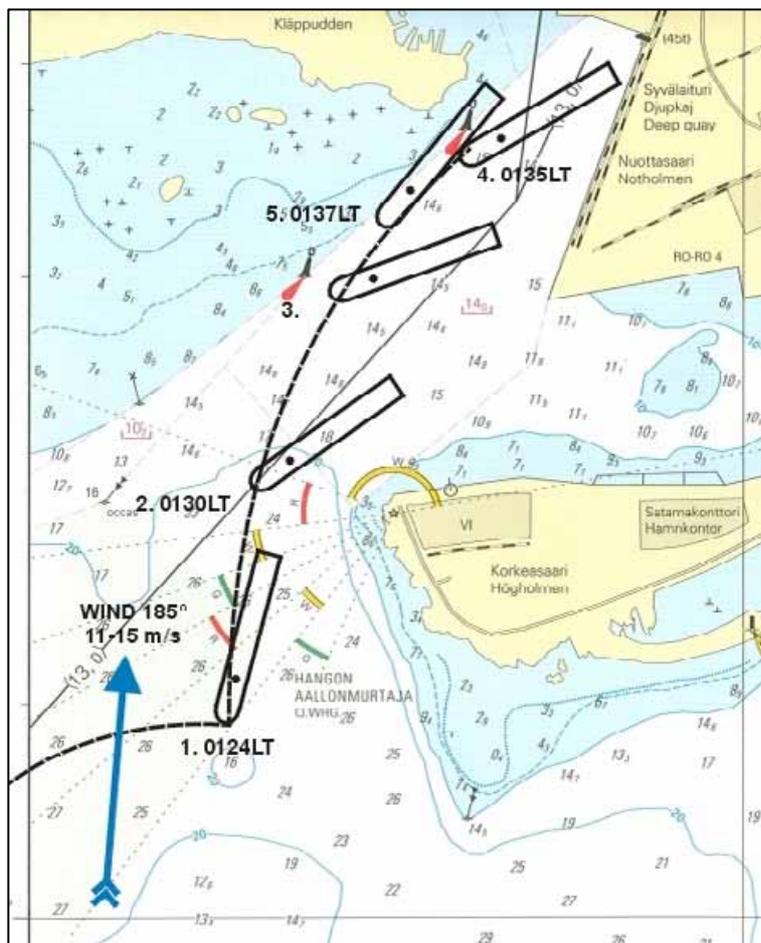
Figure 4. The idea of the investigators on the path of the vessel.

The wind was not unusually strong. The wind was from the south, and it has to be taken into consideration that the wind was almost from the bow during the reversing (Figure 4.). The pilot had taken this into consideration when he suggested a turn in the harbour basin. The master did not reply to this, which proves that he did not consider the direction of the wind to be significant. The master should have noticed the effect of the wind, when the pilot, for the first time, suggested that the approach to the pier be interrupted. However, afterwards the master was of the opinion that the grounding was due to the strong, gusty wind. The effect of the wind on the manoeuvring cannot be analysed in more detail without the information on the movements of the vessel registered onboard.

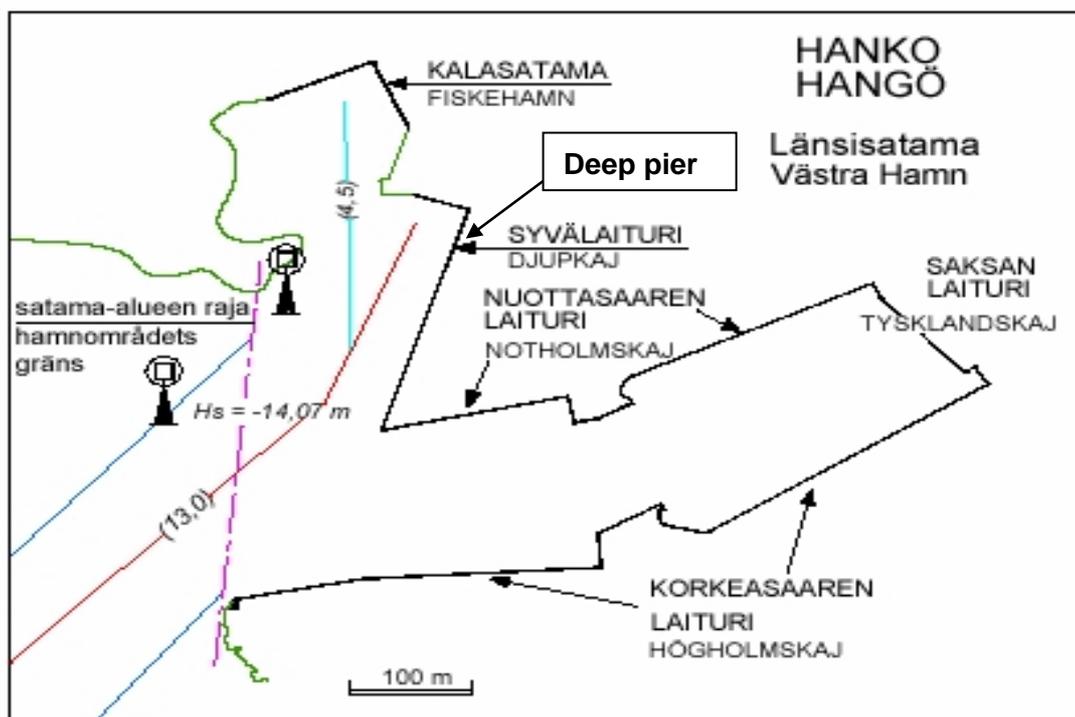
Figure 5. The vessel was reversing to the so called “deep pier”. FMA fairway chart

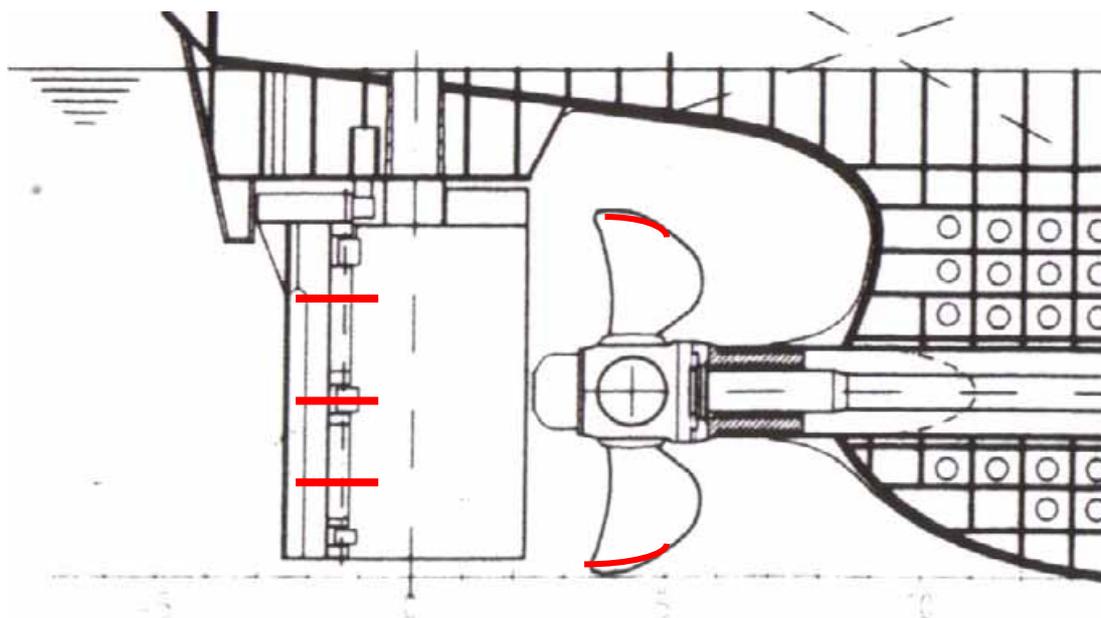
The rudder of the vessel was damaged so that the flap of the Becker rudder could not be used after the accident. The flap had to be supported by three steel beams on both sides of the rudder so that it became a conventional rudder. The tips of the propeller flaps were damaged at a length of 130 cm. Uniform sections with a length of 150 cm and a maximum height of 23 cm were cut off from the tips of the flaps. The repair work could be done by divers in Hanko. The vessel made a test run off Hanko and the classification society approved the temporary repairs and granted the vessel a three-month special permit for traffic provided that the rudder supports be examined at the end of February 2005. The vessel returned to traffic on 24 January 2005.

Figure 6. The damage to the propeller and rudder with the temporary repairs marked in red.
