Investigation report

B1/2006M

MS SINGELDIEP, fatal accident in Kotka port on 11.1 2006

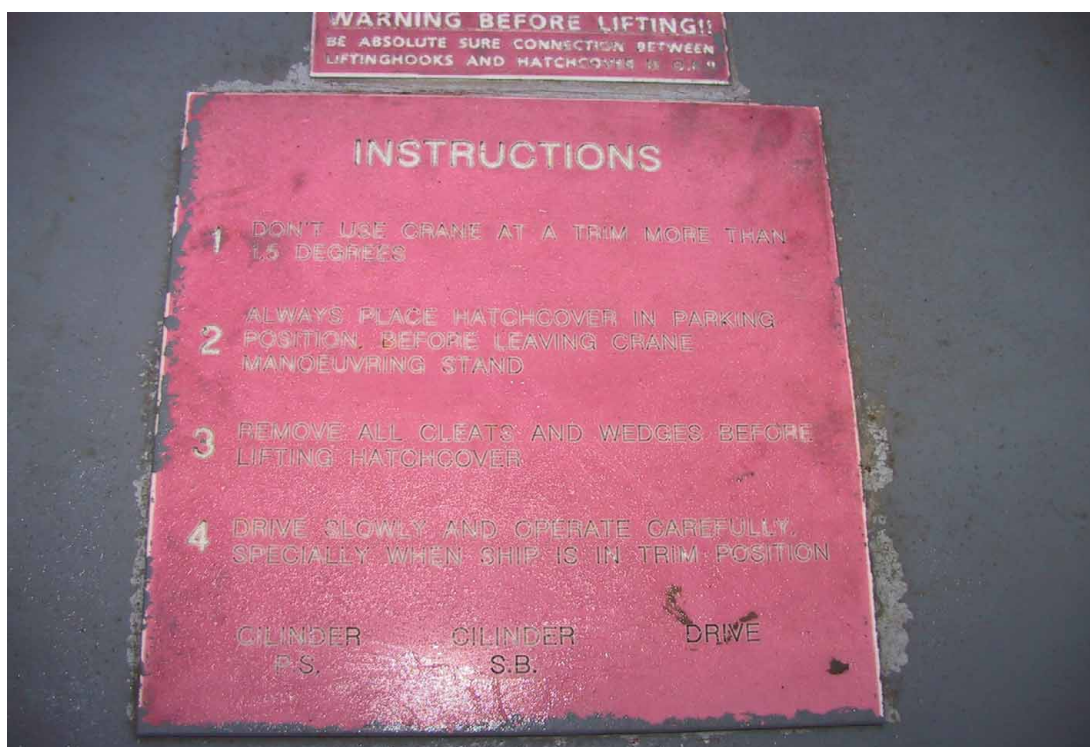
Figure 3. The crane's operating instructions at the site. Picture from a sister ship.

The operating instructions of the crane state that all hatch cover wedges must be in backward position and all lockings must be unlocked. Before use, the correct positioning of the wheels on the rails must be checked. No equipment may be attached to the crane, such as wires, E-cables, etc. The alignment of the movement of the power cable with the crane movement must be checked before use. The proper connection of the hooks to the hooking pockets is checked by both work partners; the operator checks the hooks on his side and the partner checks the hooks at the other end. The hatch covers are lifted and moved as low as possible. The crane may not be used if ship trim exceeds 1.5 degrees and the list exceeds 3 degrees.

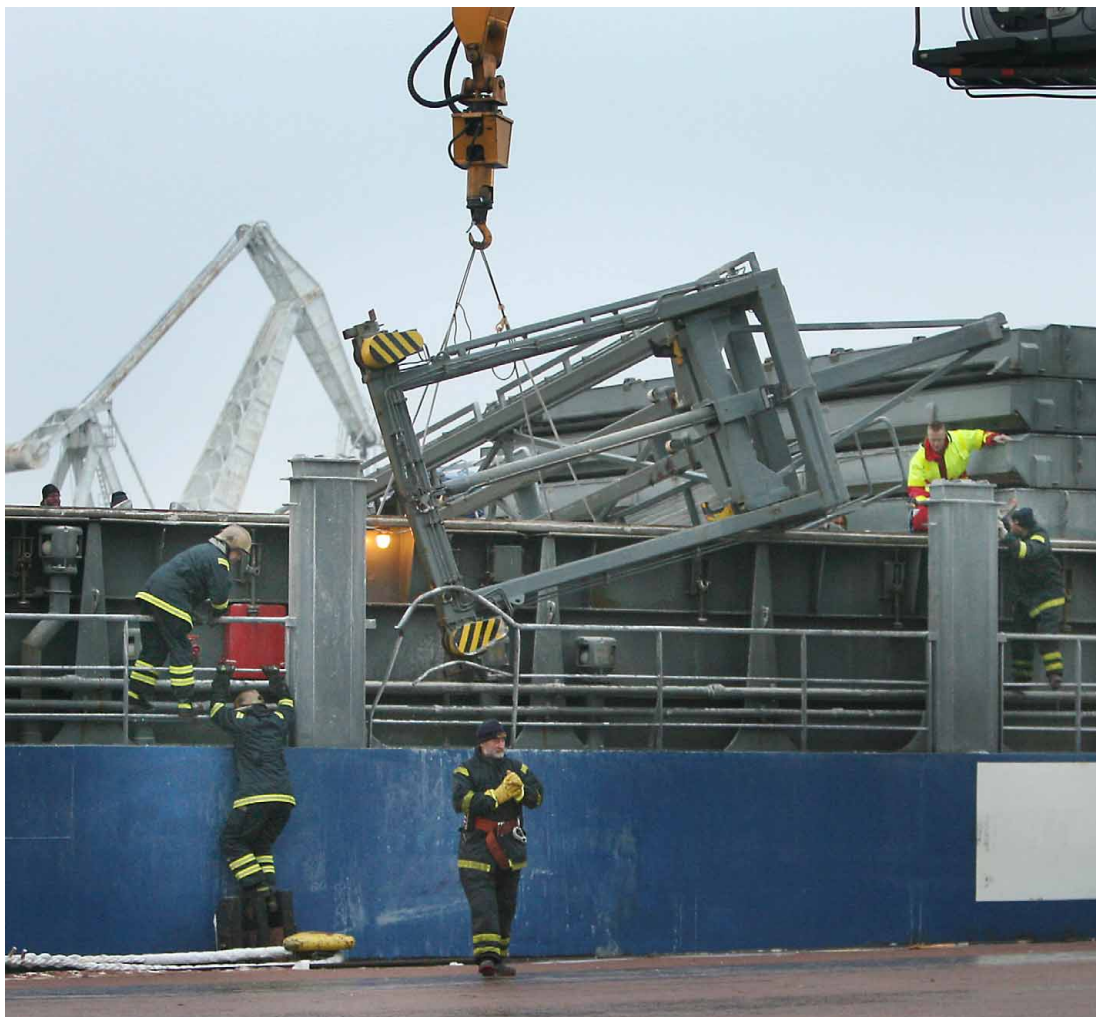
Figure 5. The collapsed crane.

The master said that he had seen that the wheels of the crane were approximately one metre from their rail on the passageway of the port-side deck. The top of the crane had collapsed towards the stern of the vessel. The upper part was slightly twisted.

The starboard-side wheels of the crane were in the cargo hold against the wall so that the frame of the crane was on paper reels. The leg of the crane had thus been lifted from its rails over the hatch coaming into the cargo hold.

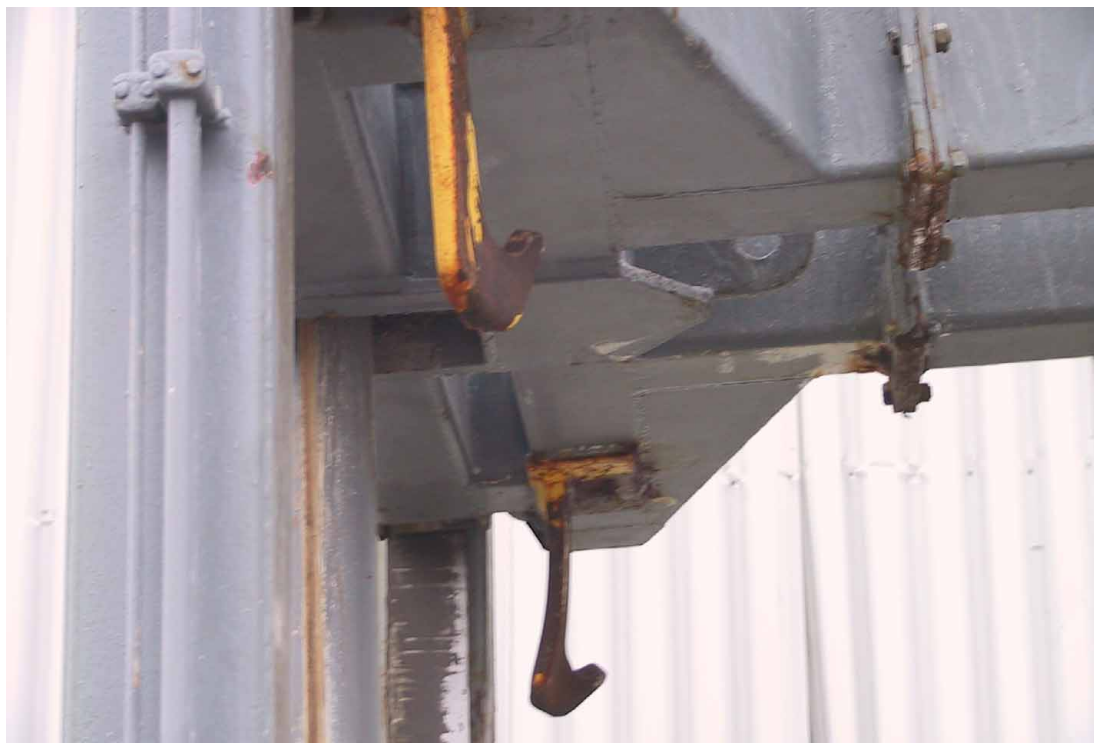
Figure 6. Twisted lifting hooks.

On the following day, when examining the crane, they noticed that the hooks on the starboard side were twisted. They concluded that that side had failed during the lifting. Representatives of the Dutch Maritime Authority, two maritime inspectors, arrived in Finland on the next day. They heard the master of the vessel and the AB, who had been the work partner. The special investigator of the Accident Investigation Board was present at these hearings.

The hooks of the crane on the side of the quay (the port side) were twisted inwards. The side plates of the hooking pockets on the side of the quay of the hatch cover had been

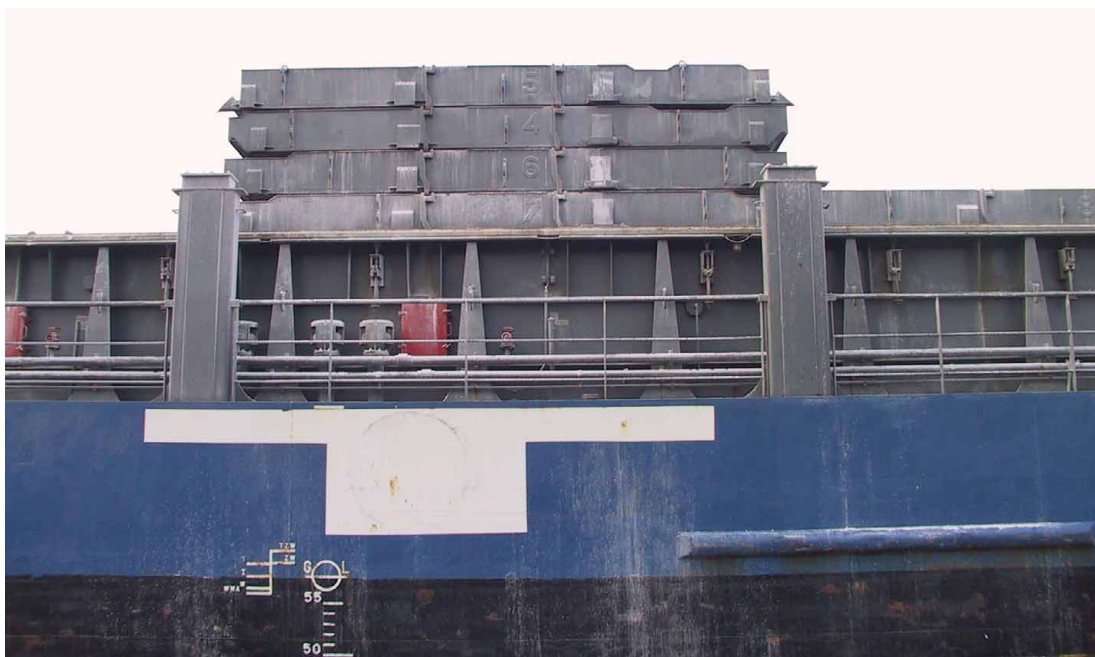
Figure 9. Stack of hatch covers, hooking pockets are not marked.
