Investigation report

C1/2006M

MS ESTRADEN and MT WOLGASTERN, collision in the Kiel-Canal on 2.2.2006

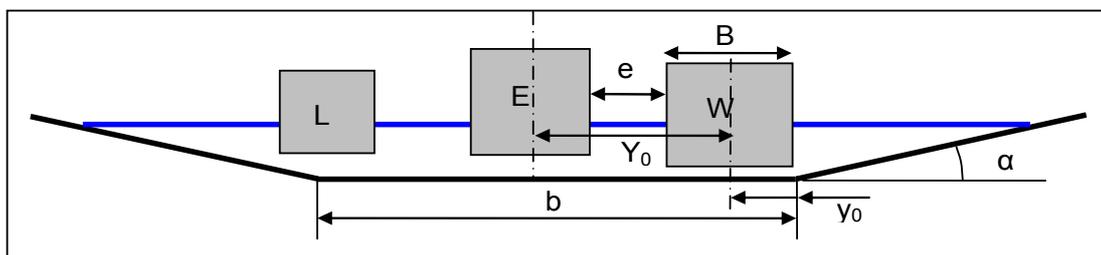
Figure 7. The view of the investigators on the positioning of the vessels in the fairway at 02.30.00: W (WOLGASTERN), E (ESTRADEN) and L (LENA). The figure also shows certain related parameters. The distance between the sides of the vessels is e , the distance between the centerlines is Y_0 , the distance y_0 from the bank bottom of the Canal has been determined as shown in the figure. The parameters are found in the calculations of Appendix 1. The width b of the bottom of the Canal varies between 100 and 150 m depending on the longitudinal position. The slope angle α of the banks is about 13 degrees. The depth of the fairway varies between 10.5–13 m.

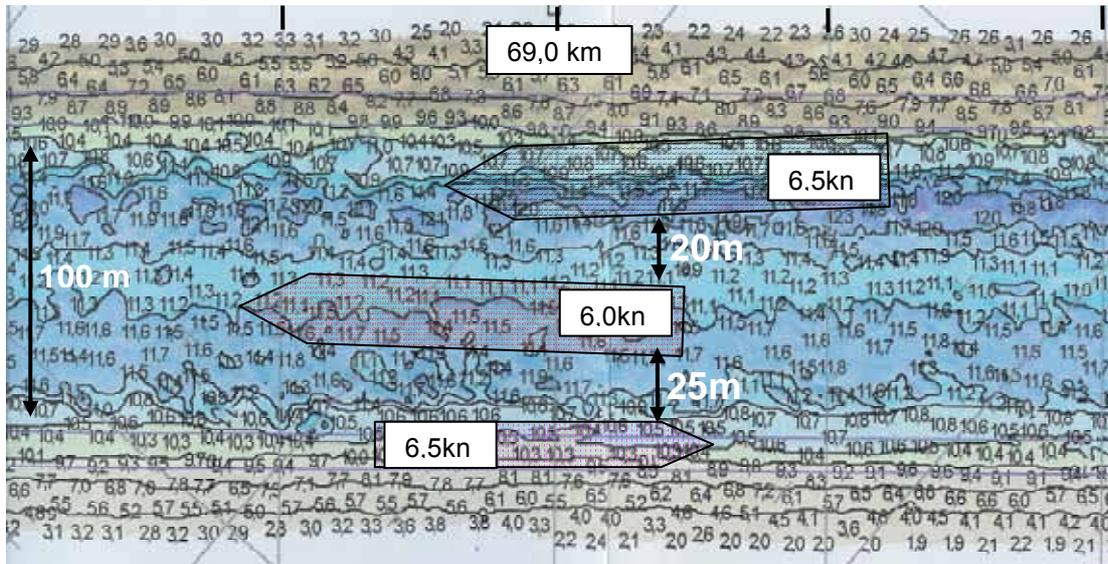
At the moment preceding the accident there were three vessels side by side in a part of the Canal with a nominal width of 100 m, Figure 9. Onboard the RIROIL 5 it was noticed that at the time of the overtaking, the bow of the RIROIL 5 was alongside the sterns of the ESTRADEN and the WOLGASTER and the overtaking distance between these vessels was smaller than the distance between the ESTRADEN and the RIROIL 5.

Figure 9. Investigators' view on the positions of the vessels in the Canal at 02.33.20.

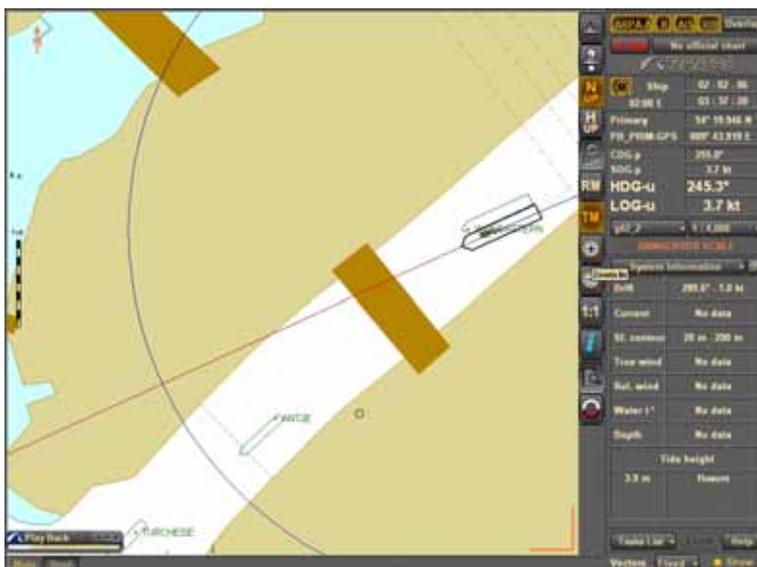
After that the stern of the WOLGASTERN turned portside and the ship hit the aft part of the ESTRADEN. Due to the strength of the impact, the ESTRADEN started to turn to starboard and her aft part approached the portside bank. The Master of the ESTRADEN immediately took control of the steering. The Master took the steering to the portside wing and set the engines to go crosswise so that the portside engine was astern at 60–70 % and the starboard engine was ahead at 40 % while the right rudder was to portside. By this measure it was avoided the stern from drifting to the bank. This measure dropped the speed of the ESTRADEN so that the WOLGASTERN started to slide along the starboard side of the ESTRADEN, Figure 12a.

Figure 12a. The WOLGASTERN is sliding along the side of the ESTRADEN on the electronic chart display. (Time on the chart is Finnish time).

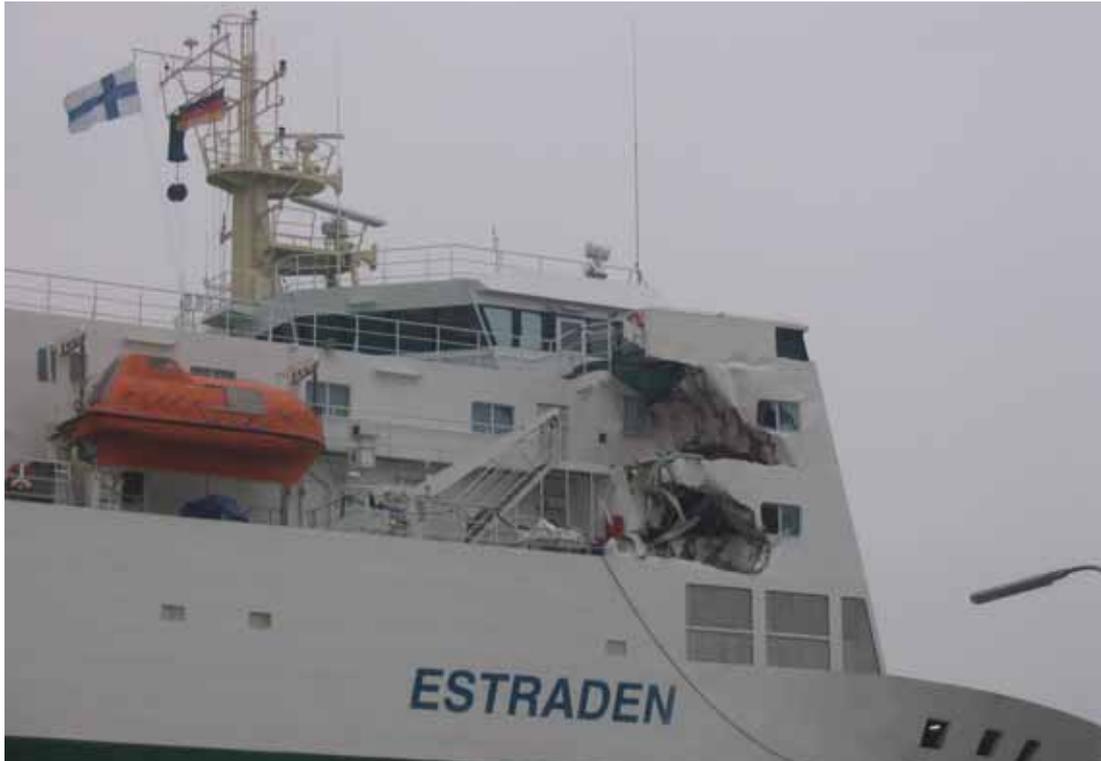
The vessel received numerous dents as well as 4 minor cracks in the upper starboard bulkhead of the main deck. Starboard from the living quarters, the wall of the mess and the master's cabin was ripped open and the interior was damaged. The starboard wing of the bridge was partly bent and its lid was bent open.

Figure 13. Damages of the ESTRADEN's SB-side.
(the picture on behalf of BSU)

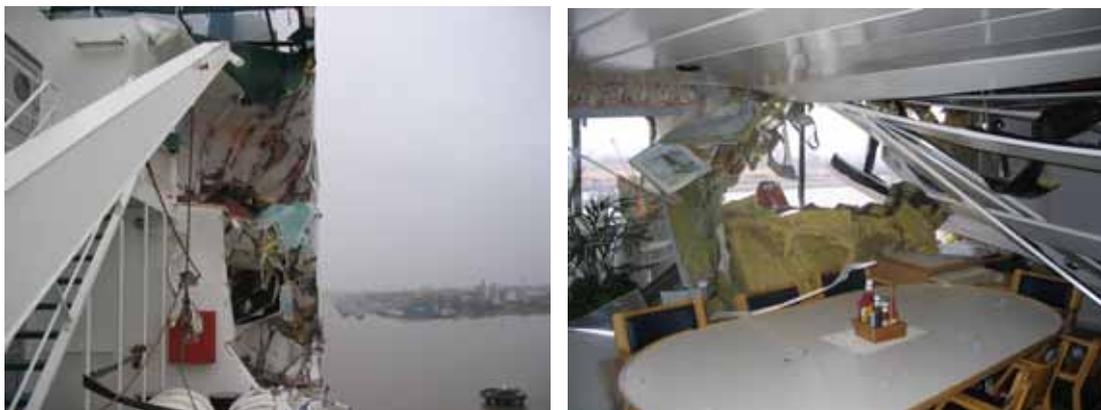
Figures 14 and 15. The outer bulkhead of the master's cabin and the mess (Figure 14, left). The mess from the inside (Figure 15, right).
(the pictures on behalf of BSU)

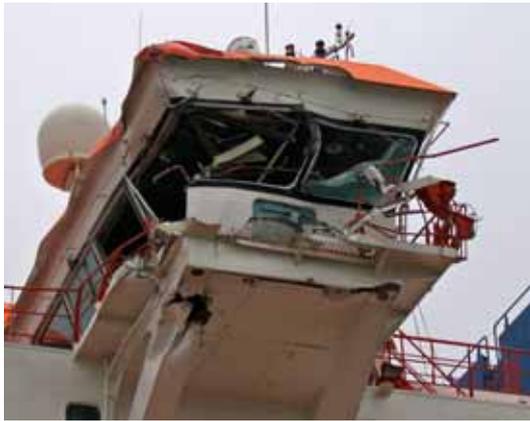
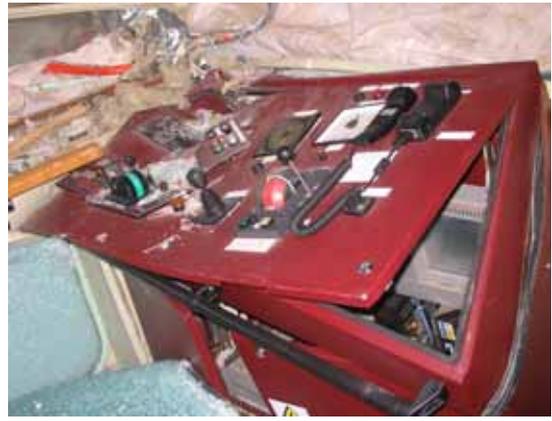
The portside bulkhead of the forecastle of the vessel was bent and the portside planking got several dents. The portside wing of the bridge and the steering console there were badly damaged.

Figures 16 and 17. The portside wing of the vessel (Figure 16, left). The portside steering equipment console (Figure 17, right). (the pictures on behalf of BSU)

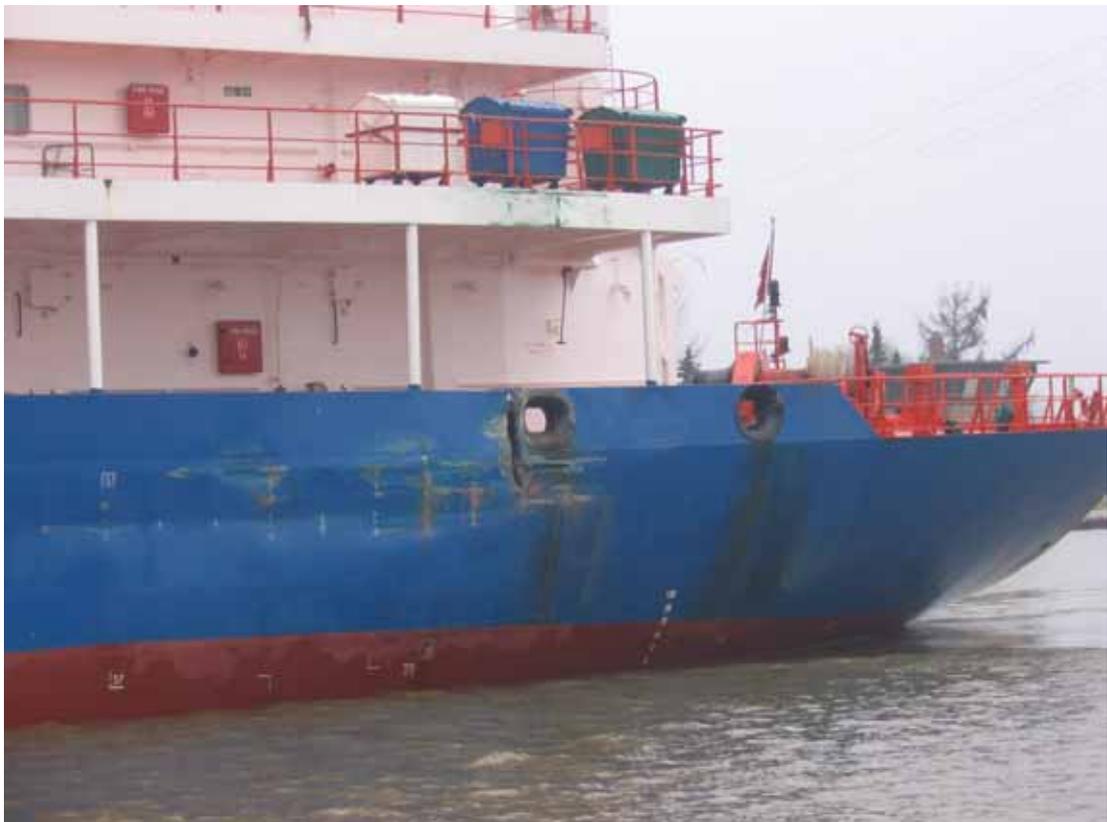
Figure 18. Damages on the side of the WOLGASTERN. (the picture on behalf of BSU)

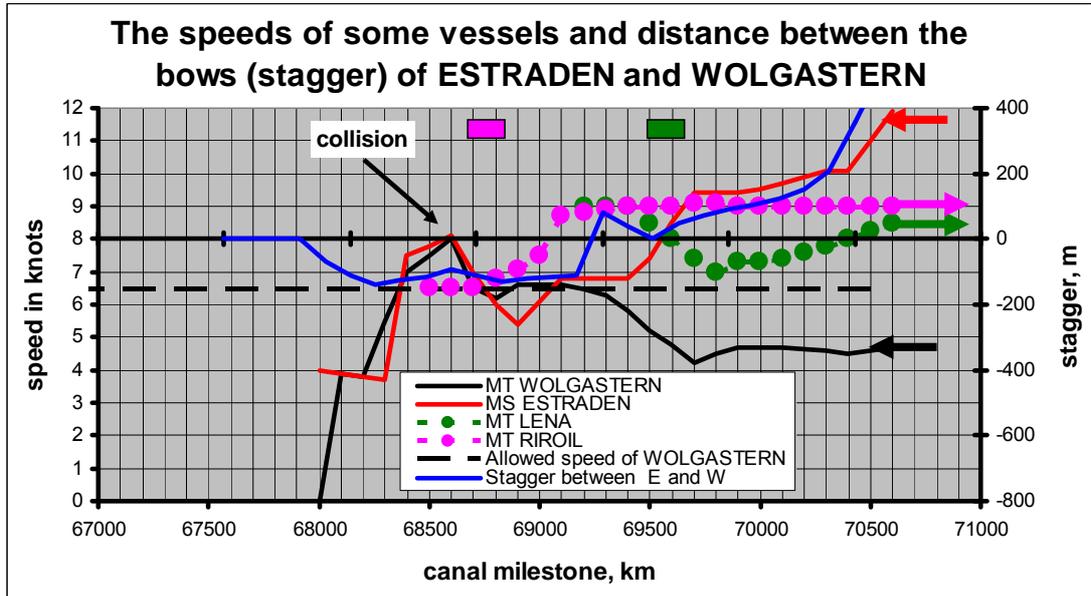
Speeds and positions. Figures 19 and 20 present the view of the investigators on the speeds and mutual longitudinal positions of the vessels before and during the accident. The mutual longitudinal positions of the vessels are indicated as the distances between their bows. When three vessels met each other, the encountering vessel had reduced its speed. The ESTRADEN and the WOLGASTERN had about the same speed about 4 minutes before the collision and both were increasing their speed. The allowed speeds were at times exceeded.

Figure 19. The speeds of the vessels and the longitudinal distance between the ESTRADEN and the WOLGASTER. The encountering situations are indicated with small rectangulars.

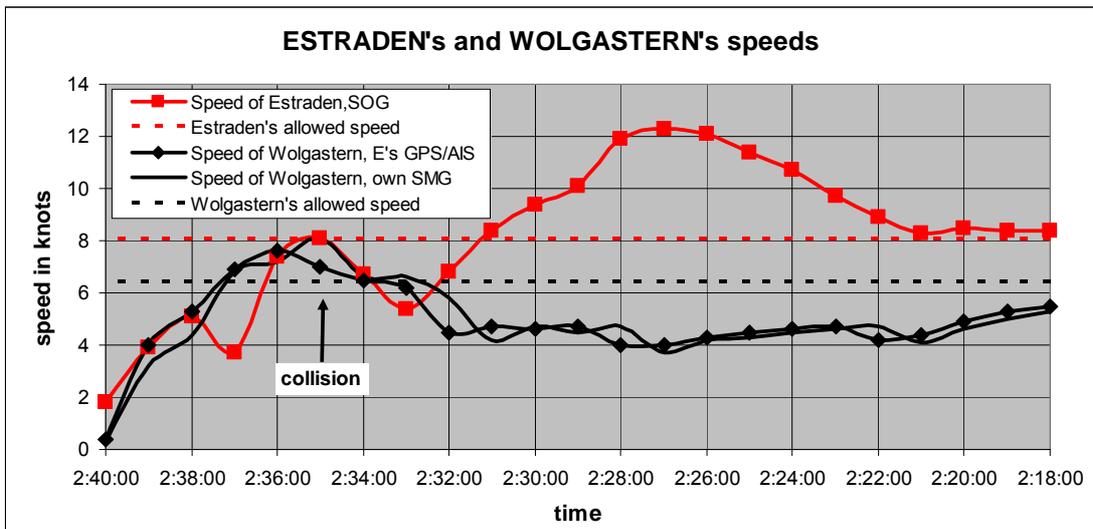
Figure 20. The speeds of the ESTRADEN and the WOLGASTER.

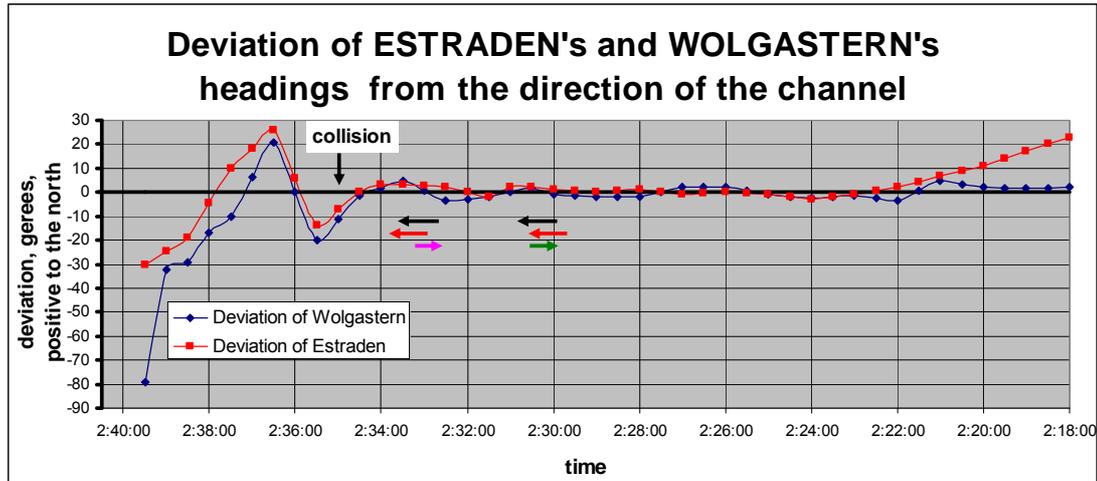
The heading of the vessels. Figure 21 presents the headings of the ESTRADEN and the WOLGASTER before and after the collision. The effects of the steering measures onboard and the mutual interaction are difficult to distinguish. However, it can be seen that, especially after encountering the RIROIL 5, the headings of the vessels started to change more strongly than before it.

Figure 21. The headings of the ESTRADEN and the WOLGASTERN. The encounters of the LENA and the RIROIL 5 are also shown.

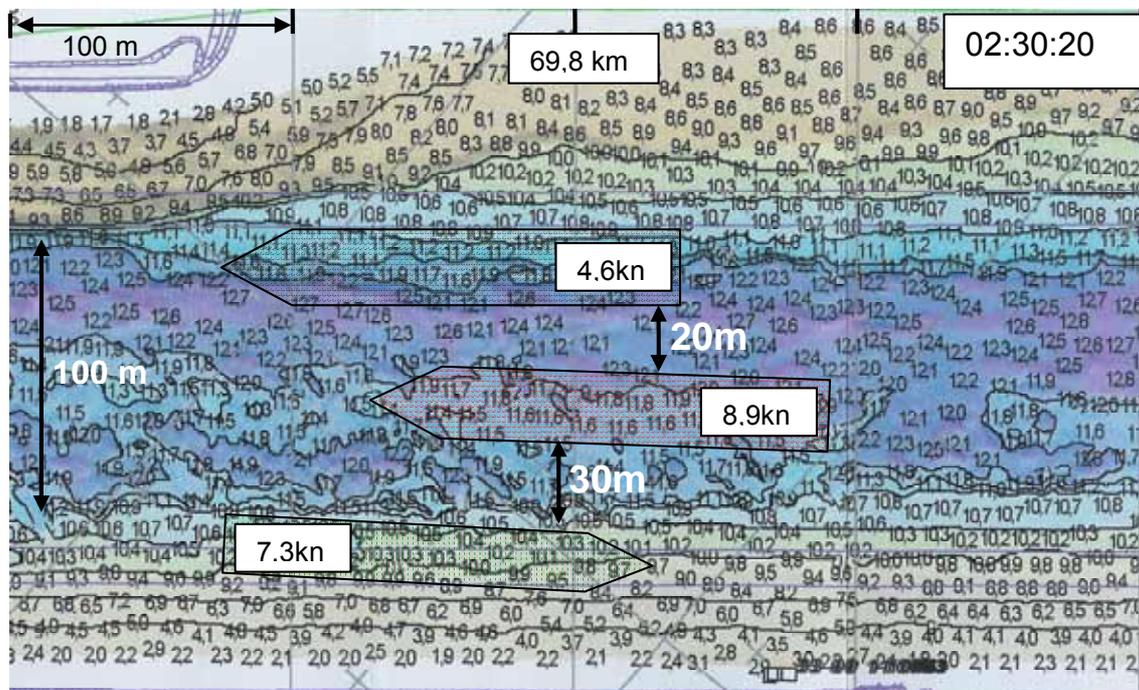
Figure 2. LENA is encountering ESTRADEN and WOLGASTERN. Vessel positions are according to the evaluation by the investigators. The aim has been to position the ships breadth wise as far as possible from each other. The draft of LENA, 6.3m, allows it to be placed into shallower water, h/T is about 1.6. WOLGASTERN's right side is in about two meters shallower water than the left side, h/T is about 1.25 on the average. For ESTRADEN, draft 5.9m, h/T is about 2.0. The encounter with LENA lasted about 40 seconds.

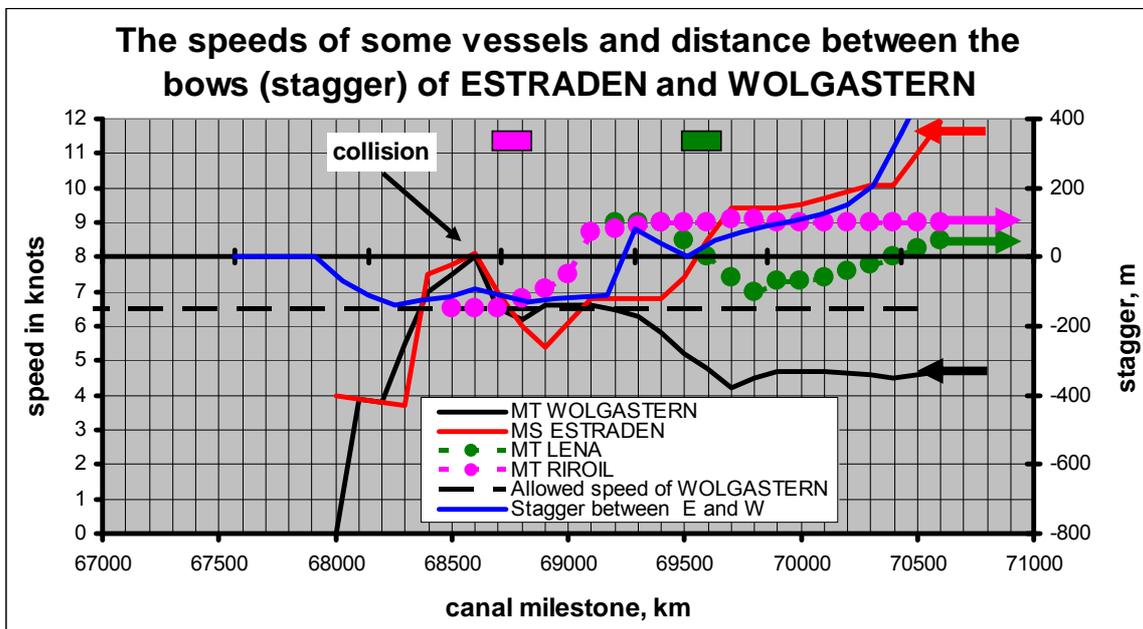
6,5 knots. When she accelerated the speed before the collision, her highest speed was about 8 knots. Also LENA and RIROIL 5 exceeded the speed limit at some instants. It may be concluded that the increase of speeds increased also the risk of collision.

Figure 3. Speeds of the vessels and stagger between ESTRADEN and WOLGASTER. The small rectangles show the encounters of three vessels. As seen, the encountering vessels decreased their speed during the meeting.

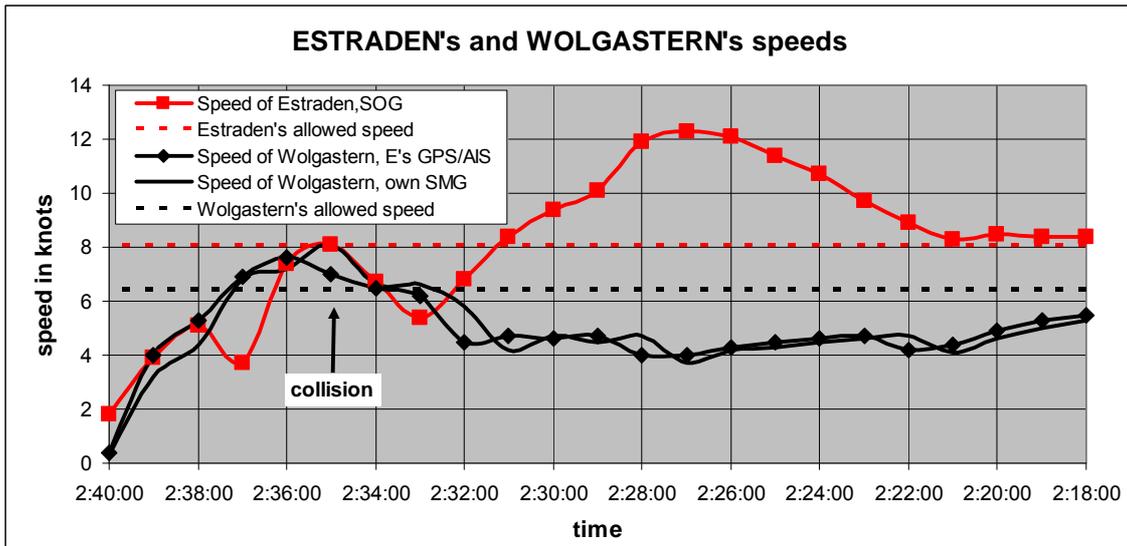
Figure 4. Speeds of ESTRADEN and WOLGASTERN and allowed speeds. Collision's first stage happened at about 02:35.

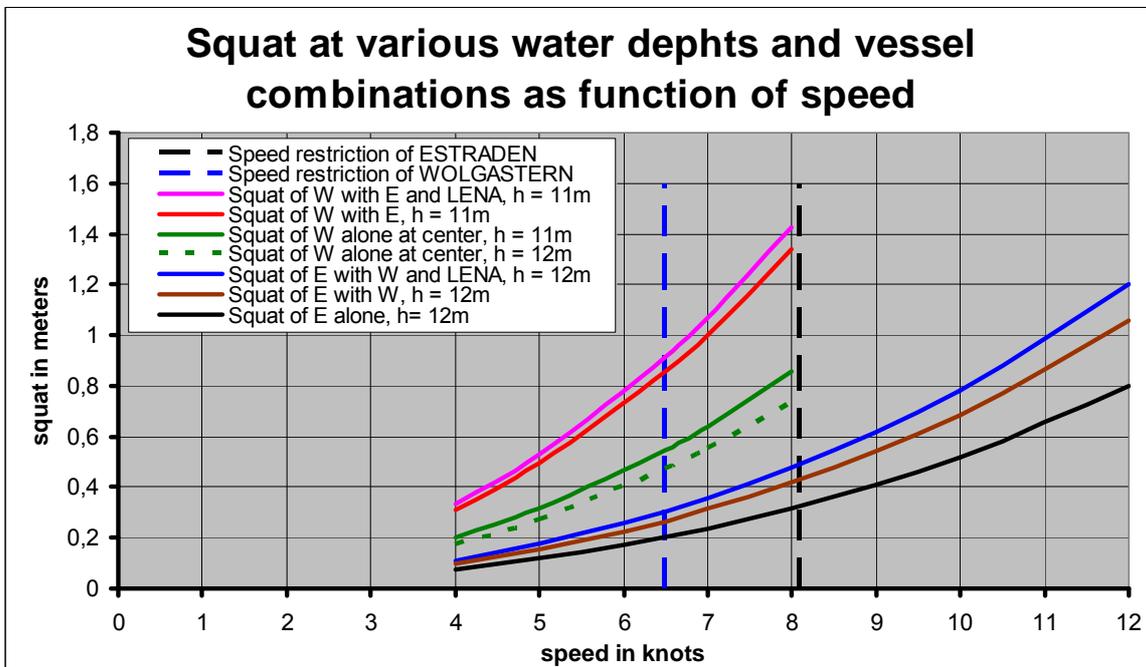
Water depth varied both lengthwise and across the channel resulting in variable squat, forces and moments depending on the vessel position. Squat is evaluated according to the principles of reference 10, figure 5. Squat at encounters with LENA and RIROIL 5 might be overestimated, because the meetings lasted only about one minute. Squat of WOLGASTERN increased considerably with the speed increase; from about 0,4 m possibly to nearly one meter. This fact has been one reason for the worsening maneuvering observed.

Figure 5. Estimated squat of various ship meetings.

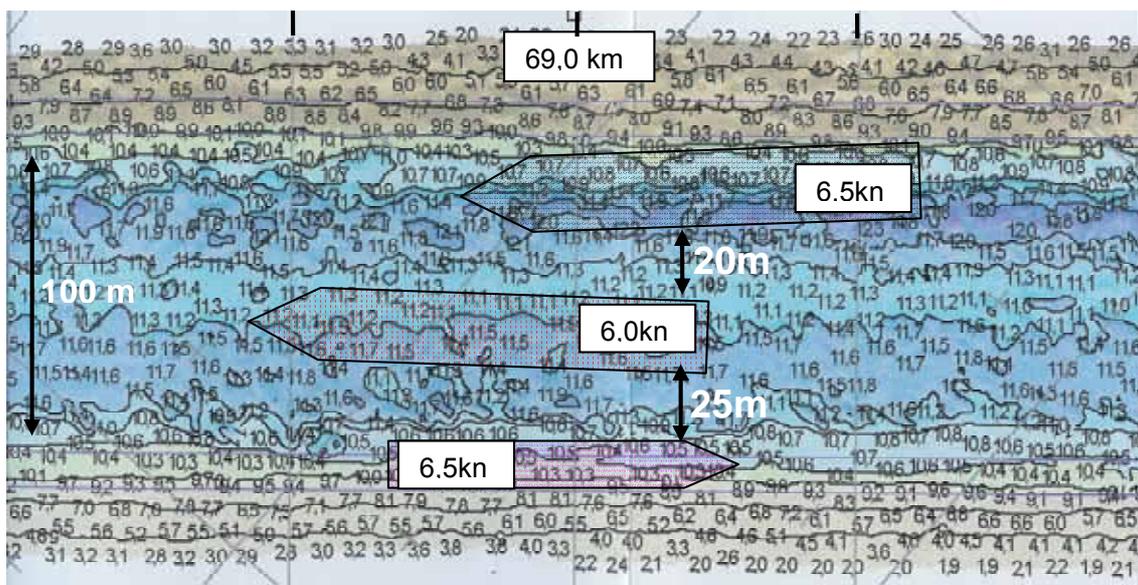
ESTRADEN and WOLGASTER had two encounterings with other ships. Therefore the separation between their sides was at maximum about only 20 meters. During the meetings of three vessels they reserved 50–55 per cent from the useful bottom breadth of about 130 m. The opinion of the investigators is that the separations shown in figures 2 and 6 were all too small. According to the reference 9, the forces and moments acting on WOLGASTER (4.5 kn) and ESTRADEN (7.5 kn) will be doubled if the separation between sides decreases from 33 m to 9 m. The reported distance between sides was 10–20 m. After the RIROIL 5 encounter this distance could have been increased to about 50 m, and the forces and moments had decreased at least by 50 per cent, if ESTRADEN had moved towards the left bank. Then WOLGASTER had probably not increased her speed and ESTRADEN had succeeded in her overtaking operation.

Figure 6. Second encounter of three vessels. RIROIL 5 is encountering ESTRADEN and WOLGASTER.

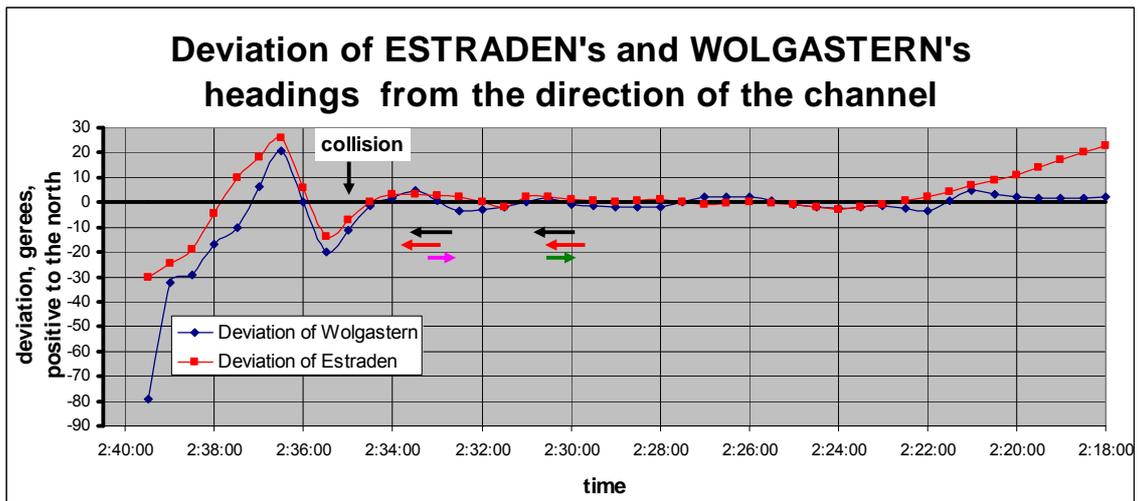
Figure 8. Deviation of ESTRADEN's and WOLGASTER's headings from the direction of the channel (229 degrees). Also the instances of encounters with LENA and RIROIL 5 are shown. ESTRADEN proceeded to the straight part of the channel at 02:23.

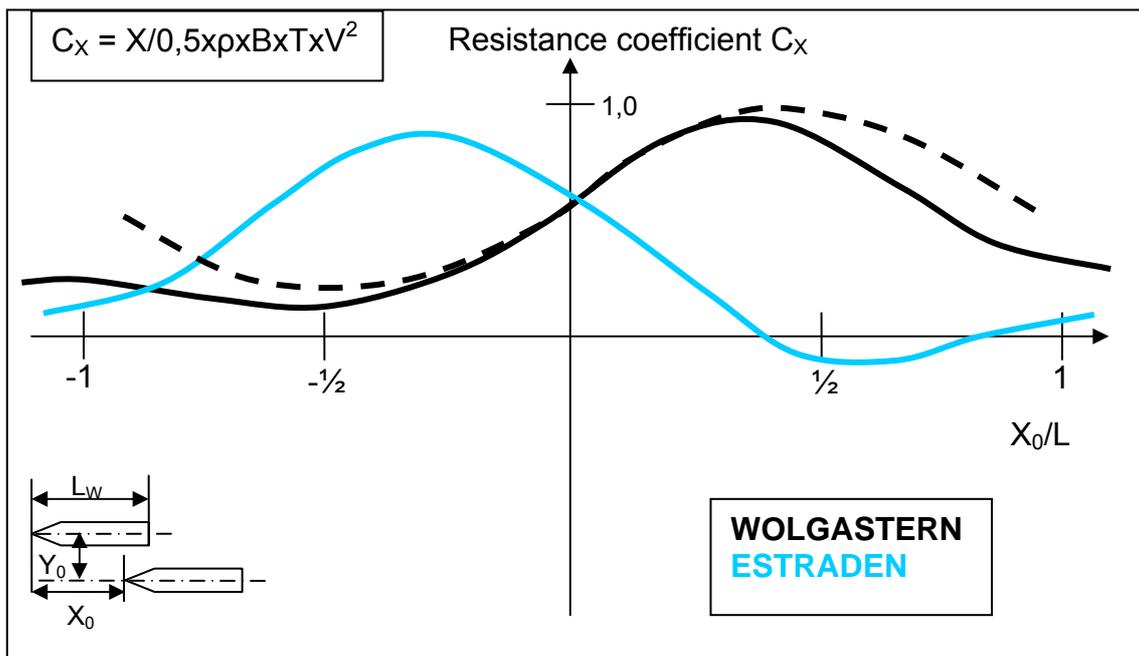
The case of equal speeds. ESTRADEN's attempt of overtaking proceeded quite quickly up to position D, figure 9a. This figure shows longitudinal forces acting on the respective vessel. If the speeds are too close and the separation is too small, overtaking will not succeed. ESTRADEN's resistance increased and WOLGASTER's decreased.

Figure 9. Longitudinal (resistance) forces. Broken line: equal speed.

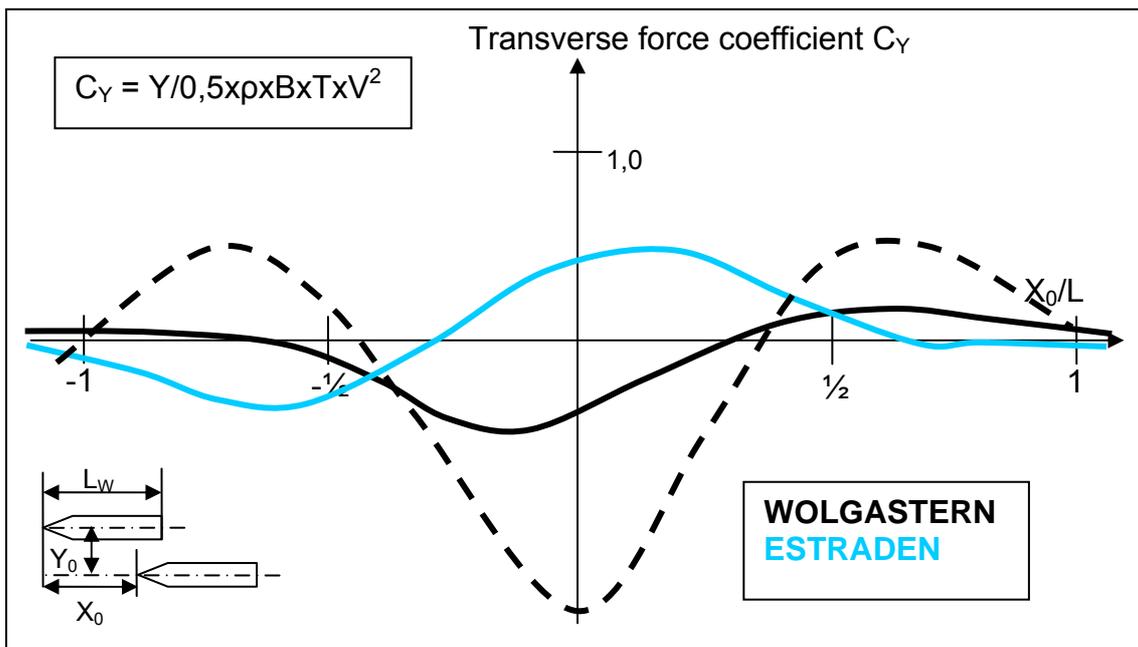
As can be noticed, the transverse forces are attractive when the ships are side by side. At this instant the turning moments are quite small and they can be compensated by rudder moments. When ESTRADEN proceeded a little bit ahead, turning moments started to grow. They can increase so much, that they are greater than steering moments. ESTRADEN had two propellers and rudders and her steering moments could be higher than shown in the figure. Another fact complicating the maneuvering is that the turning moment depends strongly on the stagger. In position D WOLGASTER had a tendency of turning her bow towards ESTRADEN. ESTRADEN had also similar tendency. As a result, the bow of WOLGASTER hit amidships of ESTRADEN. Turning moments were greater than steering moments, and the collision was not possible to be avoided at that instant. Transverse forces tried to move both ships to the left. Additionally, bank effect was affecting WOLGASTER, see chapter 2.9.

Figure 10. Transverse forces. Broken line shows situation at equal speed.

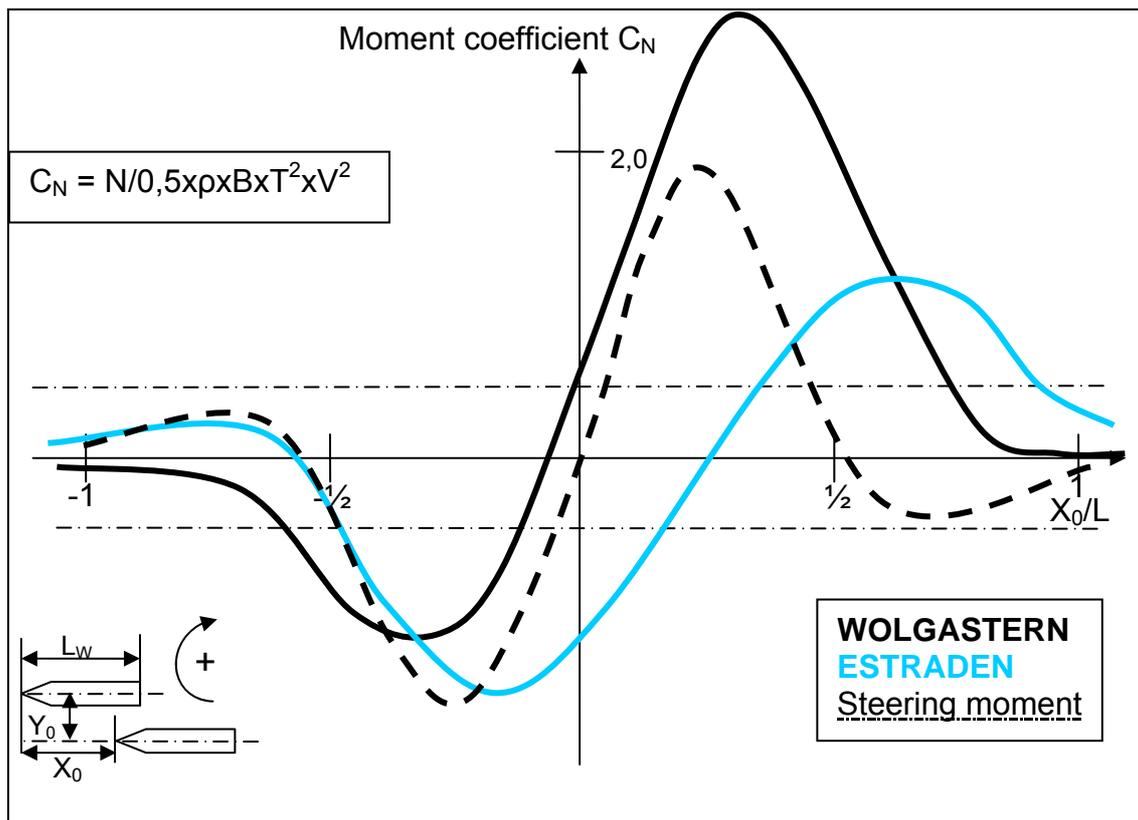
Figure 11. Turning moments. Broken line shows situation at equal speed.
