Investigation report

C6/2006M

Passenger Vessel MS NORDLANDIA, Collision with Quay in Tallinn on 28.10.2006

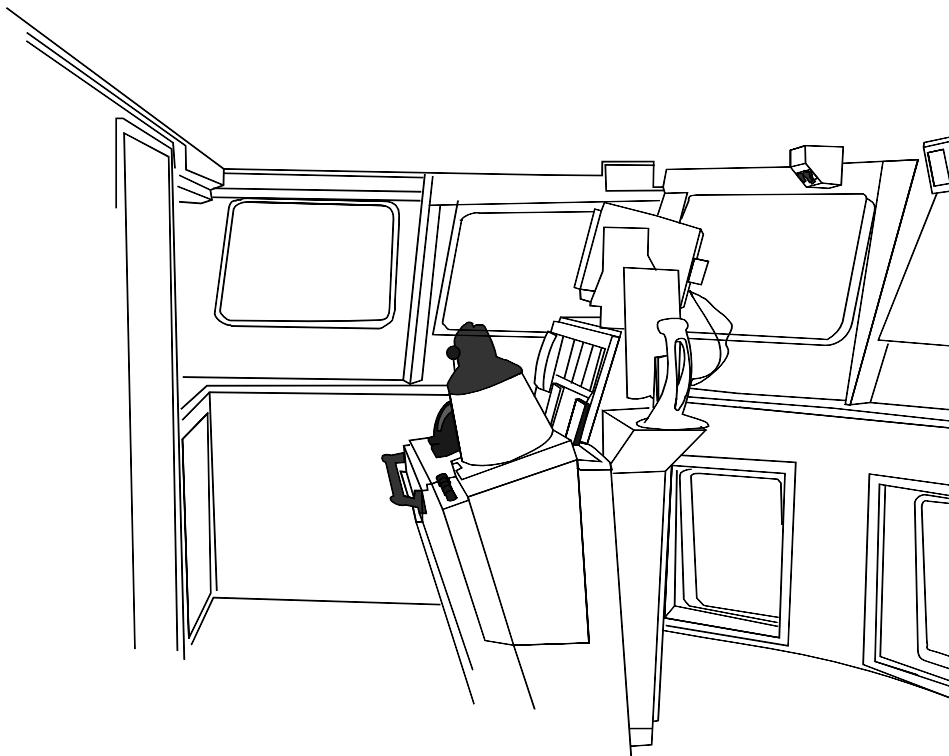
Figure 10. A side view from the port wing of the bridge. The side was easy to see. There were windows reaching to the edge of the floor, which improved visibility.

The meters (displays) and control devices were not optimal for backing. The rudder angle indicator remains behind one's back. It is difficult to adjust the bow thruster forces with the help of the push buttons, because they are too far away. In port manoeuvring the control of rudders and bow thrusters take up attention from observing the view to the quay. The bow thrusters and rudders would have required levers operating on the Follow Up-principle. When touching the lever by hand, one can feel the given order from the FU-lever, which gives the possibility to concentrate on the good visual view from the bridge.

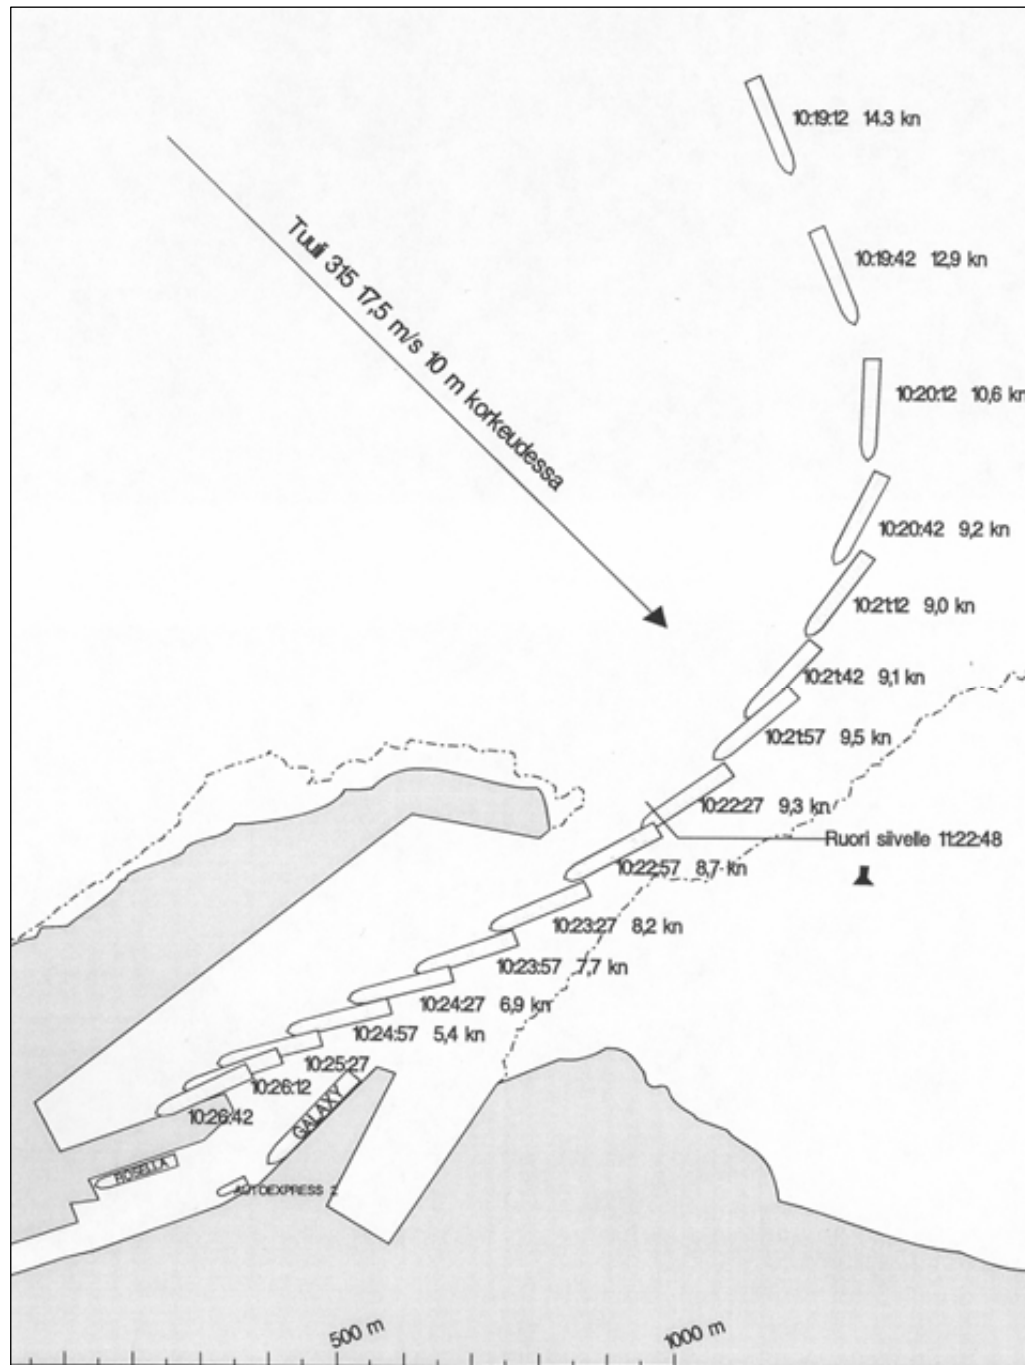
Figure 14. The track of the vessel according to the electronic chart and the GPS. The time for the coupling of the rudders to the bridge wind has been taken from the bridge speech recording,

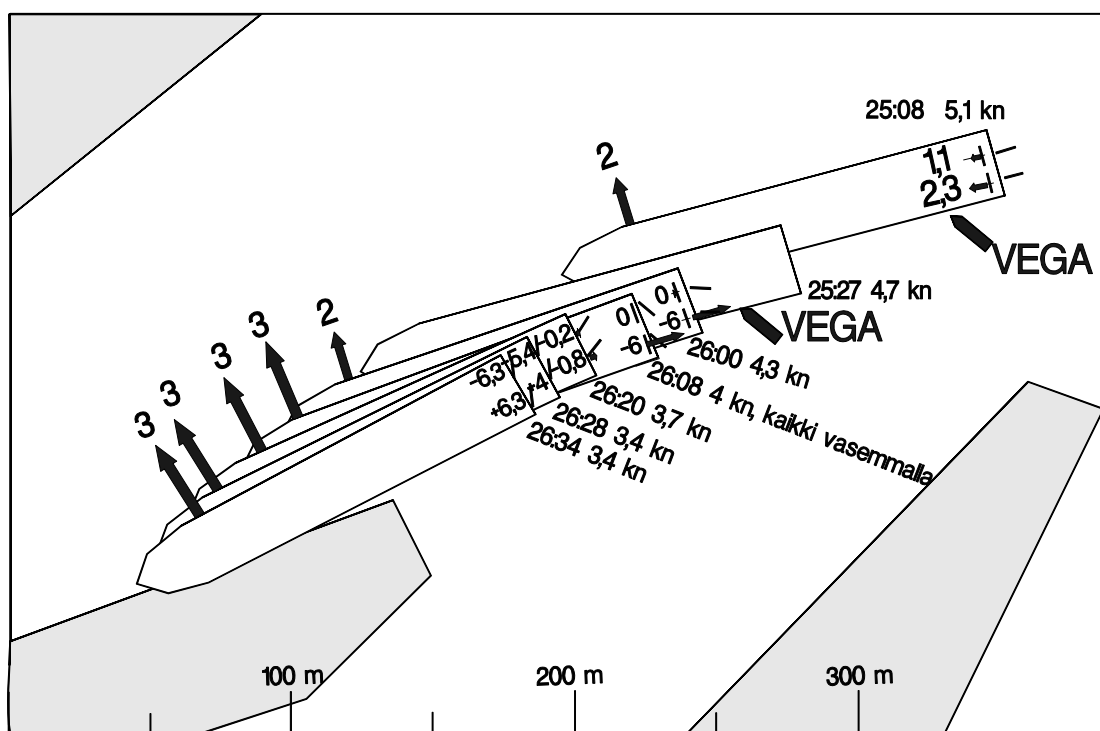
Figure 18. The collision took place 10:26:34. The VEGA did not have enough time to turn the NORDLANDIA. This figure is an illustration of the manoeuvres presented in Table 11.

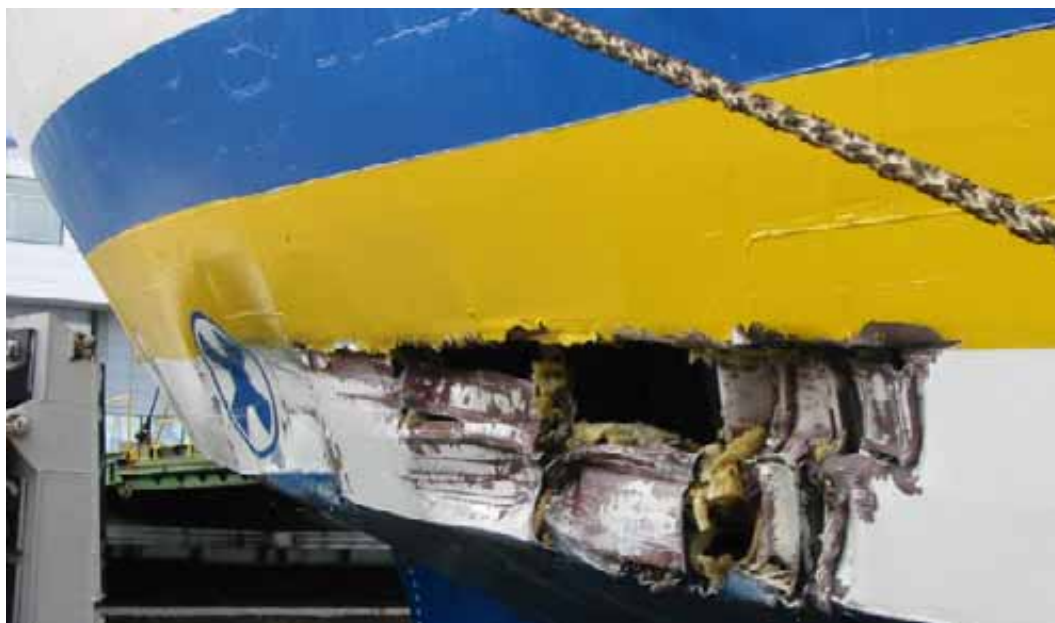
Figure 20. The NORDLANDIA's damage on the port side bow of the vessel. The damage was caused by the collision with the fender of the quay. The shock absorbing part of a similar but an intact fender can be seen to the left in the figure.

The port side part of the NORDLANDIA's bow was damaged when it hit the quay fender. A 3-4-metre long and 60-cm-high hole appeared at the frames 153-168, in the plating located next to the stairwell at the bow beside the cardeck (Figure 20). The hole was approximately 2.5-3 metres above the (car)deck. Several frames were damaged. All the damages to the vessel were located above the water line.

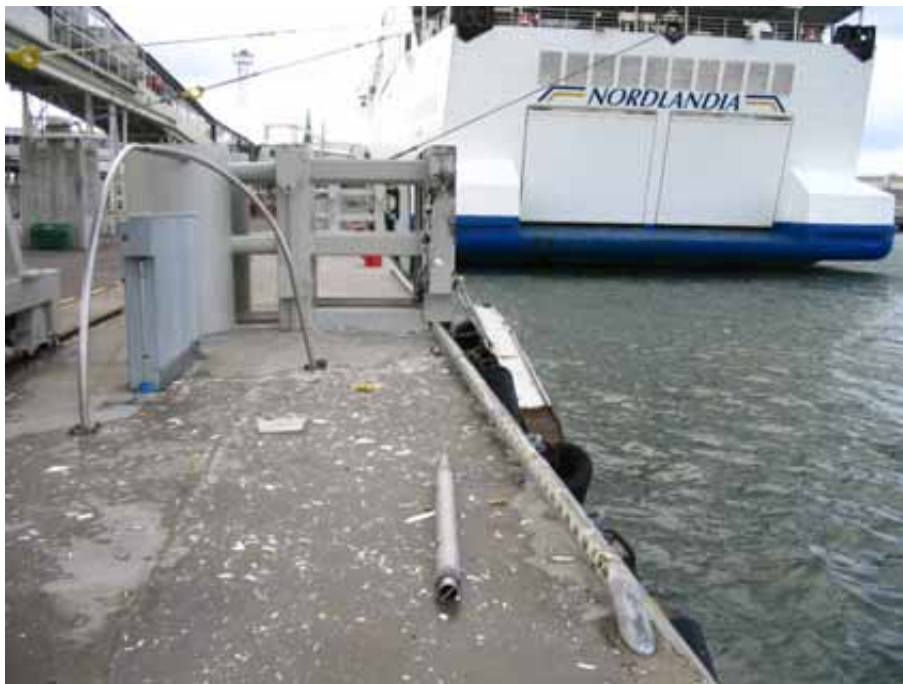
Figure 21. The damaged quay fender.

Of the port constructions, the fender and the covered passenger gangway were damaged. The bow of the NORDLANDIA only hit one fender, and its shock absorbing part

was damaged beyond repair (Figure 21). Both the damaged, temporarily repaired and an intact fender can be seen in Figure 22.

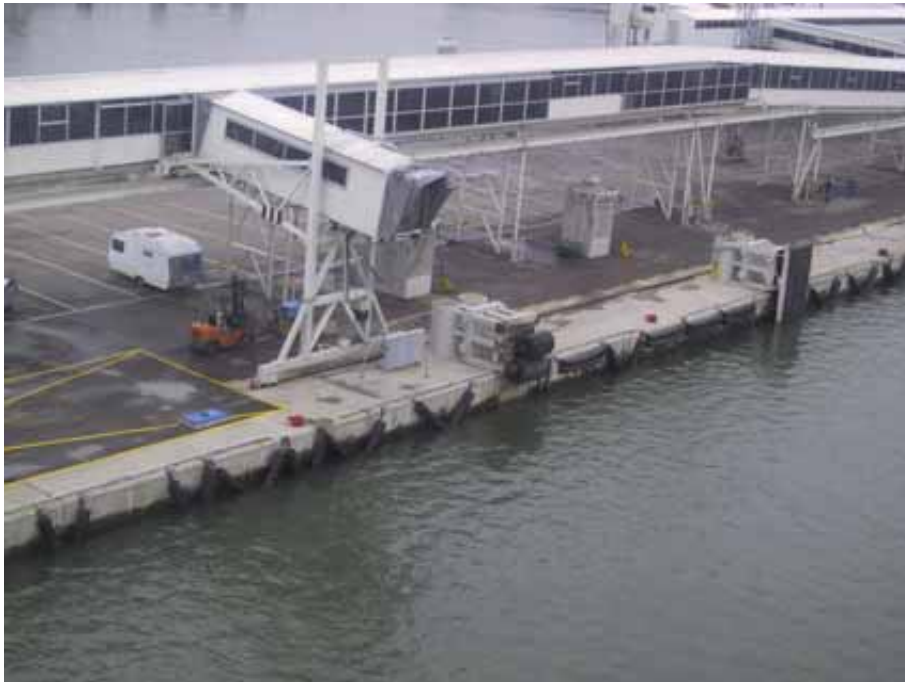
Figure 22. In the foreground the passenger gangway of the quay and the fender which were damaged by the NORDLANDIA's collision. In the figure the damaged fender located to the left has been repaired temporarily, and the intact fender can be seen to the right.

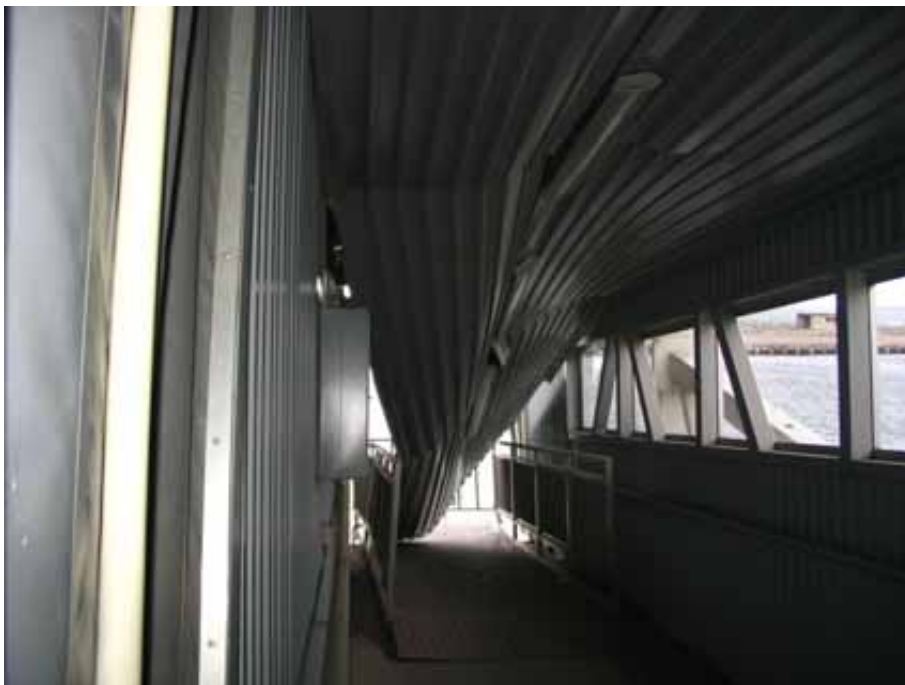
Figure 23. Damages to the passenger gangway.
