## Investigation report

C1/2007M

# **M/S KRISTINA REGINA and barge CARRIER 5, collision in Danish territorial waters at Kadetrenden 29.5.2007**

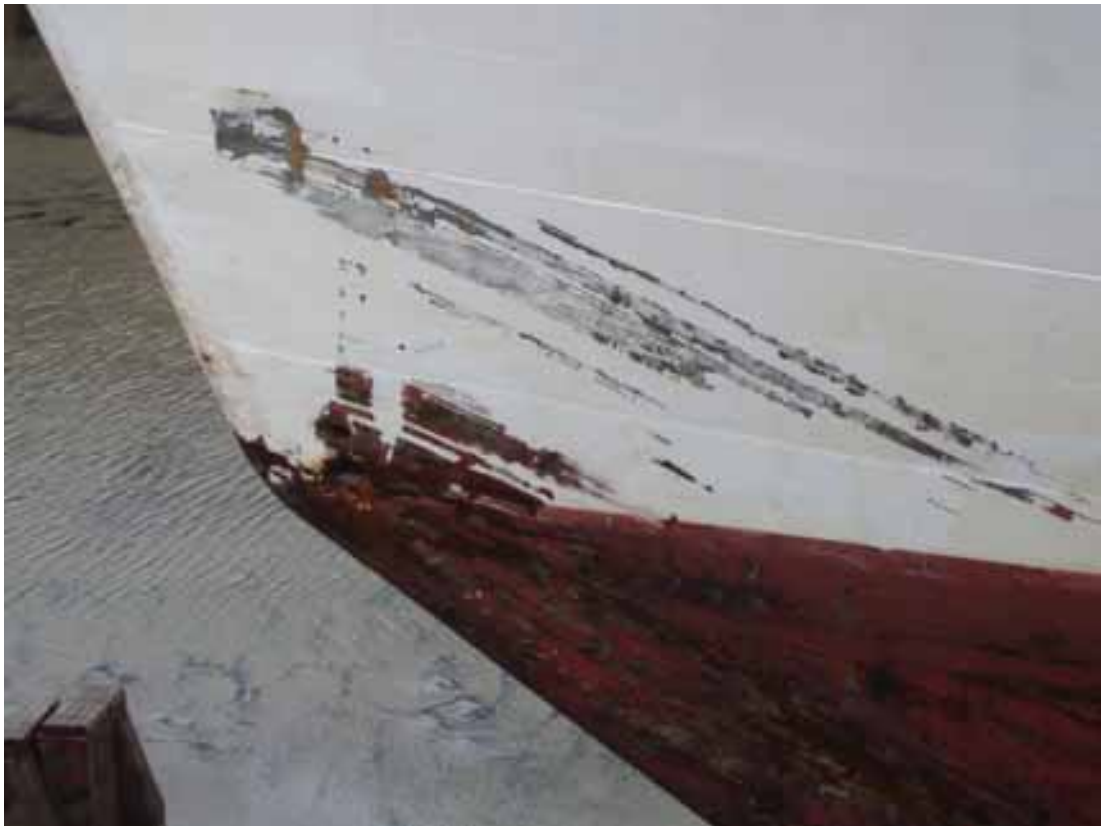
The damage to KRISTINA REGINA was at the bow of the vessel. Portside to the vessel there was a hole in the Fore Peak tank above the water level and starboard to the aft the light valve of one passenger cabins was broken. Otherwise there was paint damage in the bow due to the collision.

*Figure 5. Damage to KRISTINA REGINA on the bb side*

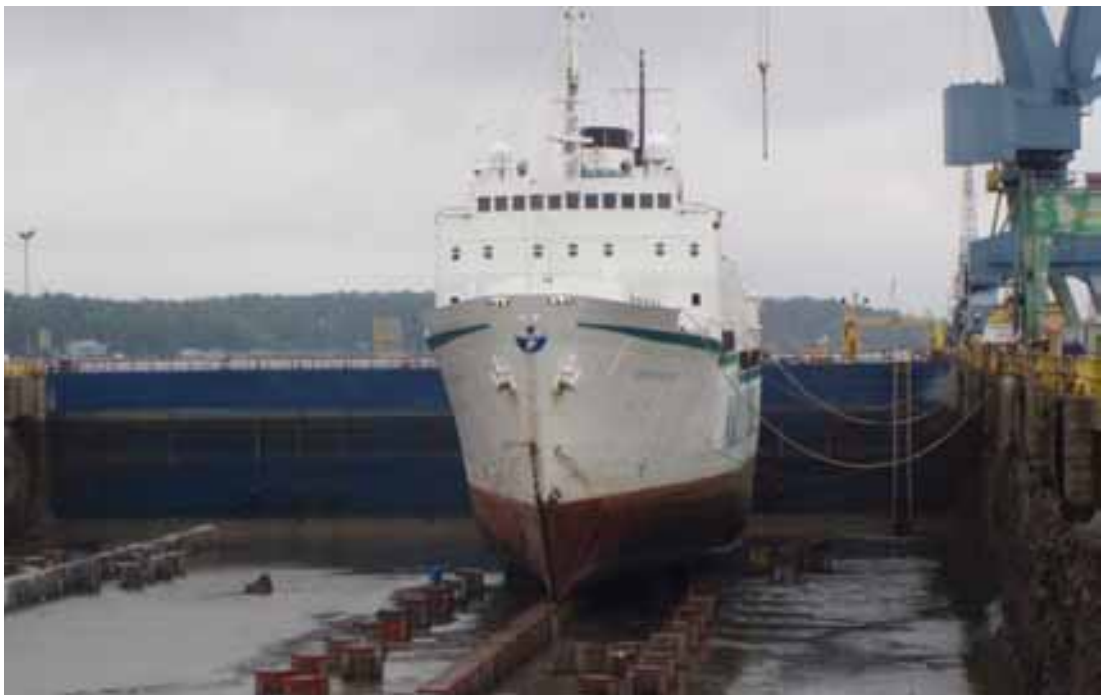
*Figure 6. Damage to KRISTINA REGINA seen from the bow.*

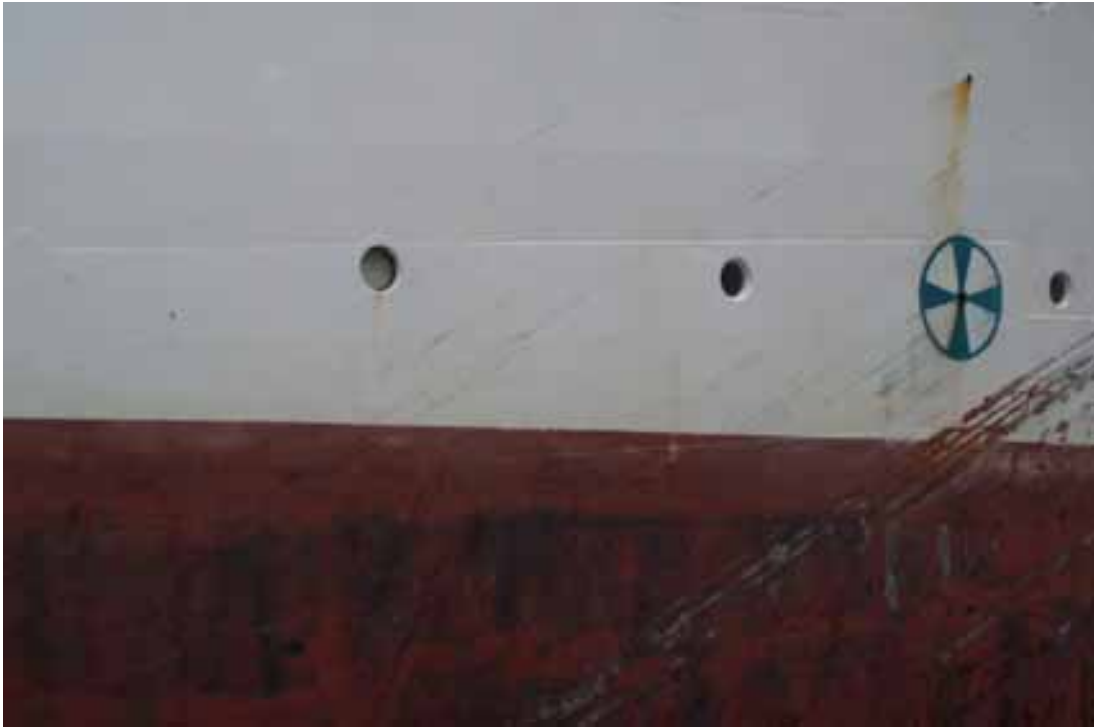
Figure 7. Broken valve on the starboard side of the vessel.

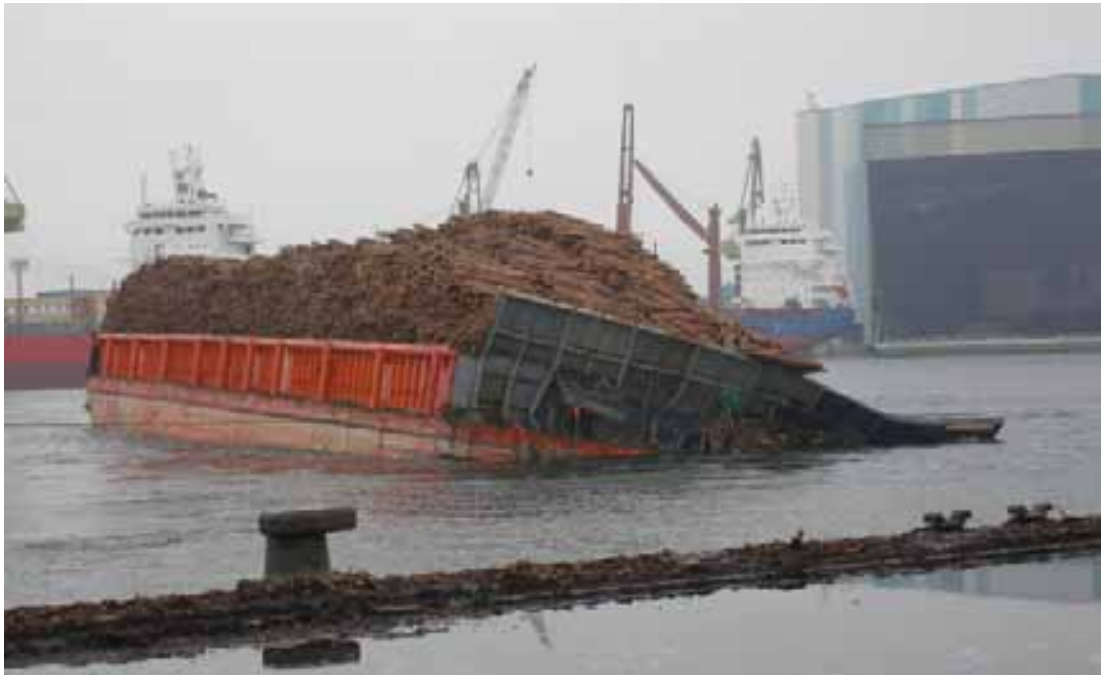
The angle of dip of barge CARRIER 5 after the collision was 20°. About 10–15 % of the sawn timber load had ended up in the sea and the barge obtained rather large damage to the hull. The damage to the barge was on starboard between frames 23–31 as well as between tanks 4 and 5. The damage to the outer side starts from the level of the deck and continues downwards about 3.3 metres all the way to the water line. The railing of the barge had suffered serious damage on the starboard side and aft. The aft railing had ended so that the anchor wheel level had bended so that the supply container fell into the sea in the collision. The economic damage was significant.

Figure 8. List of barge CARRIER.

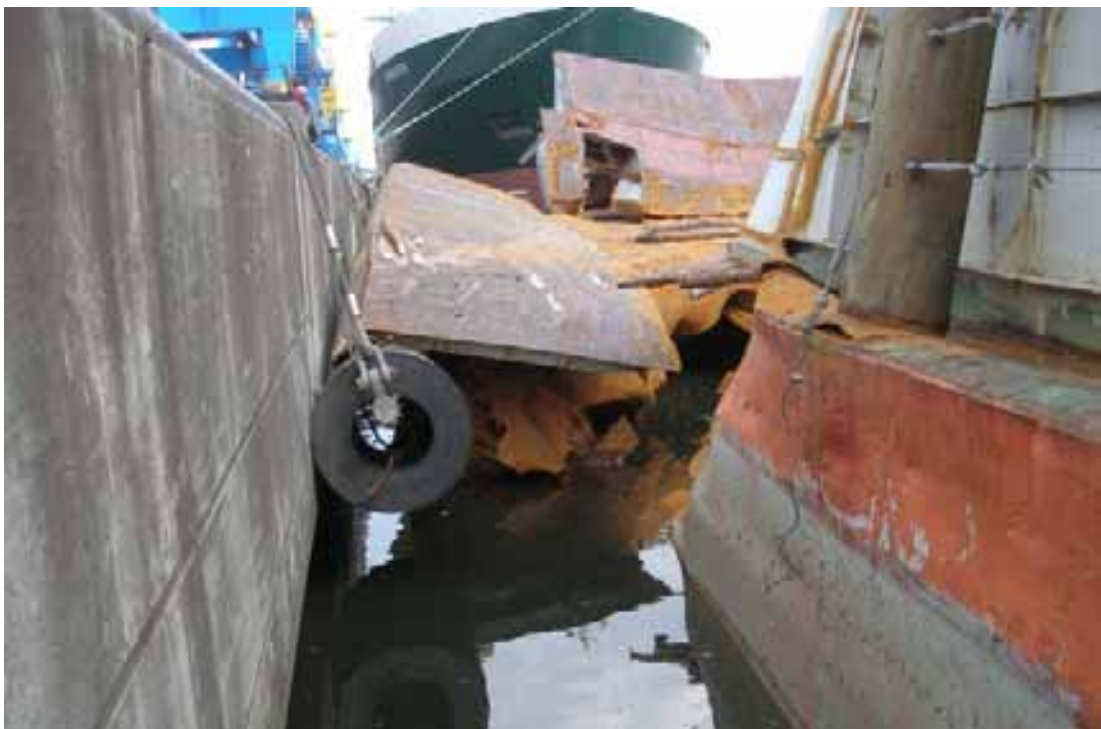
Figure 9. Damage to the side of the barge CARRIER.

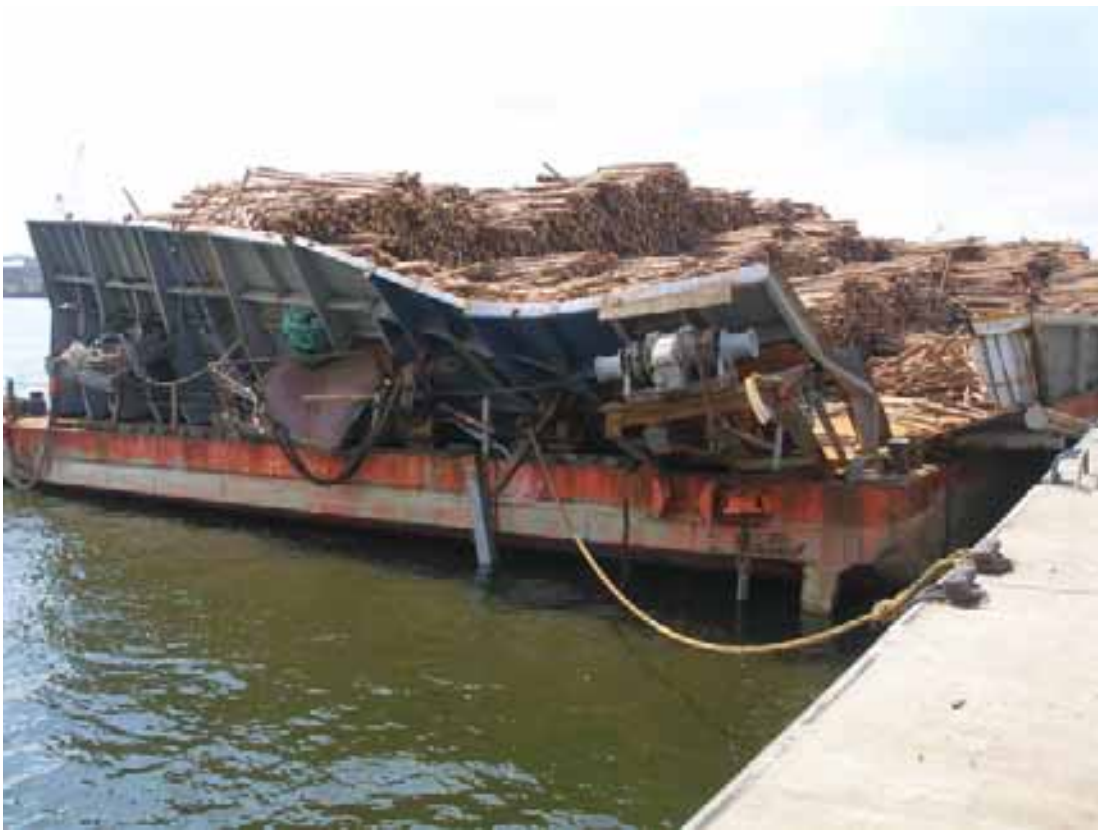
Figure 10. Damage to the aft of the barge CARRIER. (Figure Sjöfartsverket.se)

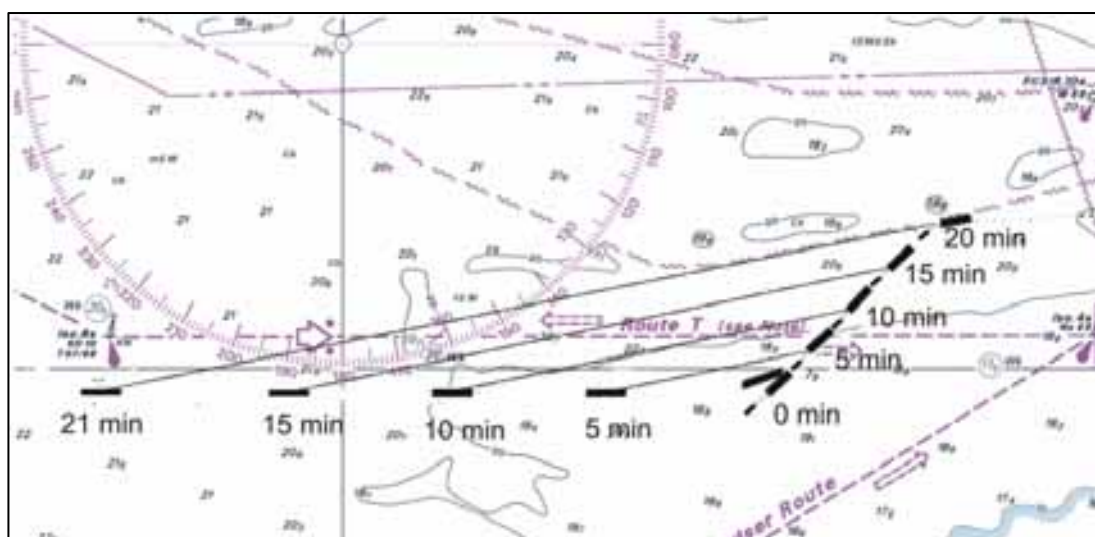
As KRISTINA REGINA changed course at buoy T 67-68 to 090°, PIONEER was one minute later at its own turning point 54° 26,1'N and 11°57.7'E and it changed its course to 200°.

Both vessels changed their courses towards the collision site almost at the same time. The distance to the radar target after the turning given in the maritime accident notification of KRISTINA REGINA coincides with the turning point given by PIONEER.

Figure 11. The approaching of the vessels before the collision.

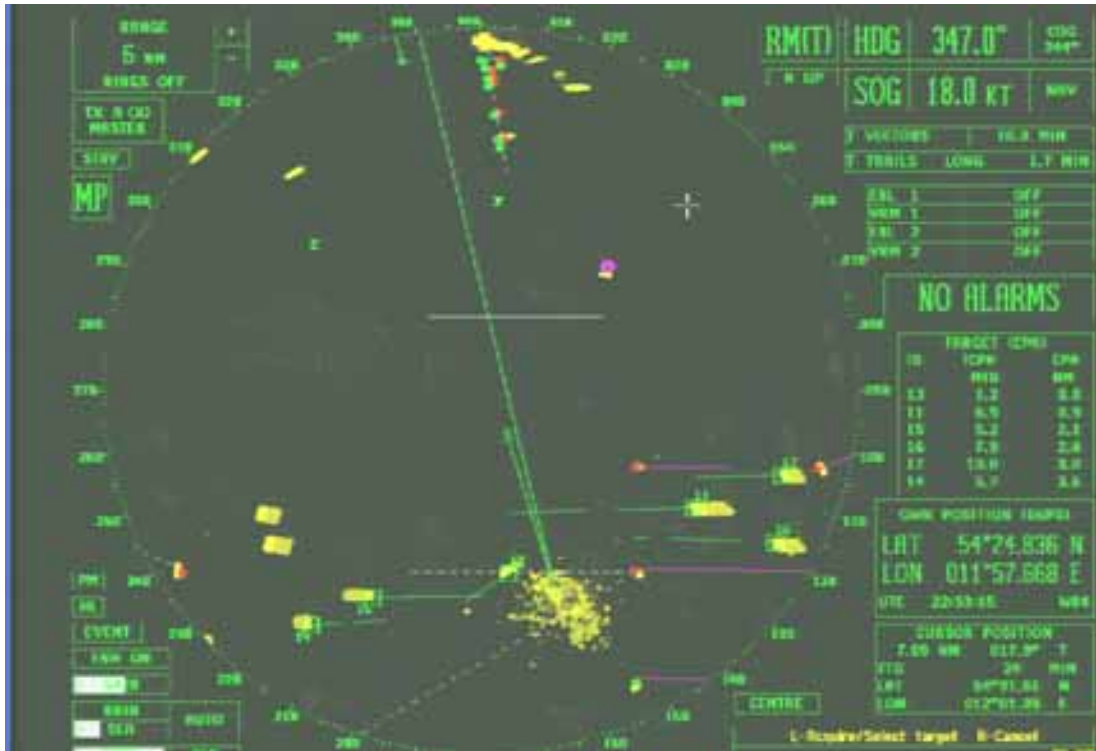
Figure 12. The vectors describing the directions of PIONEER (13) and KRISTINA REGINA (15) meet, and the length of the vector is 10 minutes. PIONEER and the barge CARRIER 5 give one echo.

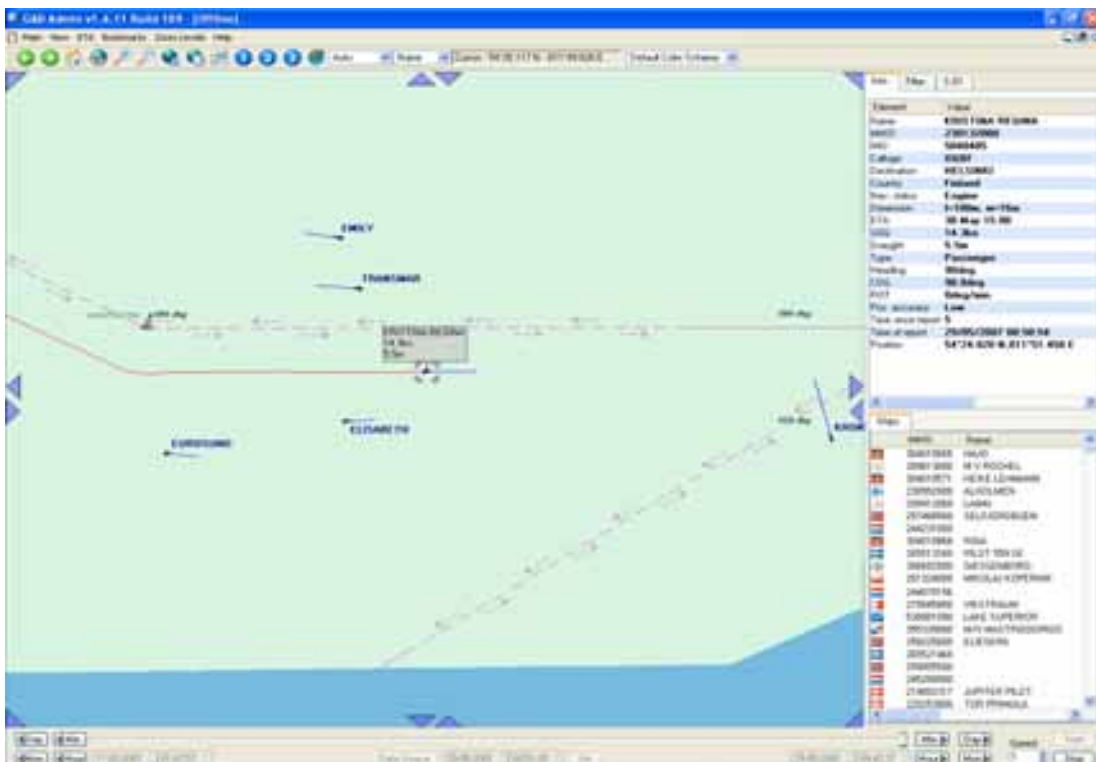
Figure 13. The image recorded by the Danish Maritime Safety Administration with AIS-targets 10 minutes before the collision.

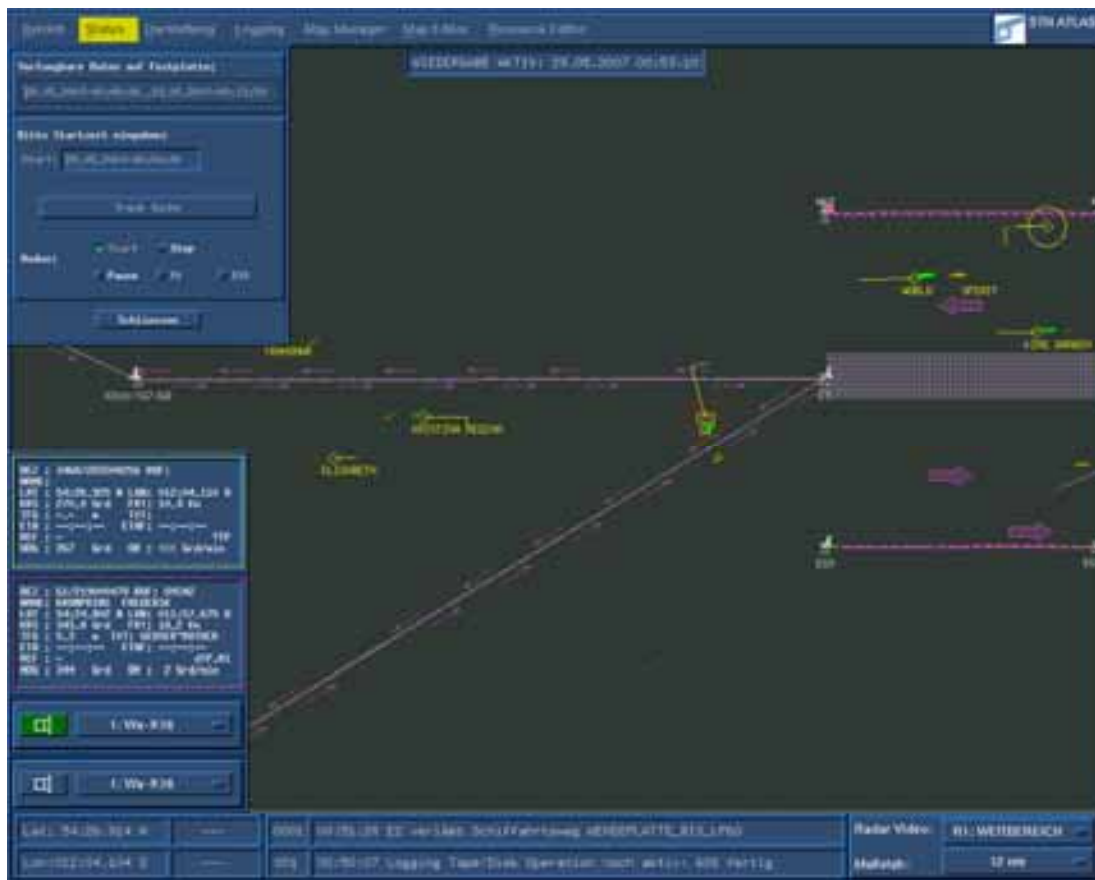
Figure 14. The radar/AIS image of the VTS Centre Warnemünde at about the same time. The barge combination gives no echo image. KRONPRINS FREDERIK has been circled in red.

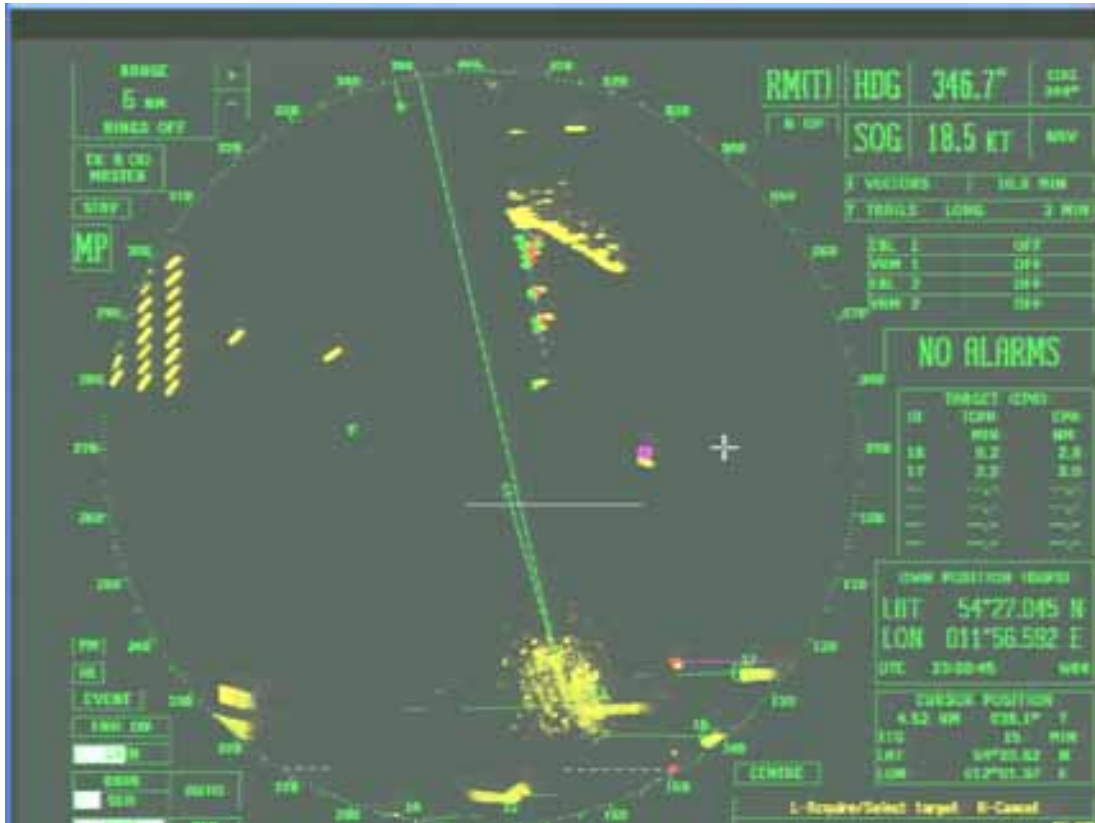
Figure 15. The collision takes place, the echoes of the vessels together at the lower part of the display.
