Investigation report

S3/2007M

Hatch crane safety

MS GRACHTBORG

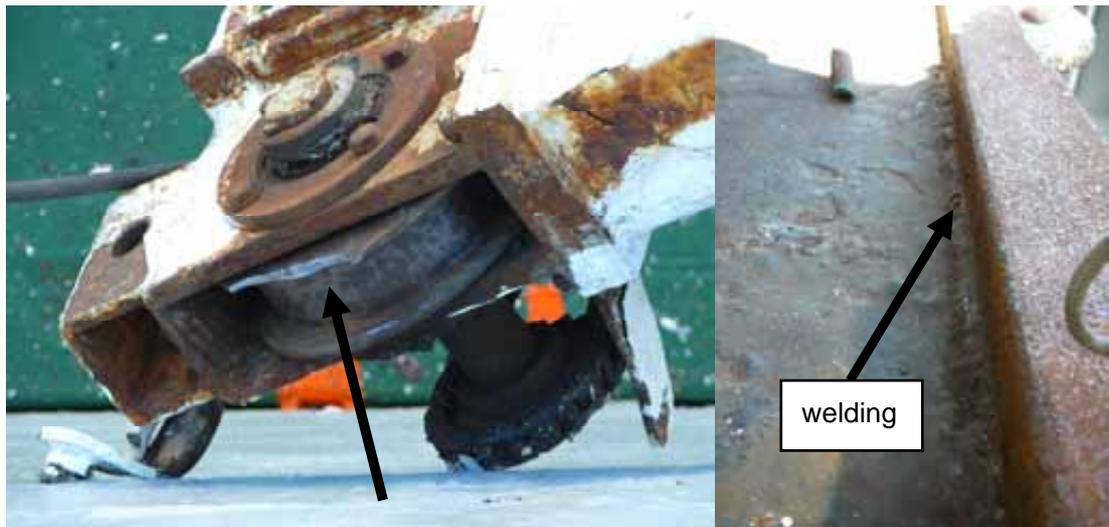
Figure 2. Figure showing a broken wheel. Due to the regular movement of the hatch crane and corrosion, the steel rail is slightly becoming thinner. This results in parts of the wheel to rest on the welding of the rail to the deck, instead of resting on the rail itself. The weight of the crane is not divided over the wheel anymore but resting on the thin cheeks at both sides of the wheel. The photograph is showing the broken cheek.

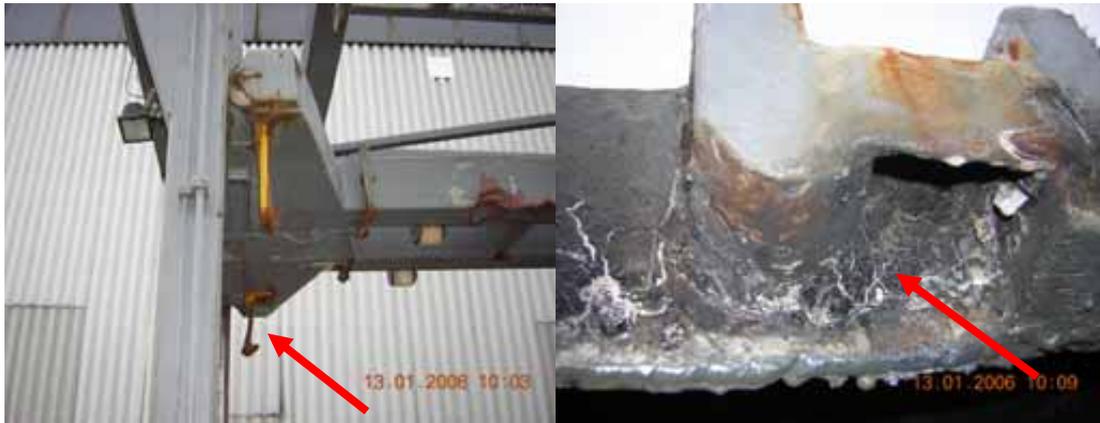
Figure 3. Figure showing the lifting hooks. They deformed as they slid along the pockets and losing the hatch cover. This resulted in toppling over of the hatch crane, injuring the driver of the crane (in three cases resulting in the death of the driver).

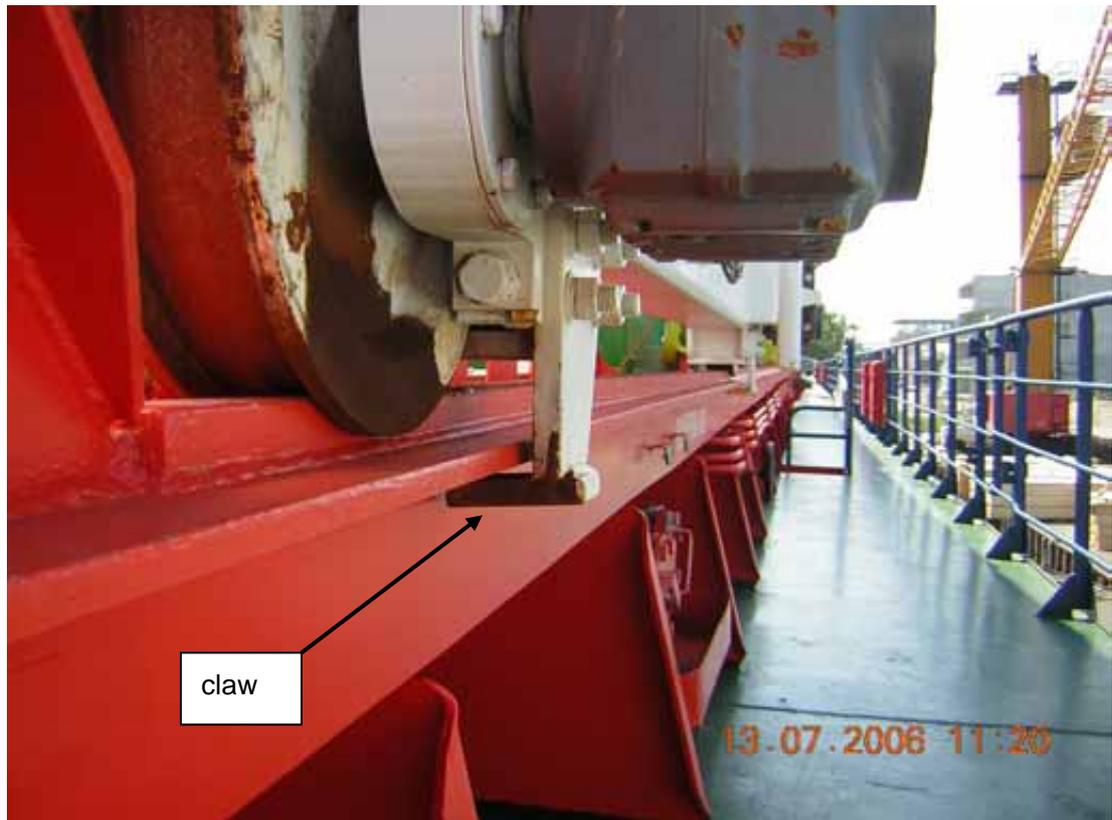
- Again the Board has to identify that the tragic accident on board is due to the fact that the hooks were not fitted correctly to the pockets on the port side, and during movement of the hatch crane came loose and made the crane to tumble. A check from a second helper could have avoided this accident. At most hatch cranes the operating desk is at the starboard side where the starboard lifting hooks can be seen. The port side lifting hooks can not be seen from this position. Checks on these hooks with a second person are a necessity if one wants to work safe. The accident could also have been avoided if the hatch crane had been fitted with 'rail claws'.

Figure 4. The rail claw, which prevents the crane from derailing or toppling over.

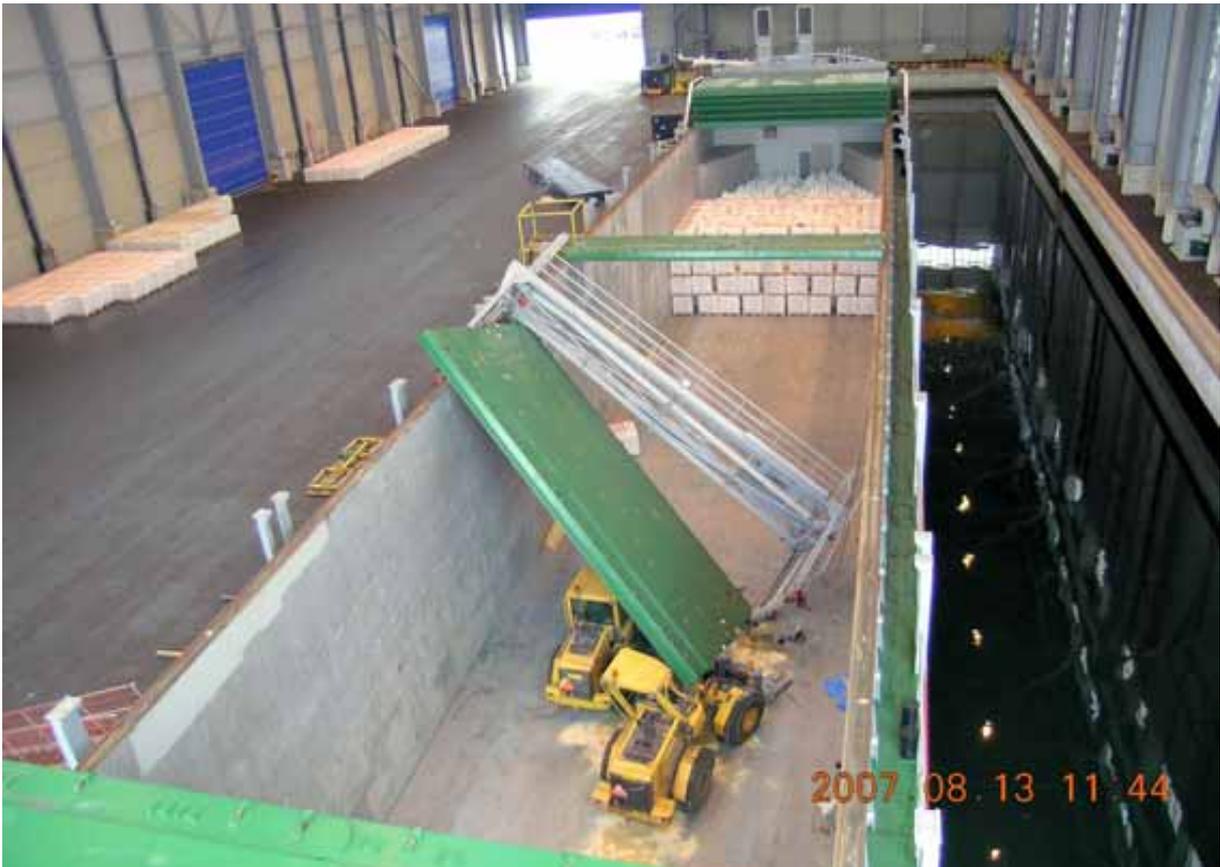
An ambulance was immediately called to the vessel and the mate was taken to hospital. According to the examination, the mate broke his rib and he received bruises, but no more serious damage. One of the wheel loaders in the cargo hold of the vessel, the Volvo L 70, was badly damaged as the hatch fell on top of it. The machine was so badly damaged that the insurance company redeemed it. The second wheel loader remained intact.

Figure 1. The hatch cover and the crushed tractor in the cargo hold.

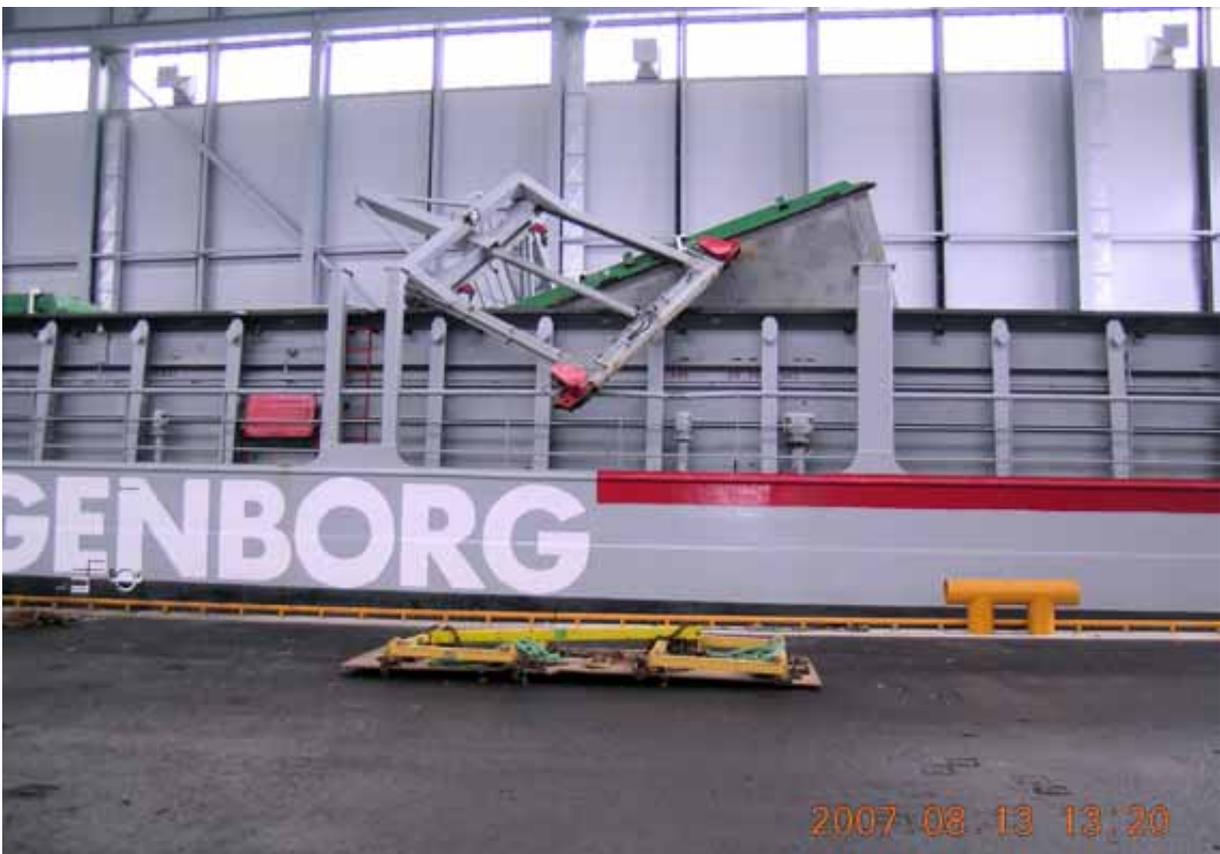
When the hooks are placed wrong, a small sway or tug will cause the deck hatch to slide from the top of the hook and the crane to become loose. In this case, the hatch falls lifting the wheel off the rails.

Figure 2. MS GRACHTBORG's collapsed hatch crane.

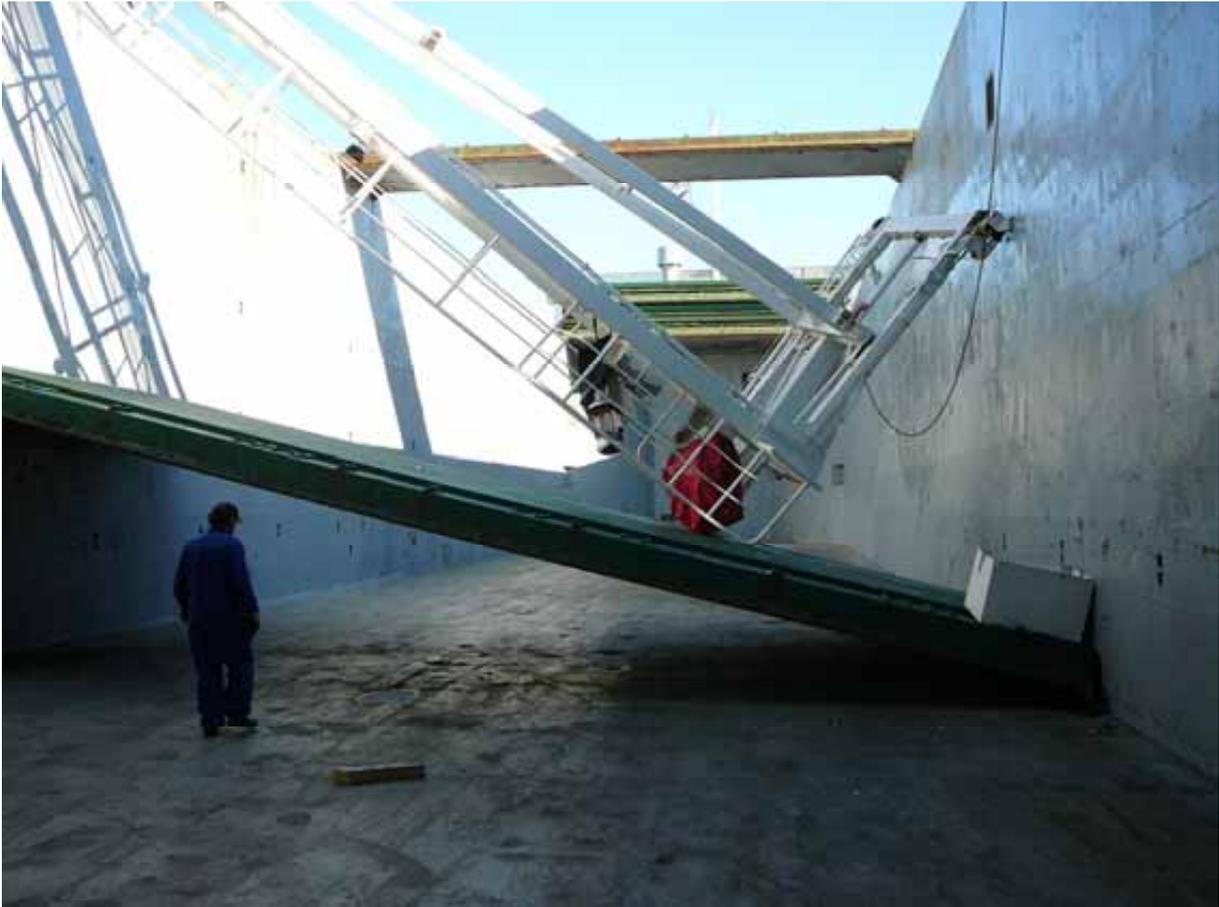
Figure 3. Another case on 2007.
