Investigation report

B3/2008M

M/S LEMO, fire in the galley of the vessel off Kotka on 22.11.2008

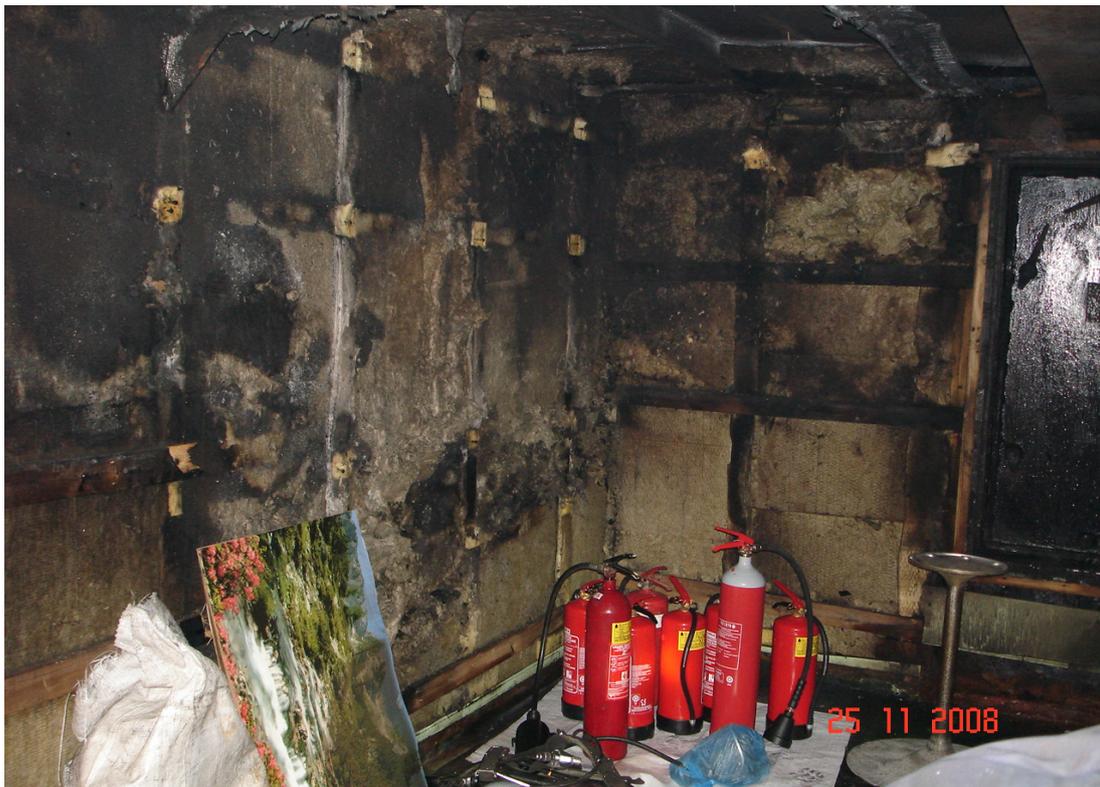
The vessel's galley, the mess and the cabins above the galley had suffered badly from the fire and heat. The surface material in these areas, electrical cables, textiles and furniture were partly burned. All of the areas around the fire site and especially the areas above it had suffered smoke damage. Picture 9 shows the location of the cabins in relation to the galley and the mess located next to the galley.

Picture 6. *The ship's galley after the fire. The galley has been cleaned up after the fire. On the right in the picture the door can be seen from where the fire service attacked the fire in the galley. The picture also shows the fire extinguishers that were totally or partly used initially.*

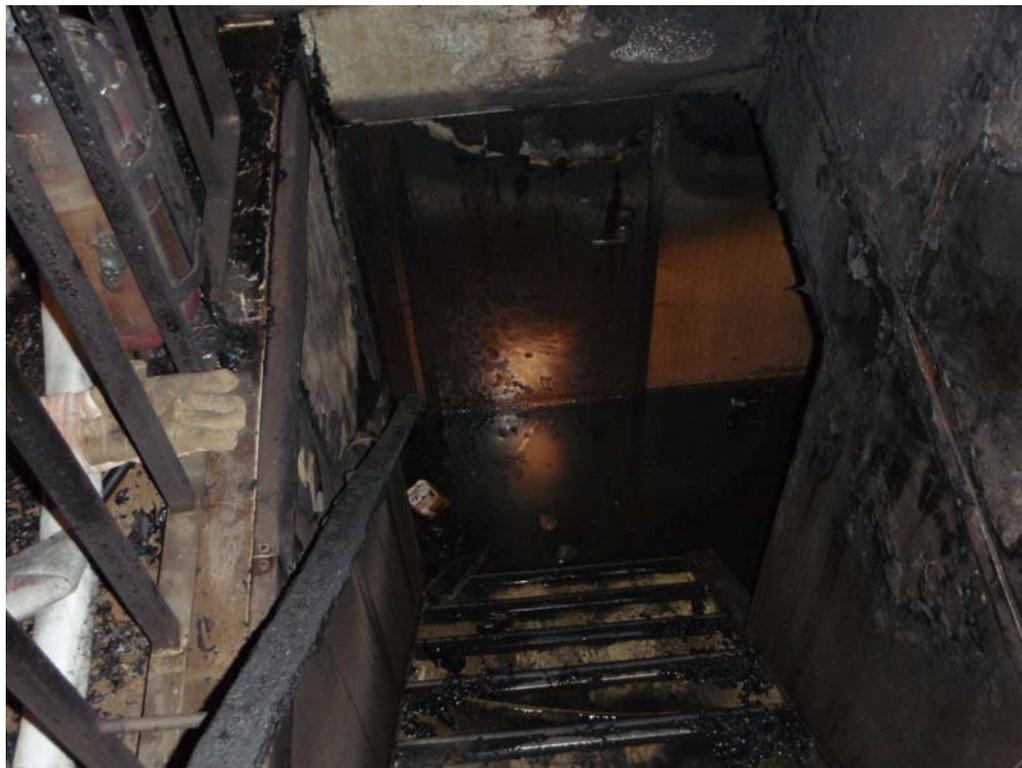
Picture 7. Central gangway from the cabin deck to the galley level. (Kymenlaakso fire and rescue service picture)

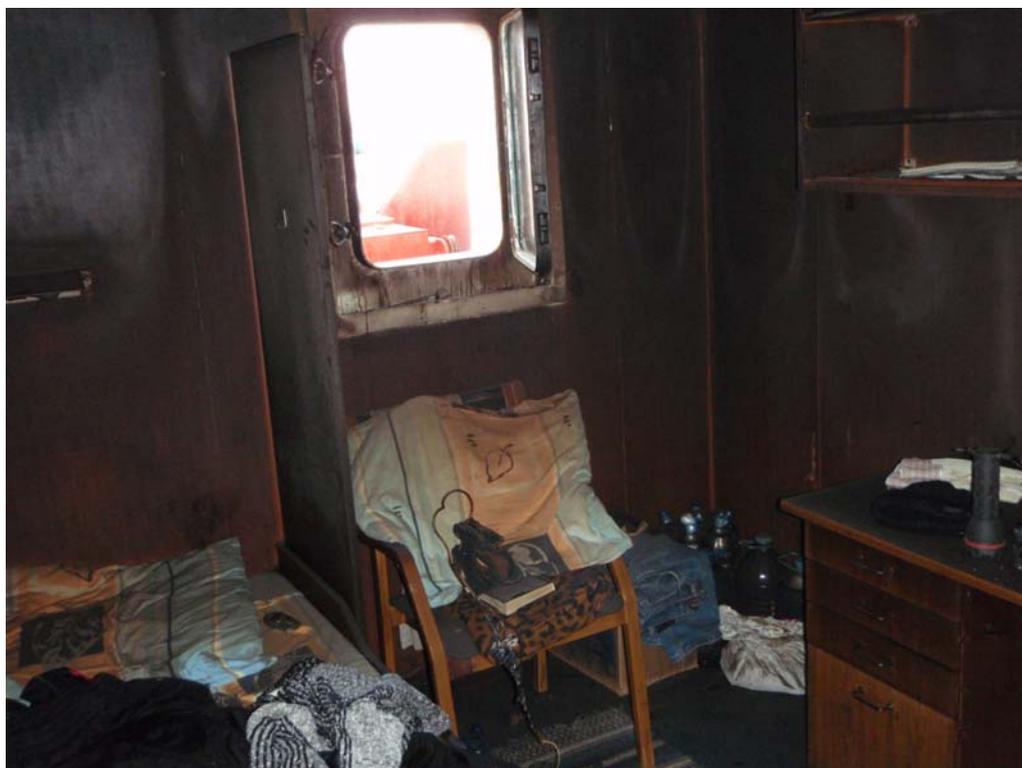
Picture 8. The cabin above the galley

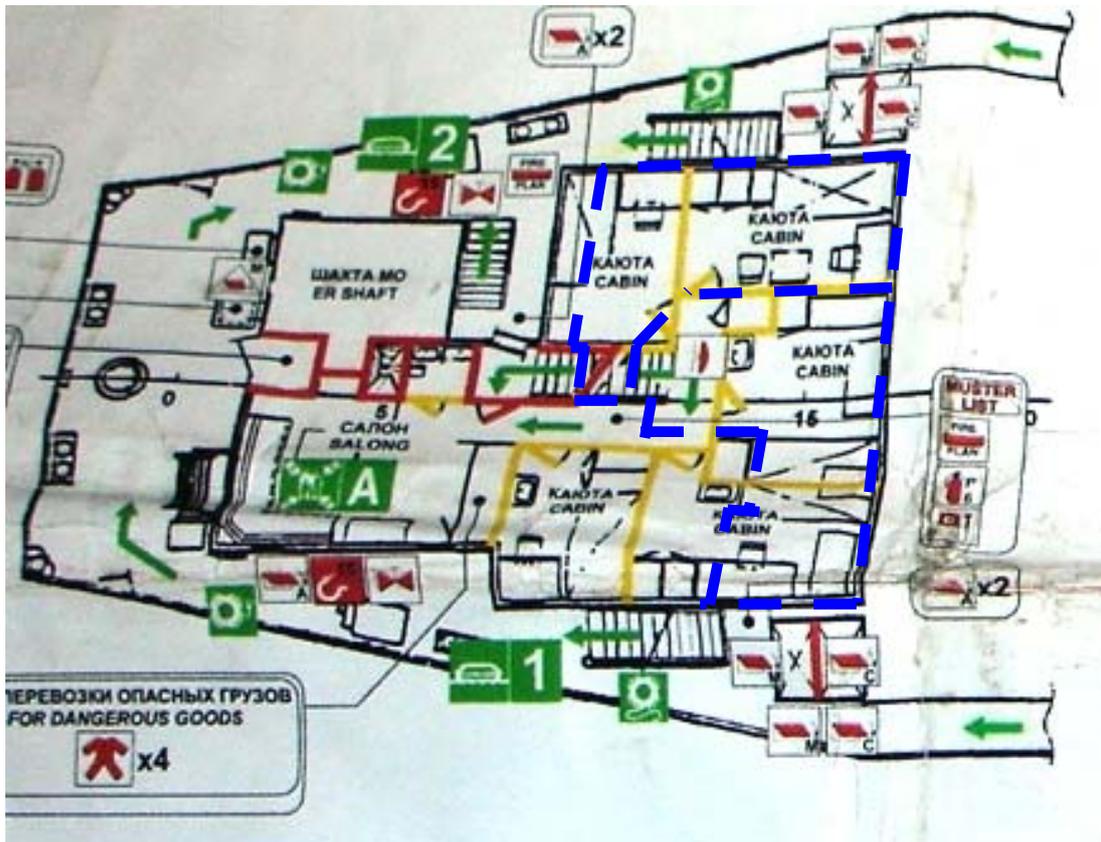
Picture 9. Cabin areas situated above the galley and mess. The broken blue line outlines the boundaries of the galley and mess.

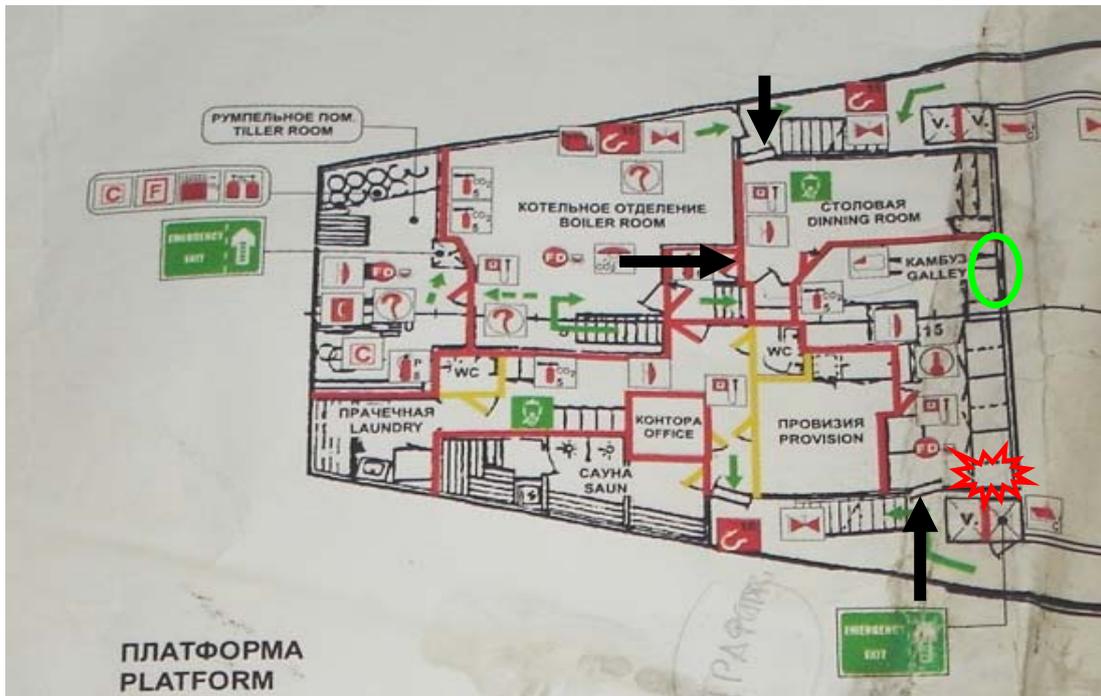
The probable place where the fire started was in the right hand forward corner (c.f. picture 10 following), in which case fire fighting with water spray via the door from the right hand side of the deck would have led to a better end result. If the ship's crew had been able to do this immediately, the fire in the galley would probably have been extinguished or the fire would have considerably contained before the arrival of the fire service when they fought the fire in the galley through this same door. As it was the fire, and the rise in temperature caused by the smoke and gas, continued for about an hour before the actions taken by the fire service. The consequence of this delay was that the temperature in the cabin areas above, rose considerably so that a fire pocket was created in this area too.

Three doors led into the galley and the mess as follows (picture 10): one from the staircase from the internal areas in the centre of the ship, one from the left hand side from the deck of the vessel before the mess and then on into the galley, and one from the right hand side from the deck straight into the galley. The crew of the vessel did not dare open the doors into the burning areas because of the heat, but rather decided to leave this work to be done by the professional firemen. As was earlier stated in paragraph 2.3, this consequence of this decision was that the fire was given about an hour to build up strength before the measures taken by the fire fighting team who arrived on the vessel.

Picture 10. Entrances to the galley at the galley level (black arrows). The red fire shape in the picture indicates the probable place where the fire started and the green ellipse shows the galley windows through which the attempts to extinguish the fire were made.
