## Investigation report

C2/2008M

# MS SERENA F, stranding north of Hiittinen on 6.3.2008

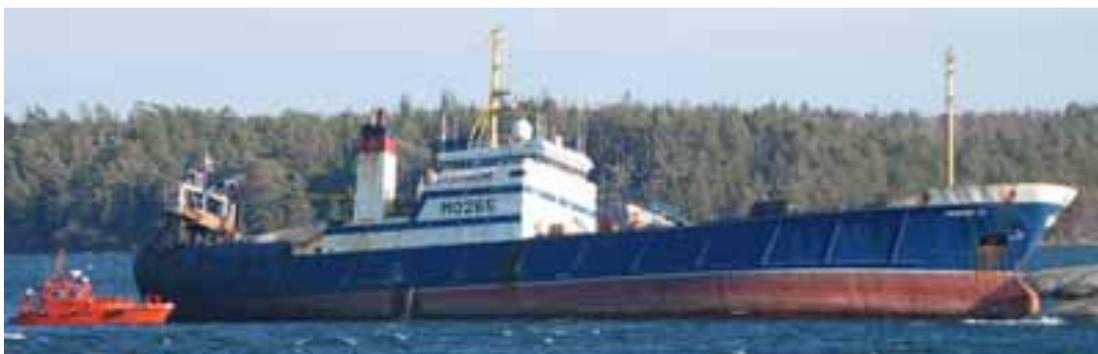
Figure 1. SERENA F on ground on 6 March 2008

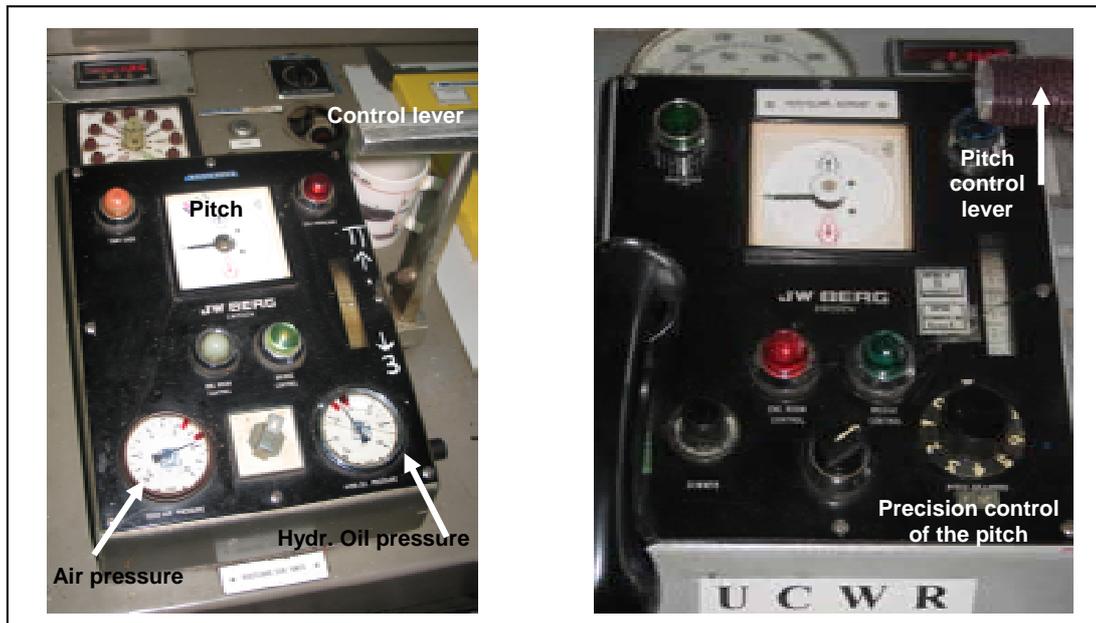
The propeller of the vessel is usually steered from the bridge with the equipment of the operator's console in figure 4. The drive gear of the propeller pitch is hydraulic but its control is pneumatic. The propeller may be steered also from the engine control room or from the emergency control console of the propeller shaft<sup>3</sup>. Also the bridge is equipped with an emergency control of the propeller, which functions with press buttons, figure 3. The operator's consoles of the bridge and the engine control room have switches for the transfer of the control place and signal lights indicating the control place.

Figure 4. The operator's console of the propeller in the engine control room (on the left,  $\Pi$  means "ahead" and 3 means "astern"), and on the bridge (on the right). The console of the bridge is equipped with a warning that the pitch may not exceed 5. The meters of the engine control room have limits for recommended pitch and pressure.

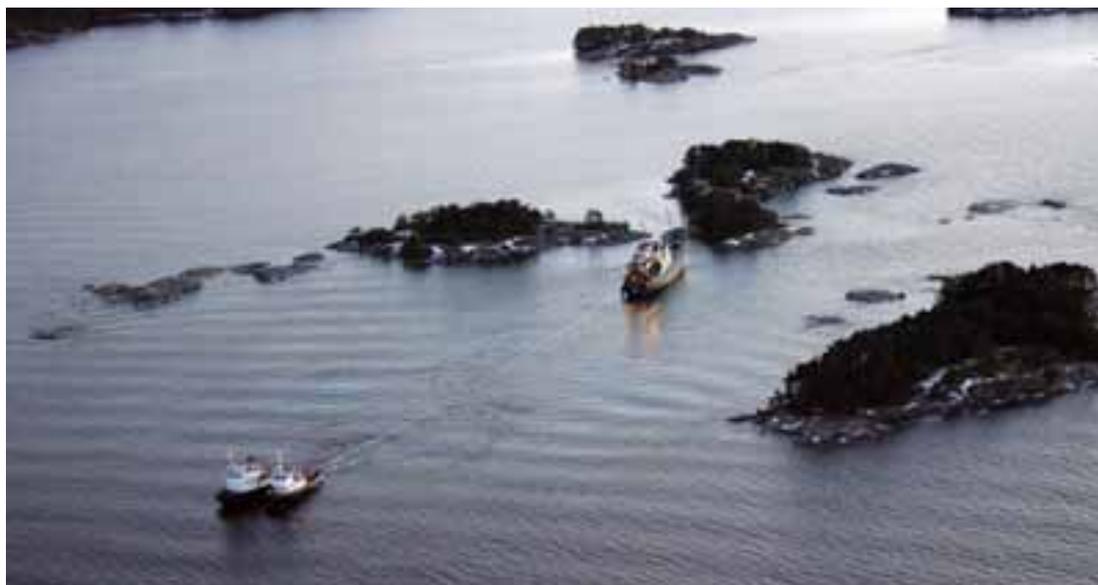
*Figure 6. SERENA F between the Norrörarna islands. Tugs AJAX and HECTOR trying to pull off the vessel (without a success). A picture taken by the Border Guard helicopter on 6 March 2008.*

At 7.40 a.m. on 6 March 2008, a coast-guard vessel arrived to the side of the vessel carrying a pilot and a coast guard officer, who boarded the vessel. The deck officers were subjected to a breath analyzer test and there was nothing suspicious. The coast-guard vessel MERIKARHU arrived at the scene at 9.40 a.m. The pilot left the vessel at 11.40 a.m. At 12.10 p.m., two representatives of Alfons Håkans and a maritime investigator boarded the vessel. At 1.05 p.m., the divers began the check of the grounded vessel, which they completed at 1.30 p.m. In the check performed by the divers, no leaks or significant damage were discovered in the hull of the vessel and it was possible to start the pulling off. The tugboat AJAX (Bollard pull 30 t) arrived at the scene at 1.30 p.m. After preparations, the tugboat tried to pull off SERENA F from the ground, however, without success. Håkans sent a stronger tugboat, the HECTOR, to assist (Bollard pull 50 t). At 6.39 p.m., the HECTOR tried the pulling off but did not succeed either. The pulling off was tried also using both tugboats but without success, see figure 6.

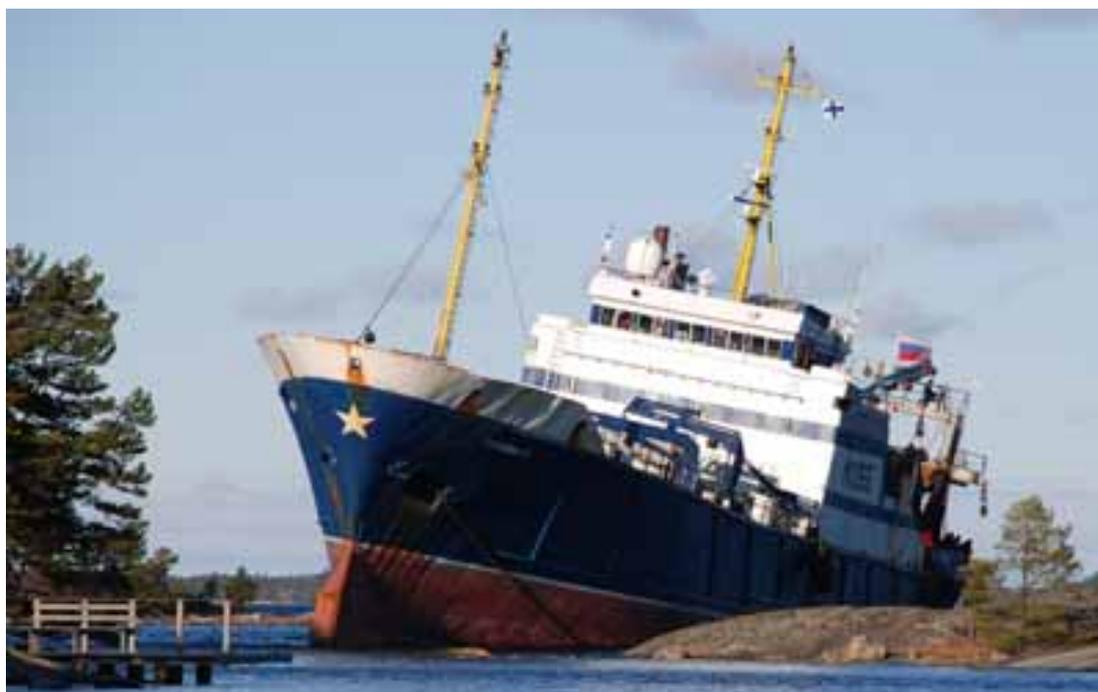
*Figure 7. SERENA F, aground.*

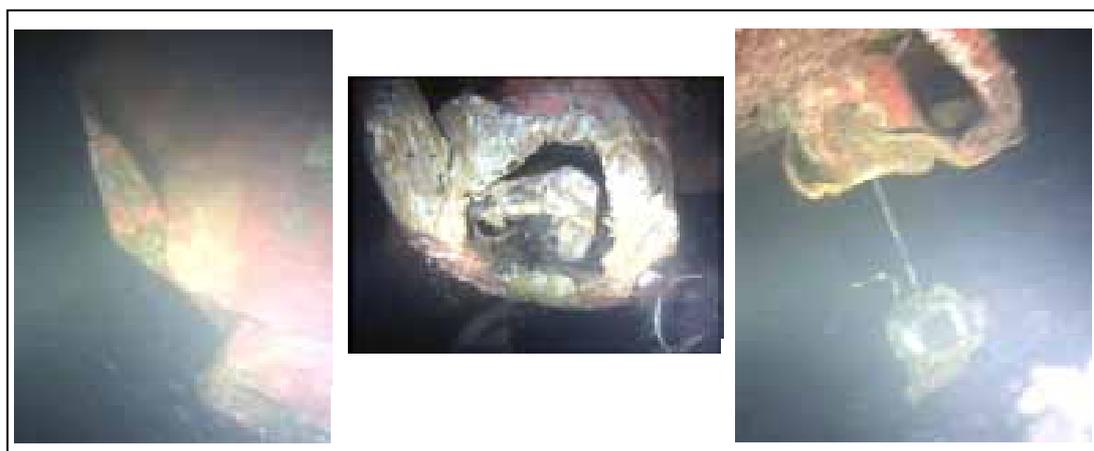
On the basis of the underwater check performed by divers and the checks performed onboard the vessel, there were no leaks. The steering gear, rudder, rudder stock and the bottom support of the rudder were damaged. The last mentioned had twisted upwards, the rudder stock had moved upwards c. 80 mm and the rudder had twisted slightly to the side. Some of the sensors of the sounders at the bottom of the vessel had been damaged and a few dents of approximately 10 mm in depth were detectable in the bottom plating. One sensor had come loose and hinged on the cable. The casing of another sensor had sunk slightly into the hull. The vessel had rested mainly on her keel. The keel had sunk most approximately in the front of the engine room. Some of the damage may have arisen when the vessel was pulled off. Seawater had flown into one tank. Any deviations of the shaft line shall be detected only after docking. On the basis of the divers' check, it seems that the bilge keels were not damaged.

Figure 9. The twisted Becker rudder of the vessel (on the left), the broken lower part of the rudder shaft (in the middle) and the detached sensor of a probe (on the right). Pictures were taken from a video recorded by the divers soon after the vessel was taken off.

1. Rudder and steering gear were damaged - heel brace was bend to up direction and rudder stock was moved up about 80 mm with damaging of the hydraulic steering engine (the cap of upper steady bearing was tore away from base in the steering room); hydraulic steering gear was damaged due to moving up of rudder stock to 80 mm), the rudder plate was bend, heel pintle was damaged.

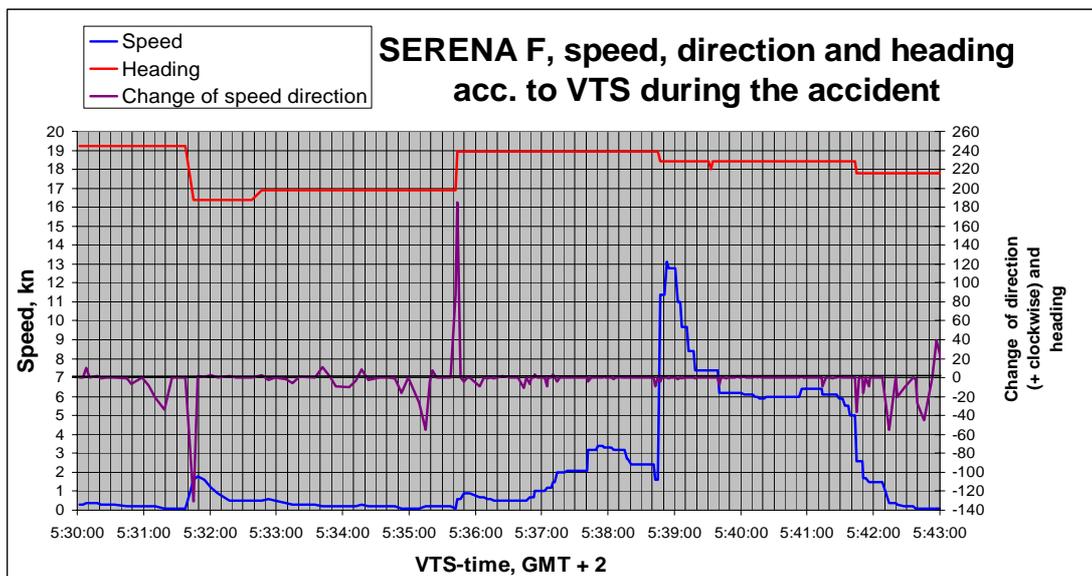
Figure 10. The speeds and alignment of the vessel from anchoring to stranding in accordance to the VTS. The vessel turned slightly to the left at the same time when she curved to the left. (The reality of the big changes in the speeds indicated in the figure and the reasons for such registration shall be handled in point 2, Analysis.)

According to the VTS registration, the speed was 13.1 knots at its highest at approximately 05.39 a.m. and, at approximately 05.42 a.m., the vessel ran aground.

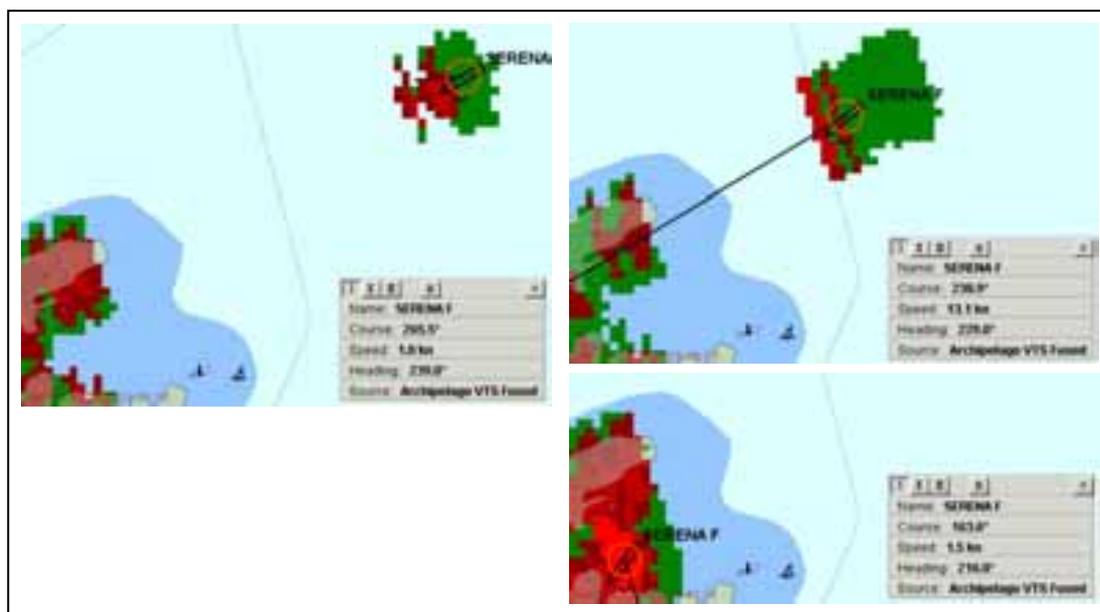
Figure 11. Positions of SERENA F on the VTS screen:  
 as the speed increases (upper left, at 05:37:00),  
 as the speed is at maximum (upper right, at 05:38:53) and  
 grounded (lower right, at 05:42:01)

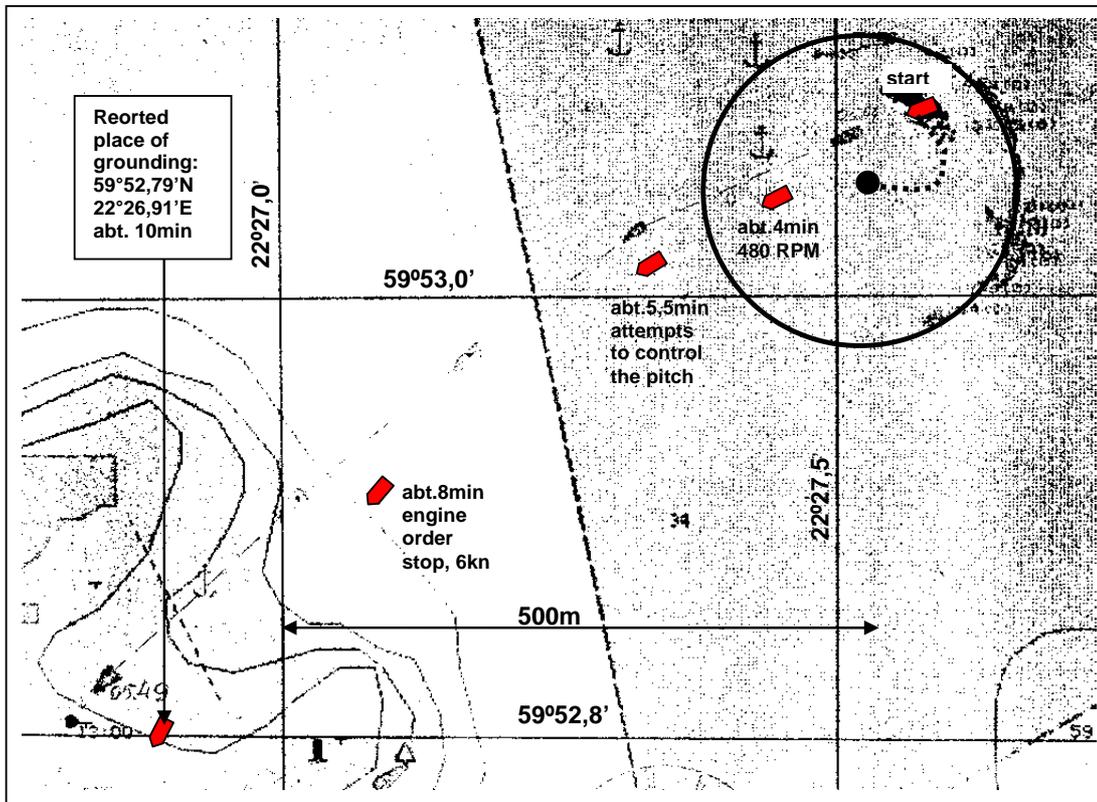
The vessel started to move with the anchor on the bottom and she sailed approximately 850 metres in about ten minutes. The wind kept the vessel anchored in about the direction south-west – north-east, which caused the direction of the vessel when she started to move, figure 13. The final route was due to the effects of the anchor and the wind.

Figure 13 indicates the anchoring circle of the vessel based on the drawing of the Master and the estimated place of the anchor (black dot).

Figure 13. The starting and sailing of SERENA while anchored. (Extract from the drawing of the Master). The red vessel indicates the understanding of the investigators of the location of the vessel at different times calculated from the start of the engine. The dotted line indicates the assumed route of the anchor chain.

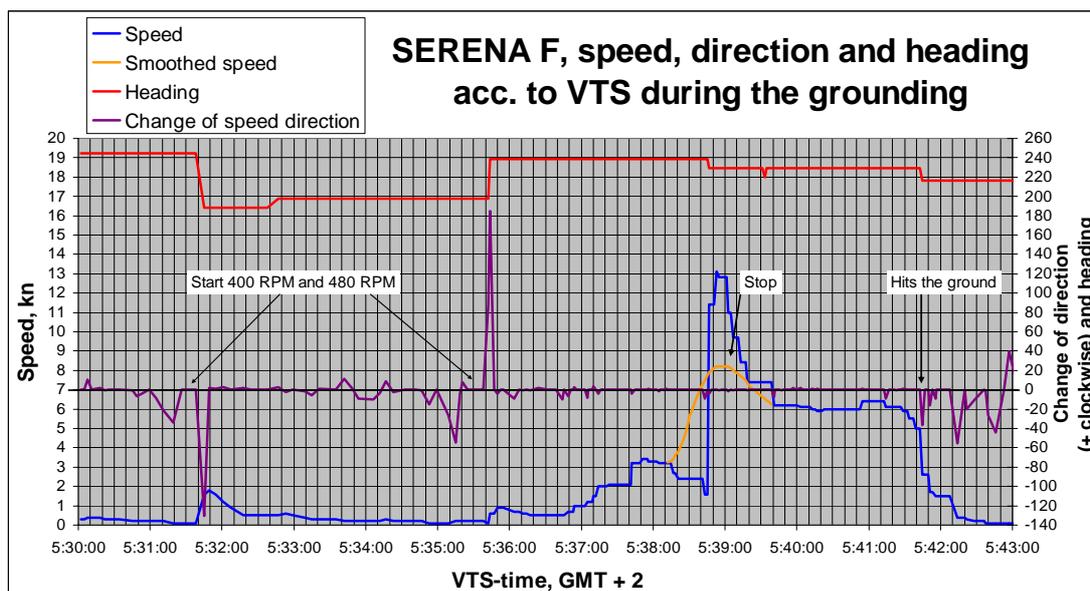
The speed of the vessel changed stepwise apparently due to the changing braking effect of the anchor (figures 14 and 15). With the help of the VTS data (changes in speed, position and direction), the starting moment has been estimated as being at approximately 5.32 a.m. with 400 RPM. After about four minutes, the III engineer raised the revolutions to 480 RPM. According to the VTS, the speed of the vessel was for a while about 13 knots, but the investigators do not consider it possible as the documented speed of the vessel is 13.5 knots (cf. more about the topic below). Figure 14 presents the opinion of the investigators on the progress of the speed. At approximately 5.39 a.m., the main engine was stopped. The time of running aground can be clearly seen as a rapid decrease in speed and changes in direction.

The maximum revolutions of the propeller were 480 RPM so that the vessel did not operate with full power (maximum 600 rpm). Part of the power of the vessel was consumed to overcome the resistance of the water, but there was enough power also to drag the anchor. The anchor and chain weighing approximately 6 tons were dragging along the bottom. When applying the friction/holding coefficient 1–2, the force braking the vessel is estimated to be 6–12 tons. Depending on the type of the bottom, the braking power may have varied even more. As the water was getting shallower, even more chain was dragging along the bottom.

Figure 14. Figure 10 again added with the results of the analysis. The differences in times correspond fairly well to the entries in the ship's log and the machine logs. There seems to be an approximate 7-minute difference in time between the logs and the VTS data.

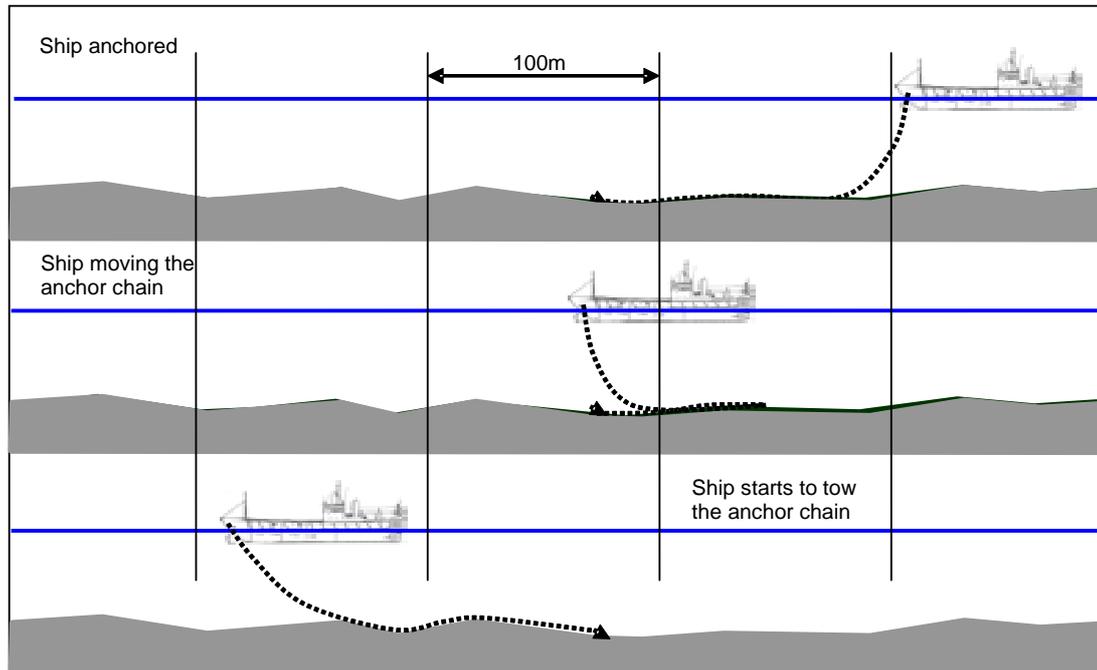
According to an estimation of acceleration of the vessel, with a force of 20–30 tons (the thrust minus the resistance of the sliding anchor with the chain and minus the resistance of the vessel), a vessel of 2000 tons accelerates  $0.1\text{--}0.15\text{ m/s}^2$ , which corresponds to an increase in speed of approximately 2–3 knots/10 seconds. Due to the increase of the resistance with increasing speed, the acceleration decreases as the speed increases. In addition, with constant pitch, the thrust decreases as the speed increases. With these presumptions, it can be estimated that the acceleration of the vessel from standstill to 10 knots takes about 45 seconds when the resistance of the anchor is 5 tons and approximately 60 seconds when the resistance of the anchor is 10 tons. Correspondingly, acceleration from three knots to 10 knots takes 35 and 45 seconds. It can be noted that in figure 10, especially the steep increase in speed must be lowered; one possible speed development according to the investigators has been presented in figure 14. It is also likely that the top speed is not accurate. According to the investigators, an explanation for the abrupt increase in speed in the VTS recording is the change of the measuring radar in the middle of the recording, which may have been affected by the dead spots caused by the islands. This can be seen in figure 11: there the vessel moves from the green echo to the red echo.

Figure 15. A drawing of the dragging of the anchor. The first close to 400 metres.

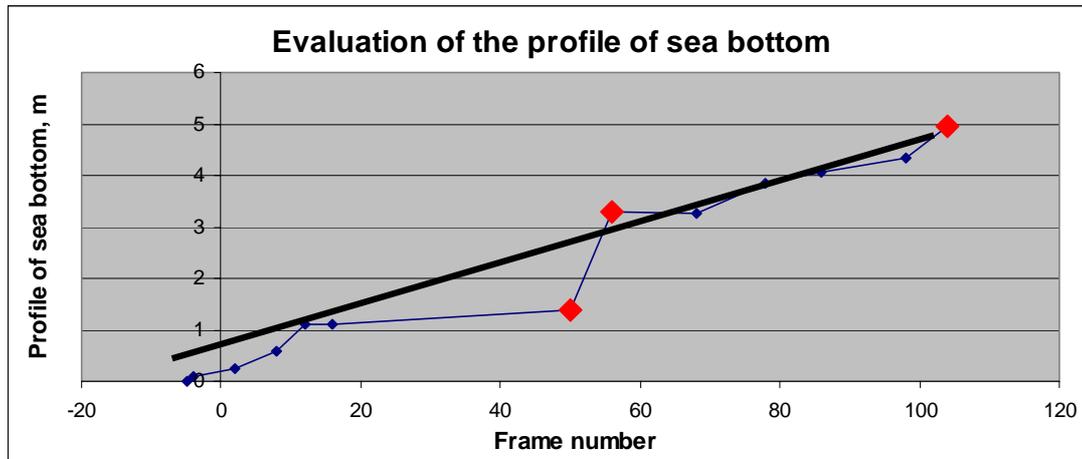
Figure 17. The shape of the rocks based on measurements done from the vessel. Missing at the red dots is the result from the right. The possible keel line of the vessel has also been marked on the figure. On the basis of the figure, the inclination of the position of the vessel was approximately 3.1 degrees.

On the basis of the bottom profile and the check performed by the divers, approximately 10 metres of the length of the vessel rested on her keel. The width of the keel has been estimated to be 15–20 centimetres on the basis of the video recorded by the divers. In that case, 460 tons rested on an area of approximately 1.5–2.0 m<sup>2</sup> in size. The average surface pressure is thus about 2–3 N/mm<sup>2</sup>. The keel had a U-beam profile and it was filled with concrete. The compression strength of concrete is c. 50 N/mm<sup>2</sup>. There was no sagging or crushing of the keel as the surface pressure remained small even though it in certain parts had clearly exceeded the average pressure.

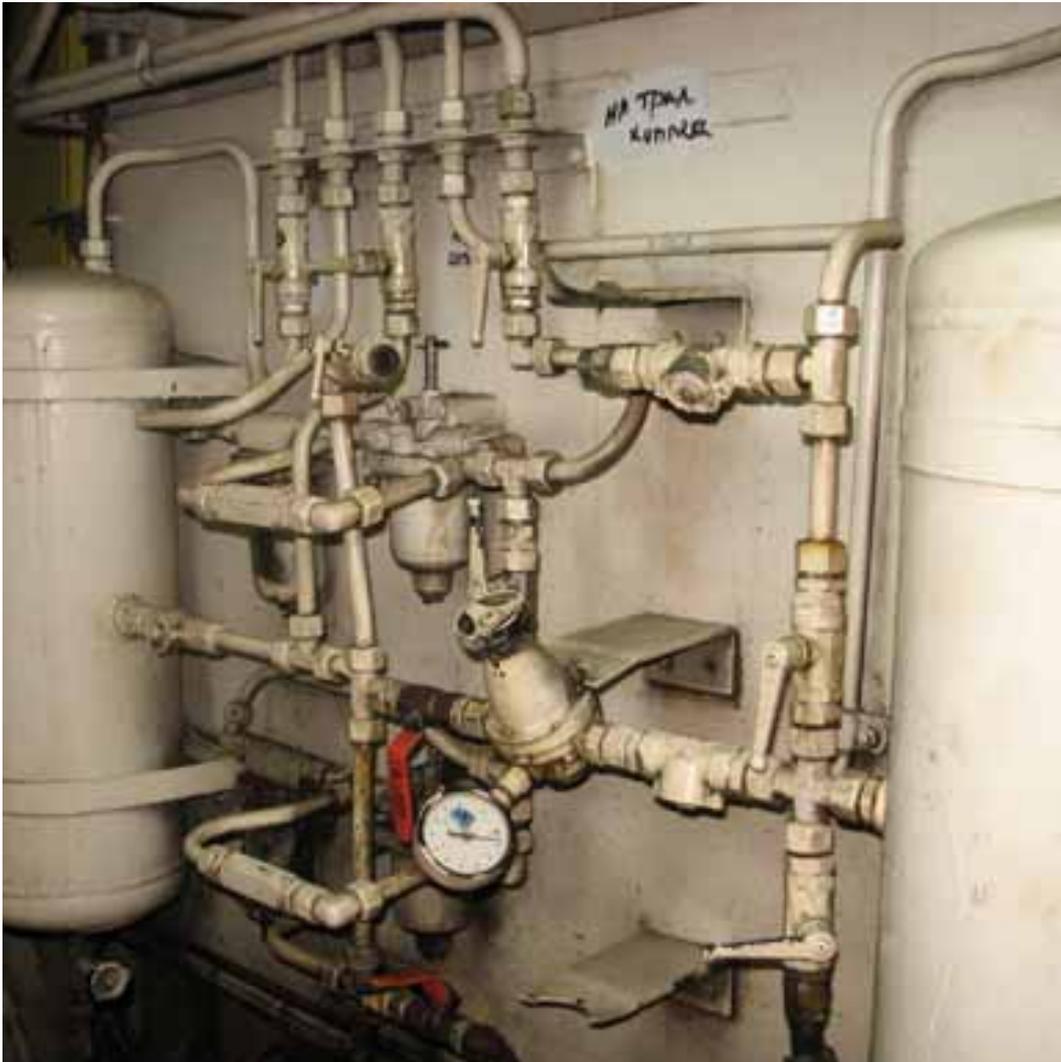
When the pressure air valve is closed, the steering system of the hydraulics of the propeller does not work. When the propeller is rotating, the pitch sets in the position "full ahead"<sup>20</sup>. At that time, the propeller may still be steered with push buttons, figure 3. The pressure gauge of the propeller steering system is only in the control console of the engine control room. It is possible that the knowledge of the mates on the operation of the propeller steering system is deficient because no one thought right away that the failure could be due to lack of pressure. If this had been noticed, the main engine could have been immediately stopped or emergency steering could have been used. No one apparently knew how to use it (or perhaps it was not in order).

Figure 18. The valves of the pressure air system of the vessel. The red valve pointing downwards is the one leading to the propeller steering system. It is in closed position in the figure. The following have been painted on the bulkhead from the left: "to the controllable pitch propeller", "to separators" and "to trawl gear".

The pressure air system manifold of the vessel presented in figure 18 looks complicated, which may increase the possibility of faulty switching. The diagram indicating the control pneumatics of the propeller from the manufacturer of the propeller is shown in appendix 6.

The start of the main engine of the vessel requires that certain checks are made in accordance with the check list. Going through the check list may have been partly superficial as the closed valve had not been noticed. The pressure gauge of the console of the engine control room has not been observed prior to the start; it is unlikely that the engine would have been started if the air pressure was insufficient.

The position of the lever of the propeller steering in the engine control room does not follow the position of the lever on the bridge<sup>22</sup>. However, the display of the pressure gauge of the pressure air should have warned the engineer that the propeller steering system was not working. Now the engineer observed the deviation only when a call came from the bridge. The engineer had not even then noticed the lack of steering pressure.

*The investigators recommend that the shipping company draw up a departure procedure to be followed after a period of a long anchoring including*
