Investigation report

C3/2008M

M/S ANNE SIBUM, grounding near Tainio Lighthouse on 2 April 2008

Translation of the original Finnish report

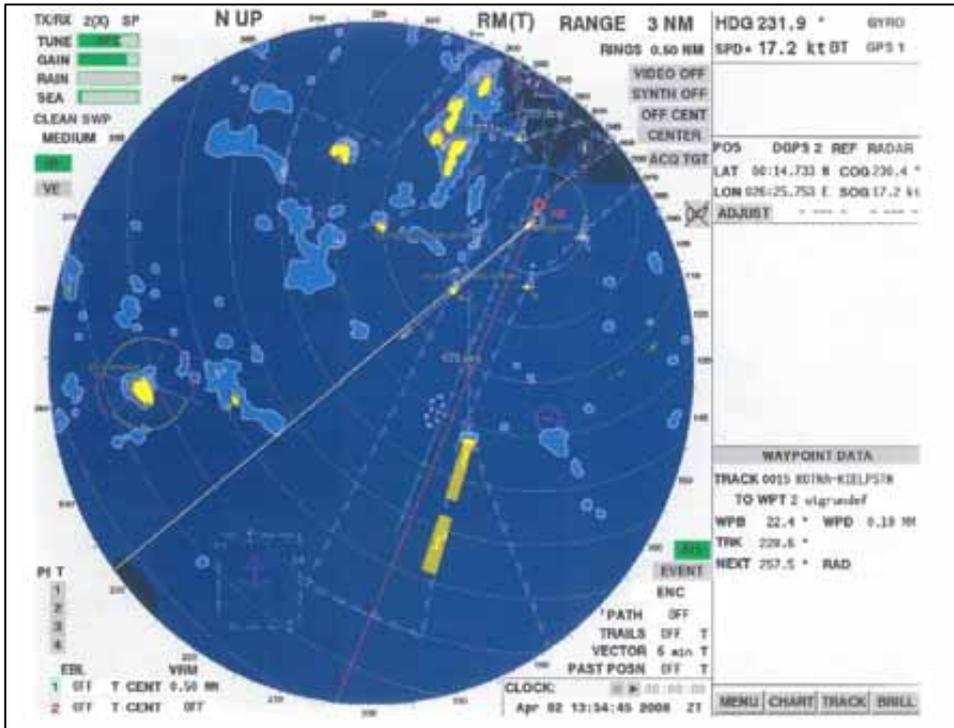
Figure 3. The COG³ is 230° and vessel should have turned to COG 203°. The red circle shows the turning point in the voyage plan. The racon signal of the Tainio lighthouse is visible right to the bottom of the display.

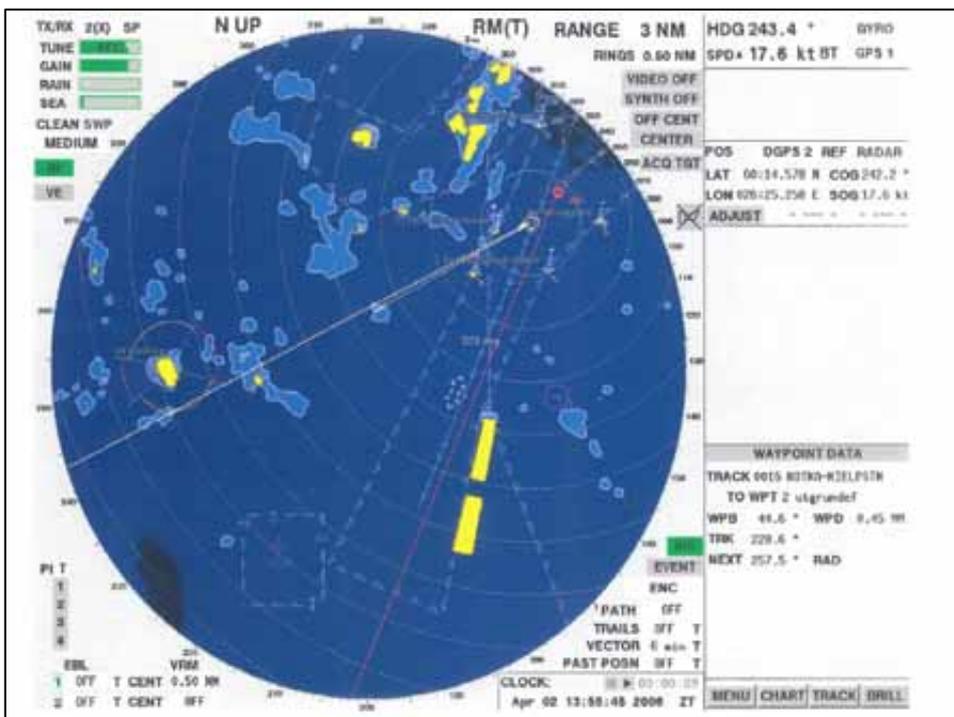
Figure 4. At 13:55:45 the COG is 242°.

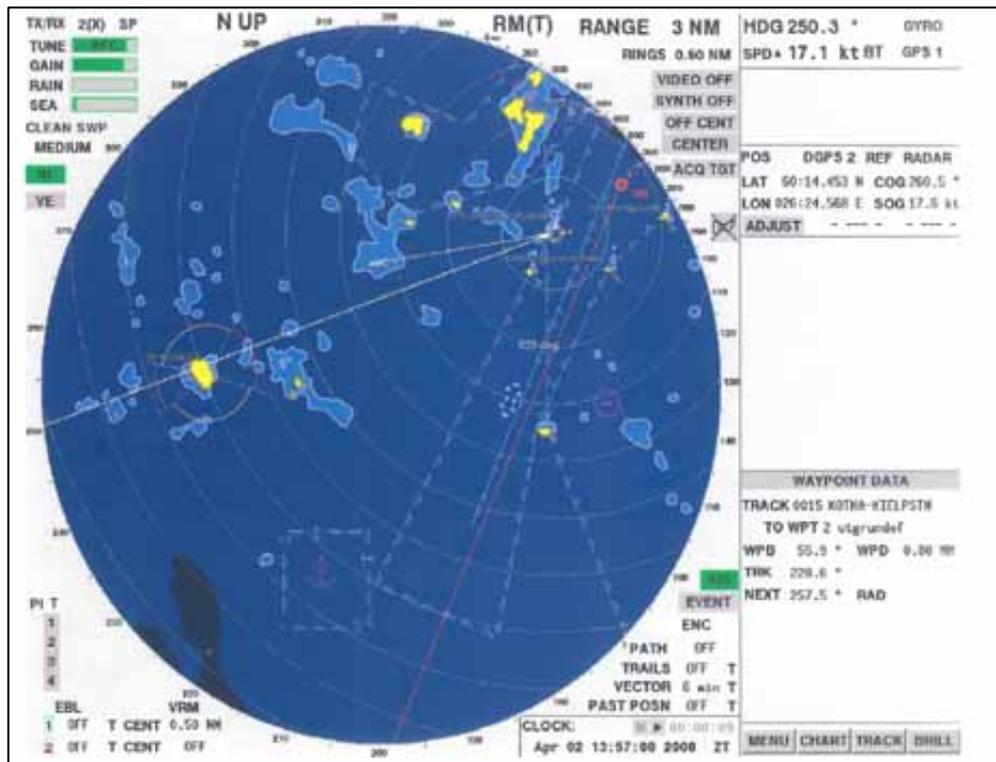
Figure 5. At 13:57:00 the COG has changed to 260 degrees. The Tainio western buoy gate was now at port bow.

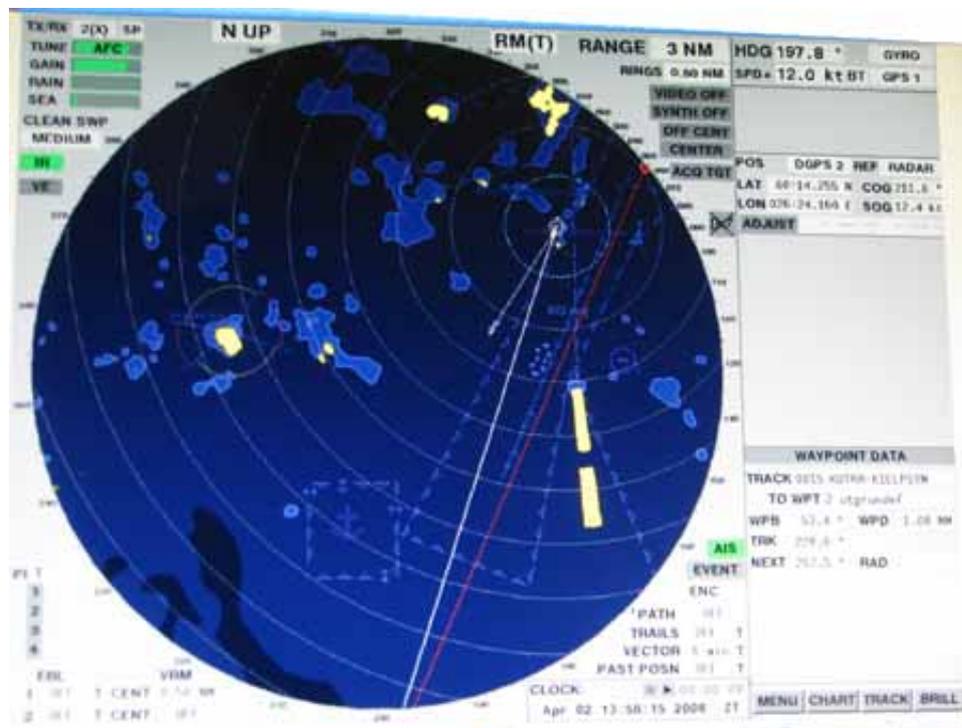
Figure 6. The vessel grounded at 13:58:15 in position 60°14.255 N 026°24.160 E. The vessel's COG was 211,6 degrees.

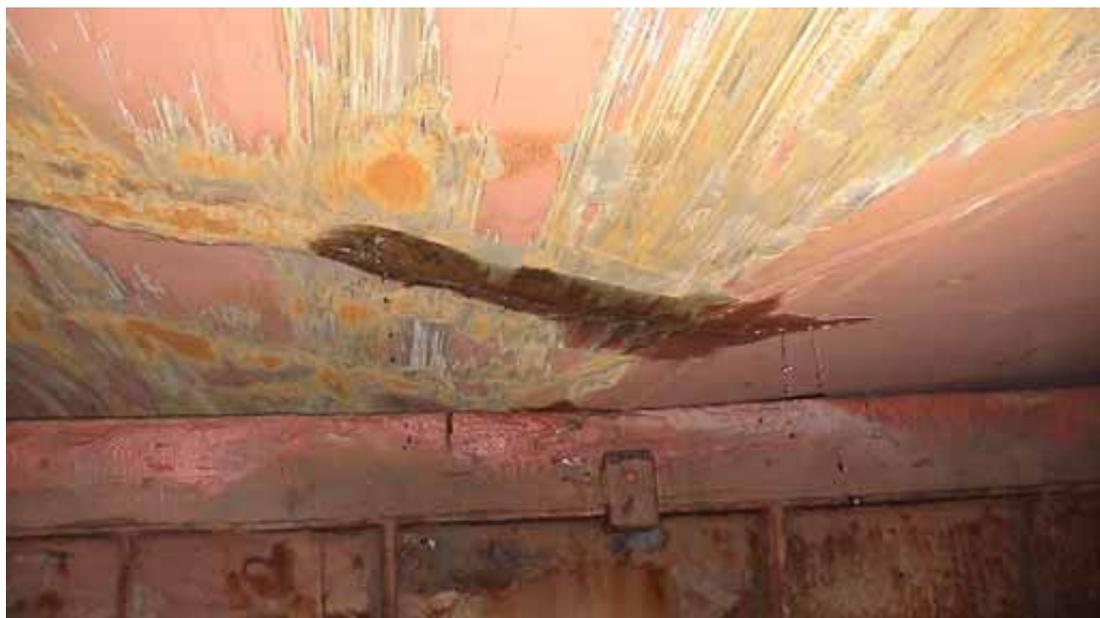
On 4 April 2008 a diver inspected the damage to the vessel. Following this, on 5 April 2008, the vessel was permitted to continue her voyage to Bremerhaven to unload her cargo and into dry dock. The cargo was unloaded on 6 April 2008 whereafter the vessel moored to a waiting berth later that day. The vessel was shifted into dry dock on 9 April 2008. The propeller and propeller shaft were dismantled and sent ashore on 11 April, followed by the steering machinery on 16 April. Steelwork repairs were begun on 17 April in the ballast tanks and the cargo hold. The propeller shaft was reassembled on 22 May 2008, followed by the rudder on 27 May. On 30 May 2008 ANNE SIBUM left the dry dock. The complete damage report was not available to the investigators.

Figure 7. Minor crack in ship's bottom ballast tank.

When the vessel arrived in Kiel, the bottom, rudder and damage to the thruster was inspected. The vessel was permitted to continue onwards to Bremerhaven, where its cargo was unloaded. Following this, the vessel went into dry dock where it was repaired for nearly two months.
