Investigation report

C2/2009M

M/T CRYSTAL PEARL, ramming of edge mark Lålättan on 26 January 2009

Translation of the original Finnish report

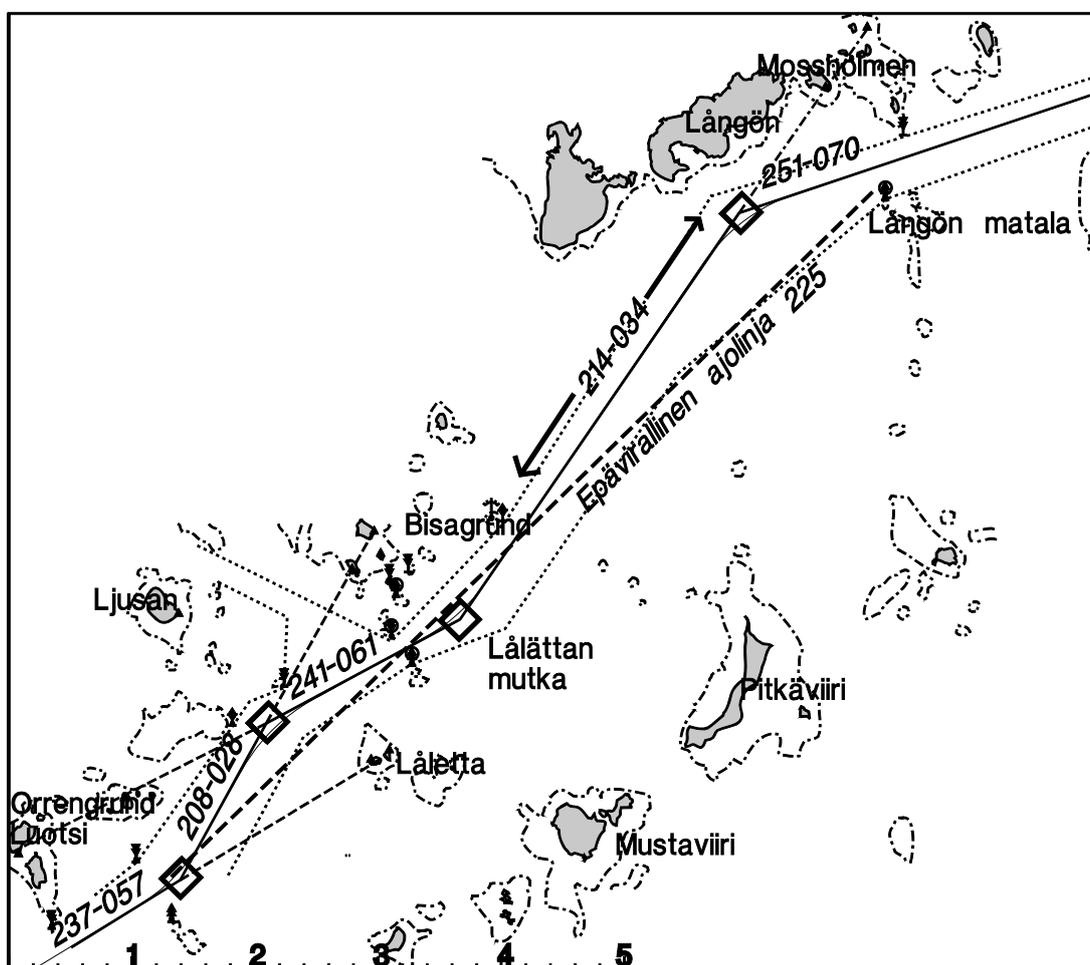
The piloting plan was based on the pilot's experience and memory. The plan was not gone through with the deck officers and the pilot did not introduce his plan to them. The pilot said he believed that the Master knew the prevailing way of (piloting) steering.

Picture 8. Vessel's route plan, which followed the fairway lines. Courses to steer were marked on top of the lines. Pilot used his recollection of the plan to steer; marked as unofficial dotted line with course 225 degrees.

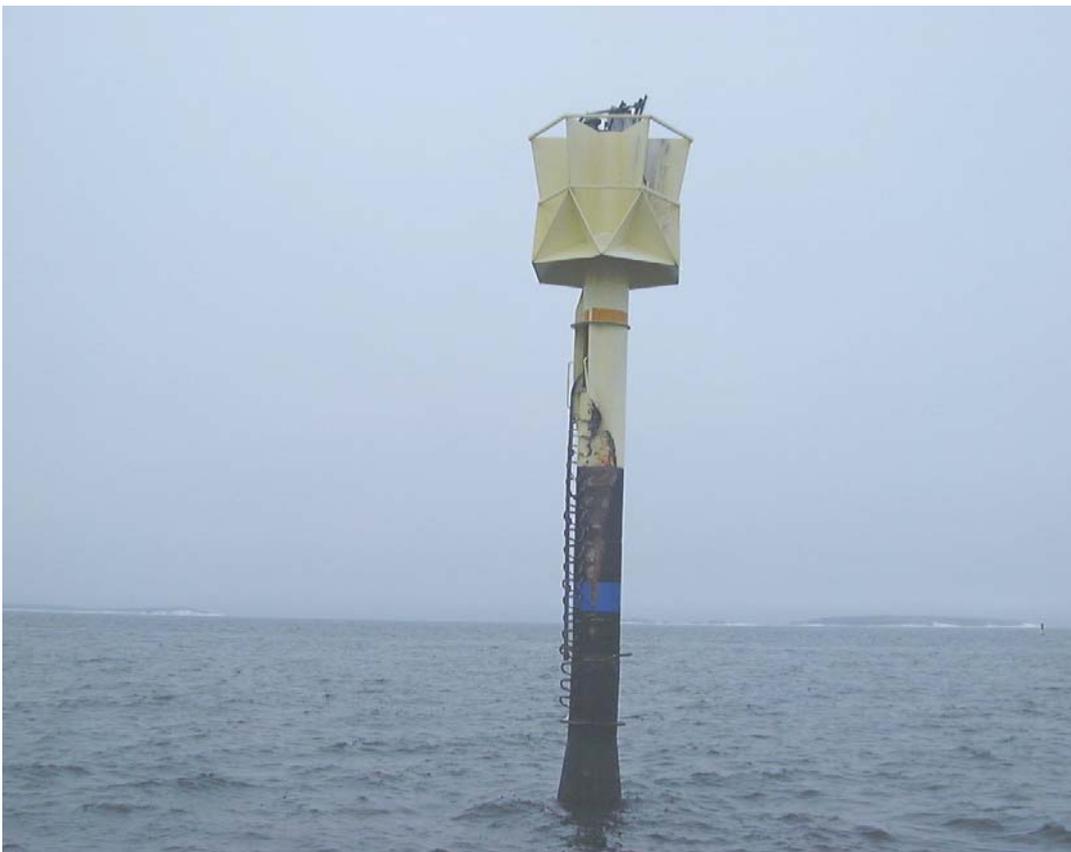
The edge mark got damaged, but remained operational. The FMA estimated that the repairs would take place during the next open water season.

Picture 9. Damaged edge mark Lålätan.

The same edge mark was damaged previously on 2 September, 1999, when M/S AMSTELDIEP rammed (dumped) it.

The foundation of the Lålättan edge mark has been redesigned and will be rebuilt in summer 2010.

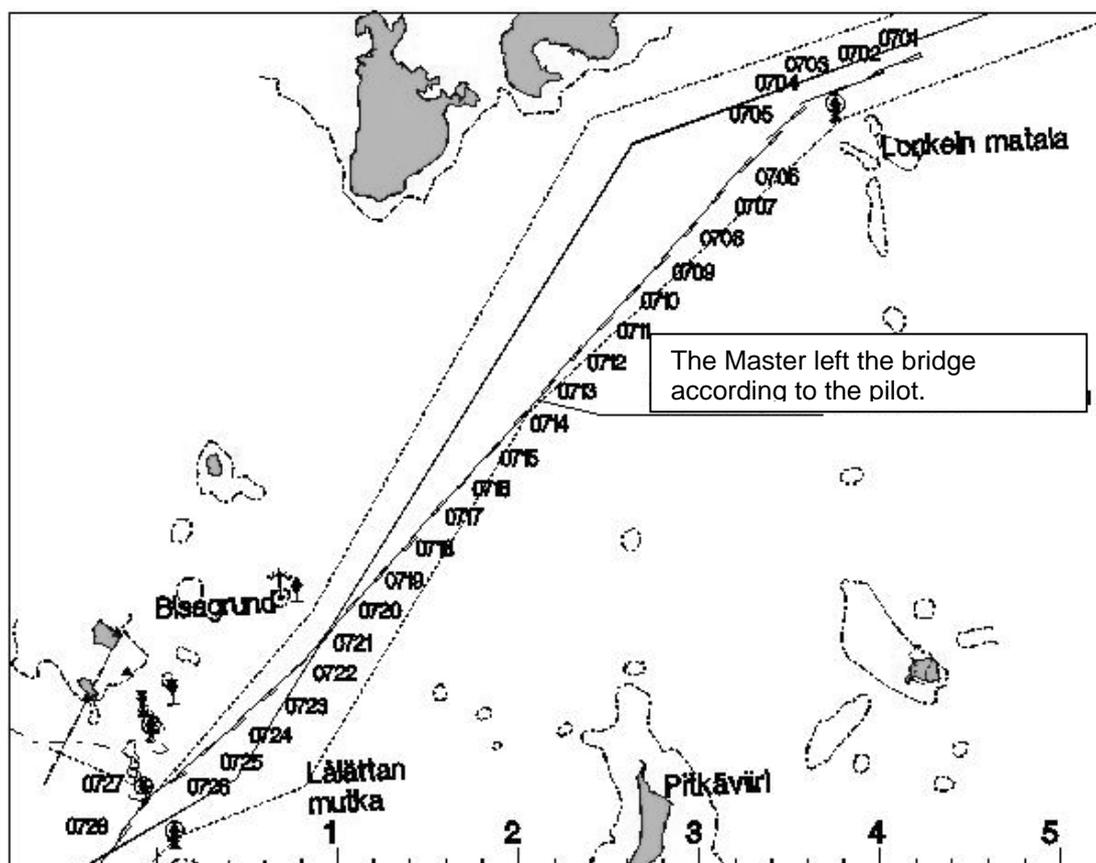
After *Långön matala*¹¹ buoy the vessel turned to 224° course towards the Gate between *Lålättan* edge mark and spar buoy north. *Bisagrund* was passed at 07.21 hours. Pilot said he checked the passing distance to *Bisagrundin* with the radar VRM. The distance was 0,5 nm (Nautical miles). According to the VDR recorded track the distance was 0,25 nm. The vessel was on the middle of the fairway.

Picture 10. Pilot's steering followed a non-published and an unofficial route to steer, widely used by the Pilots.

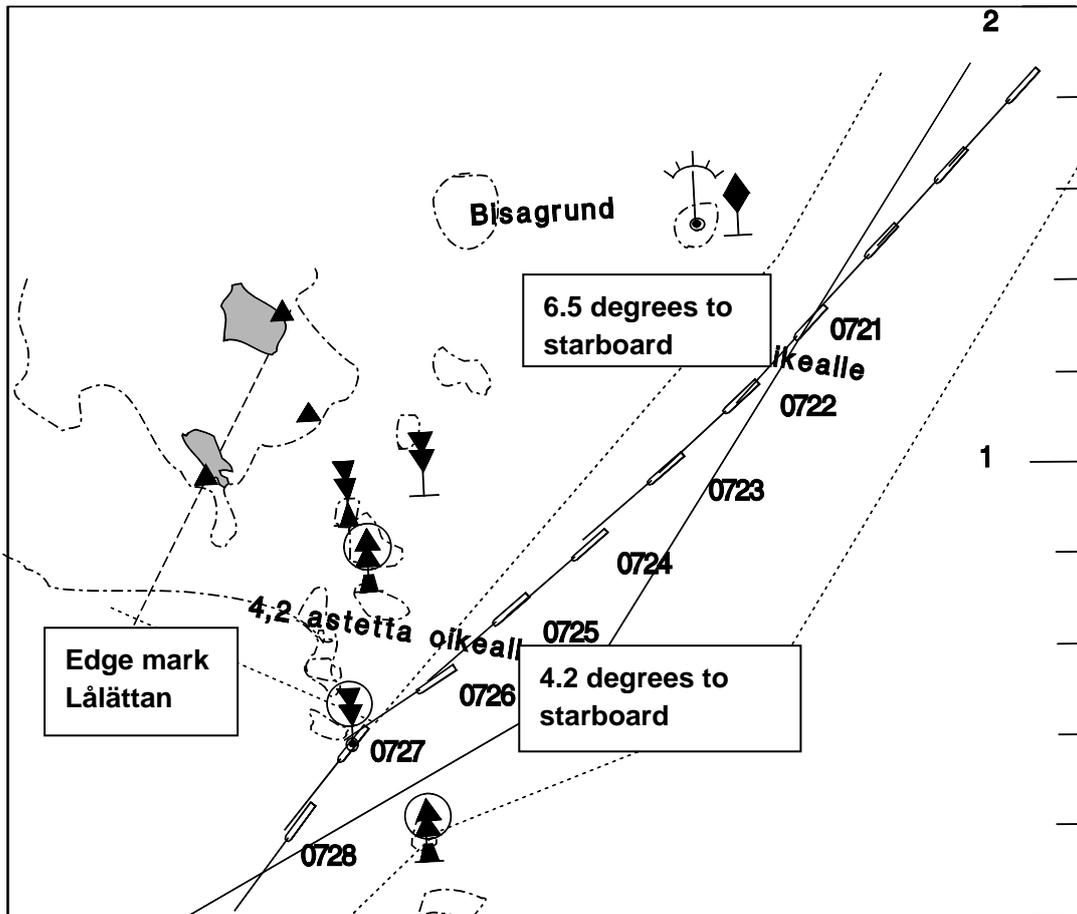
The recordings used in the investigations indicate a course change first towards the edge mark and later to its right (northern) side. In the Master's declaration it was noted, as told by the OOW, that the starboard turn initiated when the pilot was steering with the autopilot.

Picture 12. CRYSTAL PEARL's two course corrections to starboard prior to the ramming.

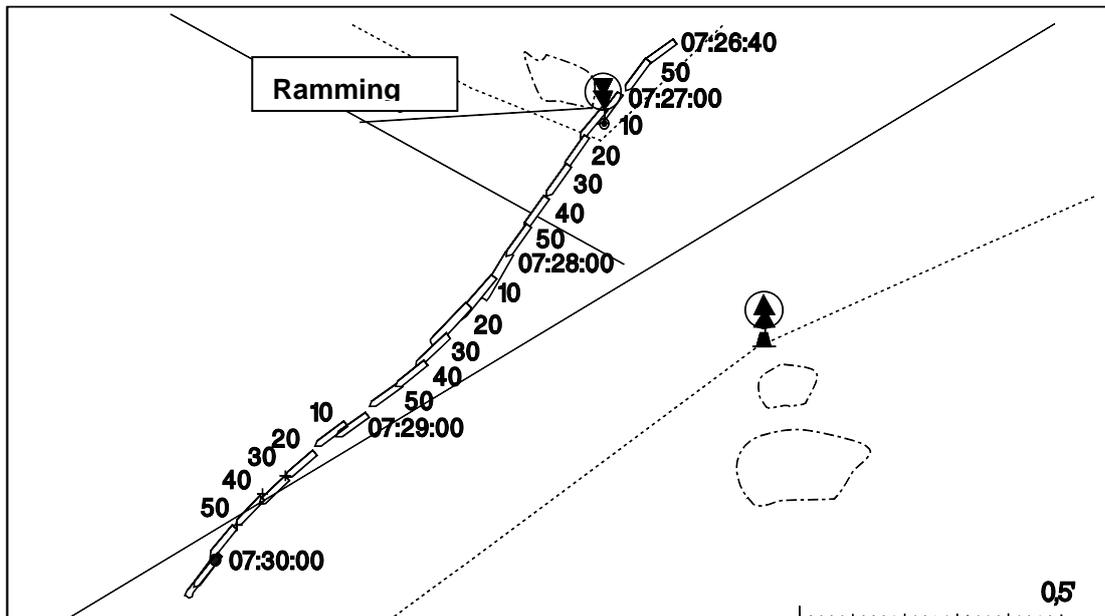
Picture 13. Ramming the edge mark and movement of the vessel after the ramming; interval 10 seconds.

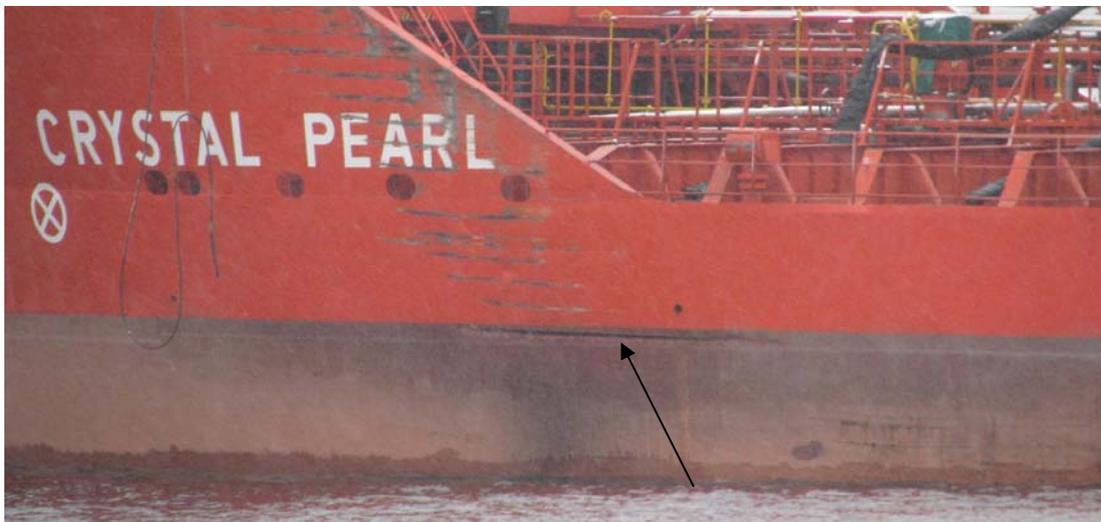
The vessel got cracks at side plating, outer side of the ballast tanks # 1 Port and # 2 Center Port, between the frames 119–126. The plating was damaged between the frames 108–125, about 5 to 8 meters below the main deck level. The gunnel was bent between the frames 122–135.

Picture 15. The arrow points the crack area on port alongside of the ship.

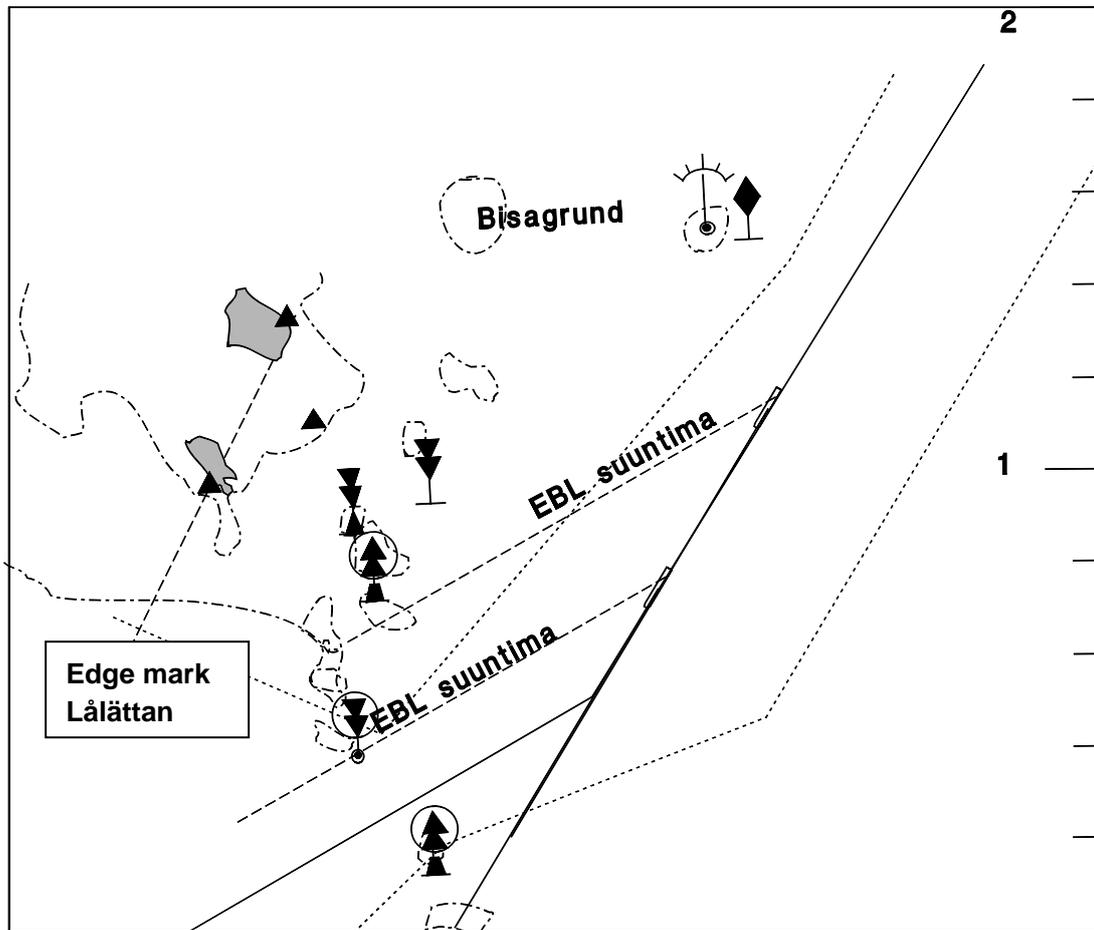
Picture 17. According to the chart's fairway lines the operator would set the next course to steer by radar's EBL 241° prior to next turn. The turn begins when the EBL points to the Lålättan edge mark.

If the pilots follow the fairway navigation lines, the deck officers are not surprised. The Pilot was reckless of the fairway navlines and thus made it impossible for the OOW to monitor the piloting.

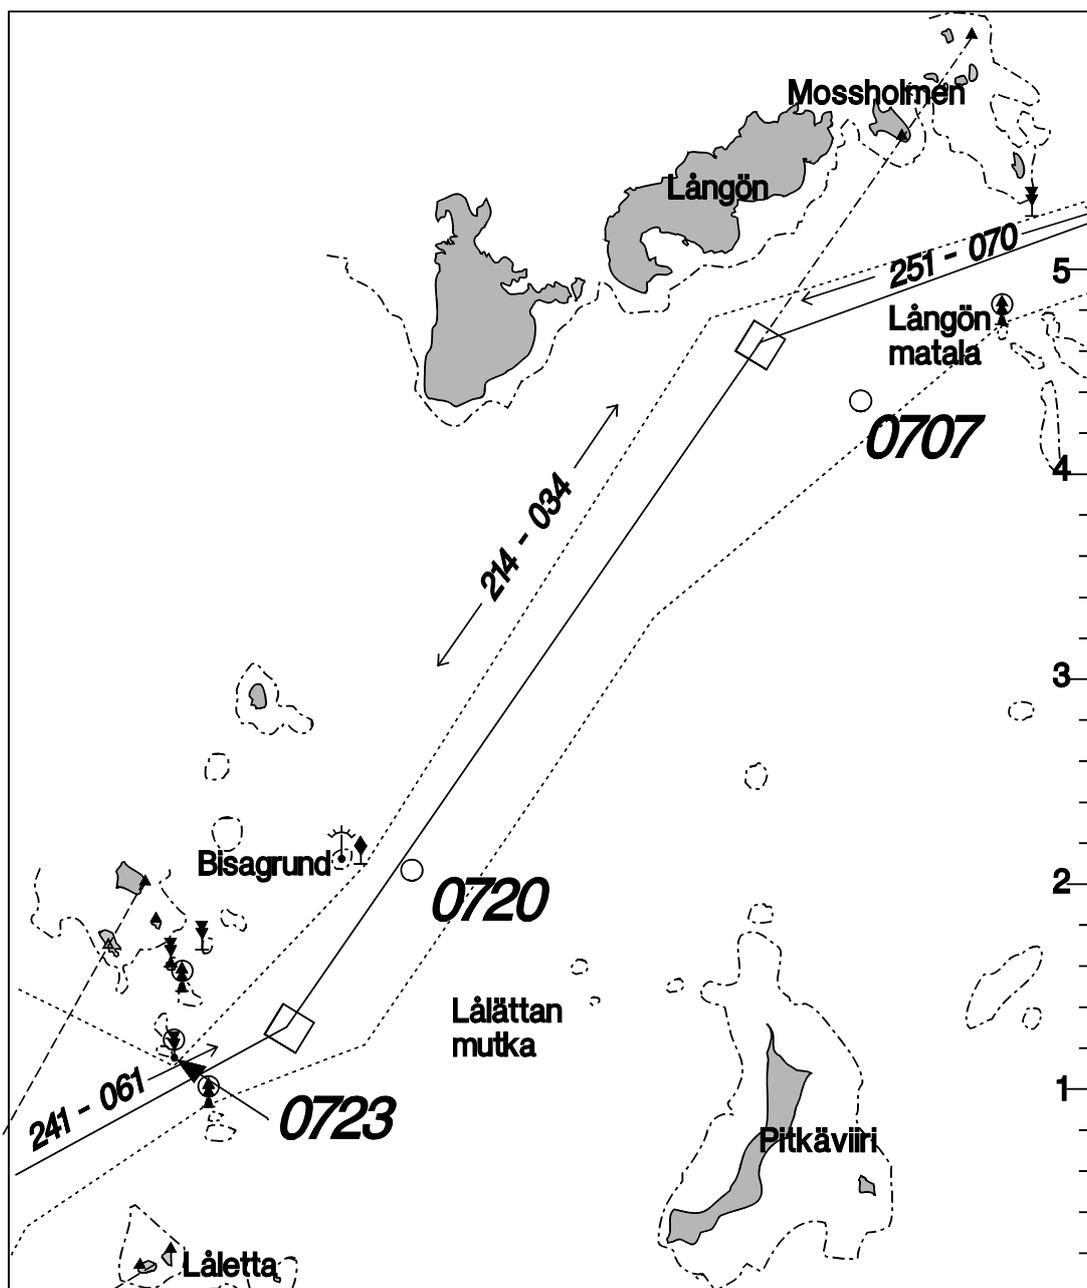
The Cadet logged the ship's position three times after passing the Långö buoy, when passing the Långö buoy at 07:07, when passing the Bisagrund at 07:20 and immediately after the ramming at 07:23. On the way back to Kotka the position was logged nine times on the same leg, i.e. three times as frequent as on the way out.

Picture 18. The Cadet's position logging after passing the Långö buoy.
