Investigation report

C3/2009M

M/Y NINAMARIA II and S/Y ILONA, collision to the north of Vänö on 27 June 2009

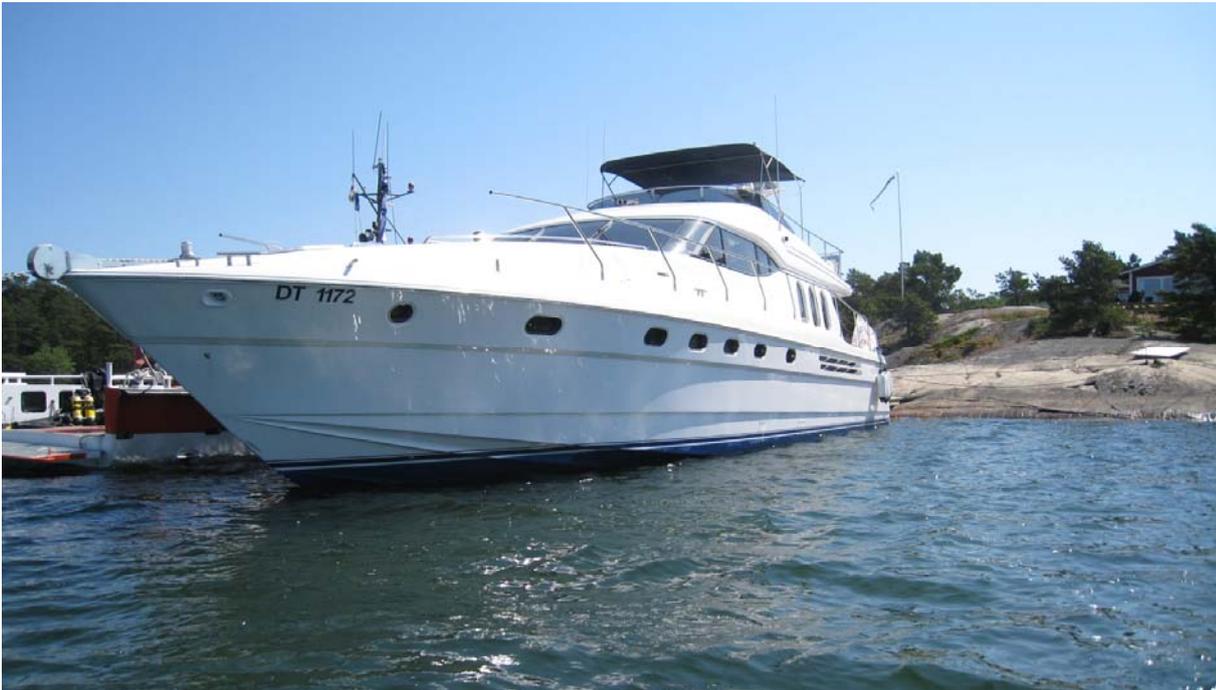
Figure 1. NINAMARIA II after the accident.

In connection with this investigation, the damage sustained by NINAMARIA II was not examined in detail. Based on observations made, however, it is known that the pulpit was bent onto the fore deck, one rail support was pulled off the deck, and the other supports were knocked down. Scratches and scuff marks were observed in the reinforced plastic. In the submerged parts, damage to the paint could be observed down to a depth of approx. 40 cm, at an estimated distance of 5 m from the bow towards the stern. Scratches could be observed over the whole length of the boat all the way to the stern on the port side.

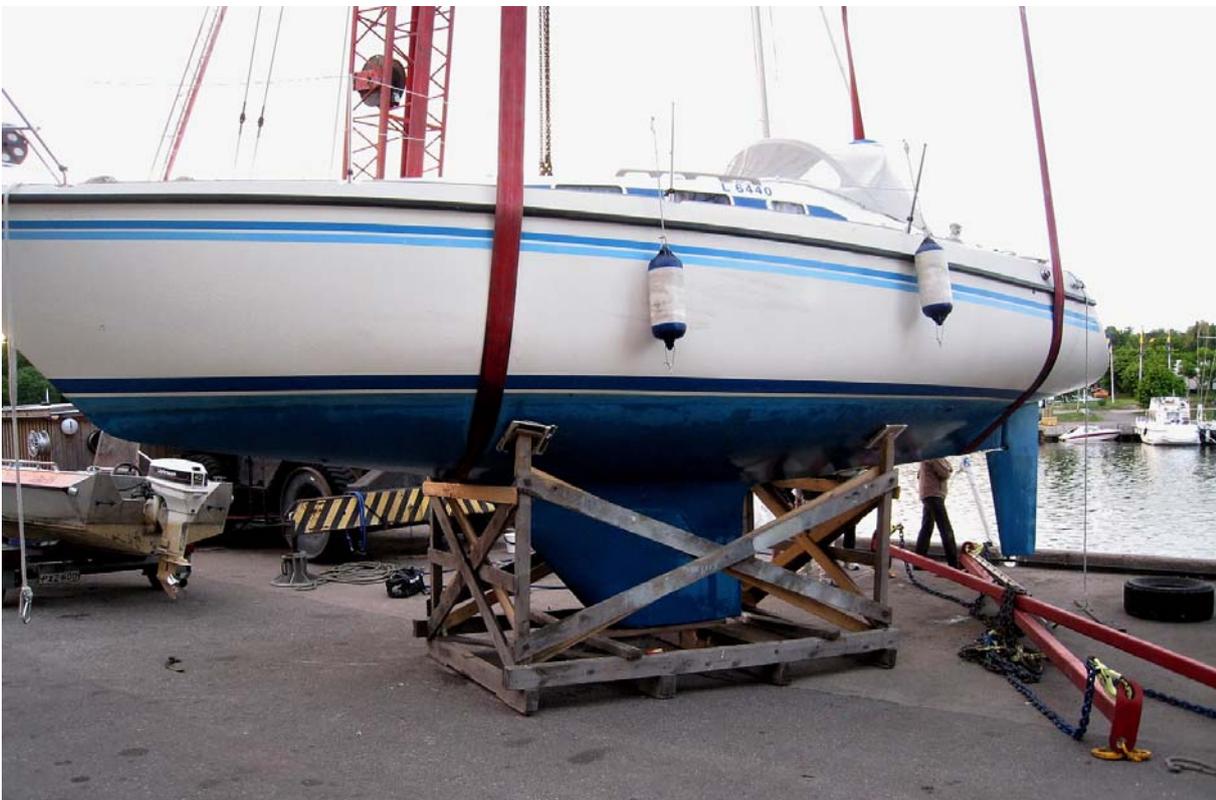
Figure 2. ILONA after the accident.

After the collision, it was found that ILONA's mast had been broken in two places, and the mast support was broken. It was necessary to detach the mast with the sails and let them sink before towing. The stern rails were bent in and to the right. The damage sustained by ILONA was too serious to continue sailing.

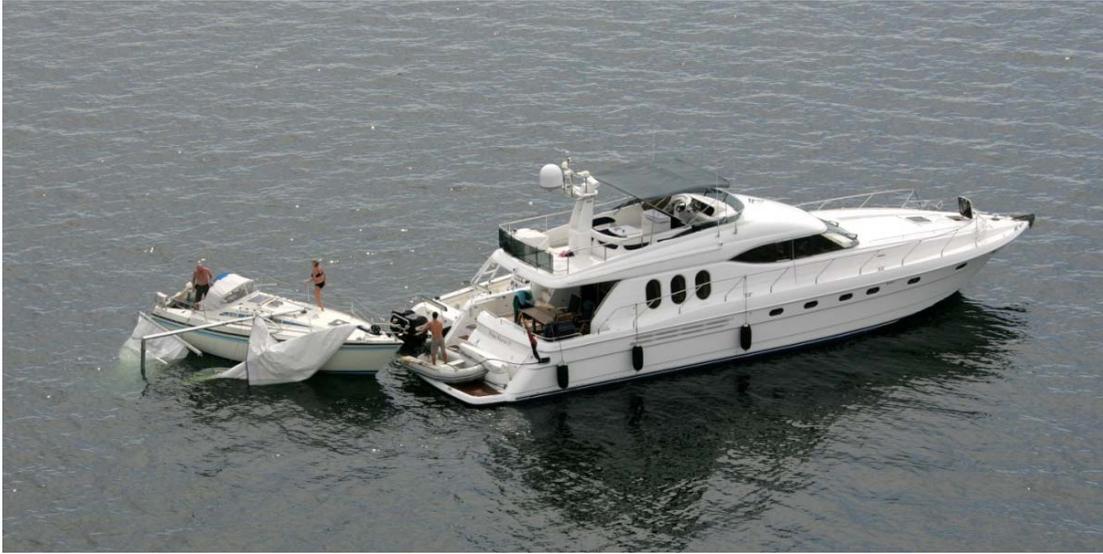
Figure 4. A photograph taken from the Border Guard helicopter after the collision. At the time of taking the photograph, the persons who jumped overboard had managed to climb up. The fast motor boat mentioned above is moored to the port side of NINAMARIA II.

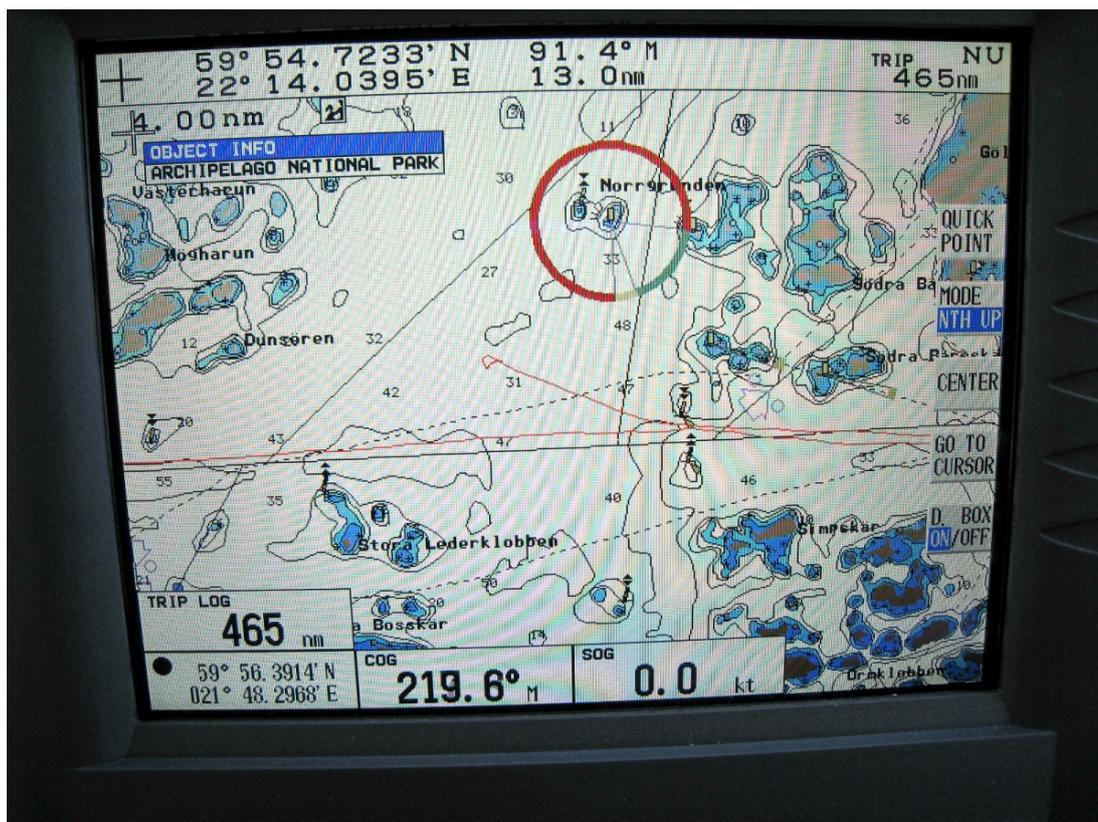
The attached photograph was taken of NINAMARIA II's plotter view after the incident (Figure 6). The trace shows the path of the boat at the time the incident.

Figure 6. NINAMARIA II's plotter photographed after the incident.

The location of the scene of the collision is slightly inaccurate. The position coordinates given in the emergency call presumably were slightly off the scene of the collision due to the boats drifting after the incident. The plotter trace on NINAMARIA II shows that the boat had turned right as a result of the collision and then travelled on for some distance before stopping and turning back. As the scene of the incident can be regarded the position where the trace in NINAMARIA II's plotter turns right.

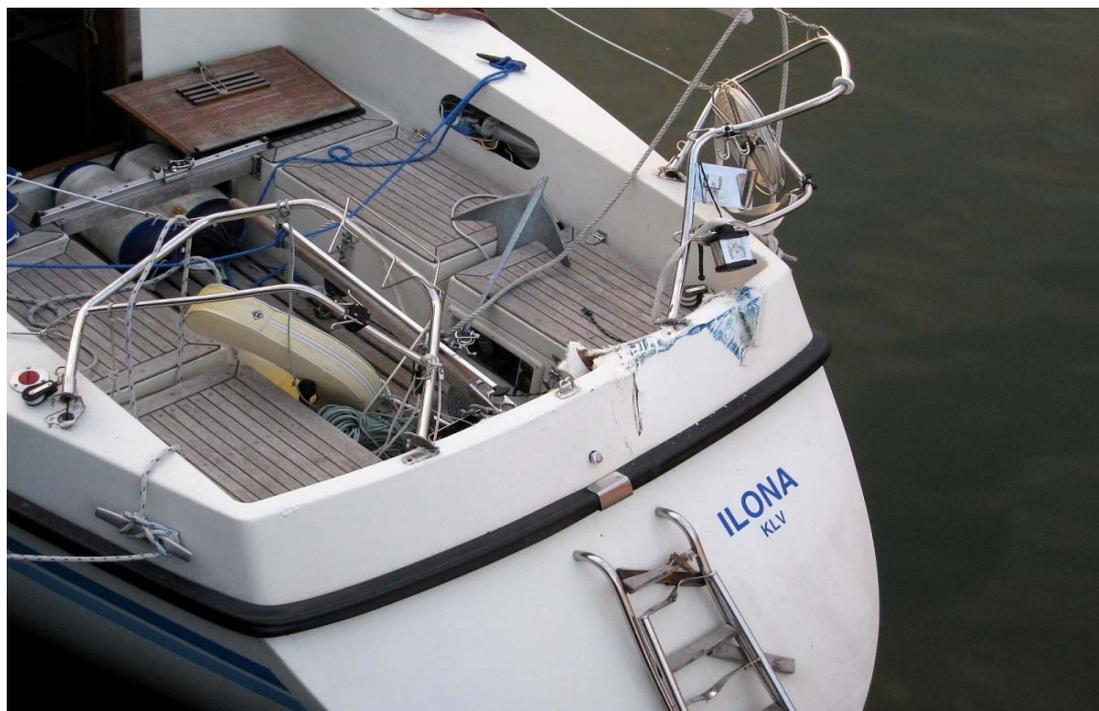
Figure 7. A photo taken by an eye witness of ILONA's stern soon after the collision.

The crew of R/B PAROC later found that ILONA's transom had been pushed in, and the structure had fractured over the whole width of the boat. As the back part of the cockpit had been pushed in, the rudder axel had been bent forward. Deformations were found in the fixing and support irons below the axel. The axel feed-through in the hull was leaking. As a result of the violent collision, the engine may also have swung, and the hull was de laminated in the stern. The yacht's chain plates were also exposed to great forces, and the delamination of the hull structure was likely.

For some reason, ILONA turned to the right in front of NINAMARIA II, which is indicated by the signs of damage shifting to the right, and in addition to paint marks, also by the way ILONA's stern railing was knocked down. At this stage, ILONA's after stay became detached.

The following contact marks are on the right (SB) side of ILONA, and they come to an end after ILONA's open deck area. As ILONA's boom was on the right, it was hit by NINAMARIA II's bow. In addition to the boom, the mast side stays (shrouds) became detached, and the mast was hit by a strong impact, as a result of which it was broken in two places.

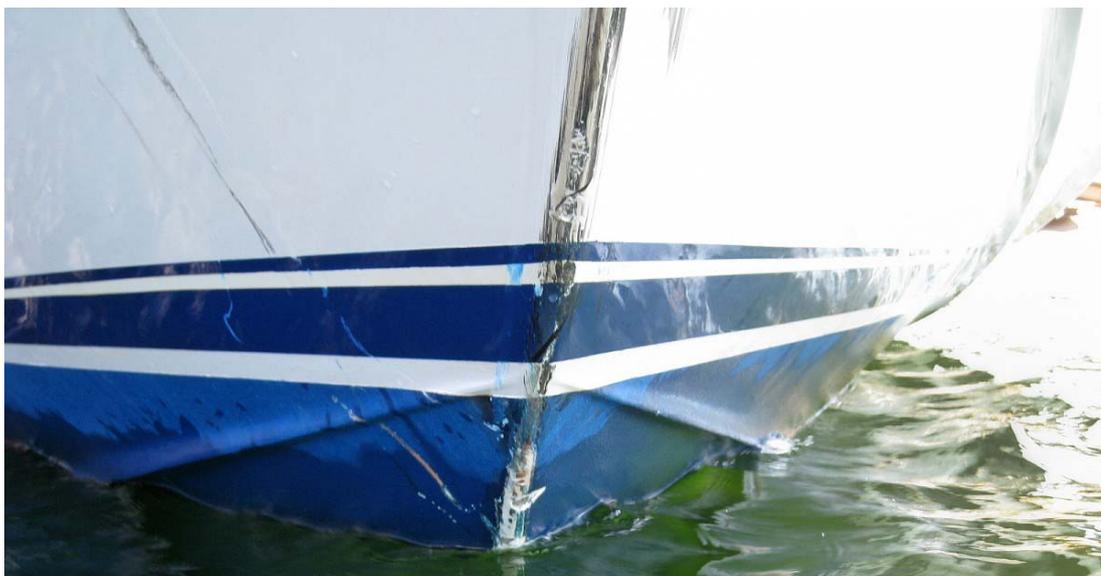
Figure 8. *The bow of NINAMARIA II after the collision (photograph taken by the crew of R/B PAROC).*

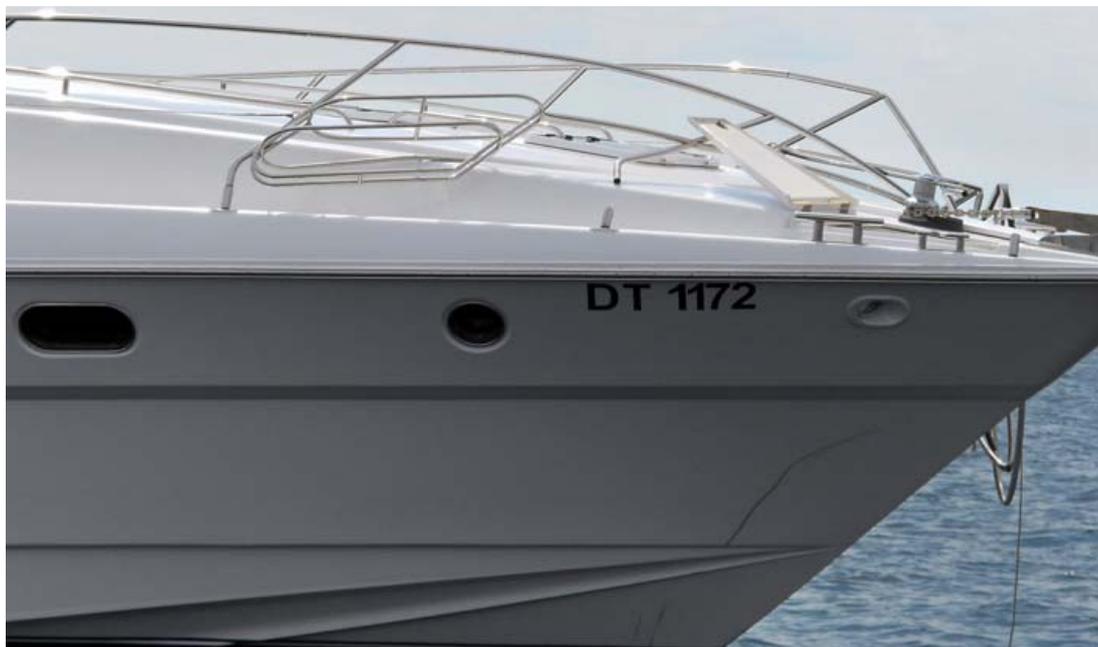
Figure 9. Pulpit of NINAMARIA II after the collision (photograph taken by an eye witness).

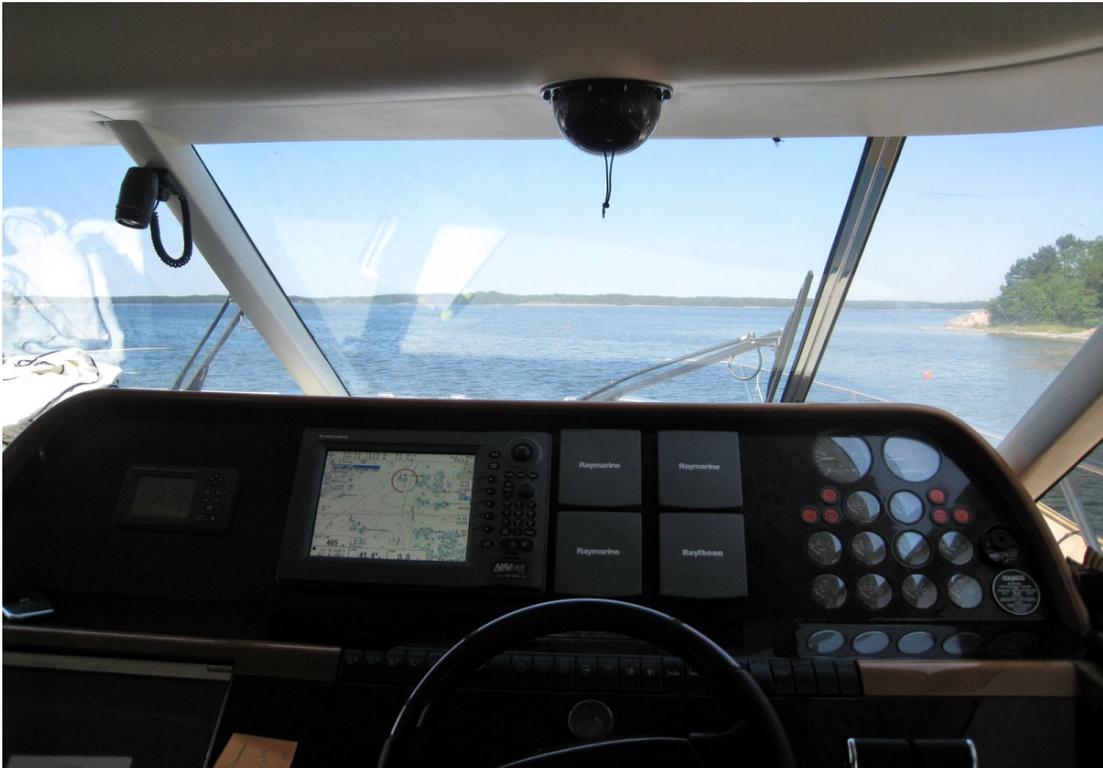
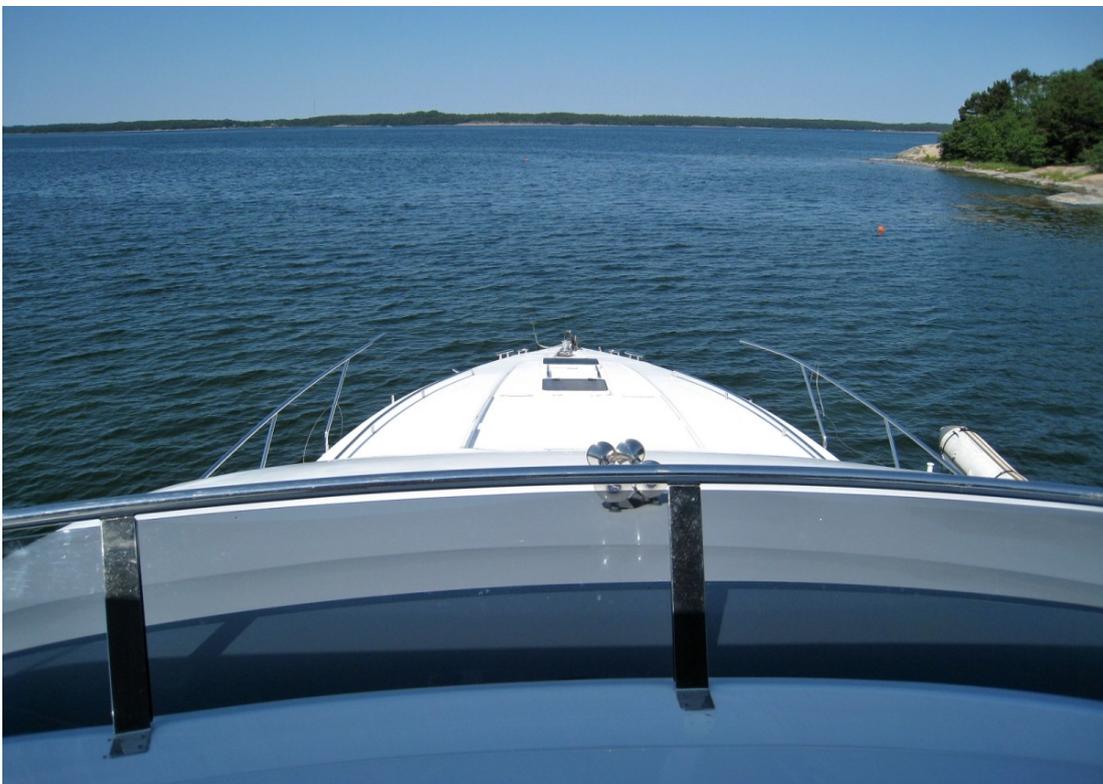
Inability to see ILONA from NINAMARIA II could not have been the cause of the accident. However, the crew failed to observe the sailing yacht. The only reason for this could be a complete failure to keep look-out on NINAMARIA II after the change of direction. The keeping of look-out prior to this must also have been so inadequate that the Master was unable to perceive the situation leading to the collision. NINAMARIA II completely failed to conceive the critical nature of the situation.

Figures 12 a and 12 b show the field of vision of NINAMARIA II's operator towards the bow both from the indoor and outdoor cockpit. The Figures clearly show how much easier it is to keep look-out from the outdoor cockpit in the direction the boat is travelling than from the indoor one. The windscreens that are tilted back produce a strong mirror effect, and the field of vision is narrow and low. When the yacht is on the run, the trim of the hull further increases the difference from the situation shown in figures.
