## Investigation Report

C4/2009M

### **M/S SILJA EUROPA (FIN), Breaking of the Starboard Rudder Shaft in the Aland Archipelago on 22 November 2009**

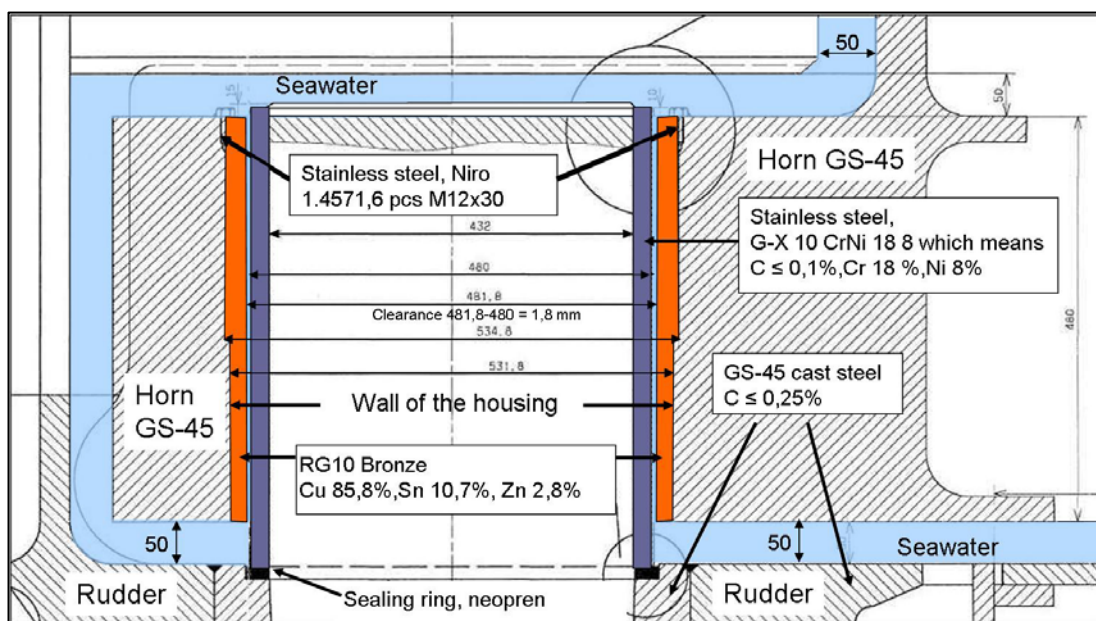
and staying in place of the bush. From the top the bush was secured against torsion and rising with six screws, which had even been welded to the casting. The height of the housing and bush is 480 mm. It is worth noticing that the cast steel of the bearing housing is in direct contact with the bronze bush in a sea water environment (galvanic couple).

Figure 5b. The original drawing of the pintle bearing, added with e.g. information about the materials. The bronze bush has been indicated with orange colour, the stainless steel liner with blue colour. The bearing clearance is 1.8 mm (481.8–480). It is to be noted that the bronze in the bush and the cast steel in the horn are in contact with each other in seawater without insulation (galvanic couple).

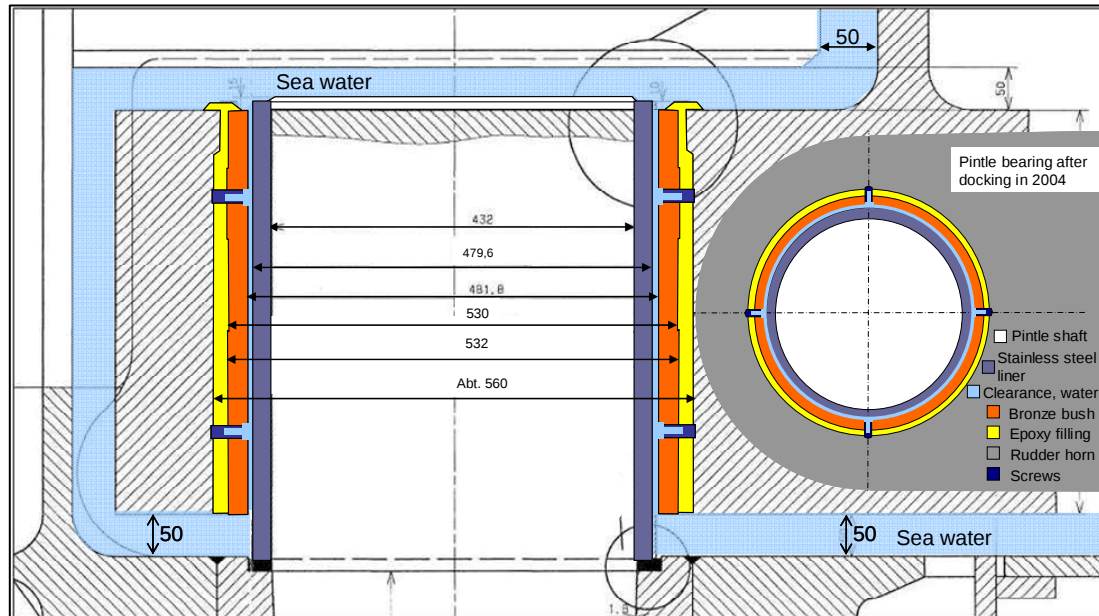
In the connection with the docking in 2004, corrosion of the housing was repaired by using cast epoxy filling and at the same time new bronze bushes were installed, Figure 5c. In order to centre the bushes when the epoxy was cast, hexagonal socket-head screws reaching to the wall of the housing were used. They remained there after the casting had been completed. This structure formed by the epoxy and screws broke in 2009. It is worth noticing that the cast steel of the bearing housing was in direct contact with the bronze bush, now through screws (galvanic couple).

Figure 5c. The structure completed in the 2004 repair. In order to centre the new bush during the epoxy casting, hexagonal socket-head screws were used (altogether 8 screws). The clearances returned to normal. The hex sockets filled with sea water.

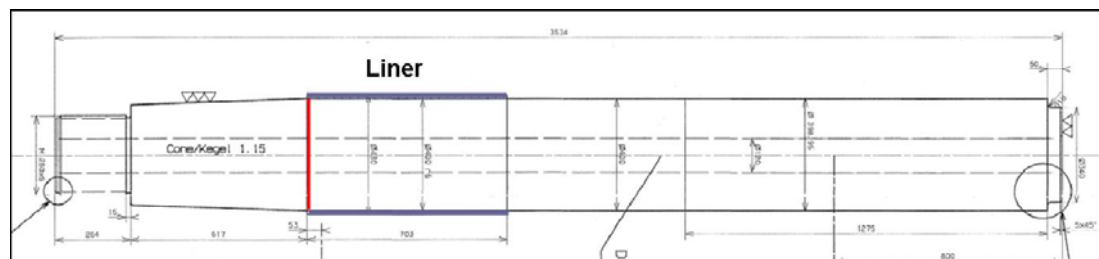
**Rudder shafts.** The length of a rudder shaft is approx. 3.5 metres and it weighs approx. 3.1 tons, Figure 6. The rudder shaft is made of non-alloy steel CK 22 N, which had been forged and anneal-normalised. The material had a classification certificate, according to which it fulfilled the standards set on it. The diameter of the rudder shaft is 400 mm. The strength properties of the shaft were normal and corresponded with the vessel's ice class<sup>9</sup>. The thickness of the liner installed by using shrink-fitting was 15 mm. For the hydraulics of the Jastram-rotor, a 120-mm-diameter hole had been drilled in the middle of the shaft. The hole only caused a minor reduction in the strength of the shaft.

Figure 6. Rudder shaft. The liner made of stainless steel is indicated with blue-grey. A 120-mm-diameter hole was drilled through the rudder shaft for the hydraulic pipes of the Jastram-rotor. Red colour has been used to indicate the breaking point of the SB rudder shaft.

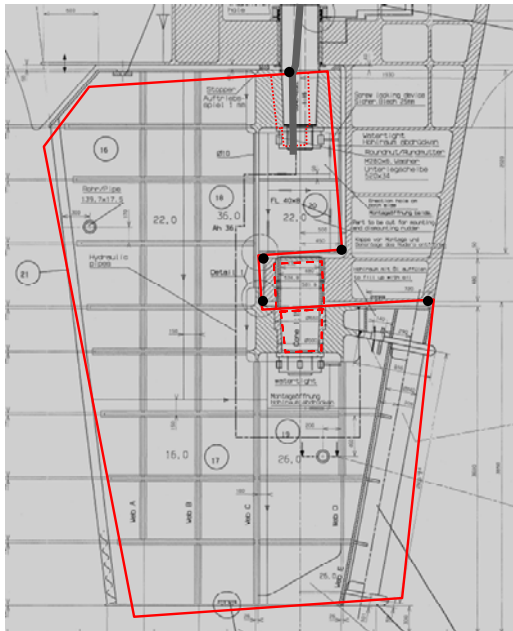
The SB rudder shaft was broken. The rudder blade had fallen and it was leaning on the rudder horn as well as on the hydraulic pipes of the Jastram-rotor (the thick grey line), Figure 10a. The rudder angle of the broken rudder was 45 degrees to the left during the diver's inspections.

Figure 10a. An estimation of the position of the SB rudder (if the rudder is midships) after the rudder shaft was broken. It was inclined approx. 3-4 degrees lengthwise. The black spots illustrate the possible supporting spots after the rudder shaft was broken.

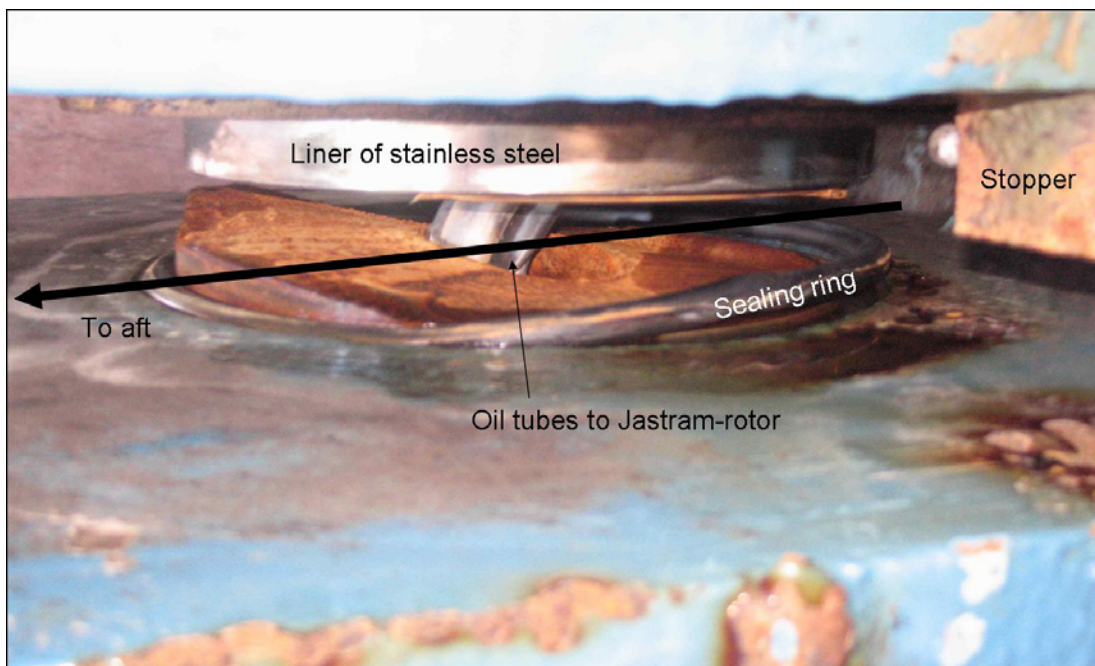
An expert from the Technical Research Centre of Finland identified the cause as a *fatigue breakage* on the basis of how the fracture plane of the shaft looked like, Figure 10b.

Figure 10b. The broken SB rudder shaft photographed in Riga on 28 November 2009. The rudder had dropped downwards approx. 5 cm and moved a little bit aftwards. The tubes going to the Jastram-rotor can be seen in the middle of the picture. The rudder is midships and the arrow points to the stern.

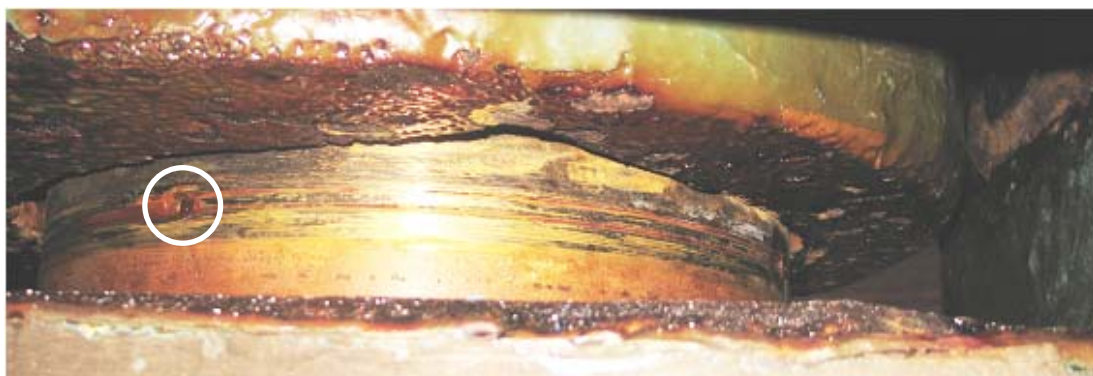
The epoxy filling cast in the 2004 repair as well as the screws had disappeared altogether from the SB side and partly from the BB side. The bronze bush of the SB side pintle bearing had dropped 130–140 mm and was now leaning to the rudder, Figure 11.

Figure 11. SB pintle bearing photographed on 2 December 2009 in such a way that the gap from which the epoxy has disappeared is visible. The inner side, the direction of the bow is to port. One of the installation screws of the bush has been marked with a white circle.

One of the screws used in connection with the installation of the epoxy casting in 2004 can be seen as broken in Figure 11. The screw area of the bush has become visible when the rudder has fallen down the distance allowed by the gap above the horn. In addition, several fretting cracks were discovered in the upper part of the cone and several cracks were found in the rudders and rudder horns. The surfaces of the rudders have corroded in places, Figures 12 and 13.

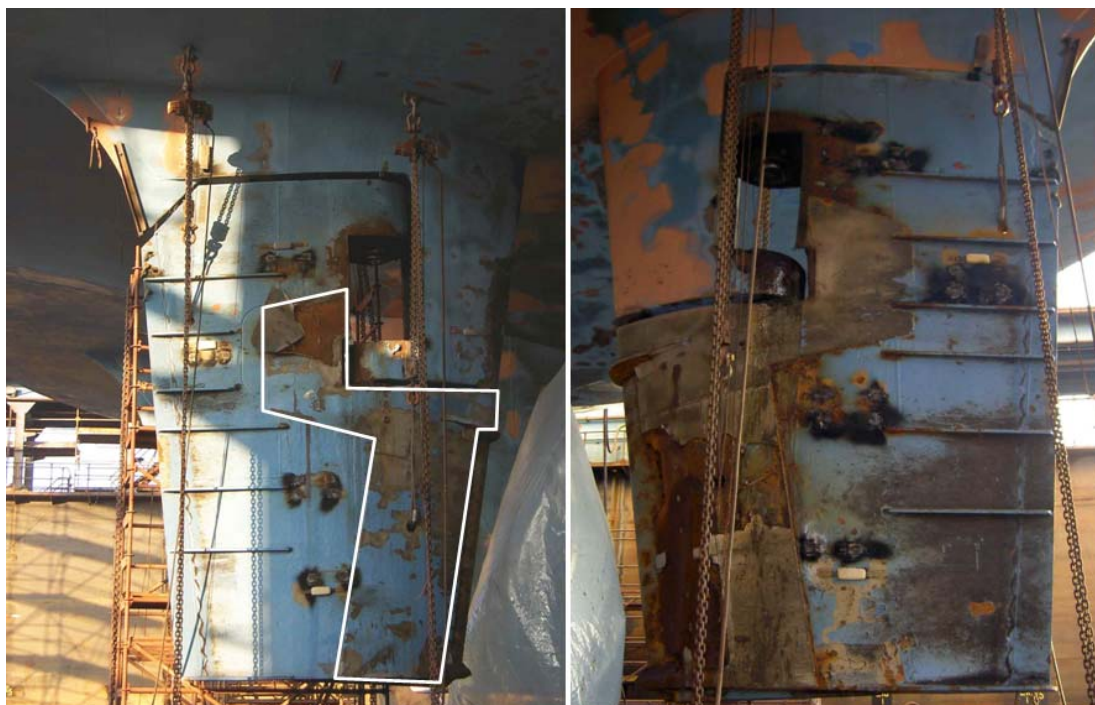
Figure 12. SB rudder in Gdansk on 3 December 2009. The picture to the left shows the outside, the picture to the right the inside. On the area indicated by the white line there was a coating made of stainless steel plate on both surfaces of the rudder.

The area coated with stainless steel plate has been indicated by the white line in Figure 12. There was coating on all the four surfaces. The state of the rudder had been quite similar even earlier.

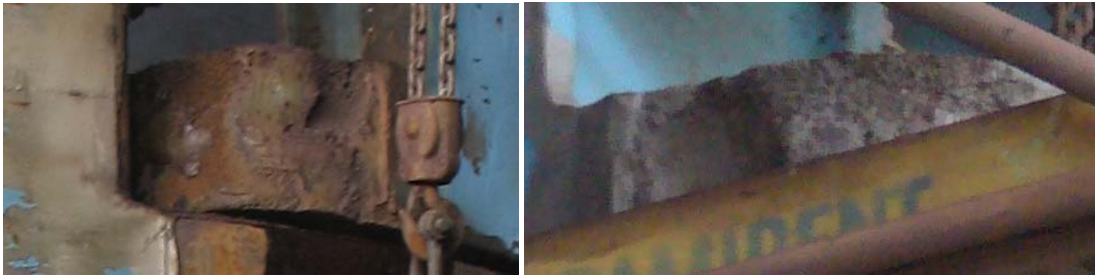
Both horns had severe corrosion caused by cavitation on the side of midships. The upper part of the corroded places were so deep that the durability of the horn was jeopardized, Figure 13.

Figure 13. Cavitation corrosion in the rudder horn. BB to the left (photo taken on 3 December 2009), SB to the right (photo taken by the Finnish Transport Safety Agency on 4 December 2009), both on the side of midships.

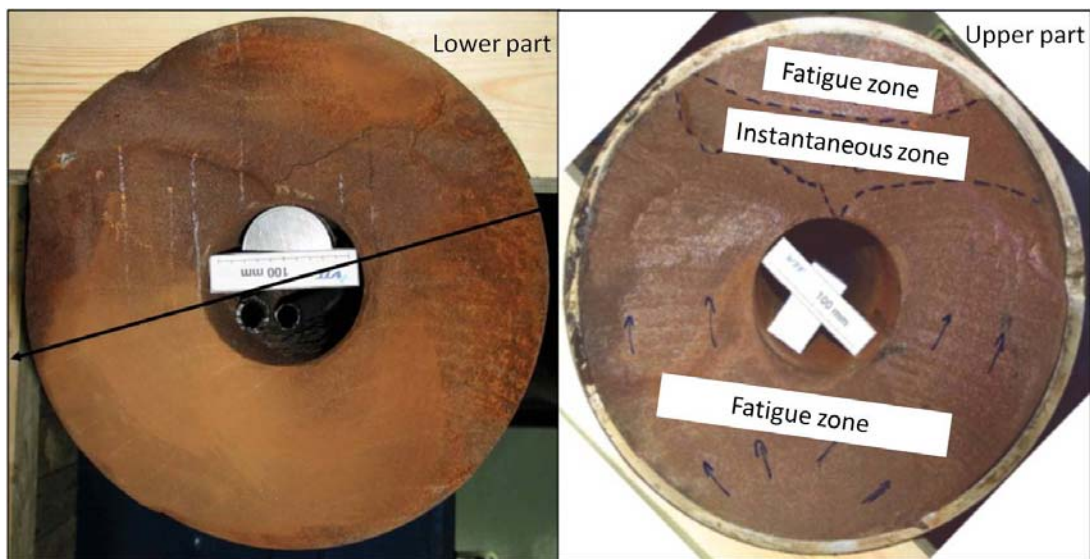
Figure 21. The upper part of the broken shaft to the right and the lower part to the left. There is still a liner made of stainless steel on the upper part on the shaft. The limits of the fatigue and final breaking have been drawn on the upper part. The direction to the aft when the rudder is midships has been marked on the lower part. An attempt has been made to place the halves in a position corresponding one another. Pictures by the Technical Research Centre of Finland.

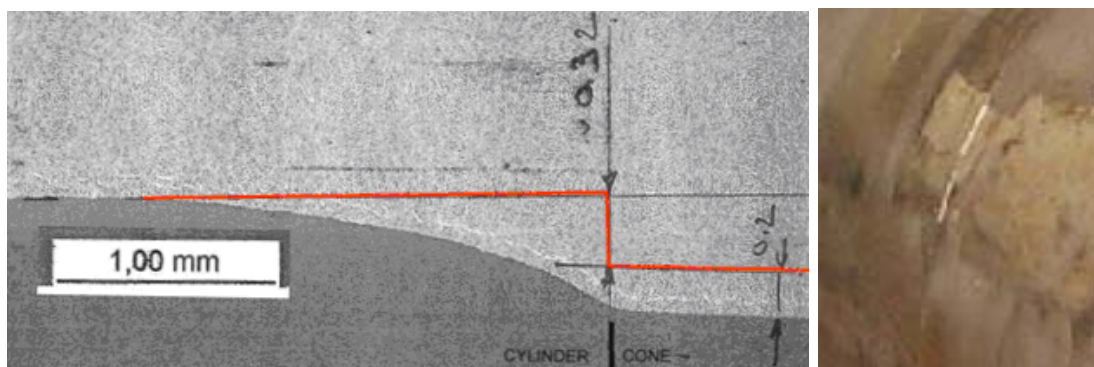
Figure 22. To the left the profile of the “intact” (BB) rudder shaft at the point of the notch (modified on the basis of the report by the Technical Research Centre of Finland) and to the right the notch point of the extra shaft. 0.2 mm was machined off the cone of the “intact” shaft so it is uncertain what the original profile of the notch looked like. The red line shows the profile of the broken shaft.

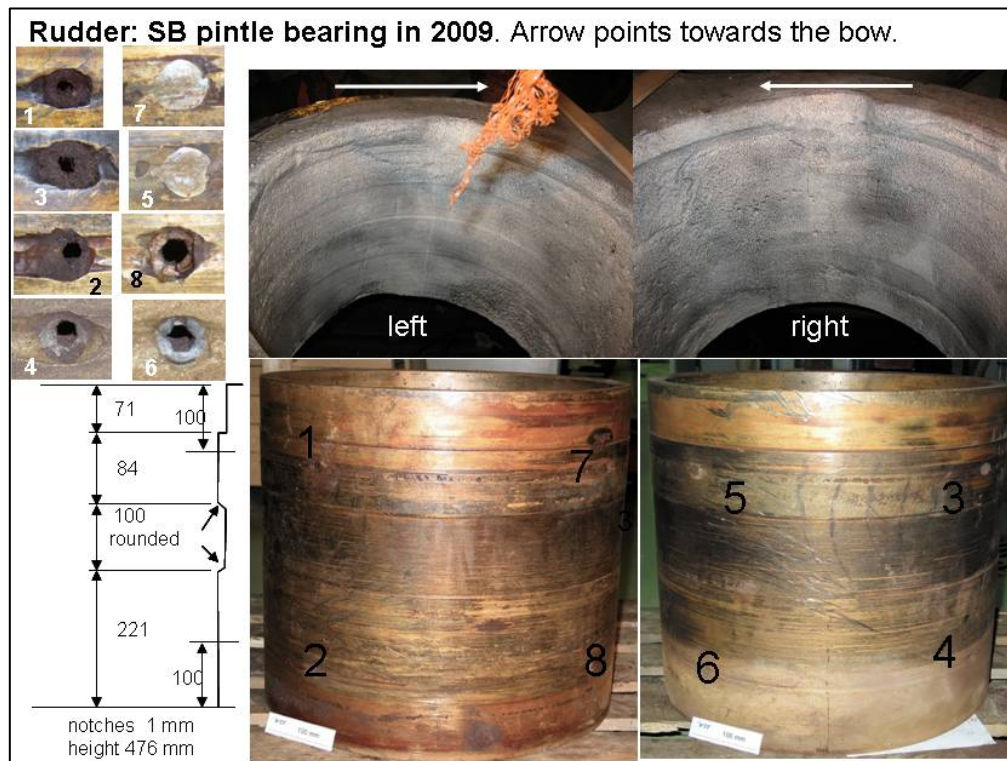
Figure 23a. The SB pintle bearing. Pictures of the housing by the shipyard, of the bush by the Technical Research Centre of Finland.

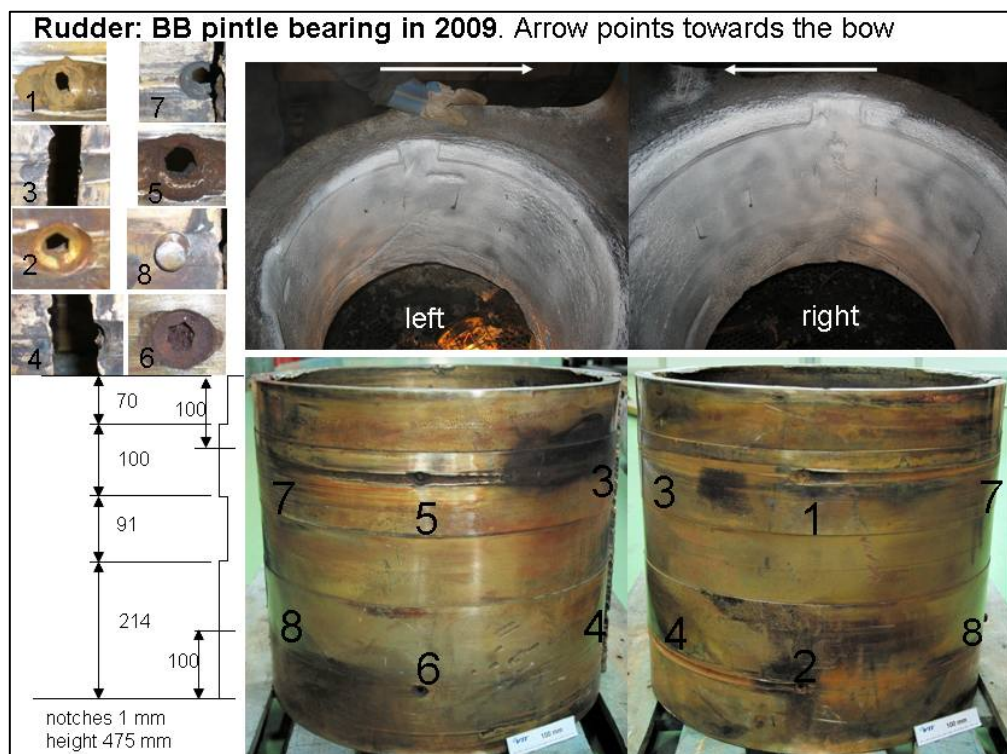
Figure 23b. The BB pintle bearing. Pictures of the housing by the shipyard, of the bush by the Technical Research Centre of Finland.

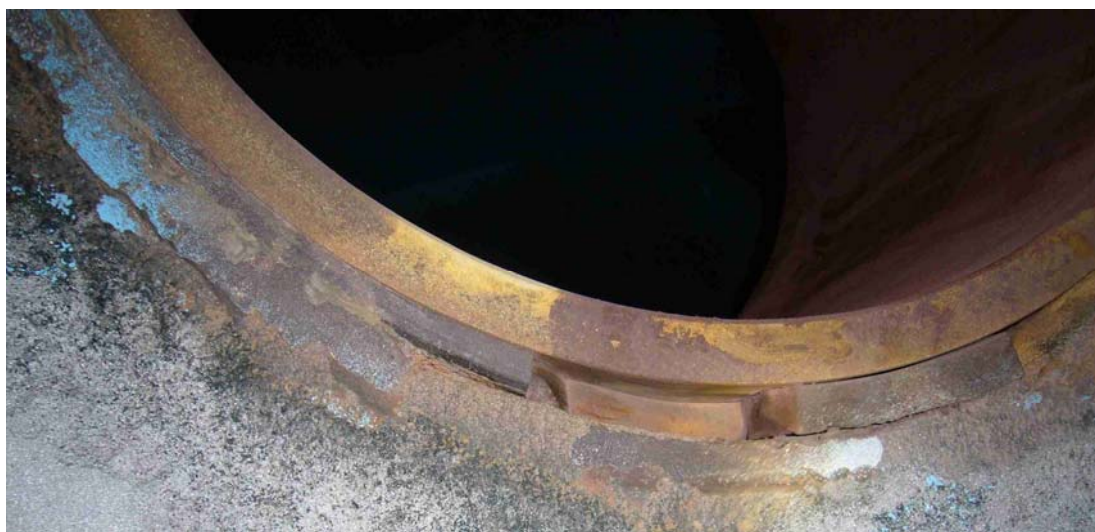
*Figure 24. Epoxy which has partly come off on the BB pintle bearing. The thin gaps between on one hand the epoxy and the housing and on the other hand between the epoxy and the bronze bush are clearly visible. Picture taken on 3 December 2009.*

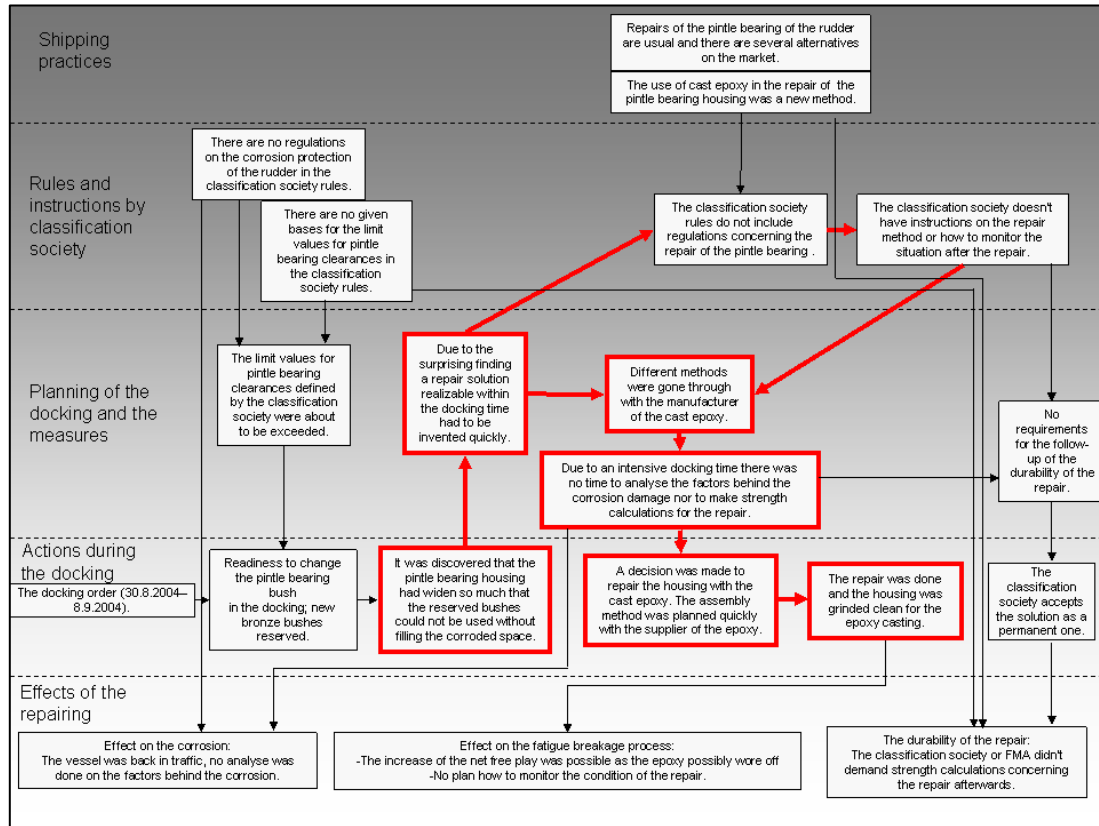
Figure 31. Analysis of the planning and realisation of the cast epoxy repair completed in connection with the 2004 docking and the consequences of the repair. The red text boxes and arrows have been used to show the quick repair process which took approx. three days. The process included the planning of the repair, consultation with the class and the casting itself.

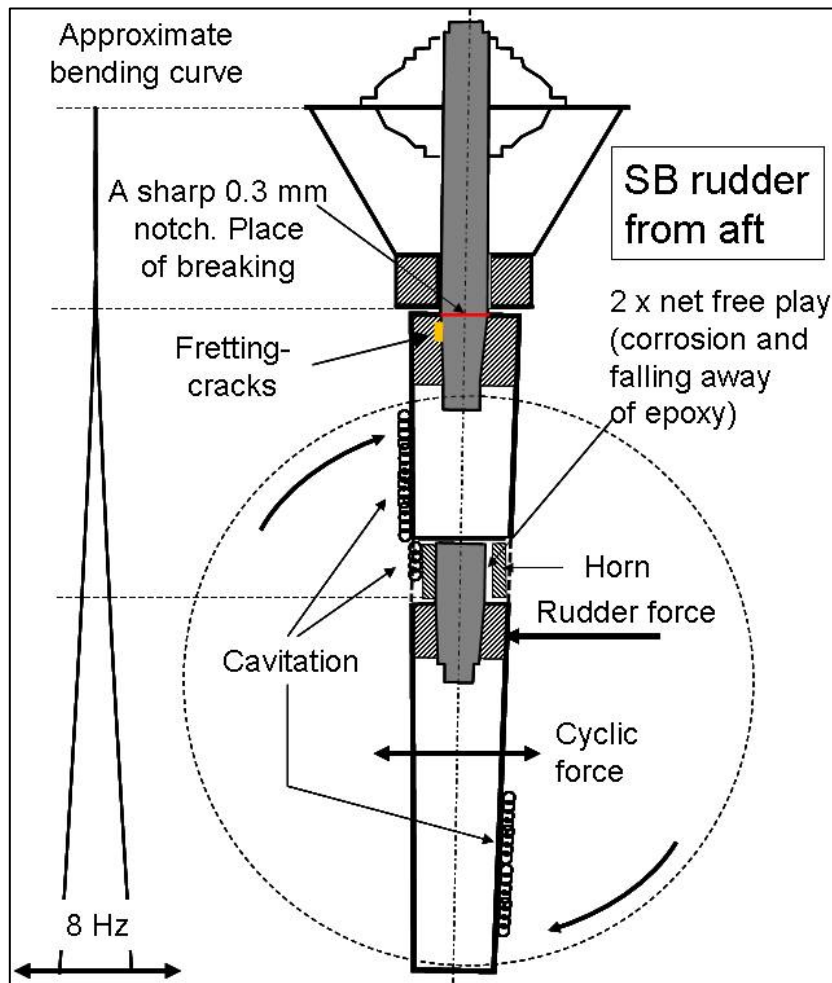
Figure 33. The SB rudder seen from behind. The transverse movement of the rudder and the factors leading to the breaking of the SB shaft are shown in the picture. In the picture the shaft and the rudder have bent towards the centre line of the vessel. The pintle bearing touches the wall of the rudder horn housing. This means that there is empty space on the other side, 2 x net free play.
