## Investigation Report

C3/2010M

### **JEANNEAU PRESTIGE 42S, A-58990 (FIN), sinking off In- koo on 28 May 2010**

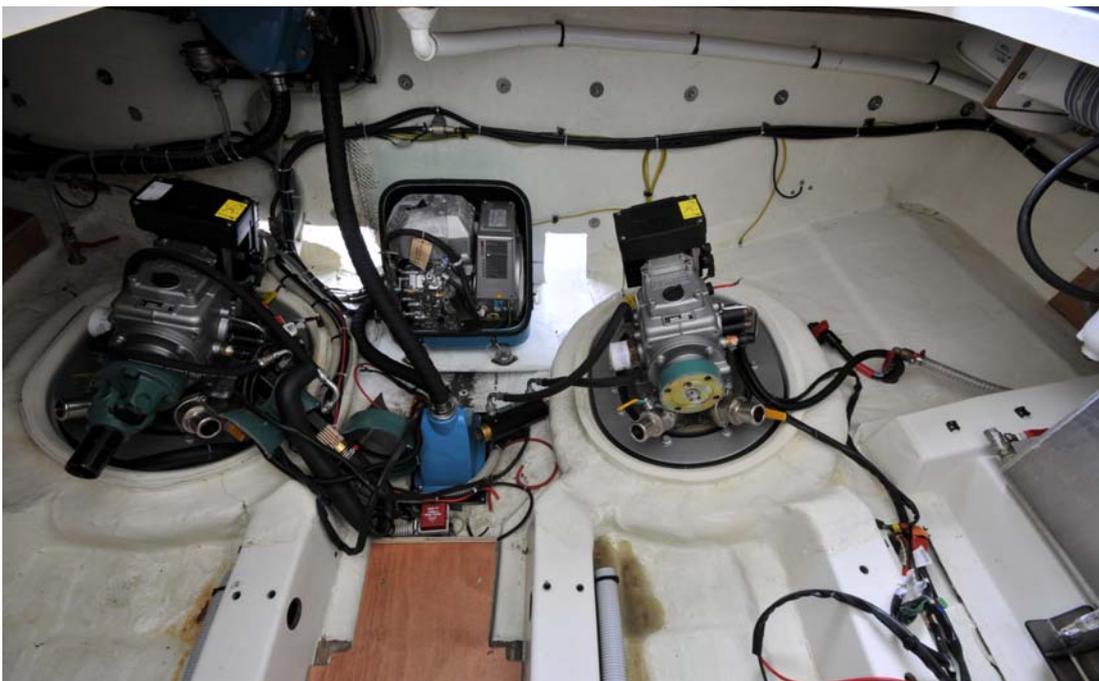
The bottom frame also forms the engine bed for the engines. It was discovered that the part of the frame which had been pre-cast in a mould had been cut between the engines and the drive unit. Aftwards from there the frame had been replaced by the glassfibre reinforced plastic mount ring of the Volvo Penta IPS drive unit and by an extra stringer attached to it (Figure 3).

Figure 3. The rear part of the bottom frames has been replaced by a Volvo Penta mount ring and the stringers supporting it. The picture was taken after the engines were demounted and the engine compartment was cleaned.

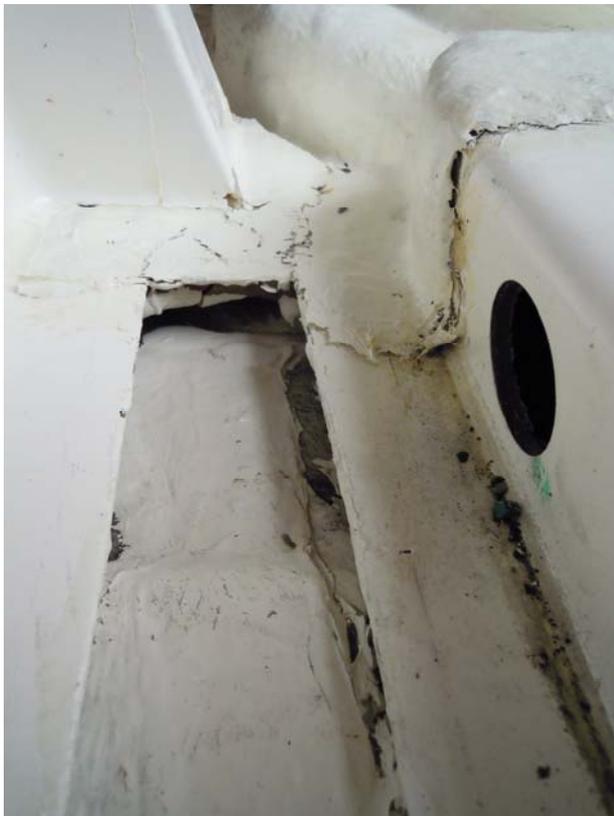
Figure 5. The way the bottom frames are jointed to the hull. The stringers were not completely jointed to the bottom. The fitting had been done by using glue filler.

Some joints of the longitudinal stiffener beams came loose from the bottom. They did not cause leakage, but the observation indicates that the fastening of the beams with the glue mass used by the Jeanneau factory is not strong enough.

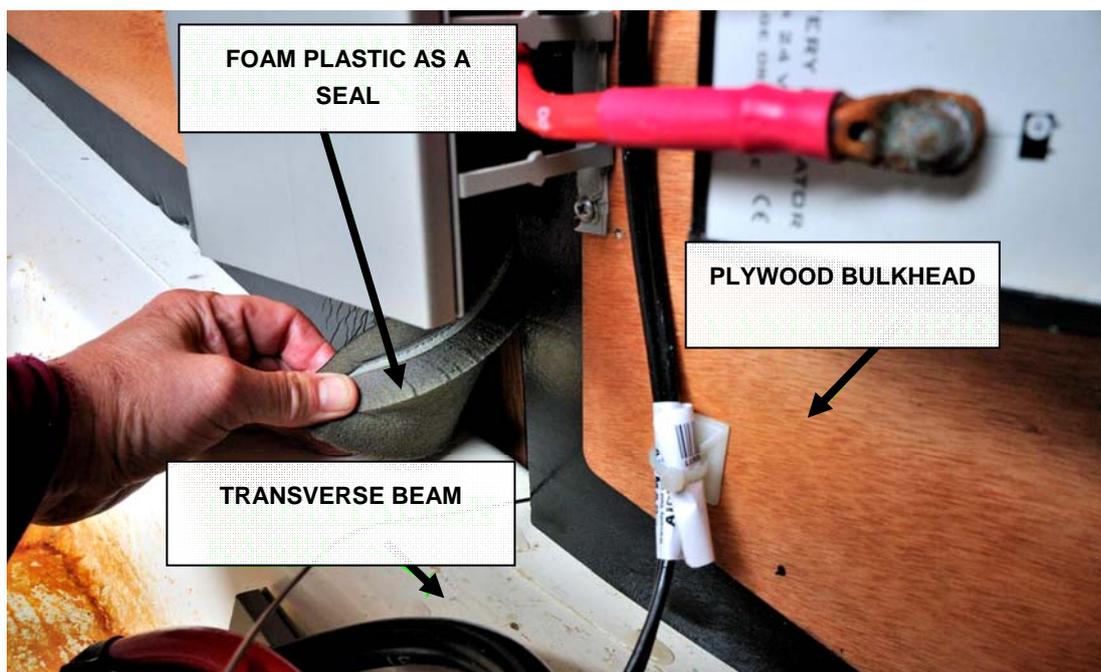
Figure 7. The plywood bulkhead and the bottom frame had not been fitted closely together. The gap was sealed with loose Styrofoam.

The bulkhead on the bow side of the engine compartment did not reach the bottom structures of the boat, but a gap had been deliberately left between the bulkhead and the bottom structures. The gap was sealed with Styrofoam and the obvious intention was that it would act as a noise insulating packing (Figure 33). The hoses and cables which were led through the gap further added to the leakiness. The longitudinal bottom stringers of the boat might also have functioned as leak channels, because their structure and joint to the hull were rather uncertain. Inside the bottom stringers the water can move from one side to the other in the bulkhead of the engine compartment.

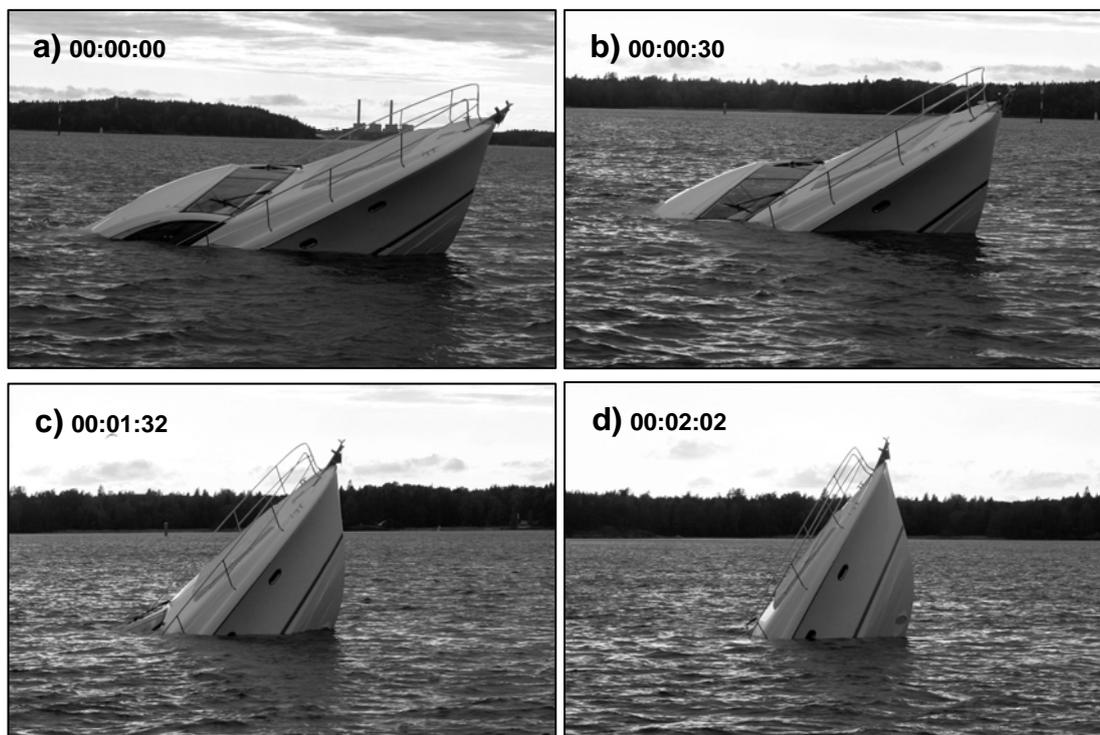
The boat ran aground at 19.50. It continued with her old speed over the rock and stopped after it because the engines did not run any longer. The boat sank (Figure 10) and because of this was a constructive total loss. There were no injuries to persons.

Figure 10. The sinking of the boat photographed onboard P/V FAGERÖ. The timeline marked on the pictures illustrates the speed with which the boat sank. The time in the first picture in the series has been set to zero. The times have been obtained from the EXIF file of the photos. The persons onboard the boat were rescued approx. 10 minutes before the first photo (10a) was taken. (© Max Weckström)

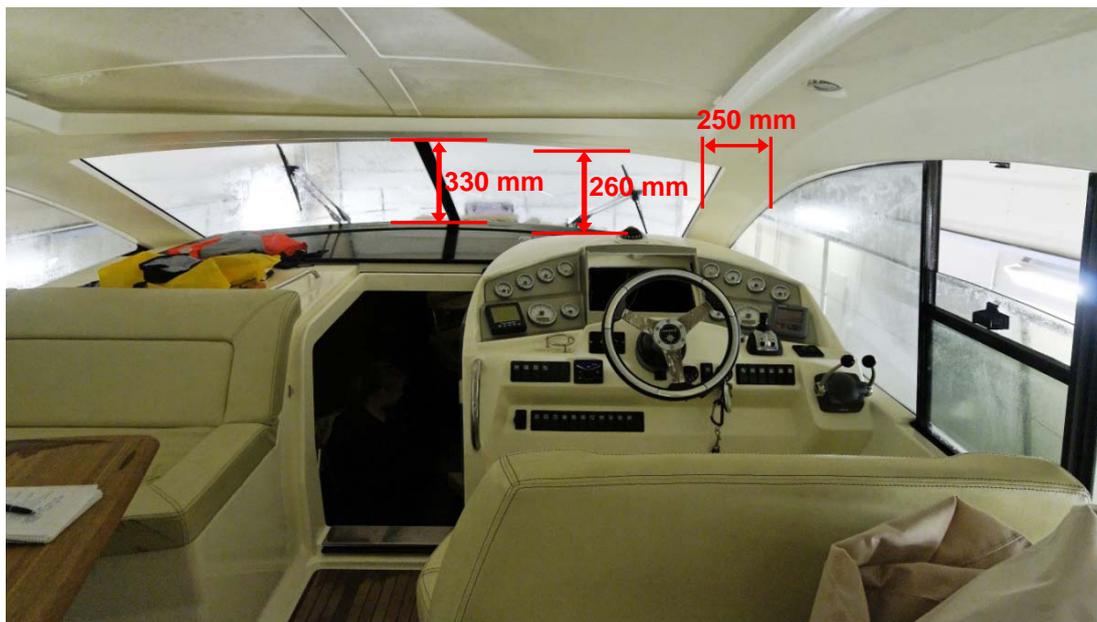
Figure 11. General view of the wheelhouse from behind the helm position. The picture was taken onboard the accident boat in the dock hall soon after the boat had been lifted. The height of the windscreen is 330 mm, the operator's console restricts field of vision from the lower part in such a way that the effective height for the visibility is 260 mm. The side pillar is 250 mm wide.

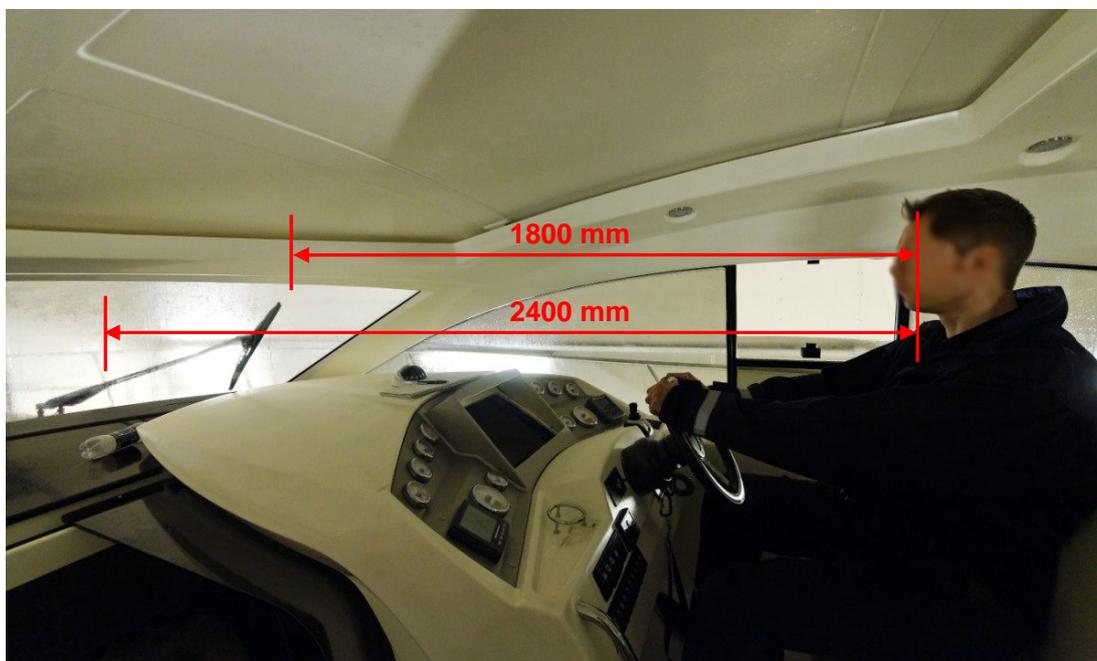
Figure 12. The helm position when the operator is in a sitting position and the roof hatch is closed. The picture was taken onboard the accident boat in the dock hall soon after the boat had been lifted. The distance from the top of the window to the operator is approx. 1800 mm and from the middle part approx. 2400 mm. The upper window beam is exactly in the middle of the visual field of the person seen in the picture. This person shown in the picture is somewhat taller than the skipper of the accident boat.

According to the skipper, the visibility from the helm position clearly deteriorated when the roof hatch was closed at the open sea of Porkkala on the request of those onboard the boat. The deterioration was caused by the lowness of the window and long distance to it when compared with the extensive view the open roof hatch provided. The skipper reduced the speed from 27 knots to 23 knots.

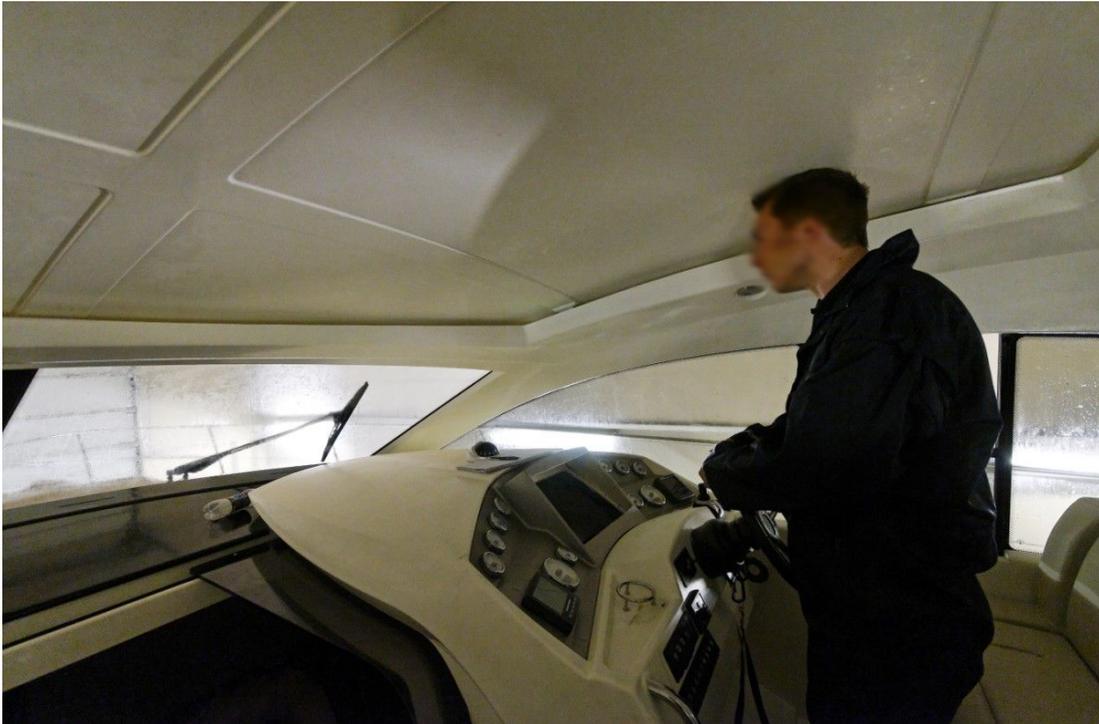
*Figure 13. The helm position while the operator is in a standing position and the roof hatch is closed. When operating the boat in a standing position, there are two heights to choose from. The picture was taken on the accident boat in the dock hall soon after the boat had been lifted. The person shown in the picture is somewhat taller than the skipper of the accident boat.*

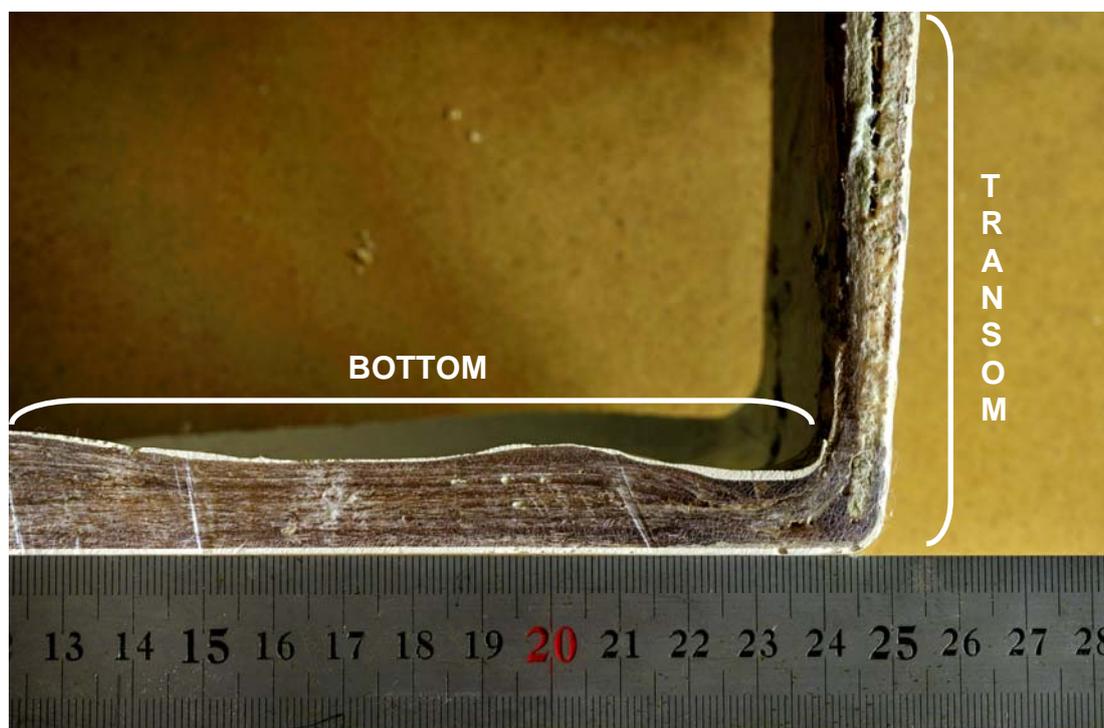
Figure 14. The picture shows a test sample cut from the hull of the boat, from the area where the bottom and transom come together. The test sample was cut off from the port side of the hull, which had remained intact, i.e. where the laminate had not torn. The thickness of the transom is at its lowest approx. 8 mm as shown in the figure. Approx. two 1.5-mm layers of this are glassfibre laminate. Between the laminates there is filling material which appears to be microbead mass and which makes the texture sandwich structure.

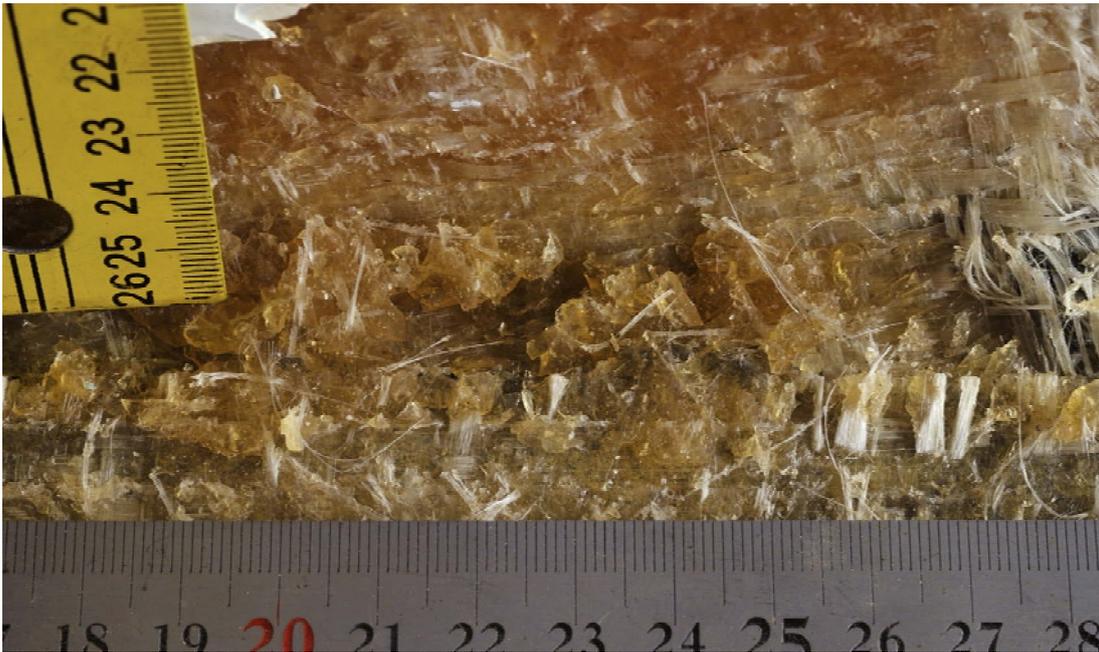
Figure 15. Laminate from the lower corner of the transom from the starboard side of the boat, from the area where the bottom and transom got torn. The figure illustrates the high resin content and the ending of the woven cloth, i.e. rowing-layers, immediately before the corner.

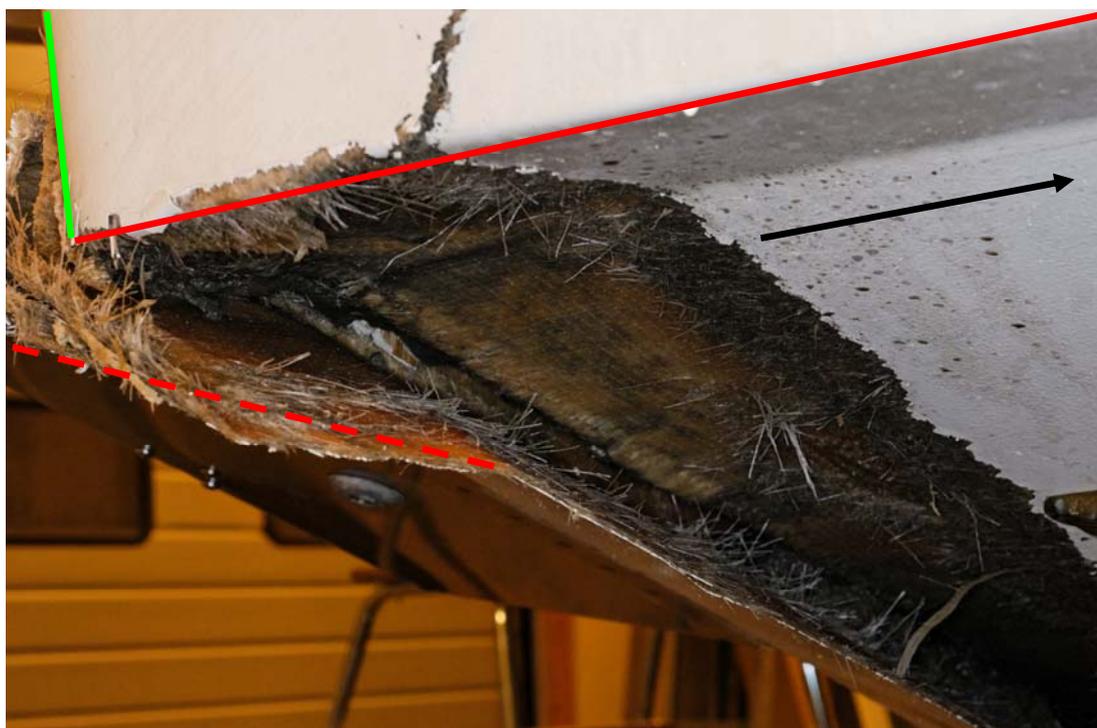
When the drive unit hit the rock, a backward force was directed to it. By lever arm principle it leaned on the bottom of the boat in such a way that a force downwards was directed to the bow end of the drive unit and a force upwards, i.e. inwards, was directed to the aft end. This broke loose the bottom plate which was mounted weakly to the transom, and a transverse gap was formed in the bottom (Figure 16).

*Figure 16. Tear in the bottom of the boat. The corner between the transom and the side of the boat has been marked with a green line, the bilge of the boat with an unbroken red line, and a red broken line has been used to illustrate the laminate going from the transom to the bottom of the boat. This laminate was torn loose from the actual bottom laminate. A black arrow indicates the direction of the bow.*

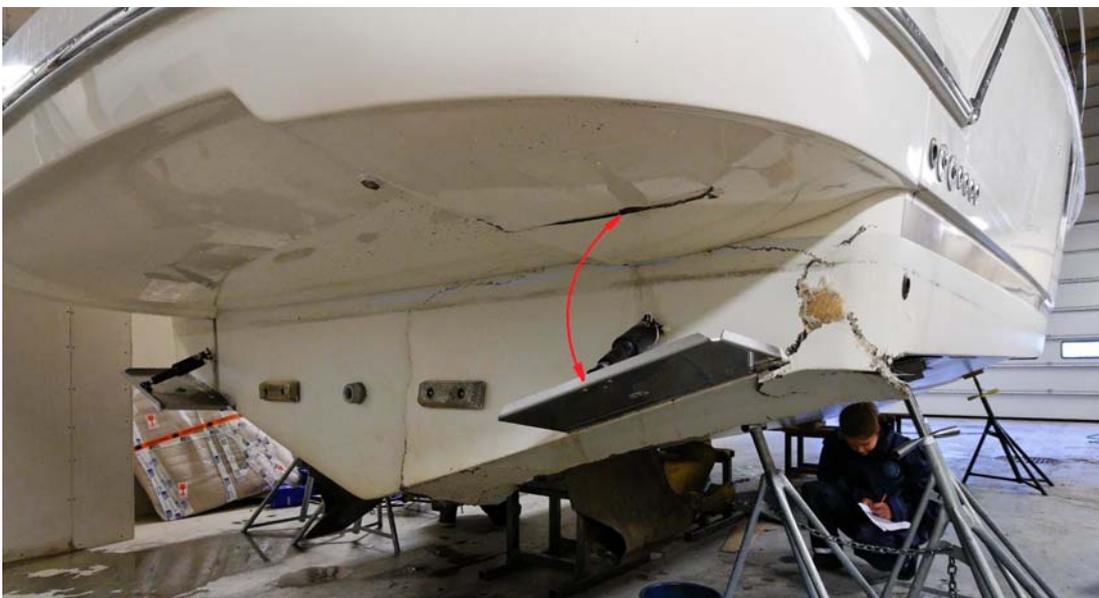
There were no marks on the bottom or elsewhere in the glassfibre hull caused by the boat hitting the rocks. The transom had been torn off from the bottom of the boat on the starboard side for the most of its breadth. The joint was open more than 10 cm. On the underside of the swimming platform there was an impression which matched the rear edge of the drive unit. On the starboard side the trim tab had cut a hole on the underside of the swimming platform.

Figure 17. The transom of the boat. The laminates of the bottom plate and transom separated from each other in the collision thus leaving in the bottom of the boat a gap the width of which was half the transom. Water filled the engine compartment and the whole boat from this gap and from the opening left by the broken IPS drive unit lead to the sinking of the boat. The transom was torn more loose when the boat was lifted, and the trimplan pressed to the swimming platform the crack visible in the picture. The gap scraped clay from the sea bottom into the engine compartment while the boat was moved along the sea bottom.

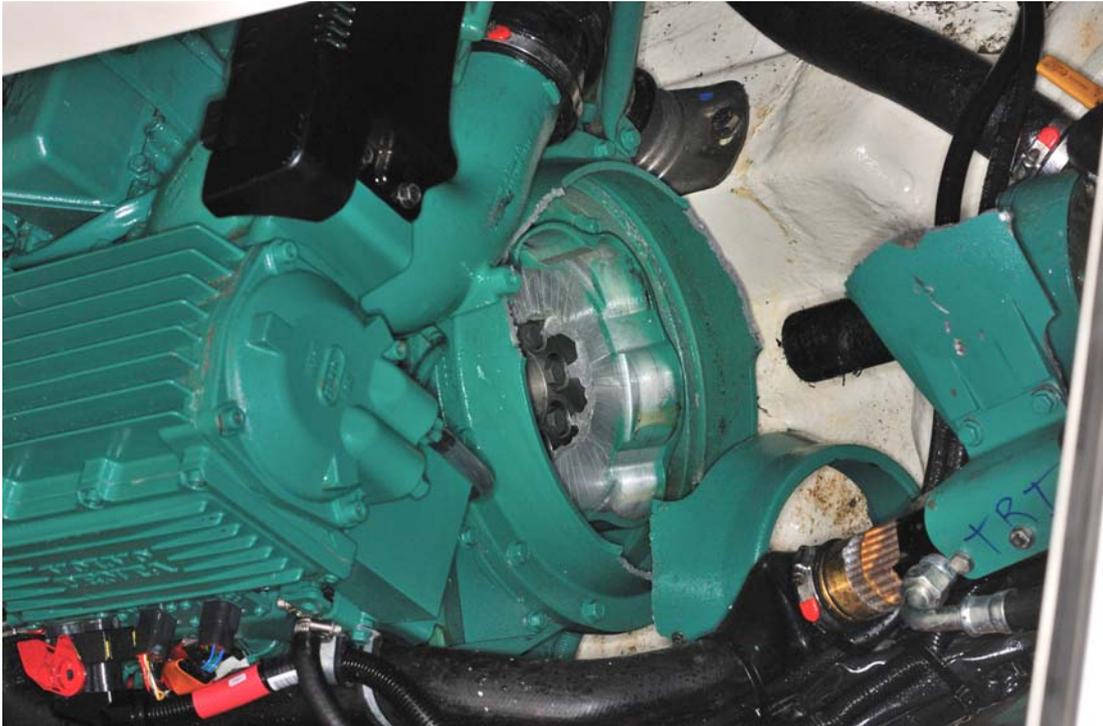
The quick stop has caused very high torque reactions in power transmission. Because of this, the flexible coupler between the engine and the upper gear has broken, and the driving shaft has hit upwards and broken the cast metal casing between the engine and the upper gear. A deep impact mark corresponding with the grooving of the shaft was left on the casing. The end of the shaft flew upwards and hit the side of the hatch leading to the engine compartment. The impact mark can be seen both on the inside and outside.

Figure 18. The broken flexible coupler and the metal casing broken by the shaft.

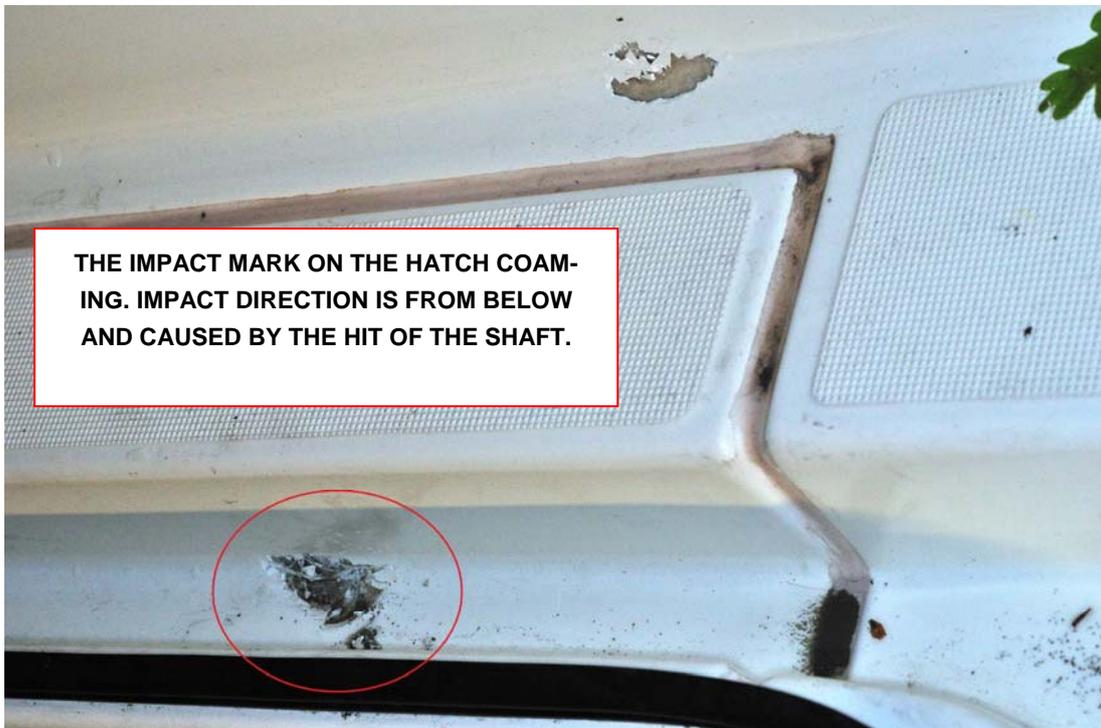
After this the shaft has come loose from its grooving and flown upwards and hit the side of the hatch leading to the engine compartment. From there the shaft has flown further to the bottom of the engine compartment, where it was found after the accident.

Figure 19. The impact mark above the hatch of engine compartment. The mark was caused by the end of the shaft hitting below the side of the hatch of the engine compartment.

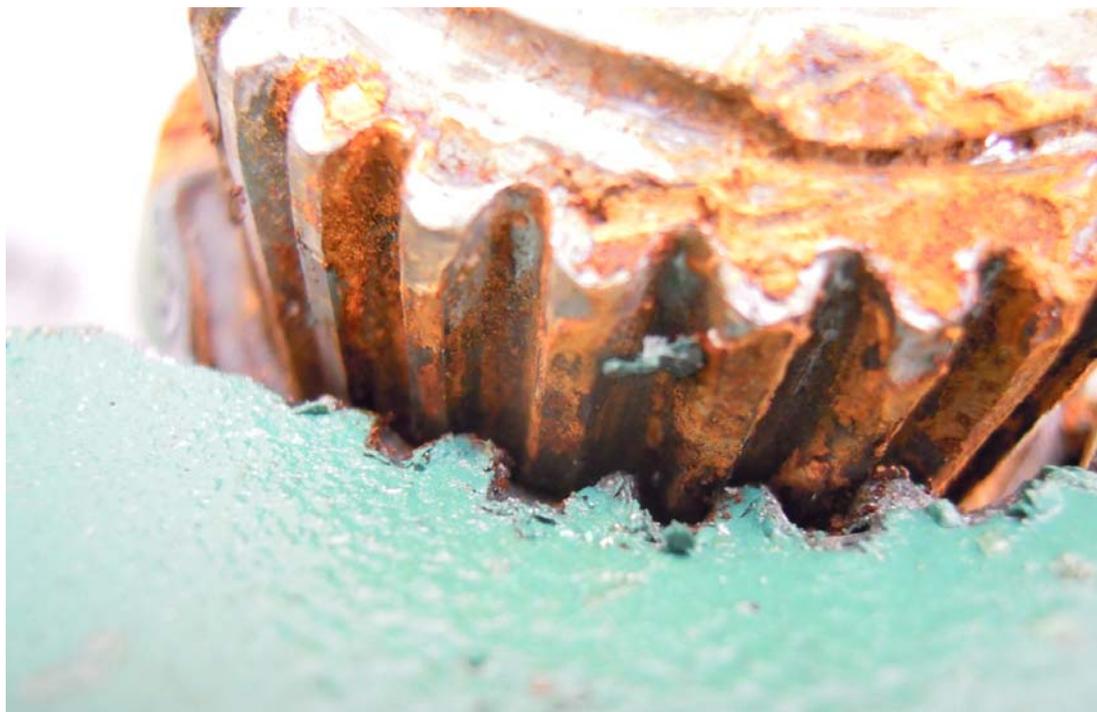
*Figure 20. The gear teeth of the driving shaft correspond with the marks on the broken connecting casing thus proving that the shaft has hit the casing with a great force.*

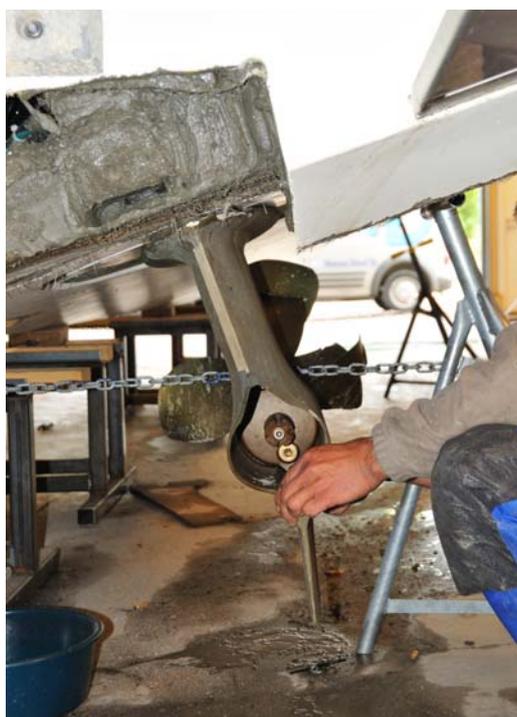
In addition to the propeller, also the skeg of the drive unit has received a severe blow from below. The skeg has broken loose by caving in to port.

*Figure 21. When fitting the skeg of the starboard drive unit back into its place, it could be observed that it had yielded to port before it had come loose. When intact, the skeg was in the same line with the body of the drive unit. The picture was taken after a test sample was cut from the transom. There is plenty of clay in the engine compartment.*

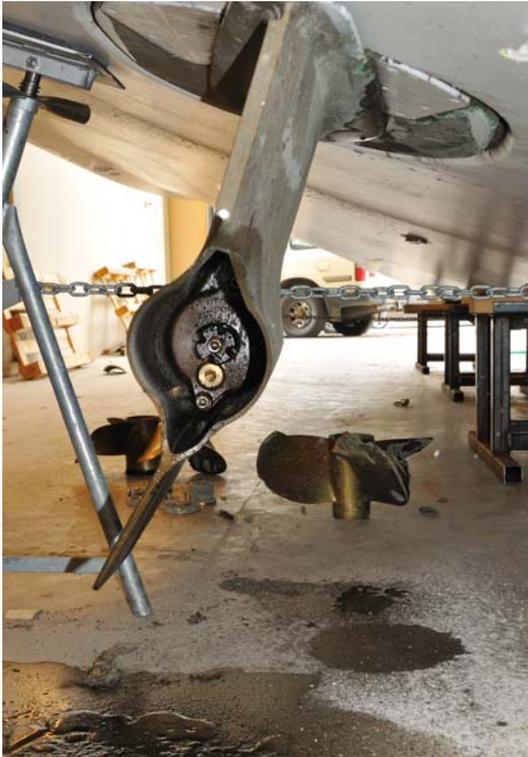
The port drive unit has also received an impact on the propeller and the skeg. Each propeller blade has been damaged, by approximate visual observation the shaft line is intact and the skeg has deflected to port. The impact indicates that the shaft has stopped more slowly than in the starboard drive unit. The impact to the port drive unit has been weaker than the impact directed to the starboard drive unit.

*Figure 22. "The port drive unit". The skeg of also the port drive unit has deflected towards port.*

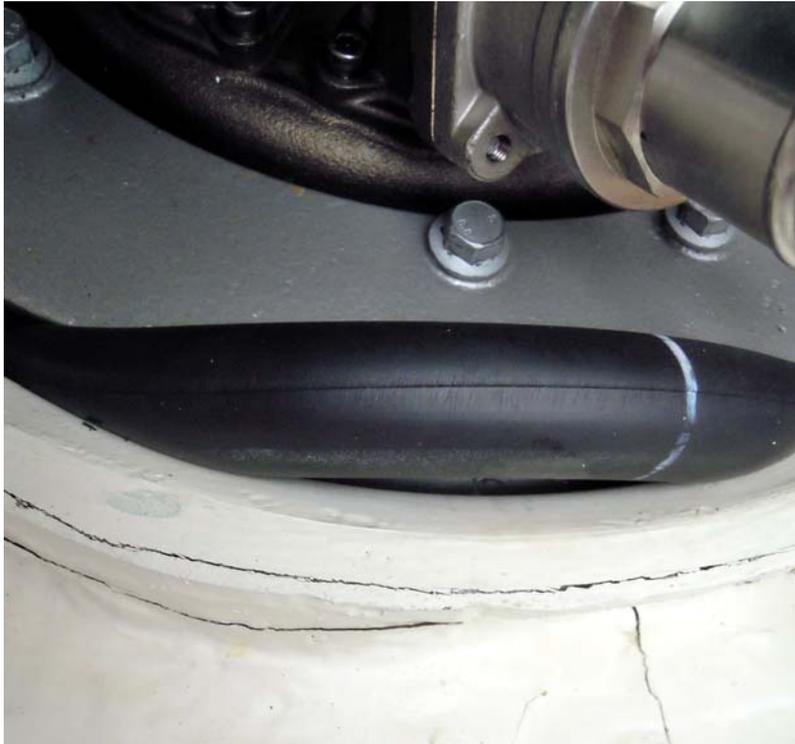
The mount ring of the starboard drive unit broke partly loose from the bottom of the boat because it was mounted weakly. The large O-ring of the mount collar of the IPS drive unit slipped out from its grooves. This caused extra leakage into the engine compartment.

It is worth noticing that the large O-ring between the drive unit and the mount collar attached to the bottom of the boat had slipped out from its groove (Figure 23). A similar phenomenon was discovered when investigating the IDA 1 accident. The O-ring had moved also in that drive unit of Jeanneau which otherwise stayed in its place and was intact as to its structure (Figure 24). On the basis of this it can be concluded that a strong shift of the drive unit in its mounting alone can cause the O-ring to slide from its groove without causing any special damage to the structure of the boat or the drive unit. If the O-ring does not stay in its place, the result is a severe risk of leakage. From a technical point of view, whether the O-ring stays in its place and the drive unit breaks in a controlled way are two separate, unrelated phenomena.

*Figure 23. The O-ring between the drive unit and the glassfibre mount collar had slipped out from its groove thus generating an extra point of leakage. Note also that the laminate had broken at the mount collar.*

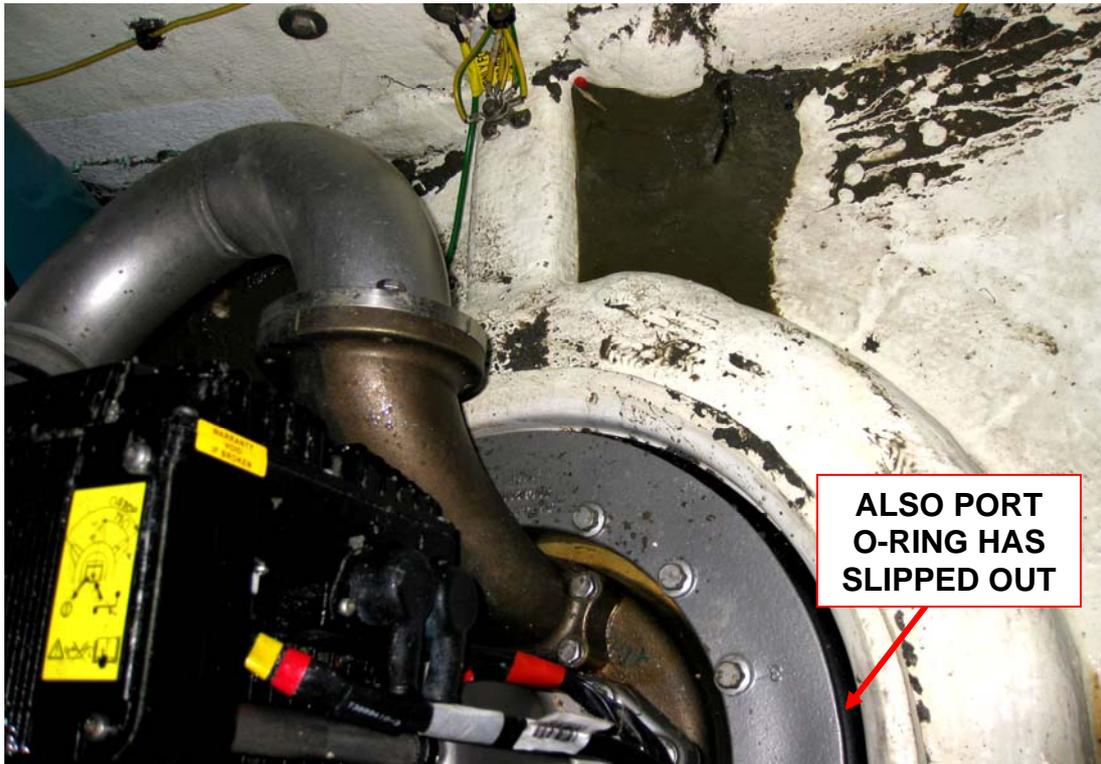
Figure 24. The O-ring of the port drive unit had also slipped out even though the impact on this drive unit was weaker.

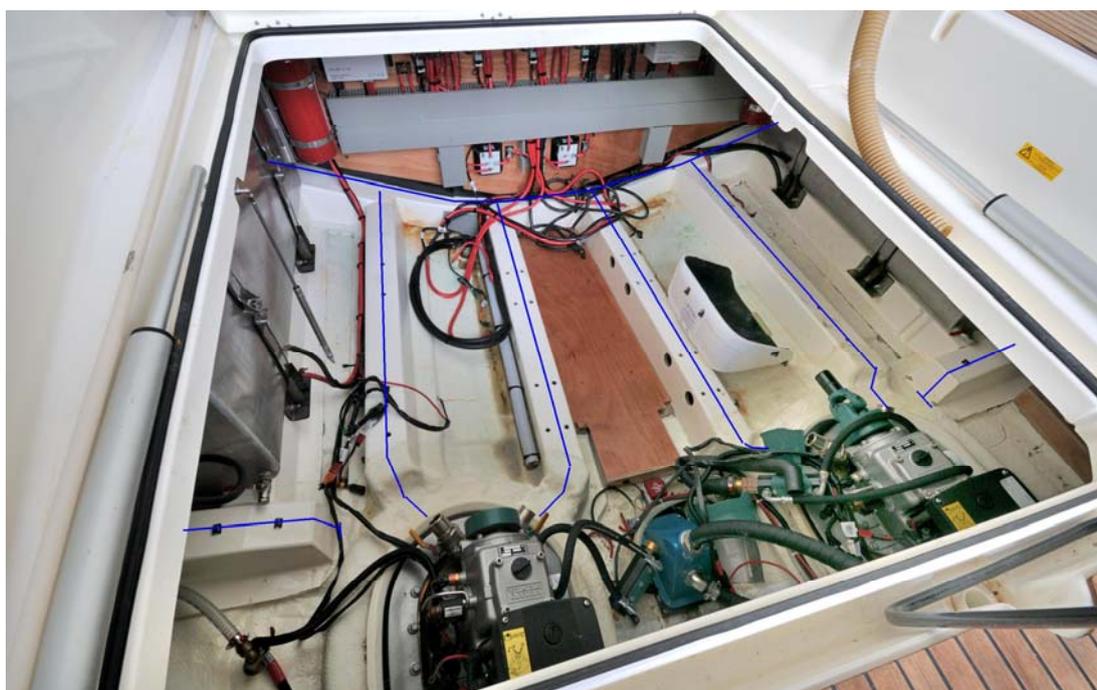
From the perspective of the mechanics of materials, the structure comprises discontinuity points which make the structure weaker. The marks on the bottom of the boat show that the structure has cracked and yielded in several places.

Figure 26. *Picture of the engine compartment after it had been cleaned and after the engines had been removed. The blue line indicates the location of the bottom stringers and the points where they have been cut off and attached to the mount ring. The joints had been laminated over a sleek surface, and in addition, from the mechanics of materials perspective, precarious discontinuity points weakening the structure were formed.*

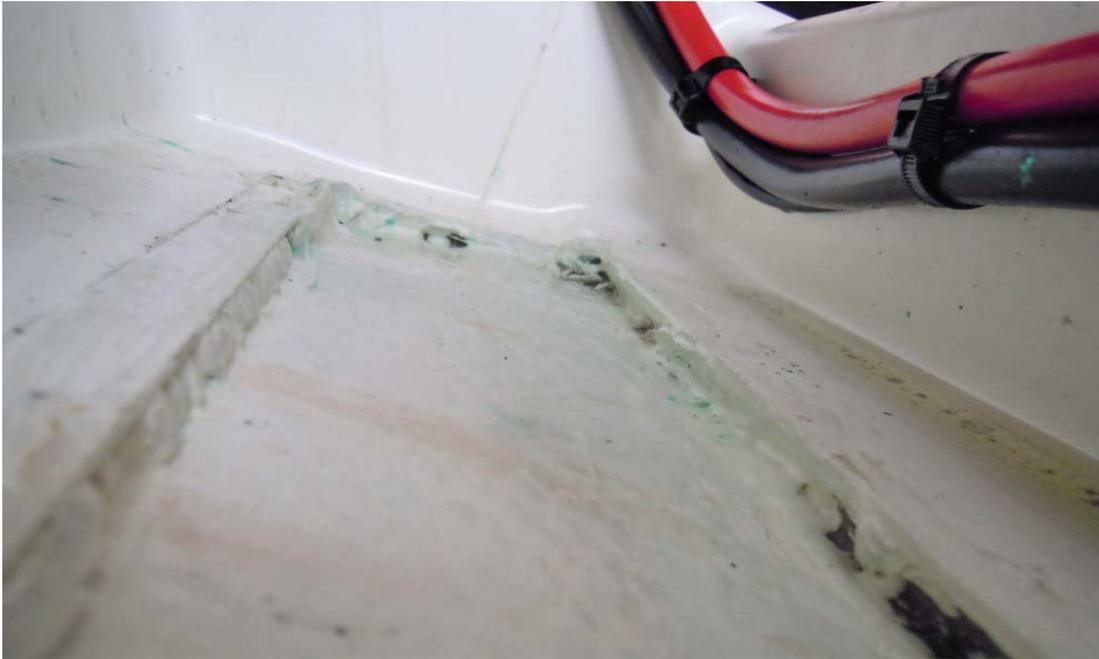
Figure 27. Bottom stringers have been jointed to the hull with glue mass. The fitting of the parts has not been accurate.

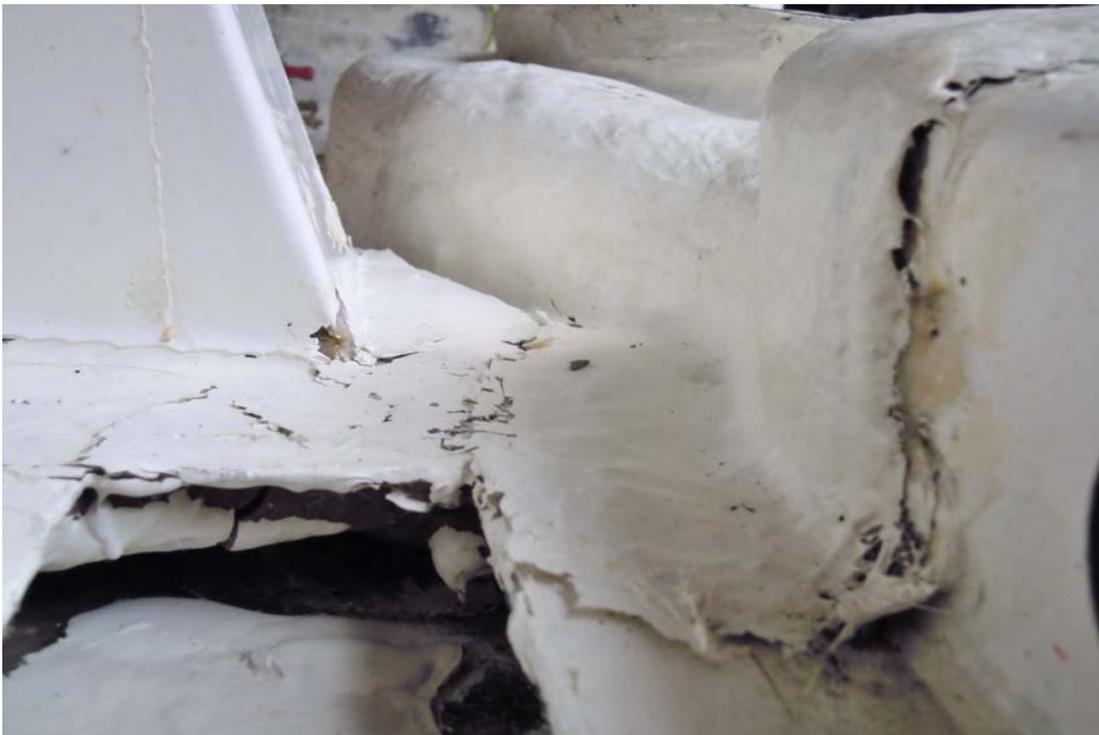
Figure 28. The stringers of the bottom and jointing them to the mount ring. According to the investigators' view, all the gaps visible in the picture have not been caused by the accident but the parts have been loose from each other already before the accident. This is indicated e.g. by the topcoat partly flowing down under the joint surfaces. The strength of the structure is questionable considering the fact that in an IPS drive unit the thrust moves to the hull by the transmission of this structure.

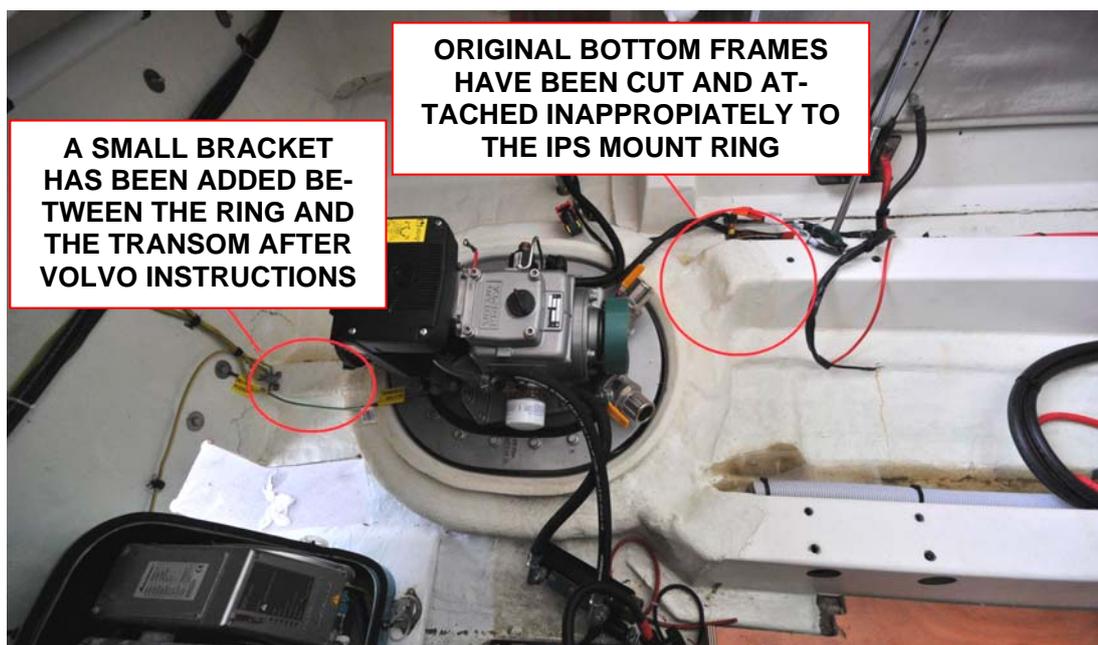
*Figure 29. The IPS mount ring has been attached to the bottom frame by cutting off the stringers and then making between the ends of the stringer and the ring a poorly completed joint from the point of view of strength. The picture portrays the port engine bed which remained intact. The point between the bottom and the transom from where the test sample was cut can also be seen in the picture (Figures 14 and 15).*

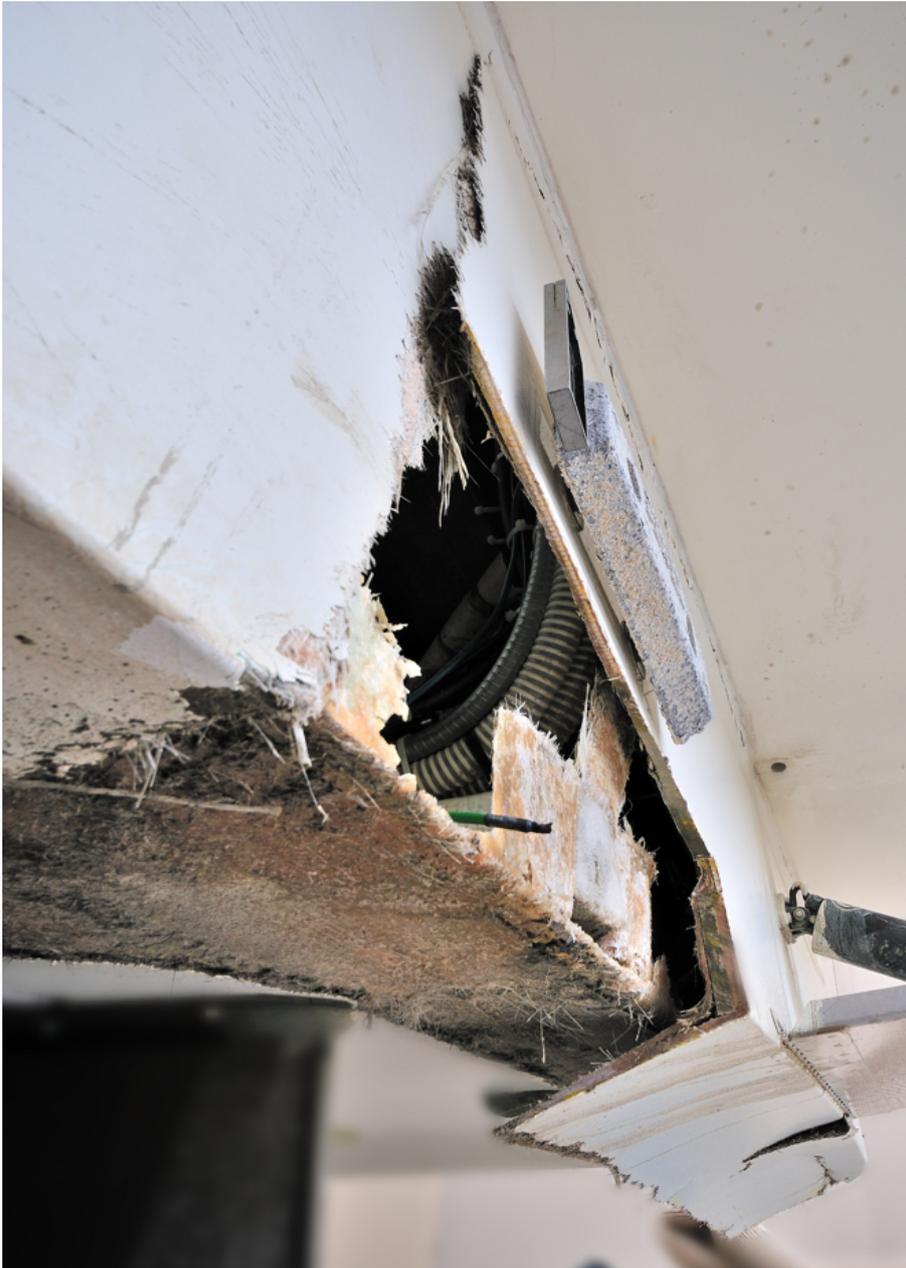
Figure 30. In the picture taken after the test sample had been cut it can be clearly seen how the transom and the bottom have torn loose from each other. Reinforcement layers have not been lapped in turns but the transom has been completed first and the bottom of the boat has been laminated on it (in a mould). The parts have come loose from each other along the joint between them. The bracket attached in a careless manner between the transom and the IPS mount ring can also be seen in the picture.

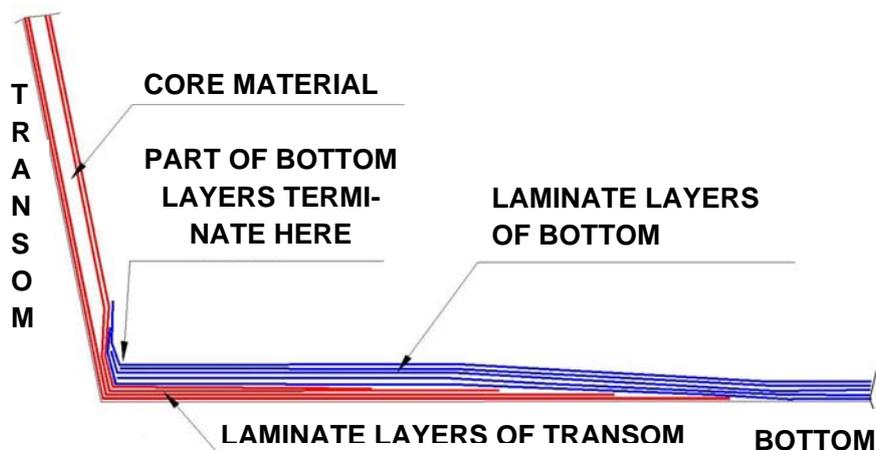
Figure 31. A principle drawing of the joint between the bottom and the transom on the accident boat. The joint between the bottom and the transom had been made by lapping layers of glassfibre. In addition, the rowing-layers of the bottom had been completed only to the corner of the transom. The transom was very thin and became sandwich structure immediately above the bottom. The figure must be compared with the profile picture (Figure 14) and with the picture taken of the broken structure (Figure 15).

The correct method would have been to laminate layers in turns thus lapping them on each other (Figure 32). Reinforcement layers should not have been cut off immediately before the corner, and the overall thickness of the laminate should have been increased at the corner area so that the stress caused by the corner would not have become too high.

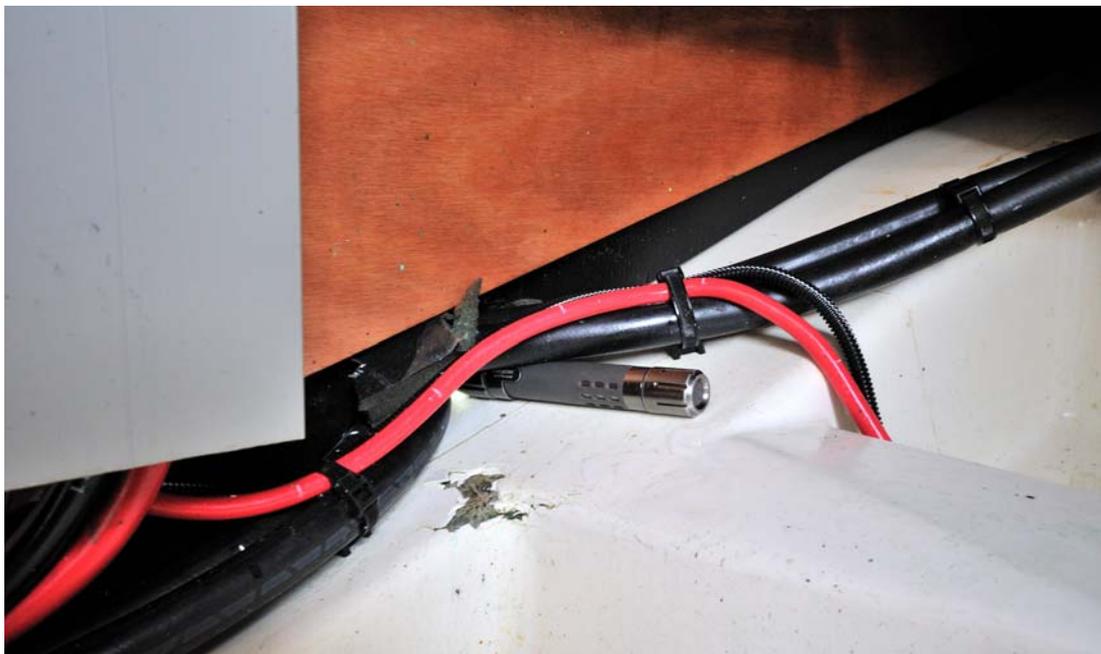
Figure 33. The gap between the plywood bulkhead and the glassfibre structure was filled with Styrofoam. It serves as the lead-through point for hoses and cables. By the way of example, also the hand torch of the investigator has been pushed under the bulkhead in the picture.

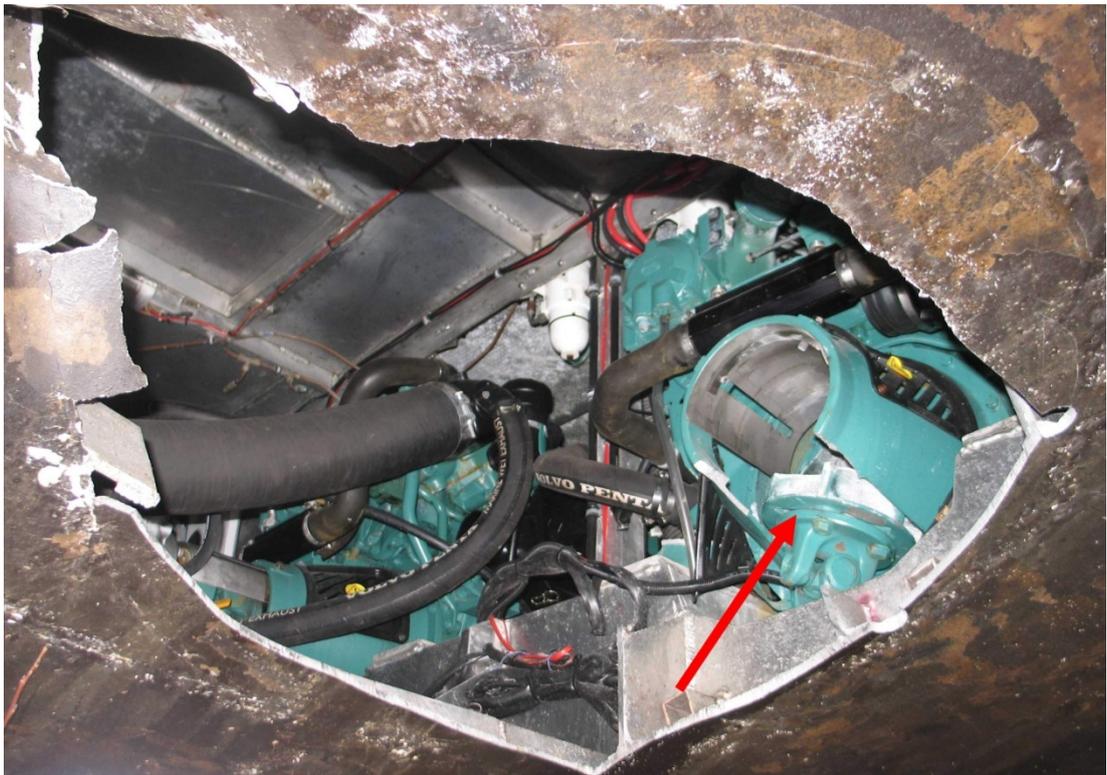
Figure 1. The hole cut in the bottom of IDA 1 after the drive unit had been dismounted. The arrow points to the broken shaft coupling.
