## Investigation Report

C3/2010M

### **JEANNEAU PRESTIGE 42S, A-58990 (FIN), sinking off In- koo on 28 May 2010**

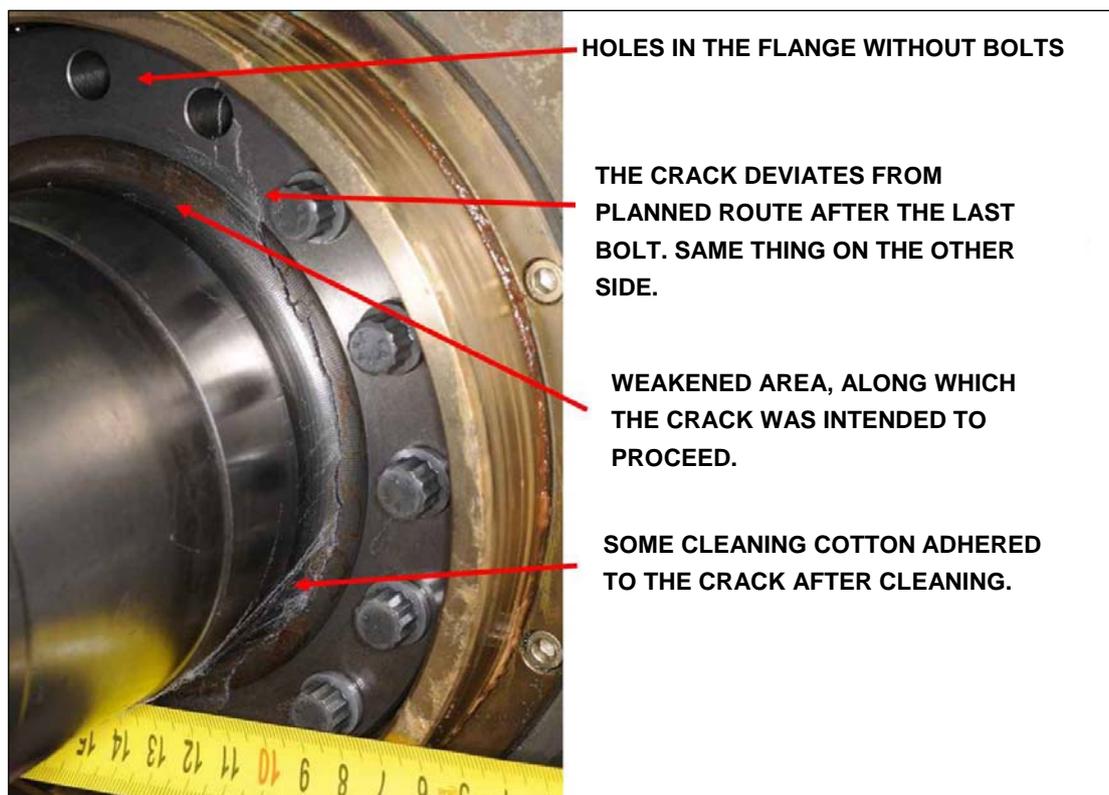
Figure 5. A detail from the other end of the breakage point.

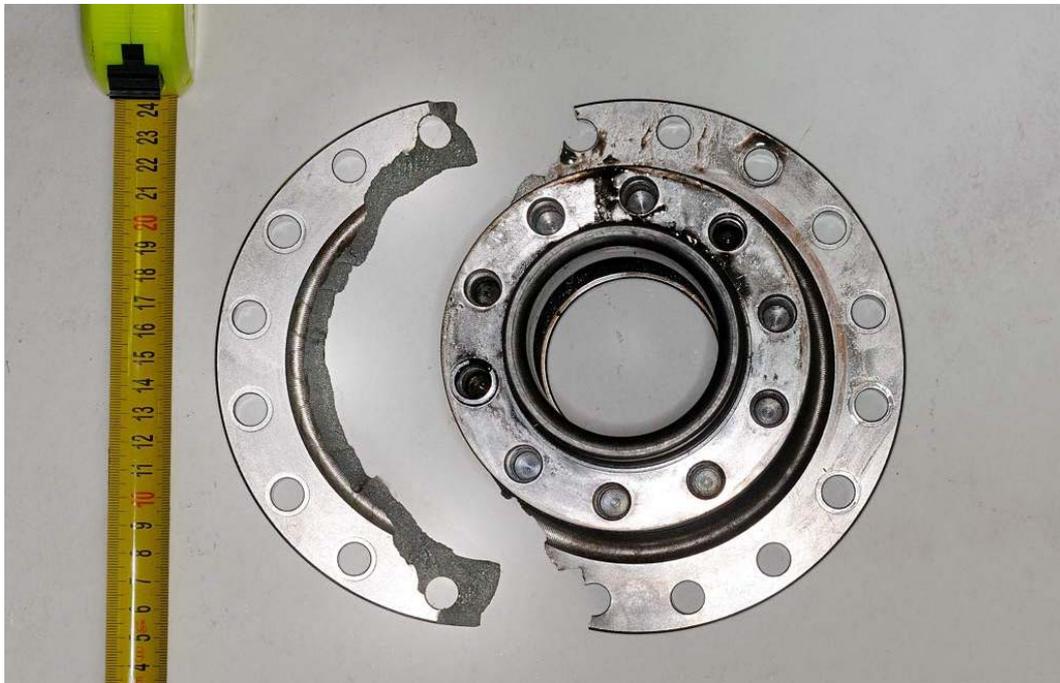
Figure 7. The pivot axle and its partly broken flange.

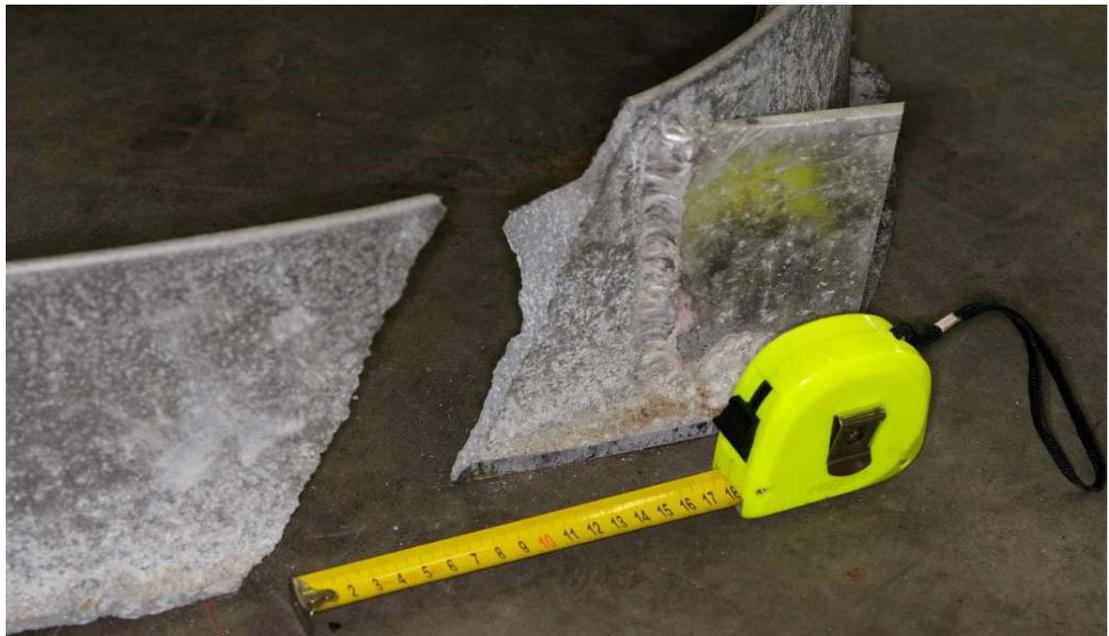
Figure 9. Breakage point of the aluminium collar.

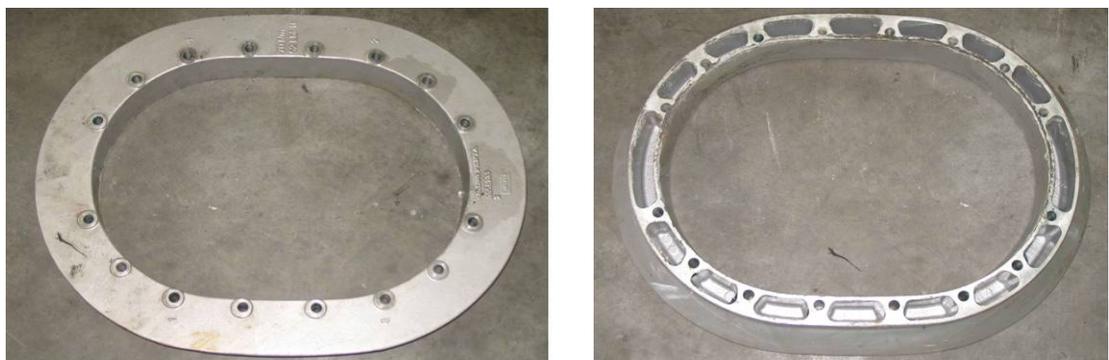
Figure 10. Mount ring from above (left) and from below (right). The mount ring was intact.
