## Investigation report

C6/2010M

# **M/S NORDLAND (NLD), Grounding in the Archipelago Sea on 13 October 2010**

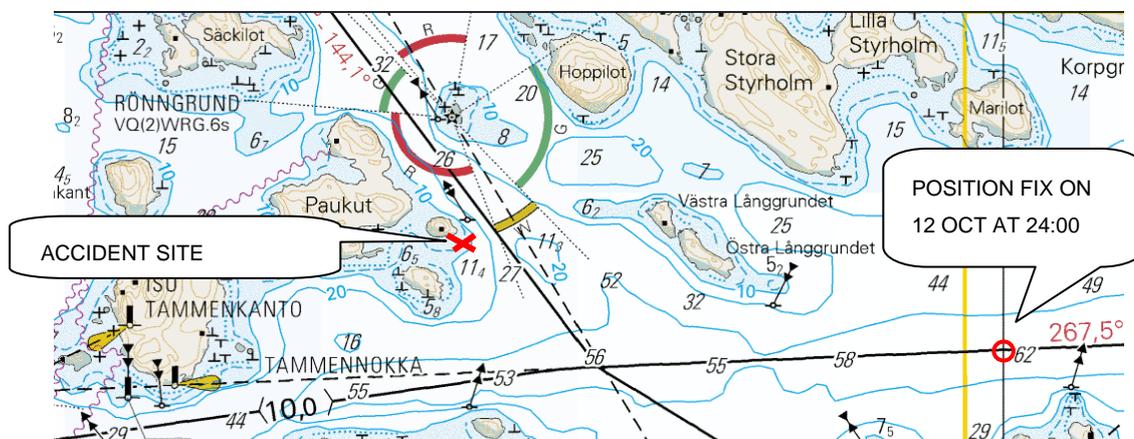
Figure 3. The accident site and the final position fix on 12 Oct at 24:00.  
(© Finnish Transport Agency / Source: Sailmate)

The accident site is located west of the 10 m Airisto – Isokari channel, southwest of the east spar buoy which is south of the Rönnggrund sector light, at 60°16.2'N 021°47.2'E between the islands of Paukut and Hoppiluo.

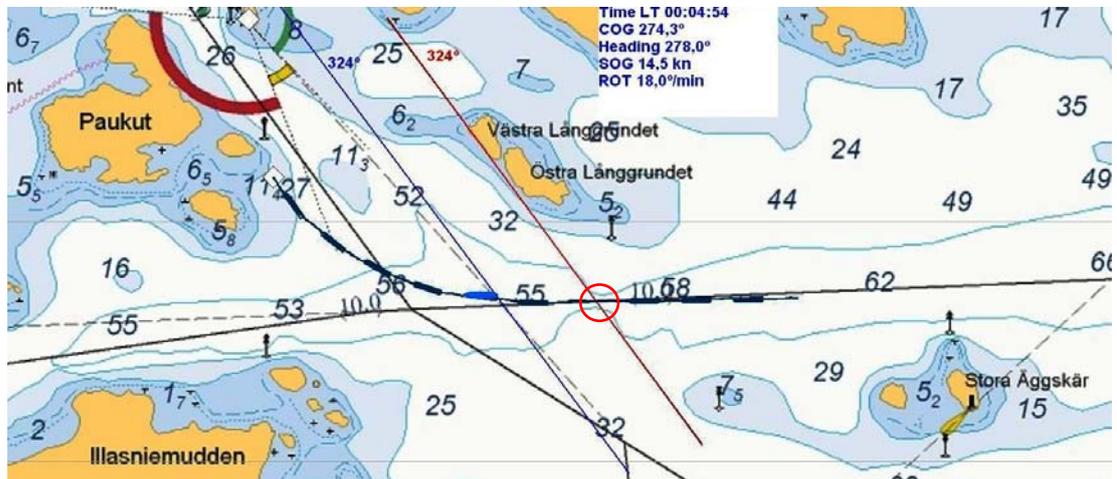
Figure 4. The ship symbols are plotted on the basis of the S-VDR recording. The red circle indicates the point where the pilot, according to his passage plan, intended to commence the turn to starboard on a COG of 269° at 14.5 knots. The pilot said that he set the autopilot heading to 300°. As per the VDR recording the heading at the position of the light blue ship symbol was 278°. The vessel continued to move in an almost straight line with a COG of 272° for 67 seconds after the pilot, according to his account, changed the heading. The Rönnggrund sector light changes from green to white. The distance between the blue and the red ship symbols is 0.27 NM and the change in heading at that time is 9°. There is a delay in the onset of the turn, which can partially be explained by the fact that the vessel only begins to turn 80 metres after receiving the steering input. (Chart: The Finnish Transport Agency, presented using Uusi Loisto programme)

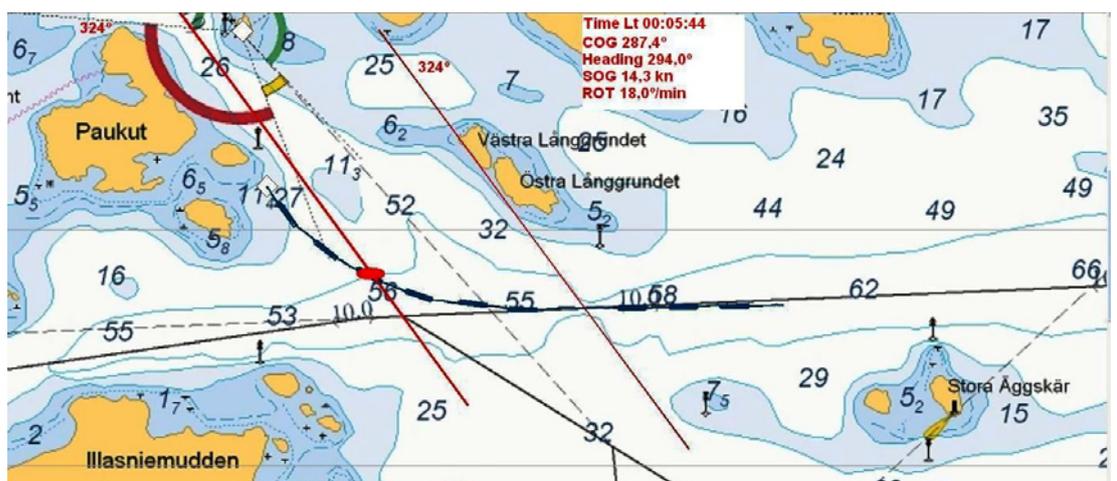
Figure 5. The heading of the vessel is 294° at the position of the red ship symbol, when it was on the 324° Kuiva Kalsaari line. At the master's maritime declaration hearing the pilot said that, at this point, he set the autopilot to a heading of 335°. (Chart: The Finnish Transport Agency, presented using Uusi Loisto programme)

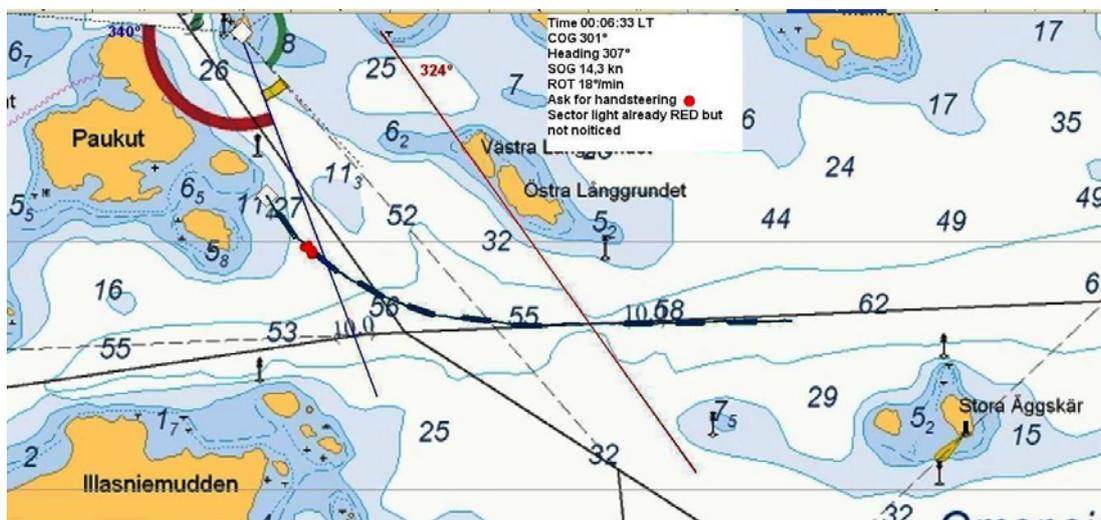
Figure 6. The vessel was in the red sector of Rönngrund. Heading 307°. The pilot and the master noted that autopilot action was a bit slow. The east spar buoy had disappeared into sea-clutter on the radar display. The pilot asked for hand steering with which he then turned the rudder angle 20° to starboard. A moment later he eased the rudder, lest the stern hit the east spar buoy. (Chart: The Finnish Transport Agency, presented using Uusi Loisto programme)

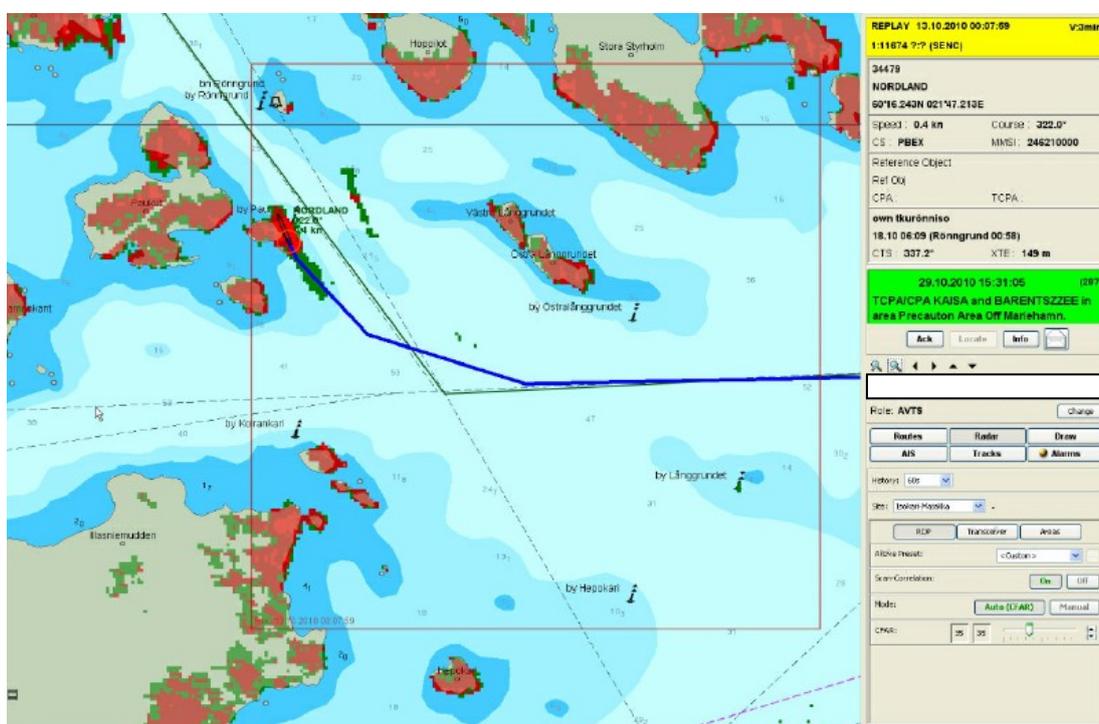
Figure 7. Related VTS recording at 00:07:58. According to the S-VDR recording the grounding took place at 00:07:30. (© The Finnish Transport Agency)

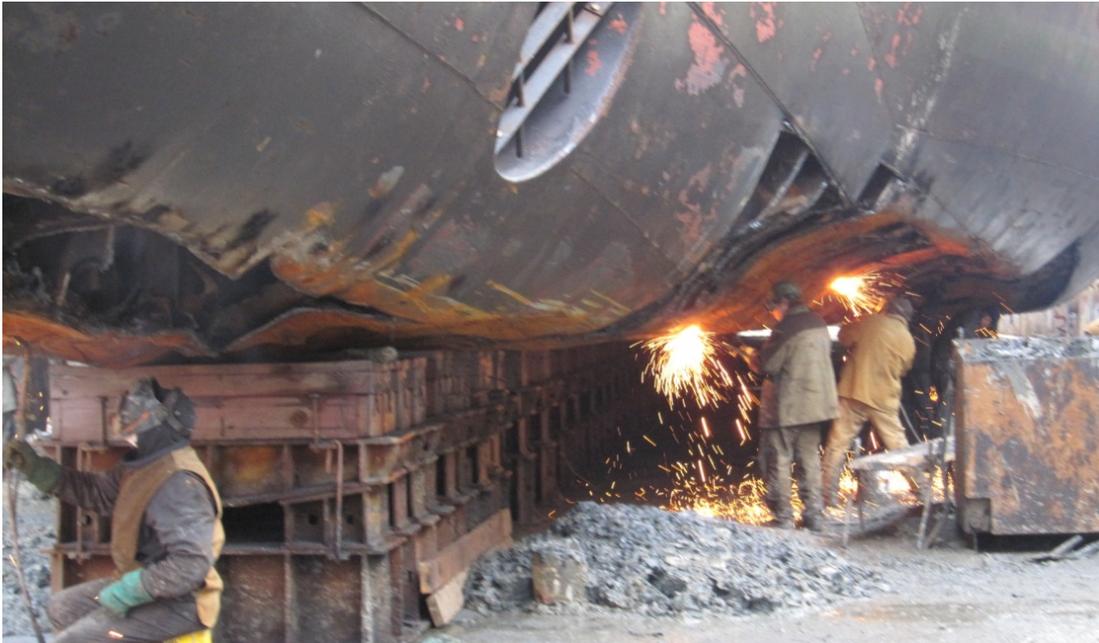
The following water ballast tanks sustained leaks: Forepeak, deeptank, side tanks 1 PS and 1 SB, side tank 2 PS and tank 3 centre. In addition, the bowthruster/pumproom sustained a leak. The damage was concentrated in the bow section. The propeller and the rudder remained intact.

Figure 8. Damage to the port side of the bow.

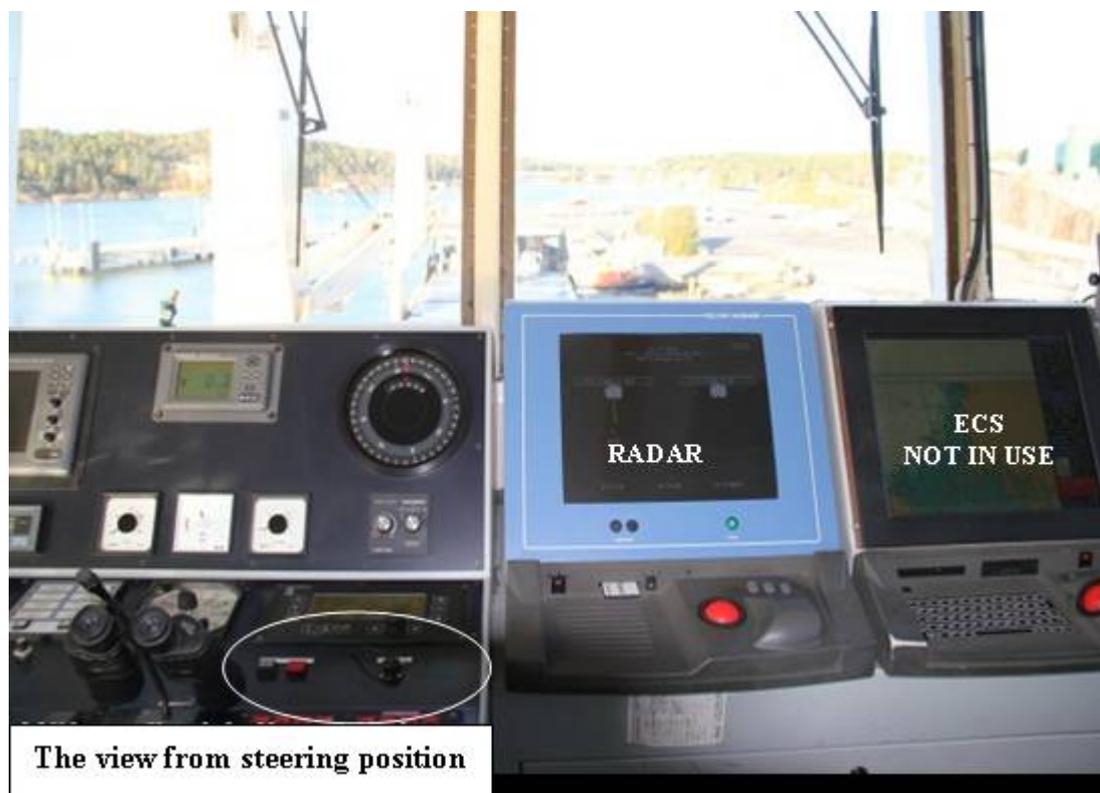
Figure 9. The pilot's steering position. The white ellipse shows the Pilotstar D autopilot.

Figure 9 shows the 3 cm Kelvin Hughes radar display and paper charts as well as the DGPS navigator which were used in navigation and the Pilotstar D autopilot which was used in steering. A VHF telephone was used in communicating with the outside world.

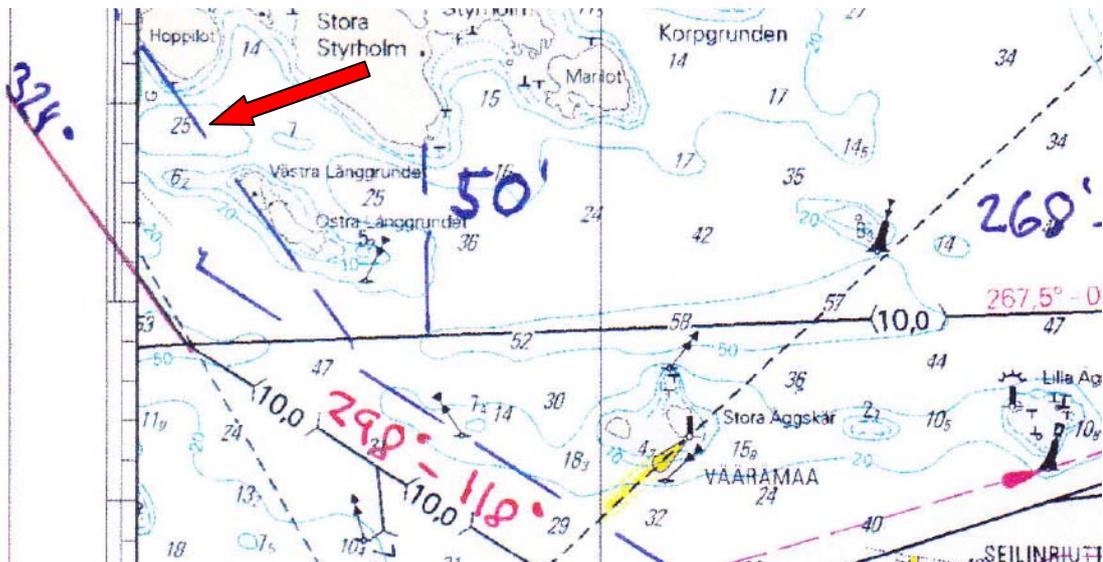
Figure 10. An excerpt from the pilot's passage plan. The red arrow indicates the Electronic Bearing Line (EBL) on the 324° Kuiva Kalsaari line. It is intended for radar navigation, indicating the wheel over point (WOP) when the EBL separates from the island of Östra Långgrundet. The passage plan has been prepared as a general one and vessels with smaller draft have not been taken into account.

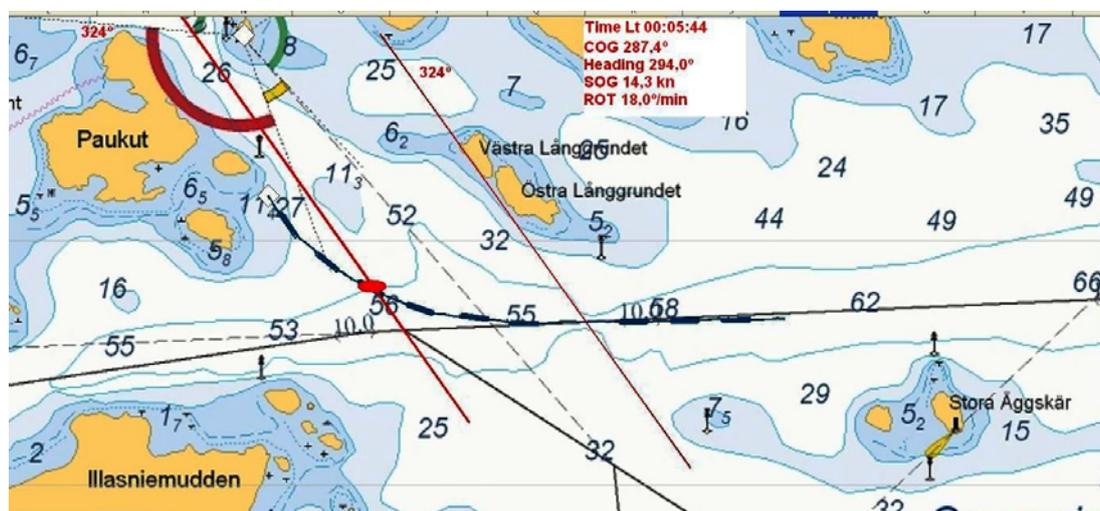
Figure 11. In this phase of the turn (red ship symbol) it was already clear that the turn to the 324° Kuiva Kalsaari line would fail. Since the turn was still incomplete by 30° by terms of heading and even more by the COG, they should have made effective steering inputs at this stage, at the very latest, and changed over to hand steering. It is likely that the bridge team partially lost situational awareness of the ship's true position in relation to the fairway. The fact that the east spar buoy was lost in sea-clutter also contributed to this to some extent. A good indication of the loss of situational awareness is the steering input which attempted to prevent the stern from hitting the east spar buoy. (Chart: The Finnish Transport Agency, presented using Uusi Loisto programme)

The turn was divided into three segments, which tends to confuse the autopilot and slow the turn. Normally turns are completed in two segments: the first segment aims to achieve the new course as close as possible, after which the heading is adjusted. Even though the pilot was familiar with the autopilot type in question, an input error cannot be excluded.

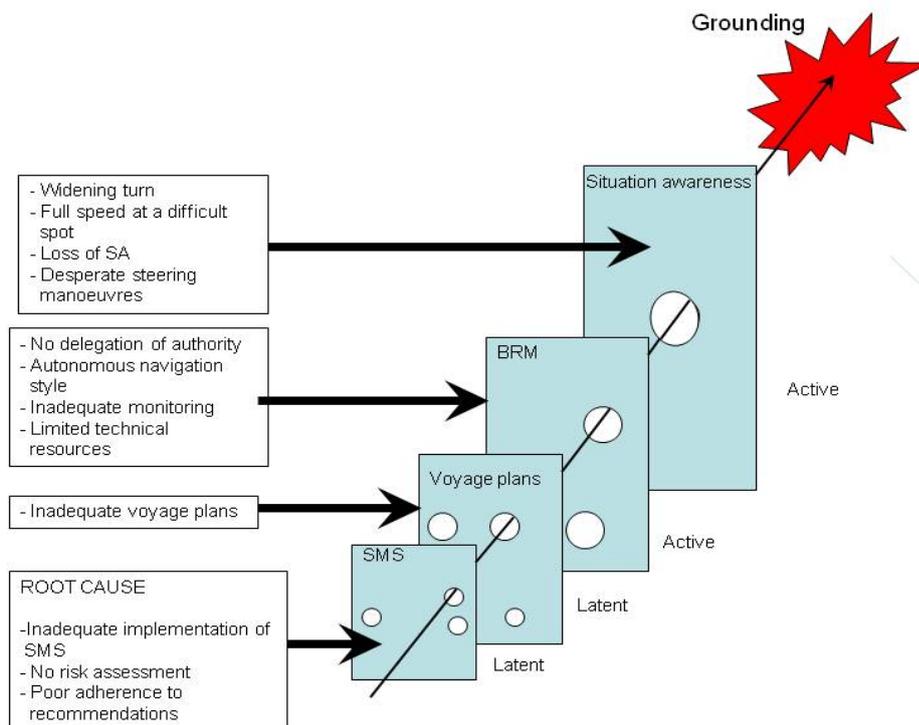
Figure 12. The course of events, illustrated by the Reason model.
