Investigation report

D10/2010M

MSC LIESELOTTE, serious accident in ship's cargo hold on 1 June 2010

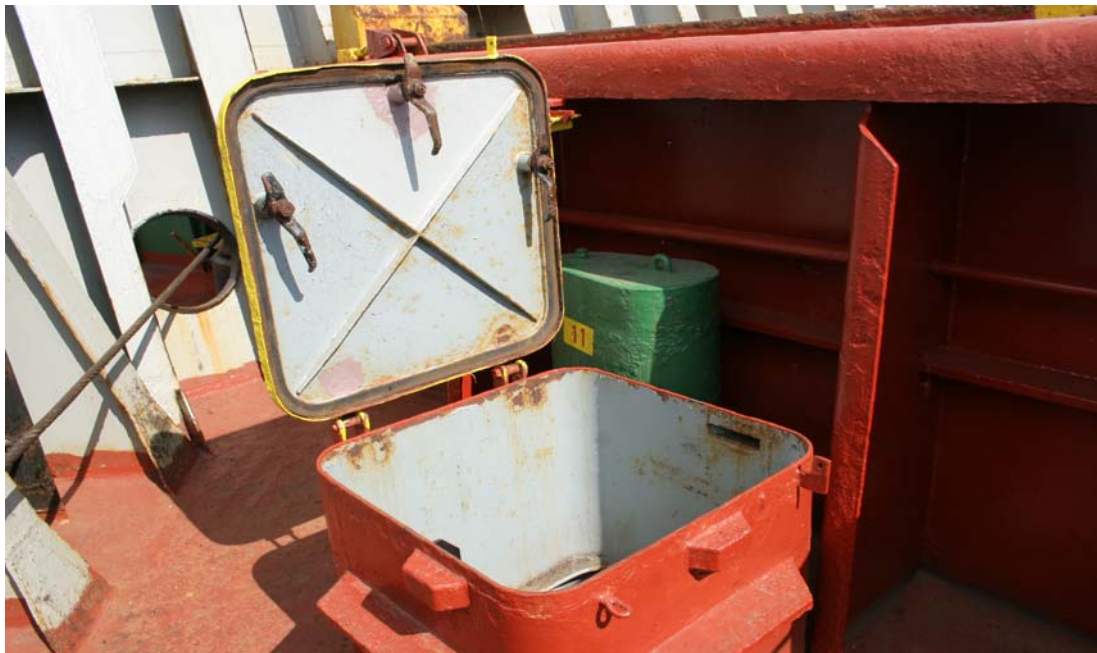
Figure 2. Manhole to hold no1 in Port side (Kymenlaakso Police)

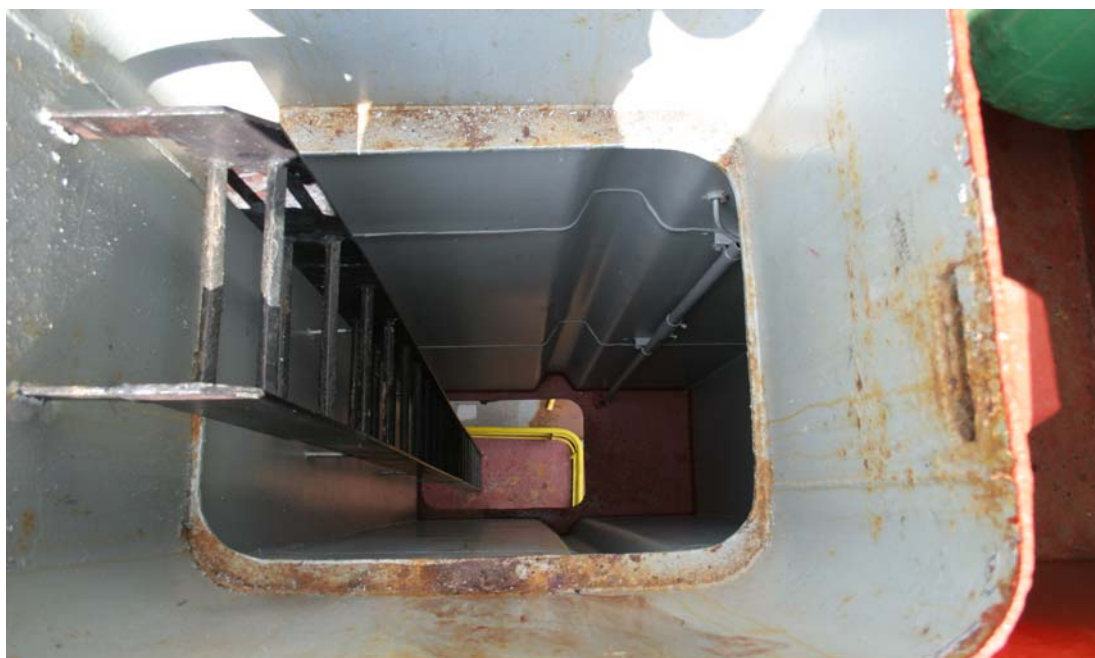
Figure 3. Casing to the cargo hold. (Kymenlaakso Police)

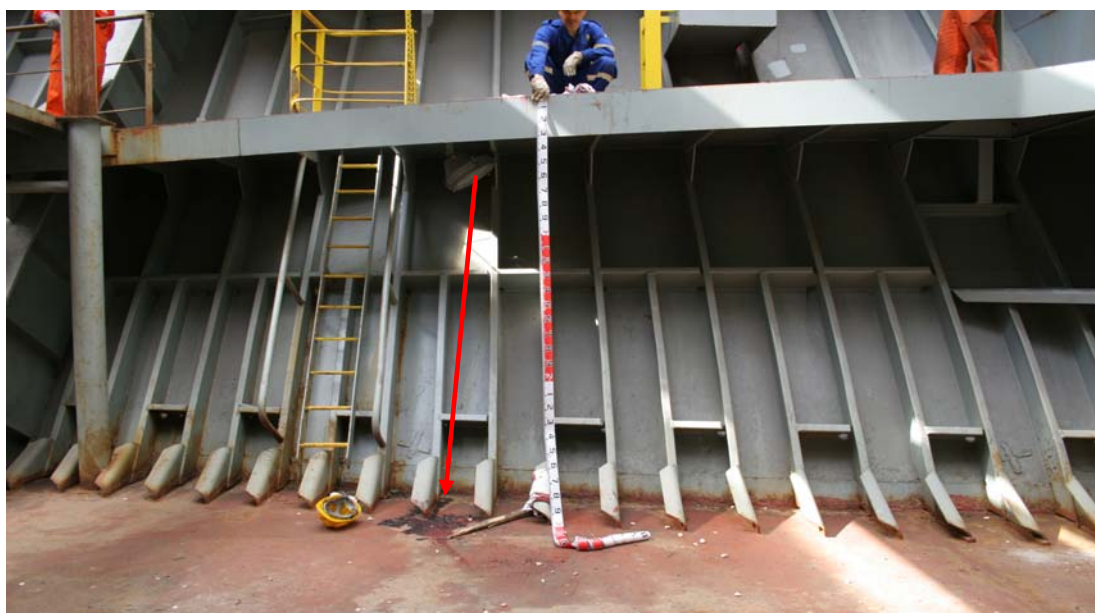
Ladders end up to the tween-deck which can be seen in the figure 4. The hatch covers of the hold were closed and the lights were out of order. It was completely dark in the hold. According to the Electrician trainee they had torch lights with them. The red arrow in Figure 4 shows the place where the Chief Electrician fell.

Figure 4. It's about 3 meters from the tween deck to the bottom of the cargo hold. (Kymenlaakso Police)

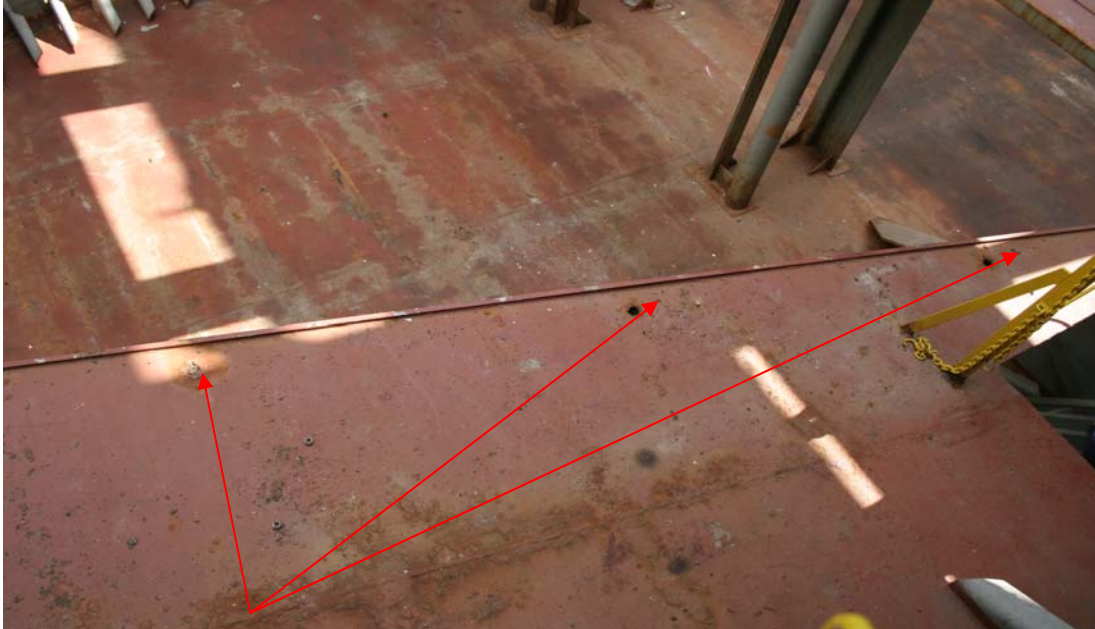
The tween-deck from where the Chief Electrician had fallen can be seen in Figure 5. It was not known, when the safety fence of the tween-deck had been removed.

Figure 5. The holes for the removed safety fence poles on the tween-deck. (Kymenlaakso Police)

The cause for the actual accident was that the safety fence of the Port-side tween-deck in the cargo hold had been removed. In addition it was completely dark in the cargo hold, since the lights in the cargo hold were out of order and the hatch covers were closed. The lighting of the hold was still out of order 2.6.2010 when the investigation was carried out.

A Safety fence has been installed to the accident site (Figure 6). The passage in the SB-side has been painted with warning coloration.

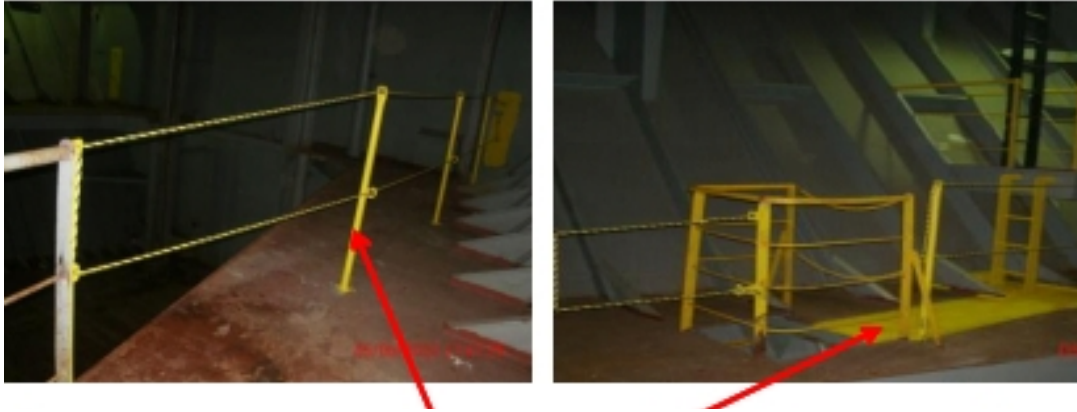
Figure 6. A Safety fence installed after the accident on the left and the painted passage on the right.
