Investigation report

B2/2011M

M/V AMAZON (BHS) and F/V FLORENCE (FIN), collision resulting in the sinking of the fishing vessel in the Gulf of Finland on 23 October, 2011

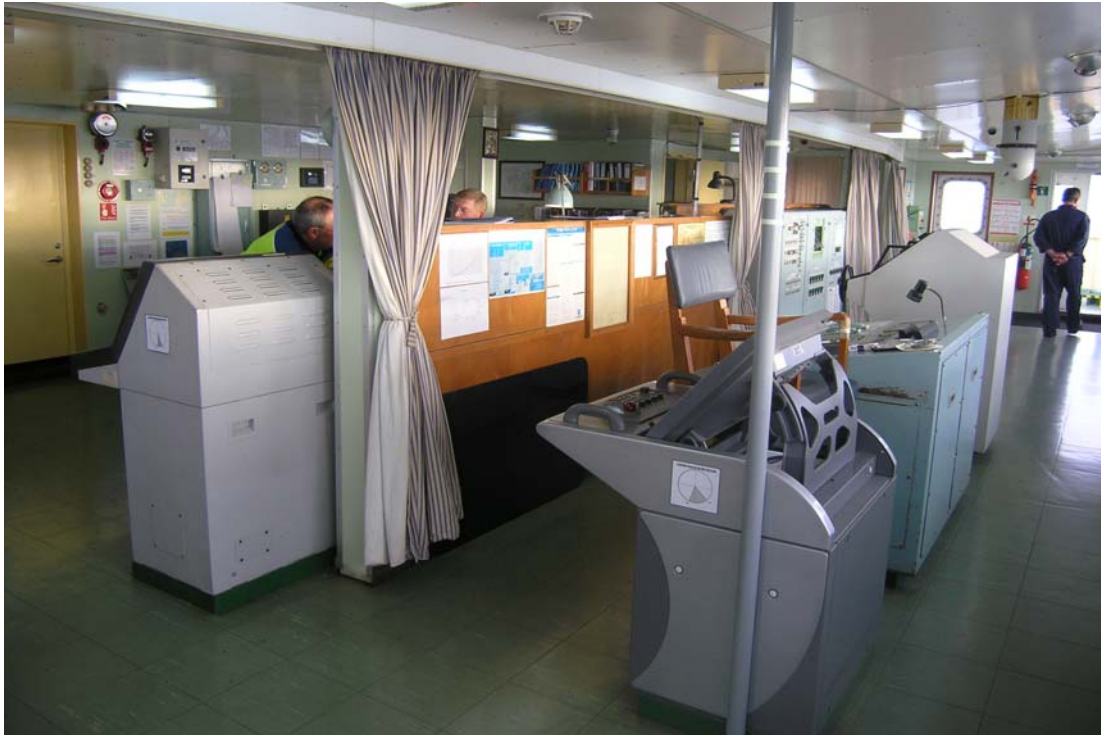
Image 5. The bridge of the AMAZON. In the dark the chart table is separated from the rest of the bridge with a curtain, as shown in the image. It obstructs the view outside from the chart table.

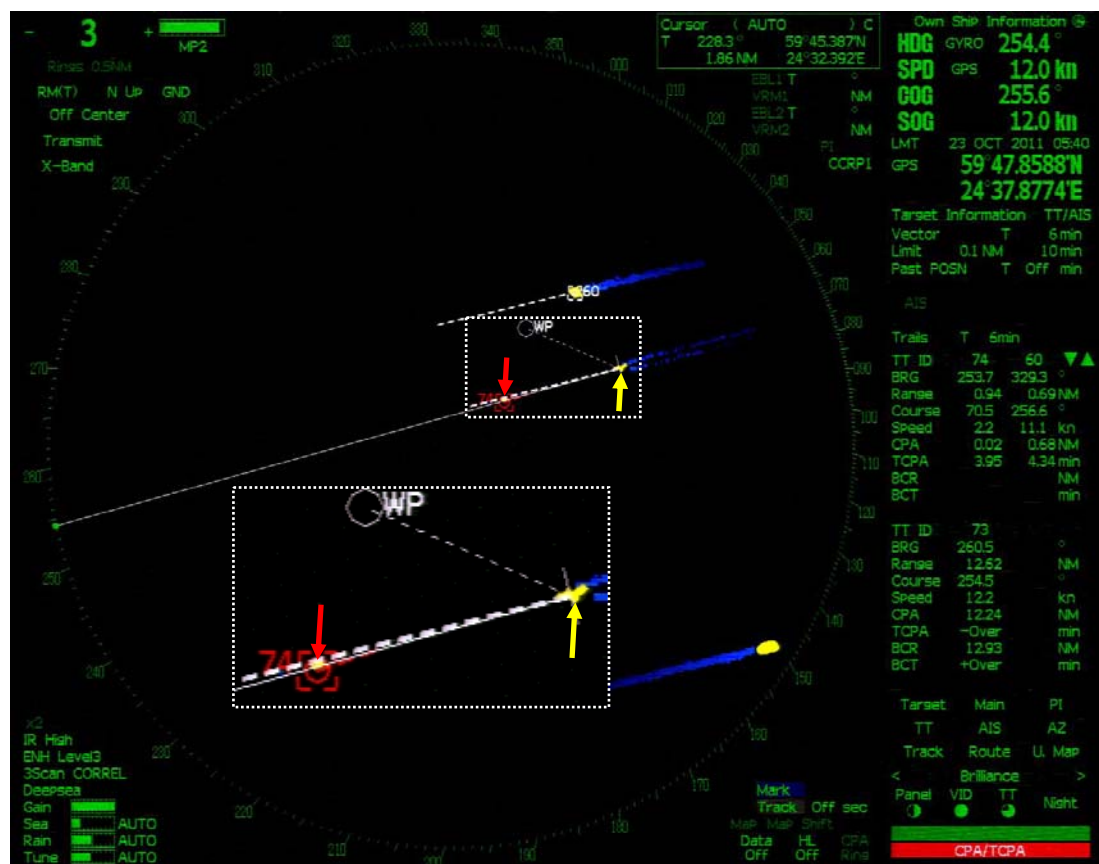
Image 12. A screenshot of the S-VDR recording¹⁵, some time before the AMAZON began changing her course. At 04:40:12, 3.5 minutes before the collision. The course of the AMAZON is 255.6° and speed of 12 knots. The AMAZON is marked with a yellow arrow and the MENHADEN with a red arrow; the echo of the FLORENCE is not visible on the radar. The fishing vessels are 0.94 miles away from the AMAZON. The STELLA POLARIS is shown on the starboard side of the AMAZON in the image.

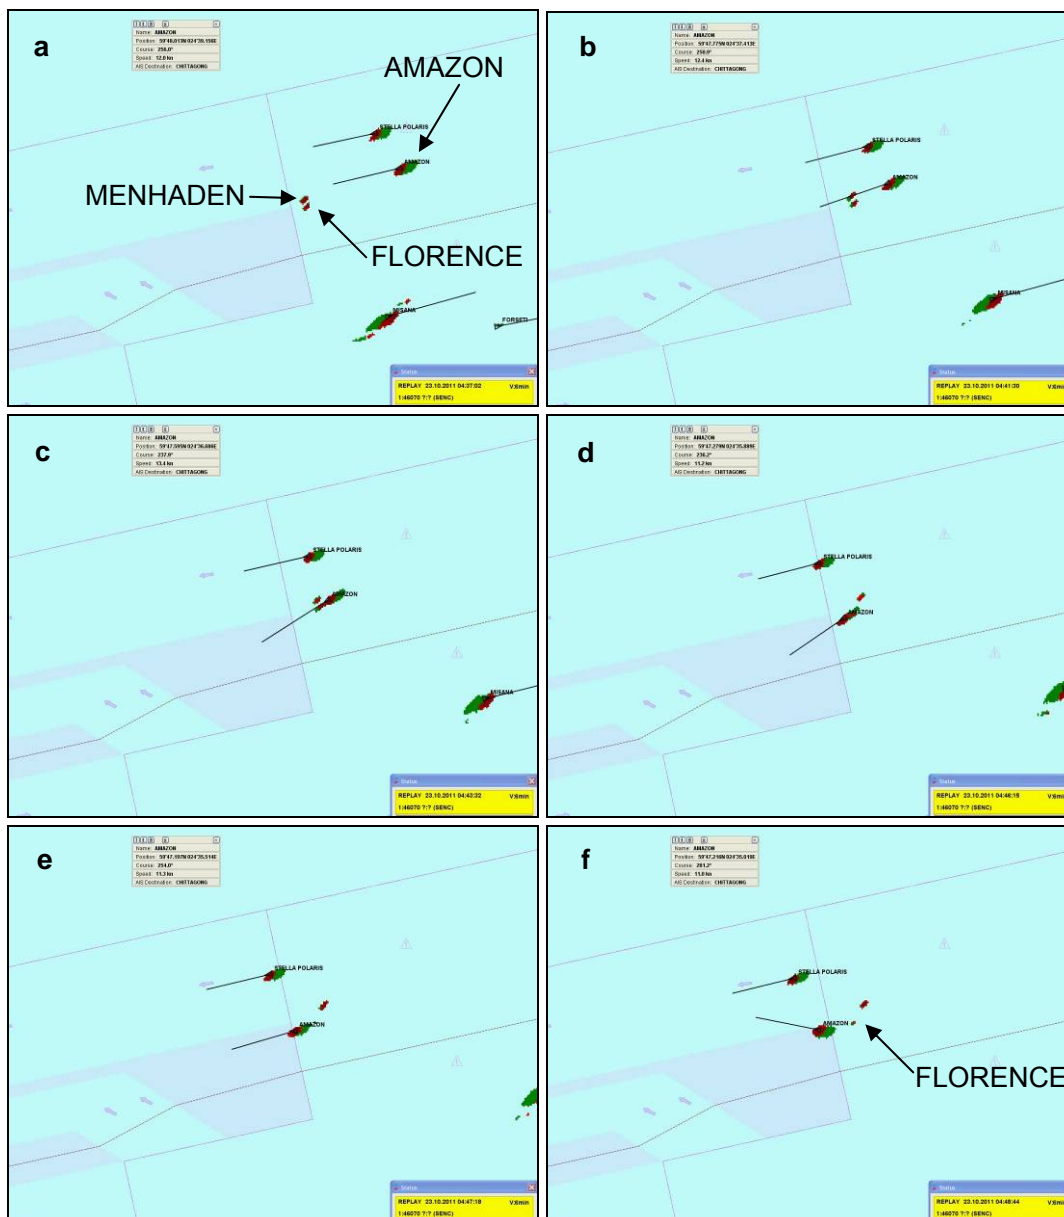
Image 15. Events during the collision according to the VTS recording.

- a At 04:37: the pairtrawling vessels MENHADEN and FLORENCE are moving north-eastwards on the precautionary area, against the recommended direction of traffic flow
- b At 04:41: the fishing vessel MENHADEN is on a collision course with the AMAZON. The AMAZON begins changing her course to the port.
- c At 04:43: The AMAZON has turned and is now on a collision course with the FLORENCE. At 04:44 the vessels collide.
- d The FLORENCE is dragged along with the AMAZON.
- e & f The FLORENCE has disengaged from the AMAZON and remains visible as a weak echo on the radar for about ten minutes.

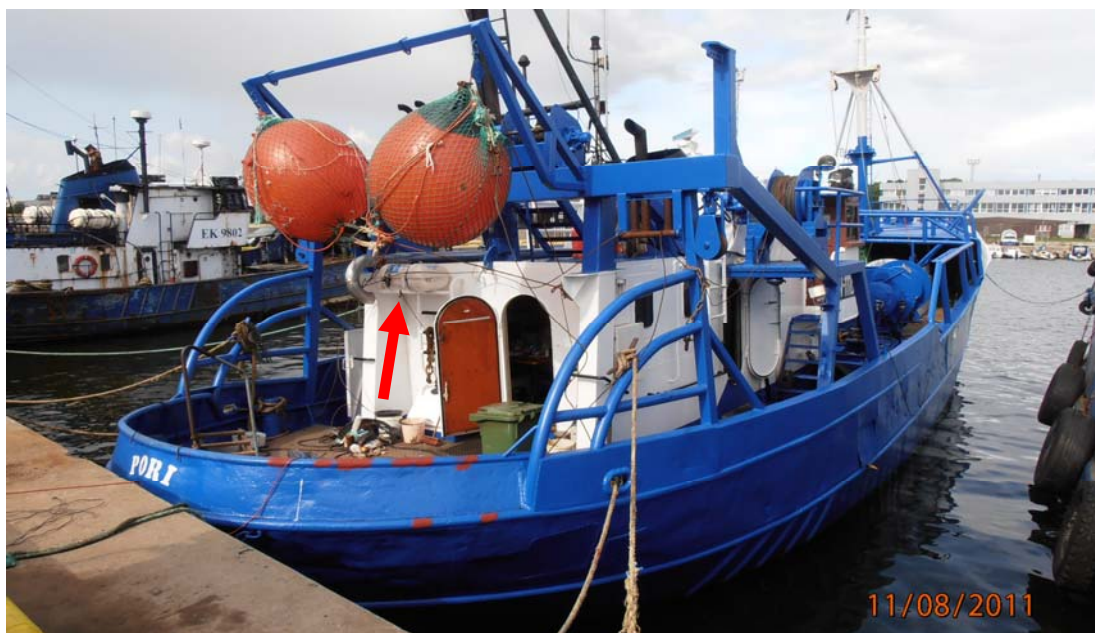
Image 16. The red arrow shows the location of the liferaft on the FLORENCE. The crew managed to escape the deckhouse through the backdoor open in the photograph.
(© Kalavara)

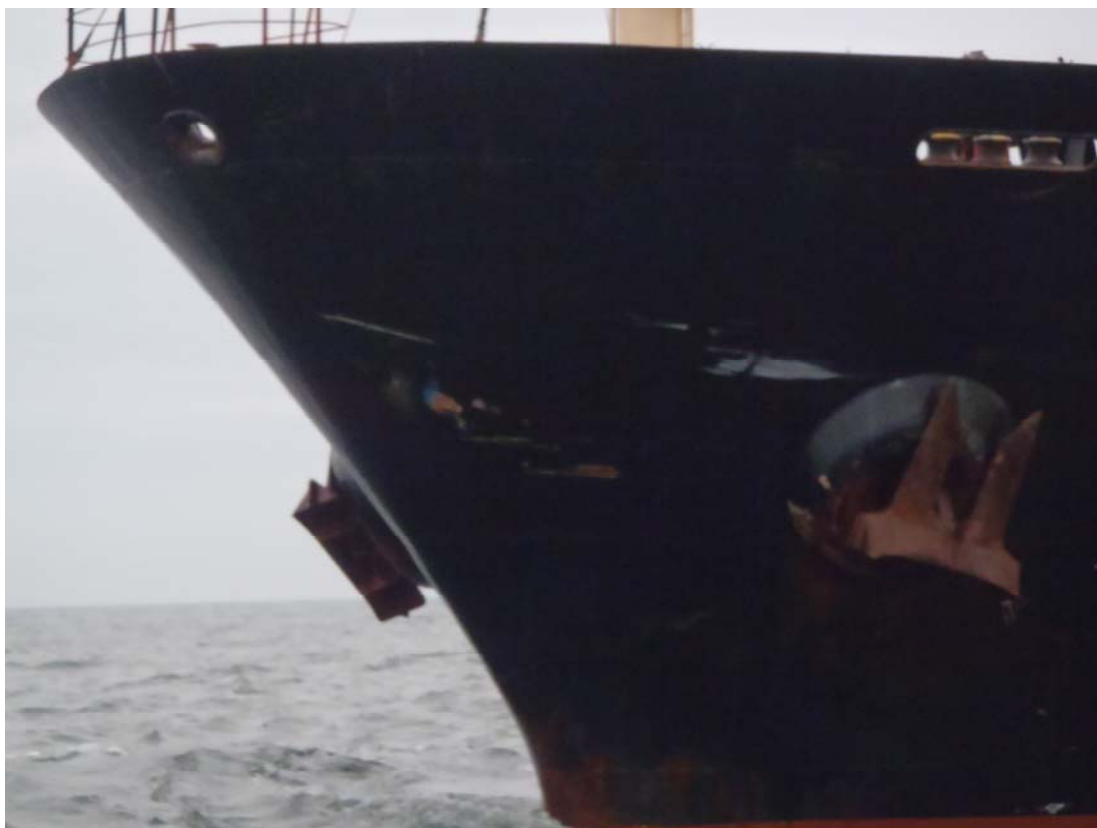
The AMAZON suffered little damage, consisting mostly of scratches and damage to the paint on the bow at anchor height and above the waterline on the port side (image 17). It was not possible to study the damages up close due to the weather conditions.

Image 17. Photograph of the bow of the AMAZON, taken while the vessel was detained in front of Hanko after the accident. Scratches and damage to the paint are visible on the port side of the bow.

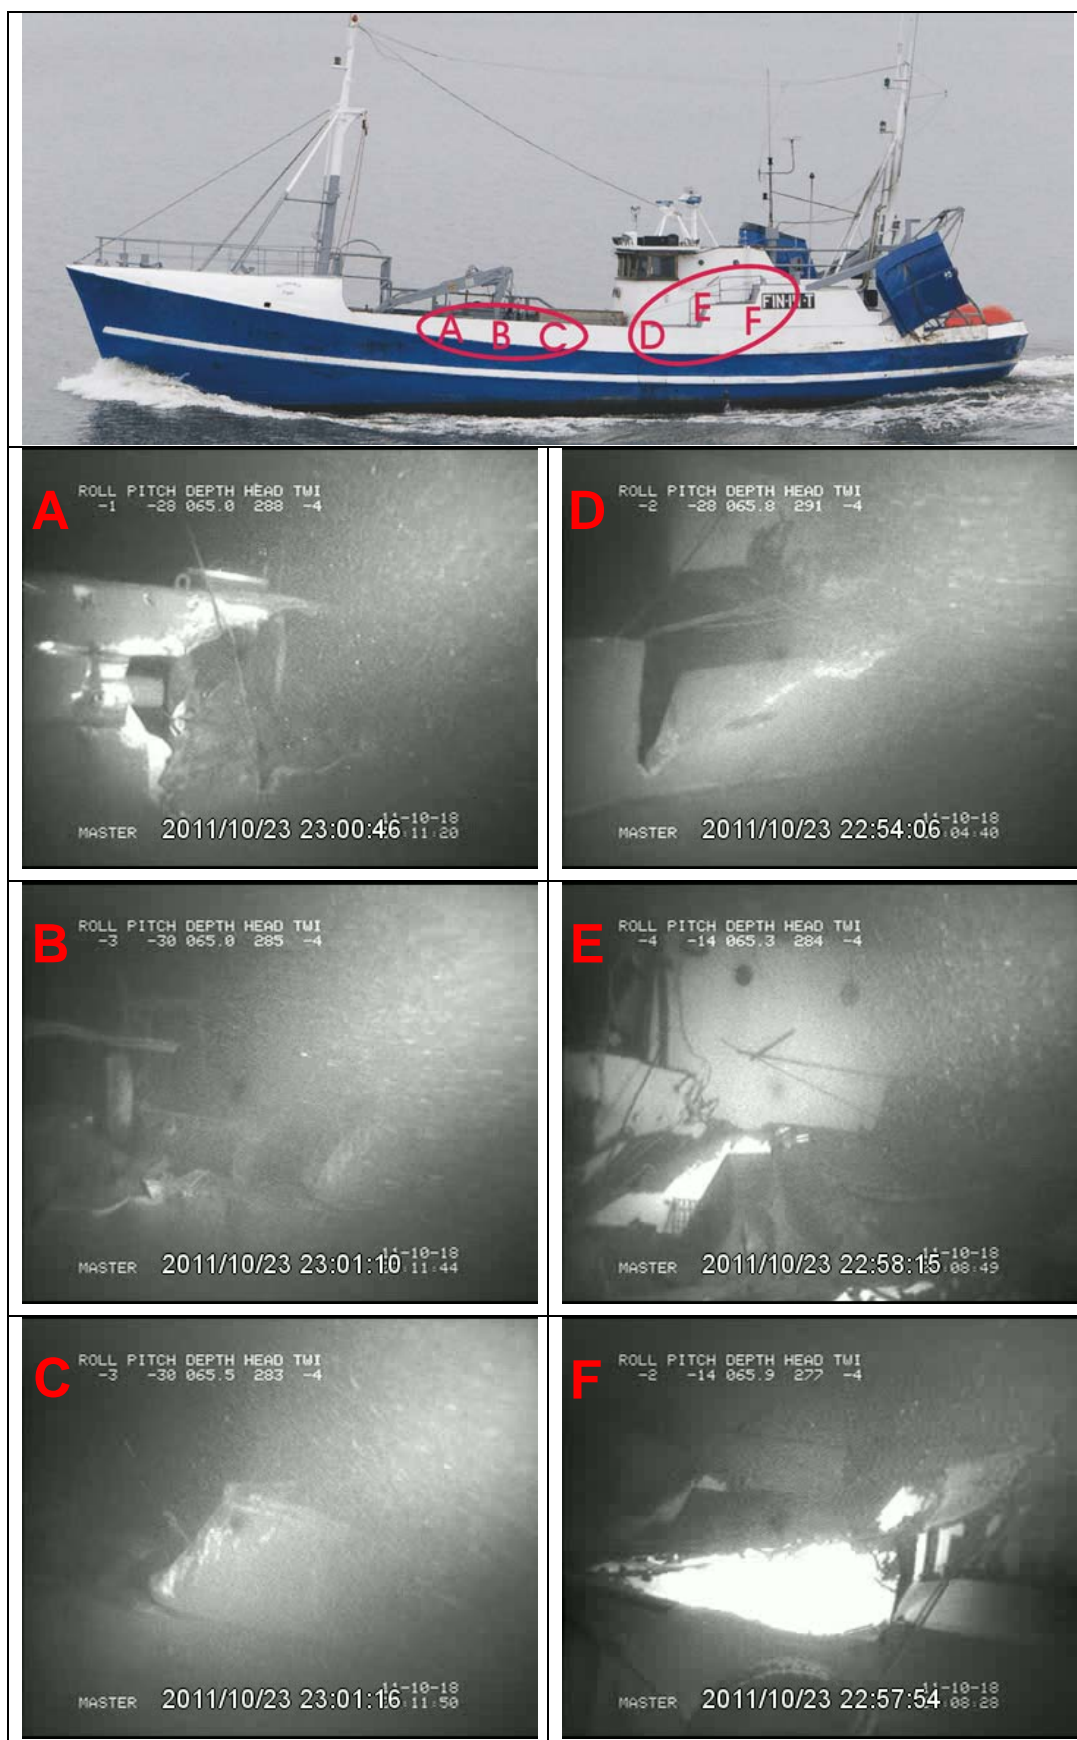
The FLORENCE sank as a result of the collision. The sunken vessel was discovered in the evening on the day of the accident at a depth of 65 metres. The vessel lies on the bottom, the right side up with her bow pointing approximately at 180°. Based on the underwater photography, the vessel seems to have suffered observable damage to the rail on the port side by the hold, to the port side of the bridge, and to the rail and the part of the deckhouse located port of the bridge (image 18). Judging from the photographs, it seems that the rest of the vessel's structures are intact. All visible damages are above the waterline and thus cannot by themselves account for the vessel's sinking.

Image 18. A series of the underwater photographs showing the damages suffered by the FLORENCE. The damaged parts have been marked on the photo with a red oval and the damages shown in the photographs are marked with letters. The photographs on the left show the rail by the hold and the photographs on the right show the bridge. (Photograph of the vessel: © Markku Saiha, underwater photographs: © Finnish Border Guard)

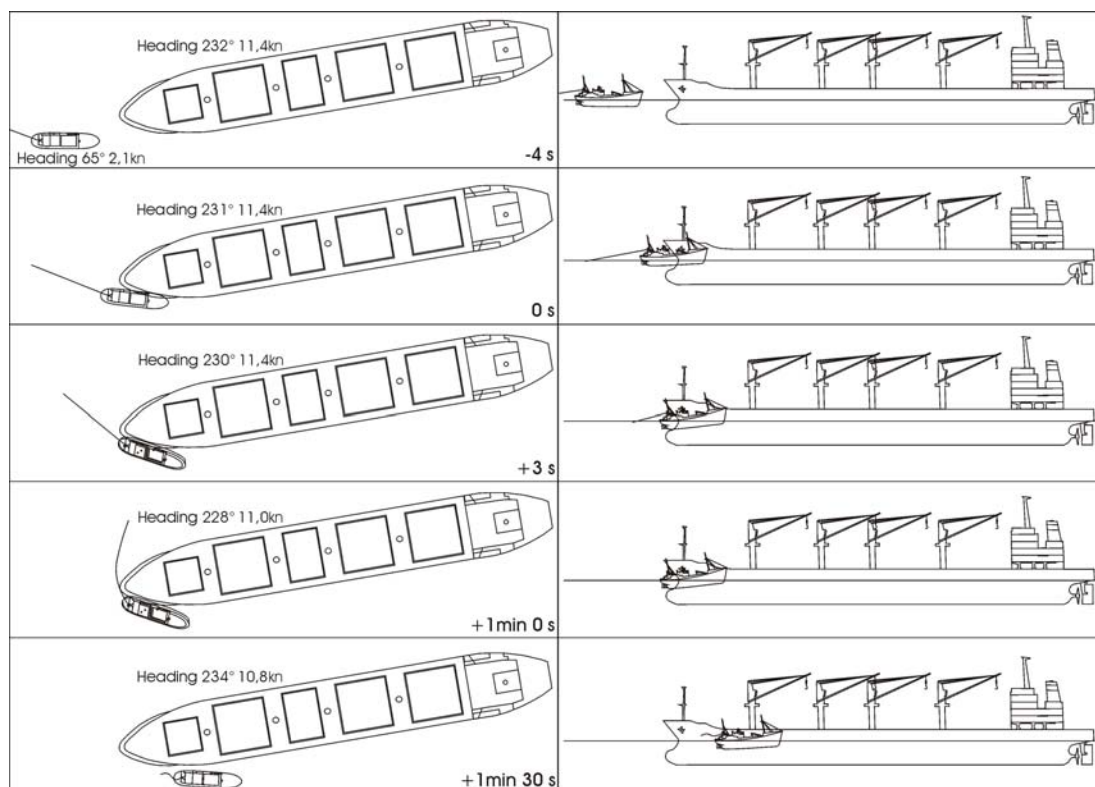
Image 28. Pictures of the assumed process of the collision. The pictures do not illustrate the possible impact of the AMAZON's bow wave which probably raised the FLORENCE higher, or that the AMAZON pushed the FLORENCE for about 1/3 of a nautical mile during the collision.

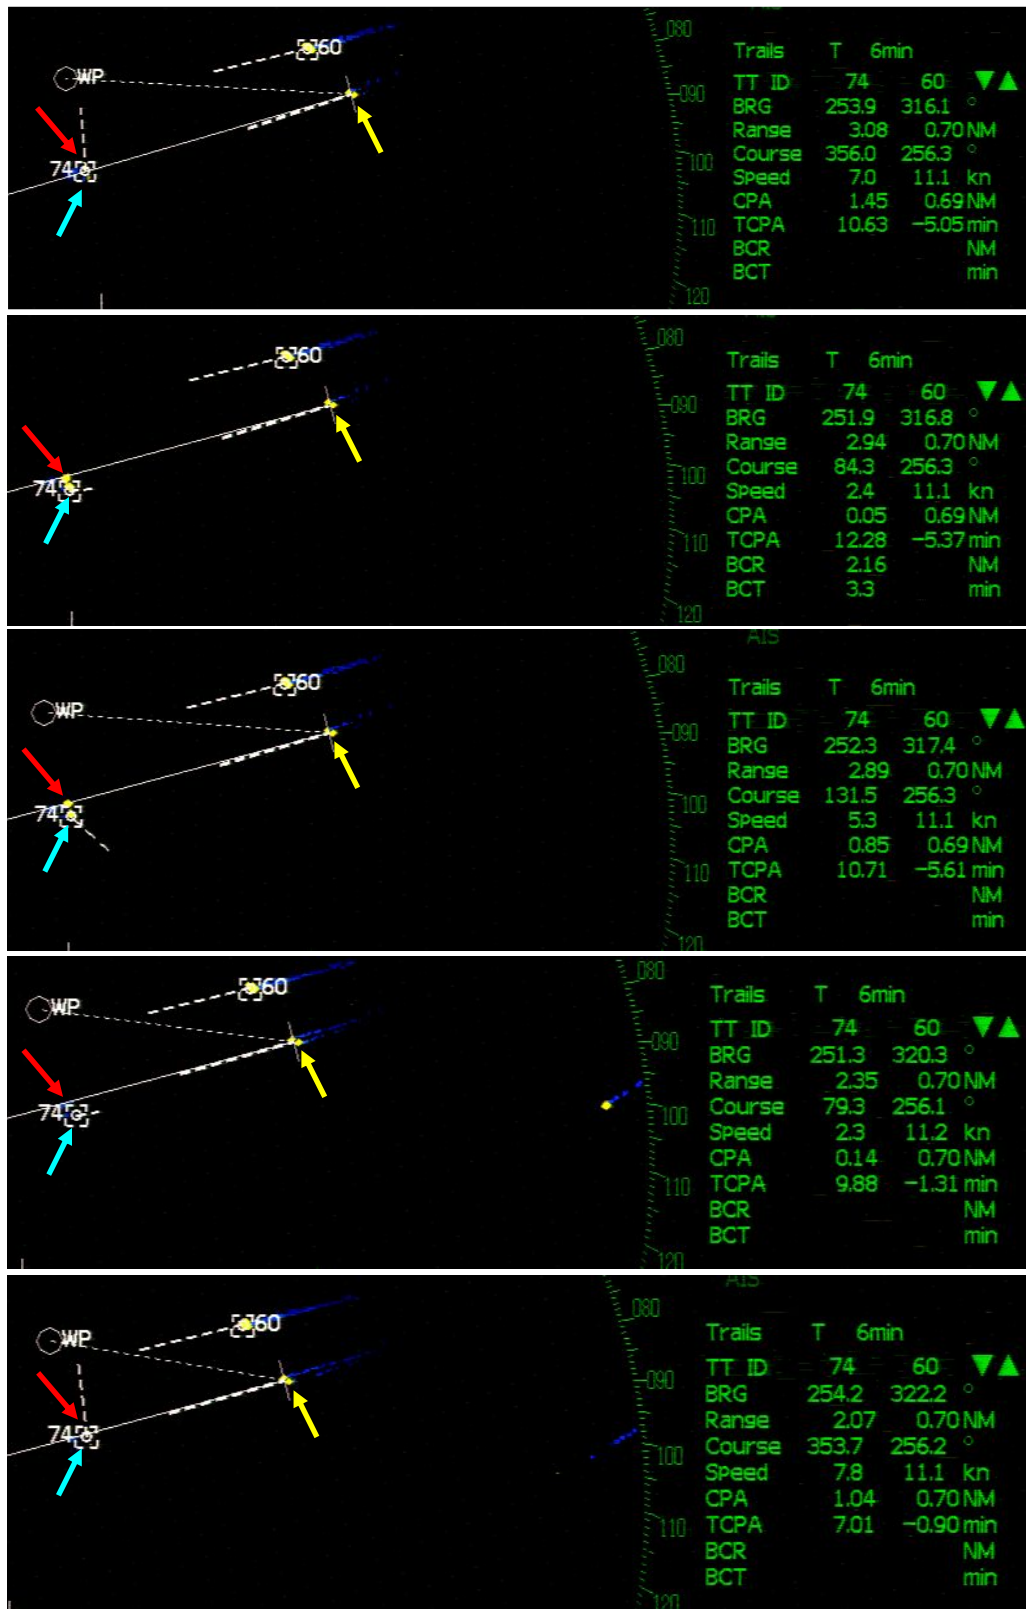
Image 7. At 04:31:22–04:35:36, depending on the image approximately 9–13 minutes before the collision. The collage of images indicates how the ARPA monitoring fluctuates between the MENHADEN and the FLORENCE. The course vector and speed vector directions and the size of the ARPA target fluctuate considerably. The second and third images from the top show the echoes of the fishing vessels. These echoes are only barely, if at all, visible in the other images. The anti-clutter sea and rain control adjustments have probably affected the visibility of small radar targets on the radar.

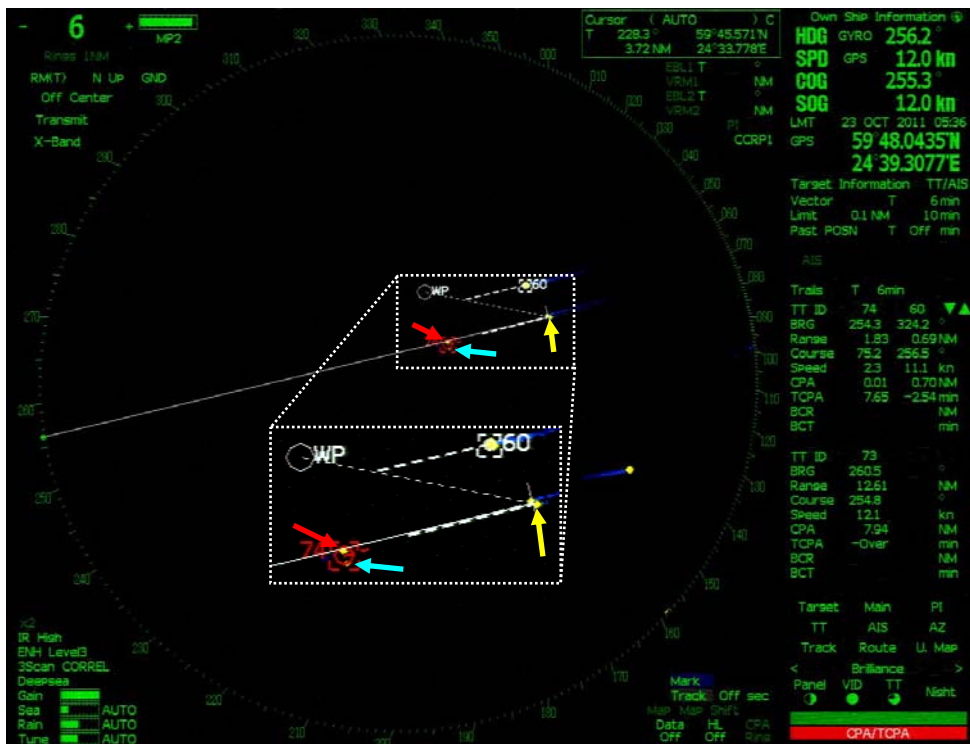
Image 8. At 04:36:27, approximately 7 minutes before the collision. The CPA/TCPA values are lower (CPA 0.01 nautical miles and TCPA 7.65 minutes) than the limit value that is set on the radar, and the radar sets a Dangerous Target alarm about the fishing vessels. The fishing vessels are within 1.83 miles of the AMAZON in the heading of 261°. The course of the AMAZON is 255.3° with a speed of 12 knots.

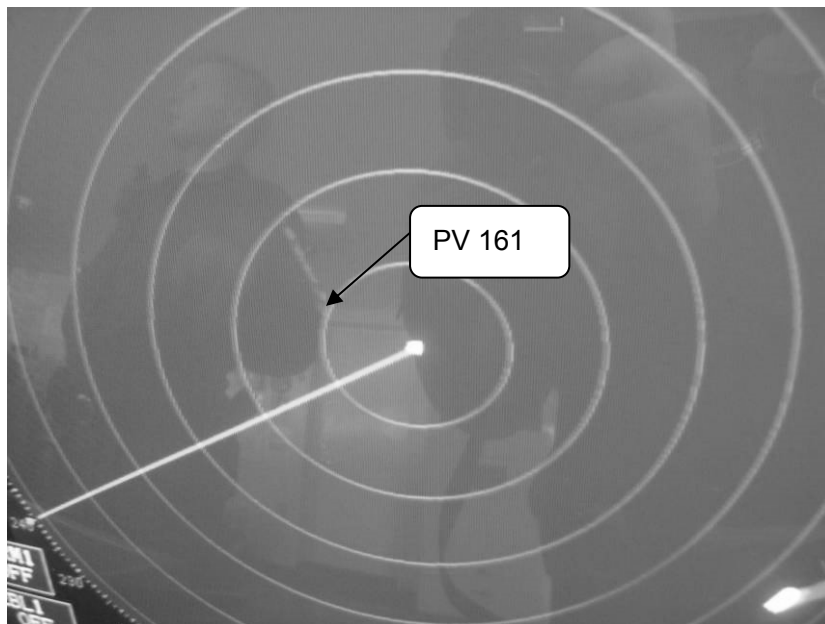
Image 4. The echo of the PV-161 disappears from the radar screen at the distance of one nautical mile.
