Investigation Report

C1/2011M

M/V STADIONGRACHT (NLD), Grounding off Rauma in the Gulf of Bothnia on 29th December 2010

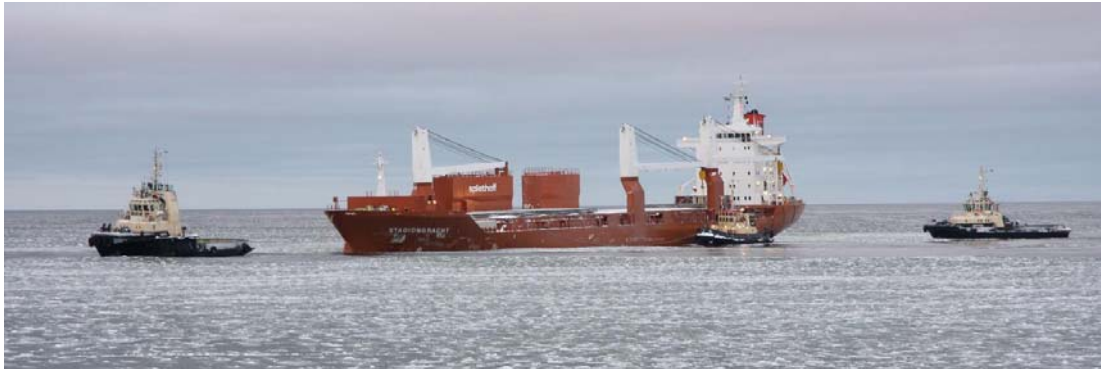
Figure 1. Photo of the accident vessel while she was aground. (Photo: LSMV)

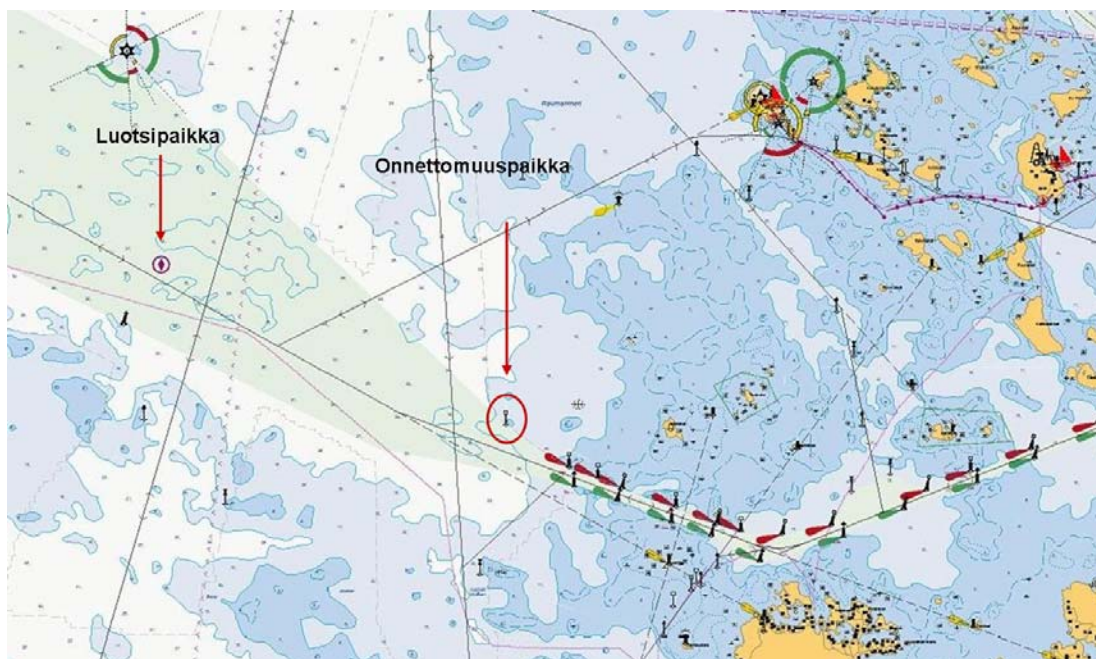
The vessel ran aground in the 10.0 metre-deep southern channel leading to Rauma in position 61° 06.57' N 021° 14.69' E, approximately 2.7 nautical miles after the pilot boarding position. The 9-metre shoal on which she grounded was marked by a lateral spar buoy².

Figure 6. Accident area and position. (© The Finnish Transport Safety Agency)

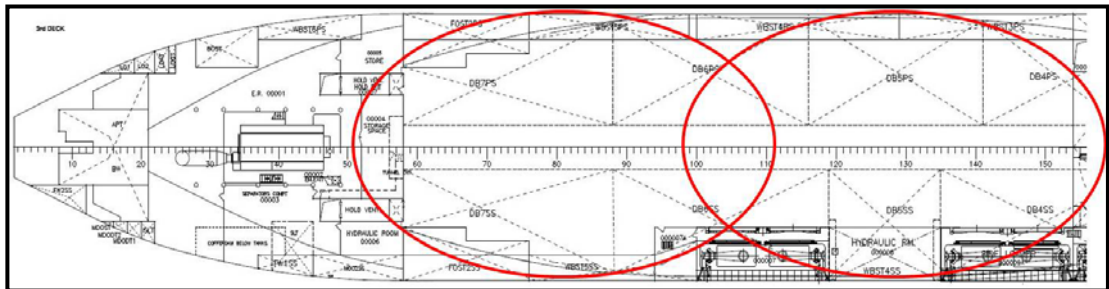
In the inspections carried out immediately after the grounding, it was found out that the vessel had leakages in the ballast tanks on both sides of the keel. Water flowed out from the spill pipes of the ballast tanks onto the deck and into the sea. The leakages in the ballast tanks of the vessel did not affect the stability of the vessel and there was not any risk of her sinking. Only seawater leaked to the sea from the ballast tanks of the vessel.

Figure 7. Damages to the vessel.

Divers later made inspections and took photographs underwater. It could be concluded that the vessel had, when grounding, got tears in her bottom and dents in the ballast tank area from frame 51 to frame 161. The vessel's propeller and rudder were not damaged.

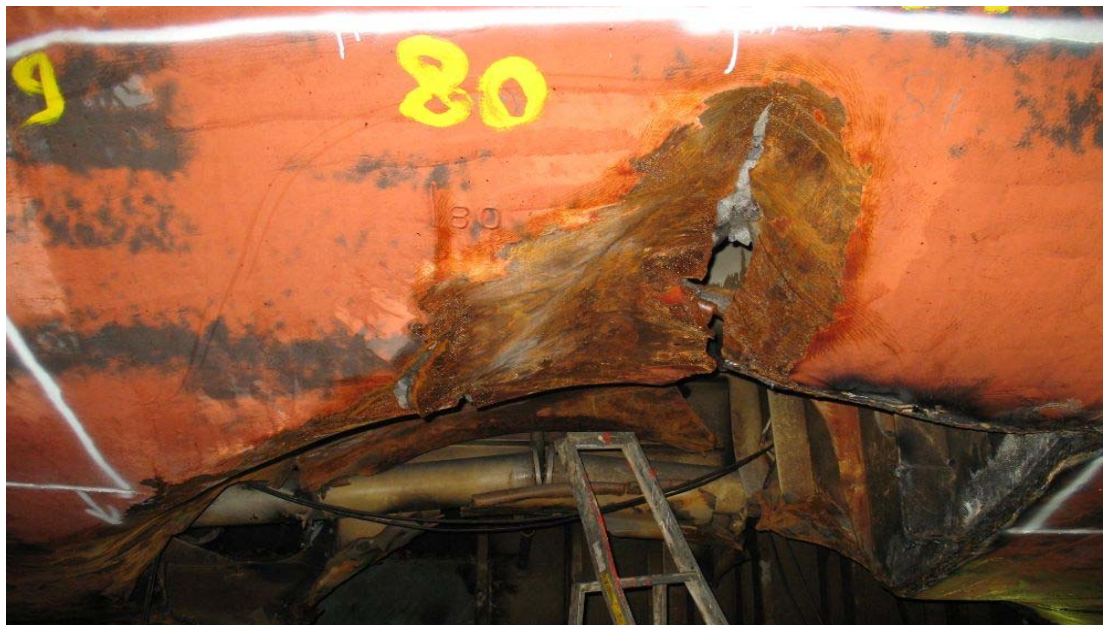
When the vessel was in dock, considerable damages to the bottom, pipe systems, valve regulators and cables were discovered.

Figure 8. Damages to the vessel; tear in the starboard-side ballast tank.

Water flow in the terminal boxes damaged almost all valve regulators thus making it impossible to remote-control them. In addition, all the cables in the pipe tunnel either got damaged or became so wet that they were unfit for use.

While the vessel was in dock, altogether 153 tons of steel were replaced in her bottom, and 150 metres of pipe systems and over 5000 metres of cables were renewed.

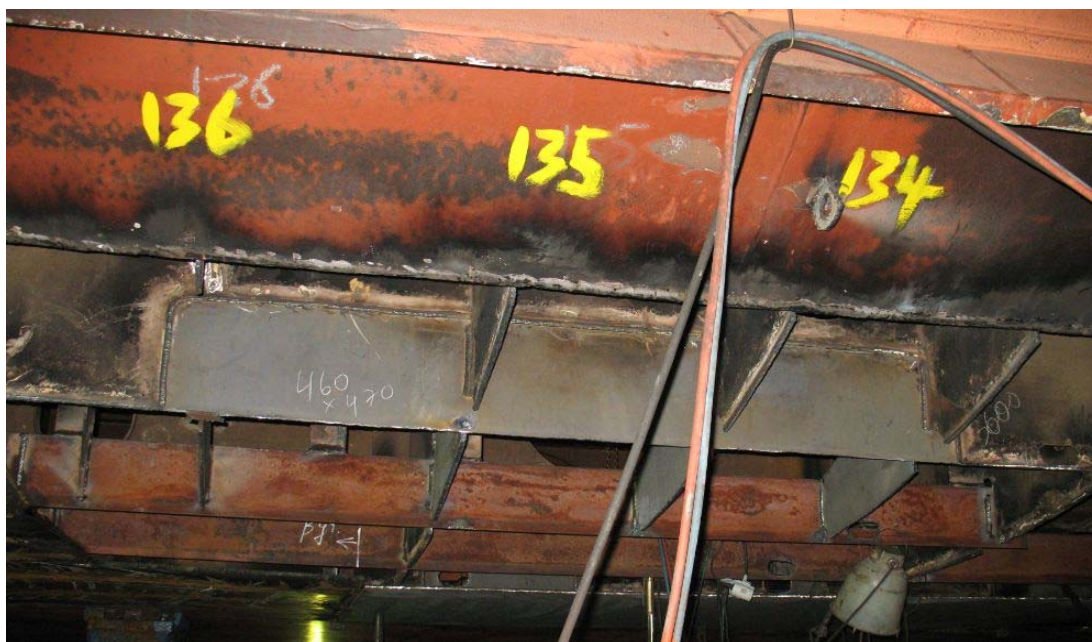
Figure 9. Damages to the vessel; a fixed tear in the port-side ballast tank.

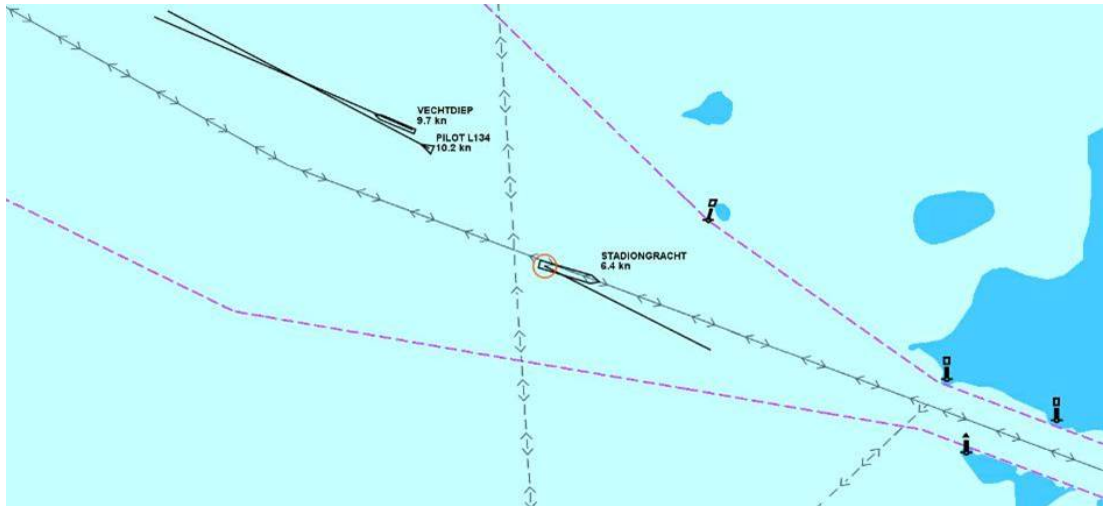
Figure 6. At 00:08:41. The VTS-operator recommends SG to turn around. SG 117° / 6.4 knots.

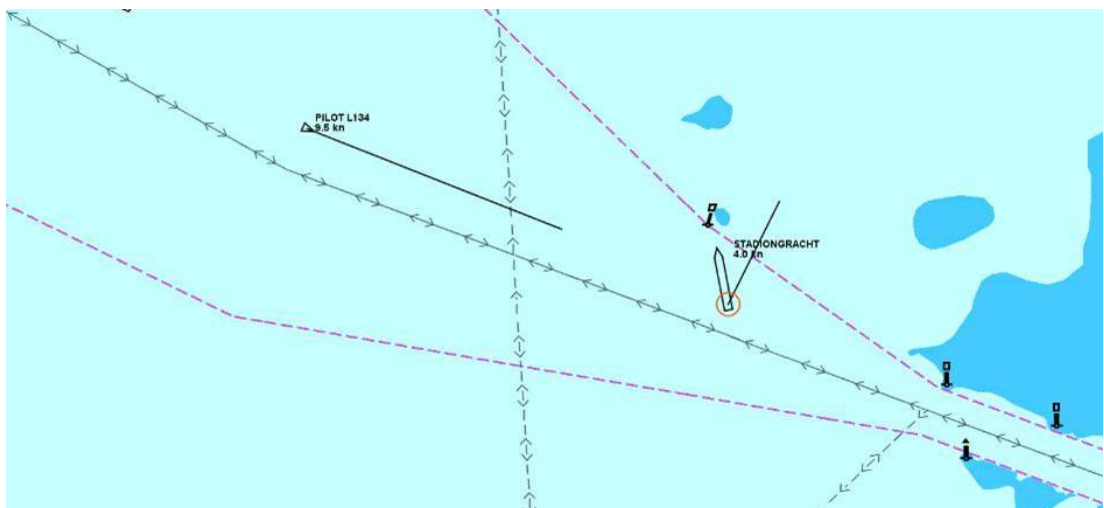
Figure 8. At 00:12:41. The VTS-operator tells to the pilot cutter that the SG has started turning via port. SG 029° / 4.0 knots.

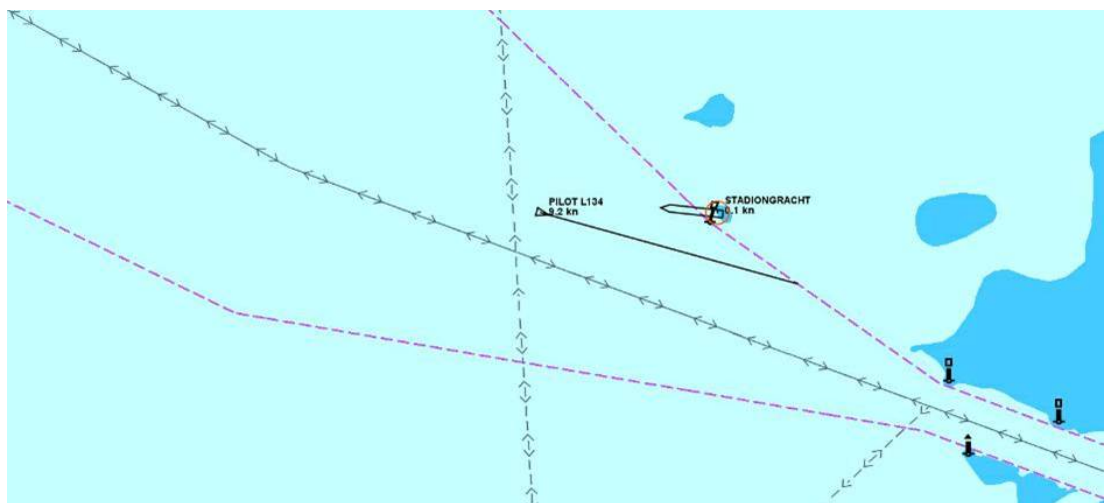
Figure 11. At 00:15:19. Motion stops – STADIONGRACHT is aground.
