Investigation report#

C2/2011M

F/V WILLEMPJE HOEKSTRA UK 33 (NLD) and M/V BIRKA TRANSPORTER (FIN), Collision off the Netherlands on 14 February 2011

**Onnettomuustutkintakeskus
Olycksutredningscentralen
Safety Investigation Authority, Finland**

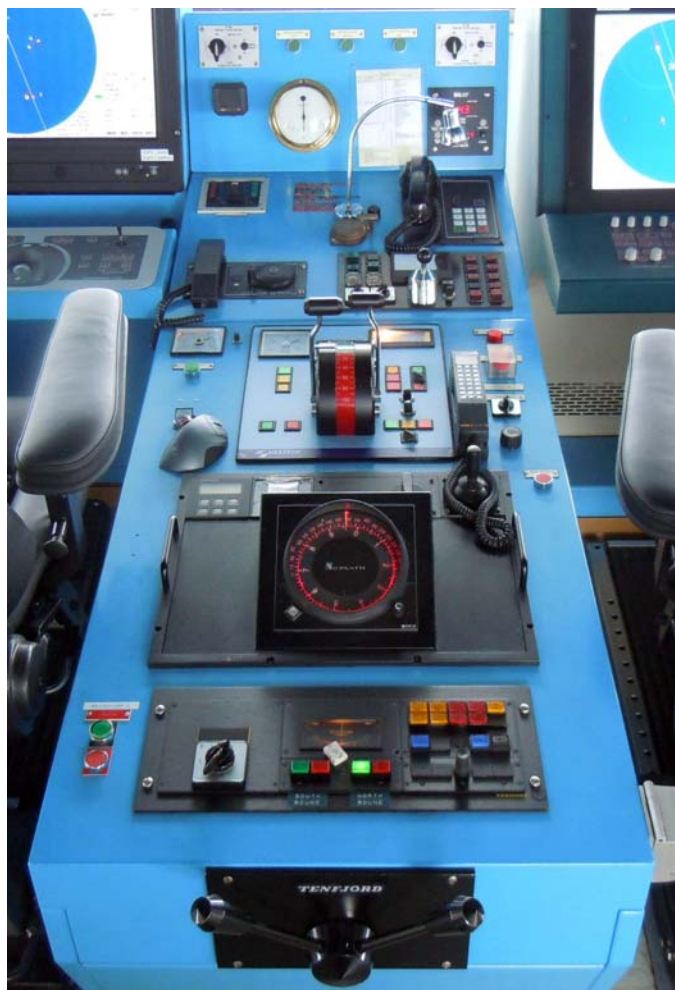
Figure 5. The helmsman's position is at the end of the main console.

Since steering at the helmsman's position was used during the avoidance manoeuvre, the OOW had to reach over backwards to be able to steer, and the motion of the ship was no longer observed.

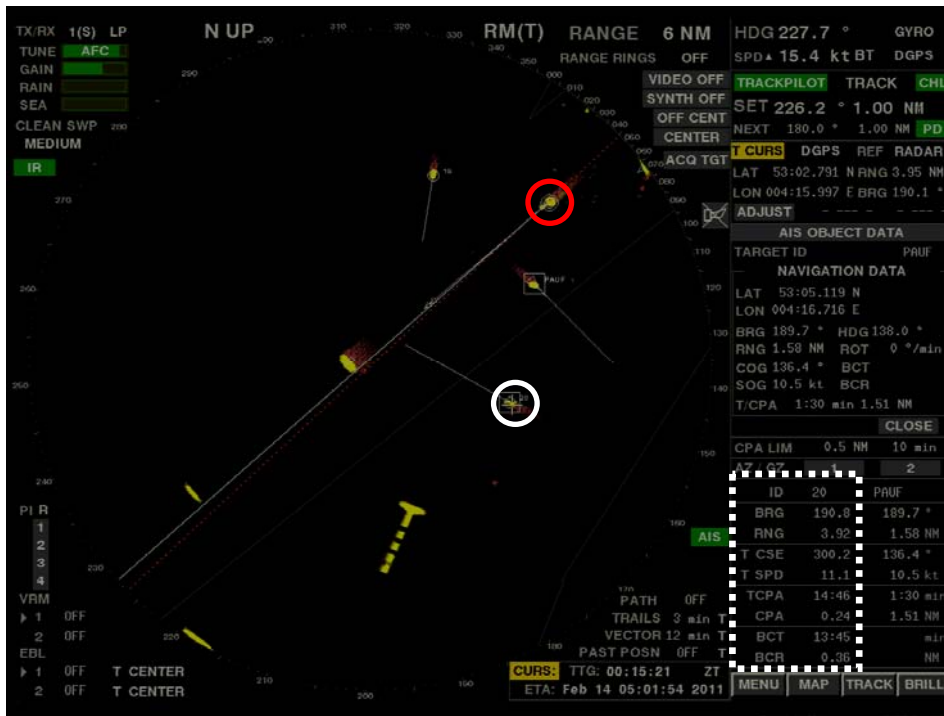
Figure 7. At 3:46:36. Time to the collision is circa 14 min. WILLEMPJE HOEKSTRA's (white circle) ARPA data (rectangle shown in white dash line) was activated. BIRKA TRANSPORTER is marked with a red circle. CPA is 0.24 miles and TCPA 14.46 min.

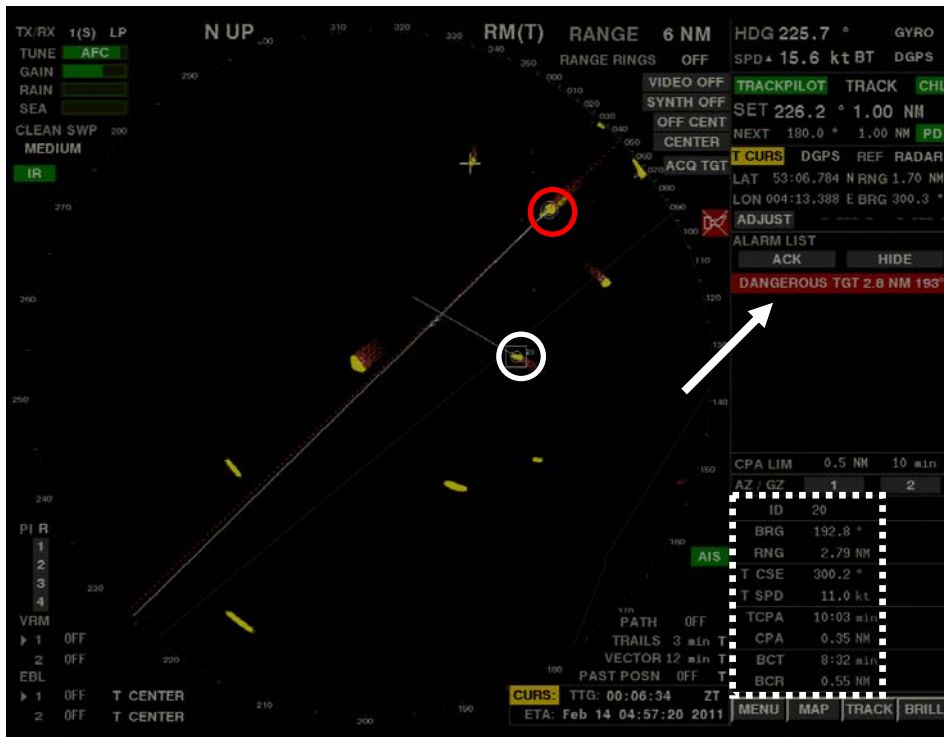
At 3:50:50, the dangerous target alarm on the ARPA radar activated, showing that WILLEMPJE HOEKSTRA was approaching at a distance of 2.8 NM in the bearing 193 degrees (Figure 8). The time to the closest point of approach (TCPA) was 10.03 minutes, and the CPA was 0.35 NM. Dangerous target limits in the ARPA radar were set to CPA 0.5 NM and 10 minutes.

Figure 8. At 3:50:50. Time to the collision is circa 10 min. Dangerous target alarm was activated (white arrow). CPA 0.35 NM and TCPA 10.03 min.

The dangerous target alarm on the ARPA radar was activated about 10 minutes before the collision, showing that WILLEMPJE HOEKSTRA was approaching at a distance 2.8 NM in a bearing of 193 degrees. The TCPA was 10.03 minutes and the CPA 0.35 NM²¹. The dangerous target alarm did not result in any decision-making or activities by the OOW, the alarm was just acknowledged (See Appendix 1/3, Table 1). At this stage, the OOW should have requested the fishing vessel as the give-way vessel to declare her intentions by light signals or by the VHF. The OOW observed the movements of the fishing vessel both visually and by radar. The OOW observed the decreasing CPA on the radar, but took no action, and the situation was allowed to develop to a close quarter situation.

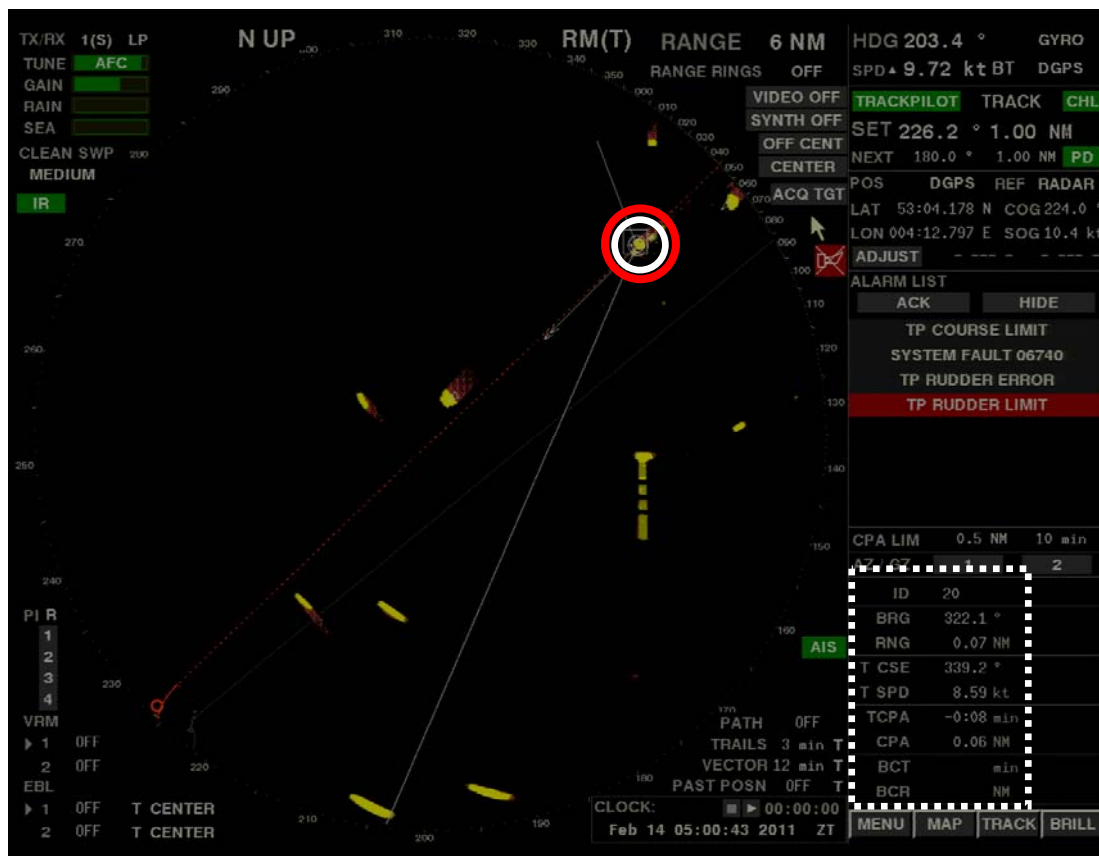
The collision took place at 4:00:43 UTC; BIRKA TRANSPORTER's bow hit WILLEMPJE HOEKSTRA's forward part on the starboard side (Figure 9).

Figure 9. At 4:00:43 the collision took place according to the S-VDR audio.

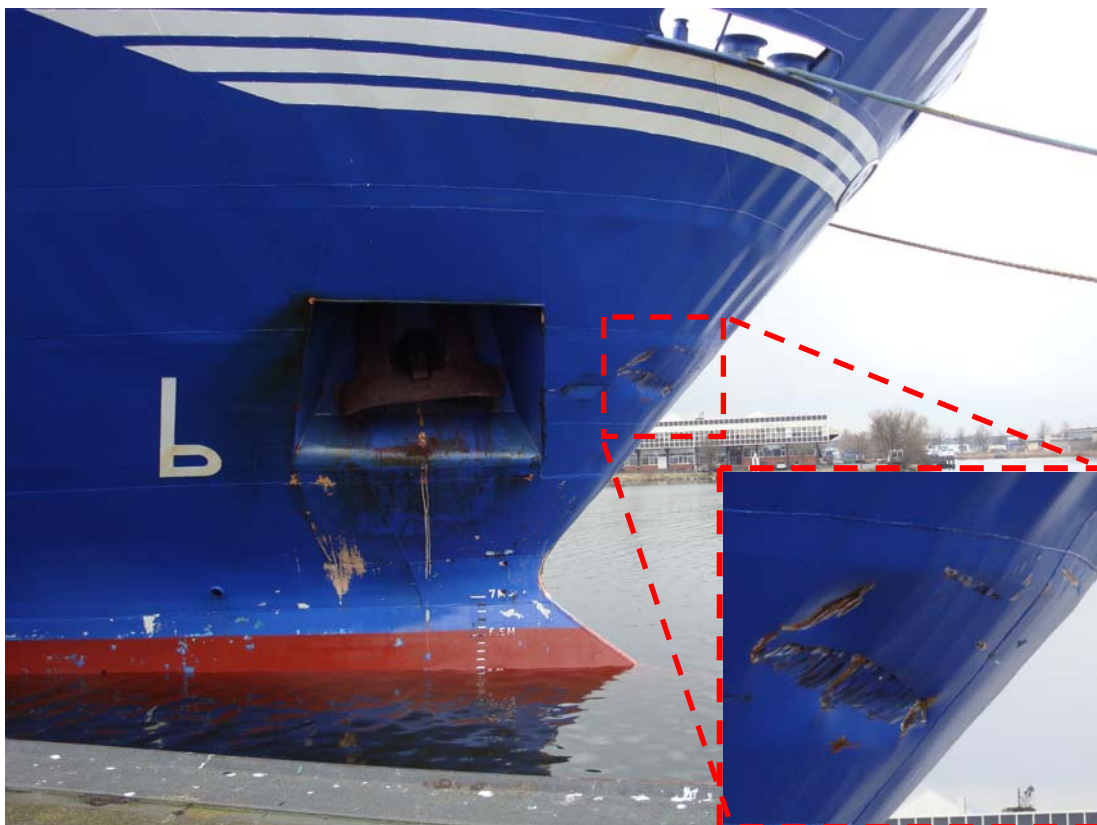
BIRKA TRANSPORTER sustained damage to her bow on her starboard side. According to the survey report by the DNV, there were several buckled vertical shell plating stiffeners between the forecastle deck and the first stringer inside forepeak tank (Figure 10) at center line. One stiffener was found to be cracked. Shallow dents on shell plating located in way of buckled frames.

Figure 10. *BIRKA TRANSPORTER's* damage next to the stem.

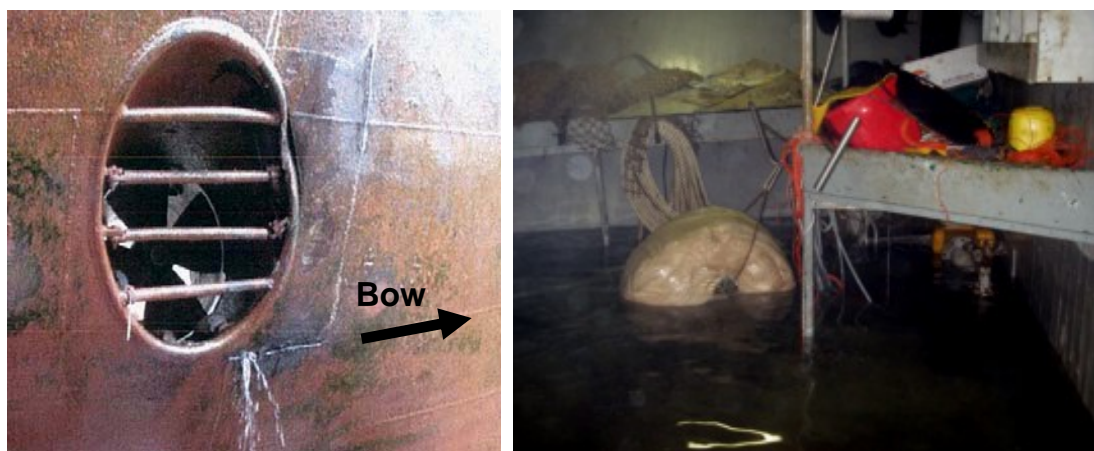
WILLEMPJE HOEKSTRA sustained cracks to her starboard side approximately 2 meters below the waterline. The forward part of the bow thruster tunnel was dented approximately by 500 mm in length, while the grille in front of the bow thruster tunnel was deformed as well (Figure 11 on the left). Due to the cracks there was water ingress to her storage/bow thruster room (Figure 11 on the right).

The leaked water had been in contact with the electric switchboard of the bow thruster and fish processing pump, and it was thus alleged that the electric switchboard had been affected by water. The fixed stay of the starboard fishing derrick was damaged due to the impact. There was blue paint on the steel rope over a length of approximately 4 m, and the socket area at the forward end of the steel rope had also sustained some damage.

Figure 11. **Left:** damage on the starboard side of WILLEMPJE HOEKSTRA, in the bow thruster tunnel.

Right: water inside the storage/bow thruster room on WILLEMPJE HOEKSTRA.

The total cost of the repair work was approximately EUR 43,000.

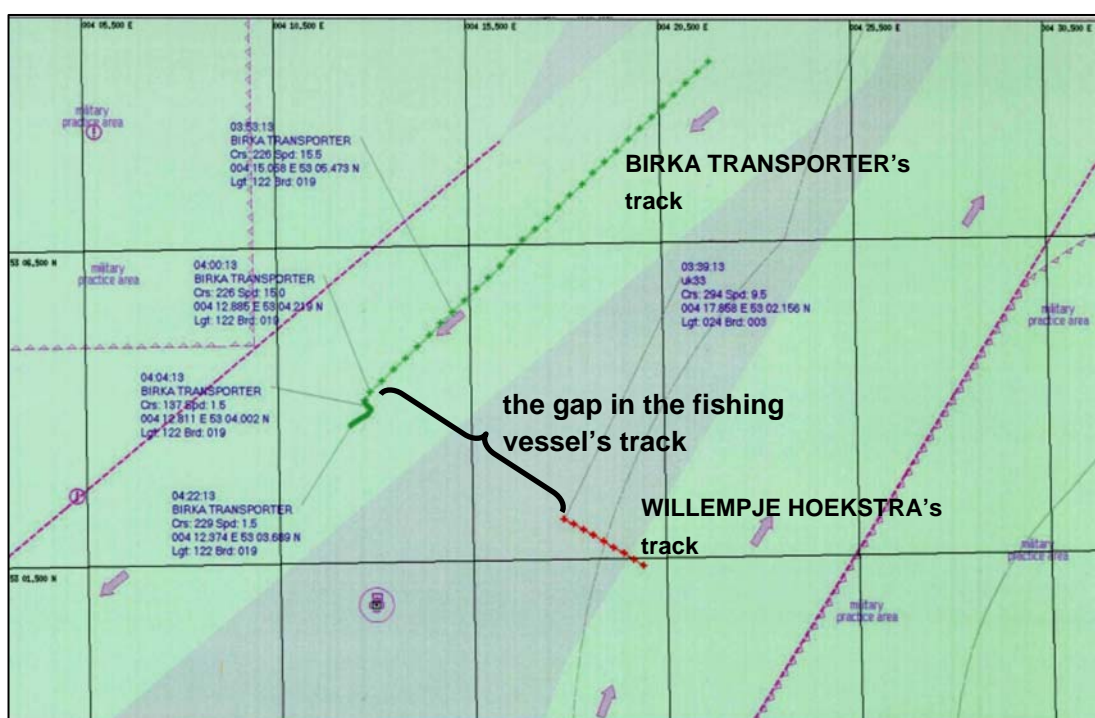
In the figure 13 there is a radar plot from the Netherland Coastguard. According to the plot BIRKA TRANSPORTER maintained a steady course until 4:00:13, at which time the vessel started to turn to port. Also WILLEMJE HOEKSTRA maintained a steady course in the beginning of the situation. There is a gap of approximately 15 minutes in the track of the fishing vessel.

Figure 13. An overall picture of the situation provided by the Netherlands Coastguard Service. The Figure shows the tracks of both sides, BIRKA TRANSPORTER's in green and WILLEMPJE HOEKSTRA's in red. There is a gap of approximately 15 minutes in the track of the fishing vessel prior to the collision. (© Netherlands Coastguard)

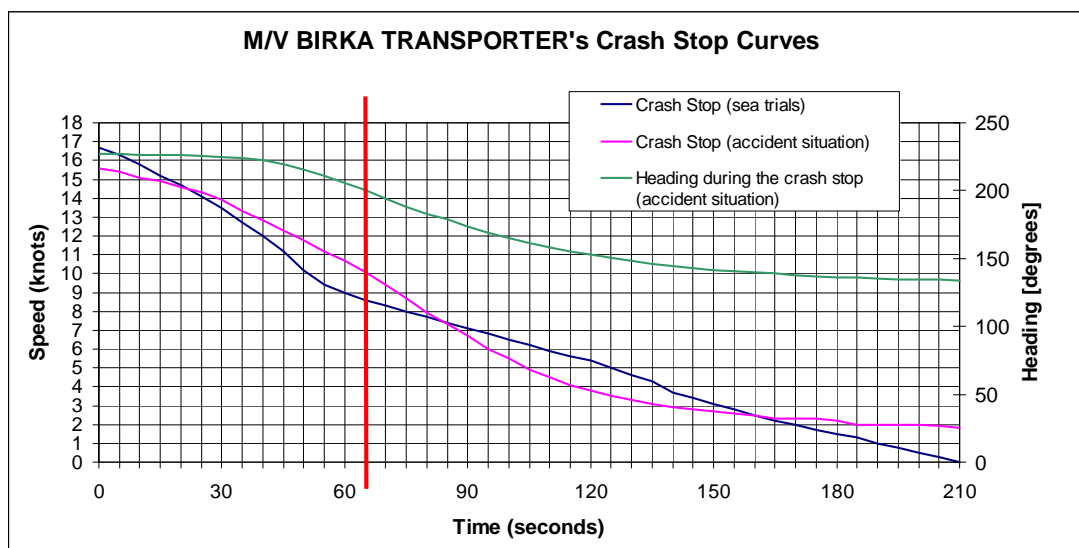
BIRKA TRANSPORTER had almost stopped abt. two minutes after the collision when her heading was 135 degrees and speed slightly under two knots.

Figure 15. Crash stop manoeuvre of BIRKA TRANSPORTER at sea trials (blue line) and in the accident (red line). The green line illustrates the heading during the accident crash stop and the red vertical line the accident time. Sources: S-VDR data and BIRKA TRANSPORTER's crash stop test poster.

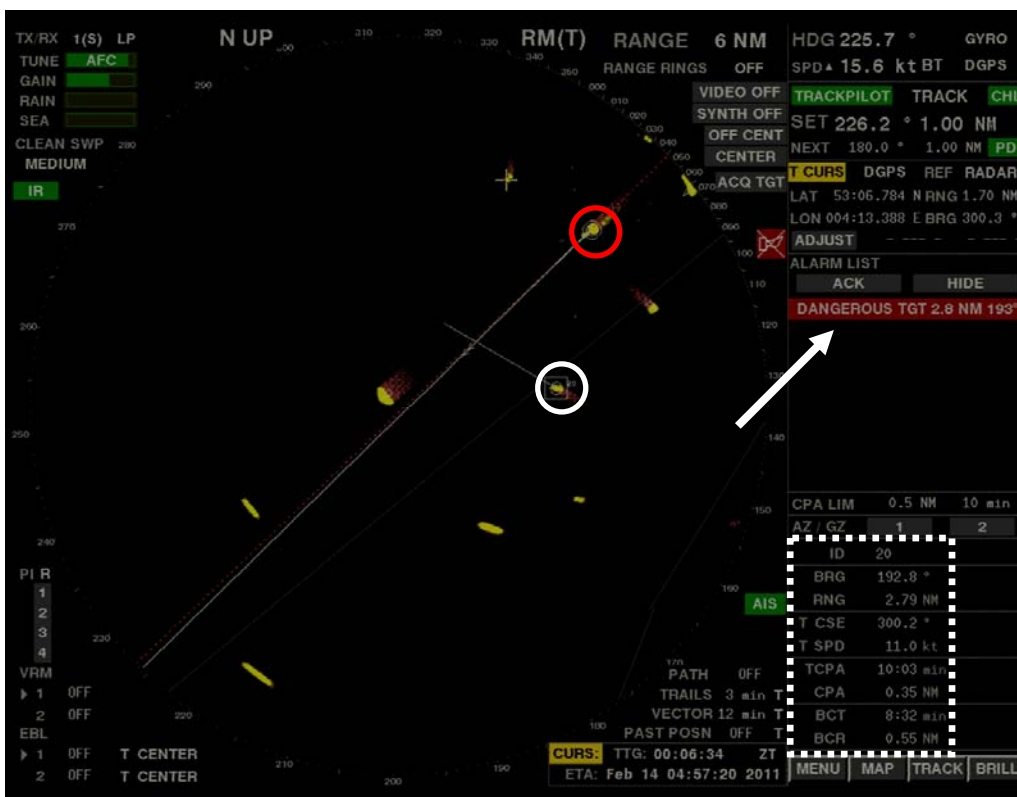
Figure 5. At 3:50:47. Dangerous target alarm is activated on BIRKA TRANSPORTER's radar (white arrow). Target limits were set at CPA 0.5 NM and TCPA 10 min. CPA 0.35 NM and TCPA 10.03 minutes. Time to the collision is circa 10 minutes. The rectangle shown in white dash lines indicates WILLEMPJE HOEKSTRA's ARPA data.

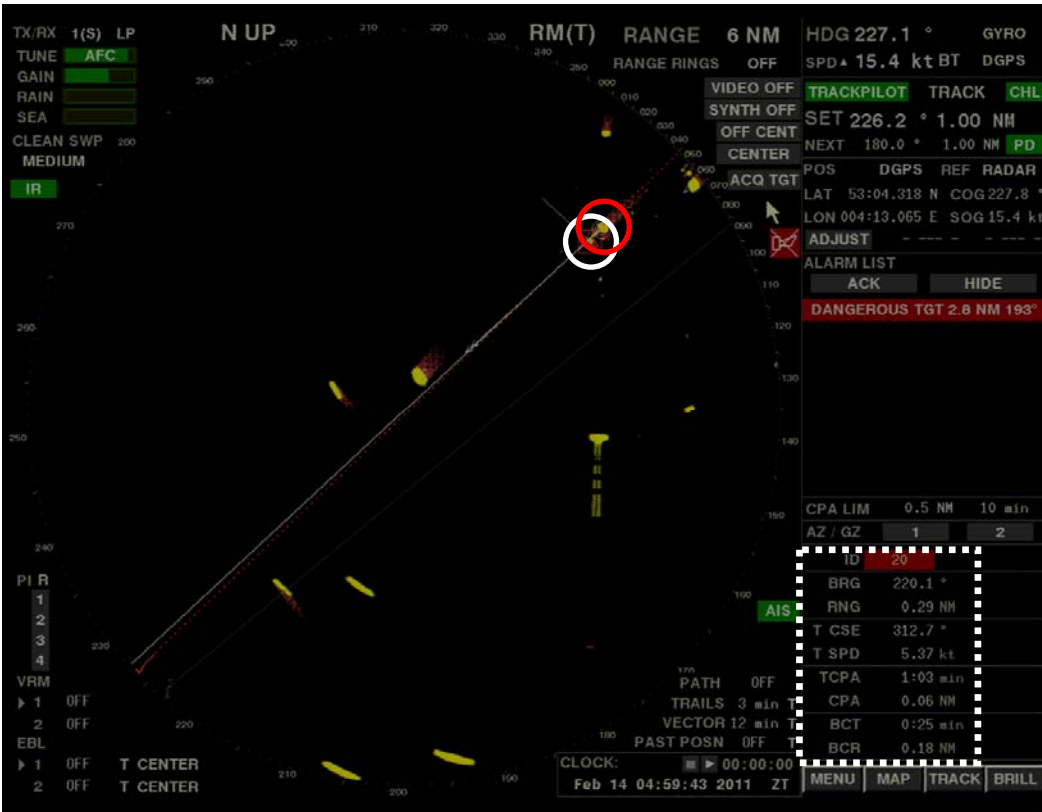
Figure 6. At 3:59:43. BIRKA TRANSPORTER's speed starts to decrease. The white circle represents WILLEMPJE HOEKSTRA, the red circle BIRKA TRANSPORTER, and the rectangle in white dash lines is the ARPA data. Time to the collision is circa 1 minute. CPA 0.06 NM, TCPA 1.03 min.

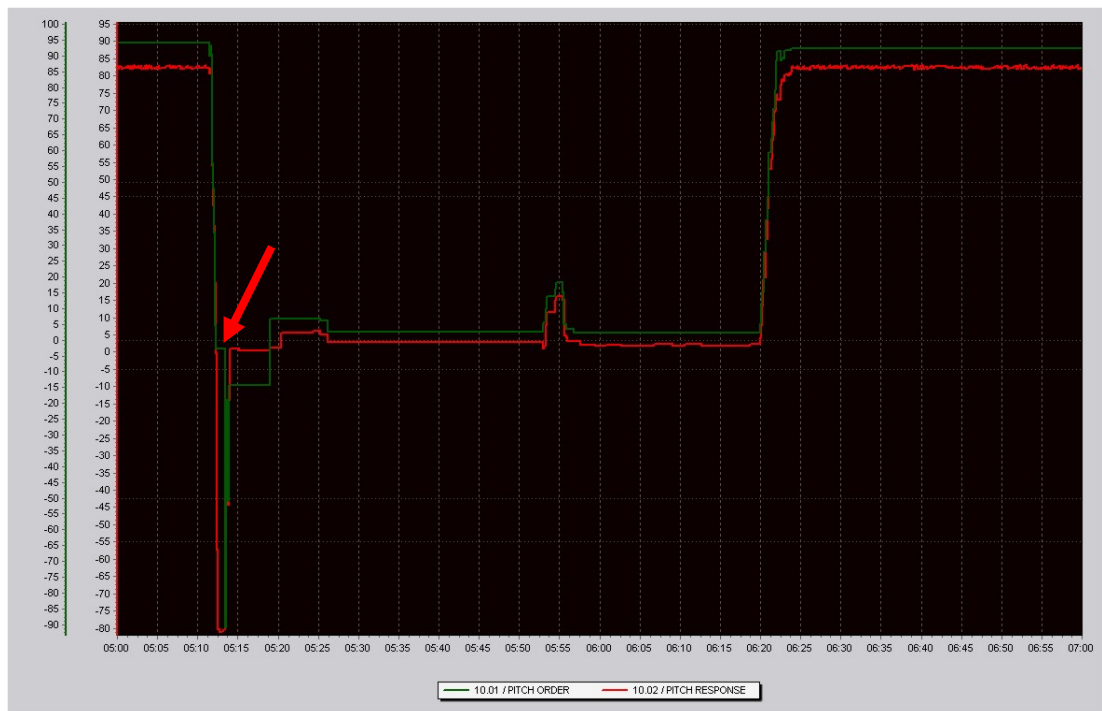
Figure 8 illustrates the pitch order and response of BIRKA TRANSPORTER in the actual accident situation. The reduction of speed was initiated about a minute before the collision. The OOW started the speed reduction by adjusting the pitch lever to zero during 30 seconds. After a few seconds the lever was set to full astern (indicated by a red arrow in the picture)

Figure 8. The pitch log from BIRKA TRANSPORTER. Pitch order is shown in green and pitch response in red. The time is approximately 12 minutes ahead of the S-VDR time.
