Investigation report

D2/2011M

M/S BIRKA CARRIER (FIN) and M/Y LED ZEPPELIN (RUS), Collision in the Gulf of Finland on May 17, 2011

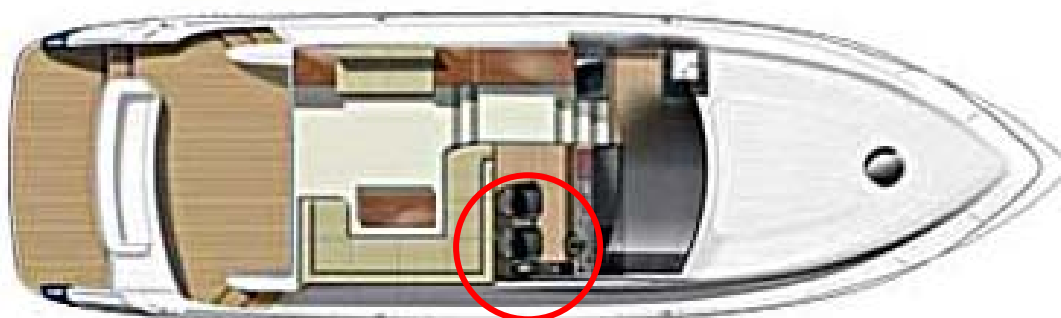
According to LED ZEPPELIN's skipper, BIRKA CARRIER was seen on port side about half an hour before the collision at the distance of about 7-8 miles. According to skipper he did not look out to the direction of BIRKA CARRIER, because he concentrated to watch navigational devices located in steering place and looked straight ahead. BIRKA CARRIER could not have been seen to the steering place because of the structure of the cabin. The combined radar/chart display device was switched only on chart display. Therefore no radar observation from BIRKA CARRIER was received.

Figure 4. The location of steering place. (Source: manufacture's brochure)

LED ZEPPELIN did not undertake actions according rule 17 b due to neglect of proper look-out. The skipper partly lost the control of other traffic when he switched off radar display, concentrating only to study the chart and to look-out ahead. This indicates that the route plan had not been worked up. Visibility from the steering place was restricted to the port side. In order to get better optical observations, one should have been on the move.

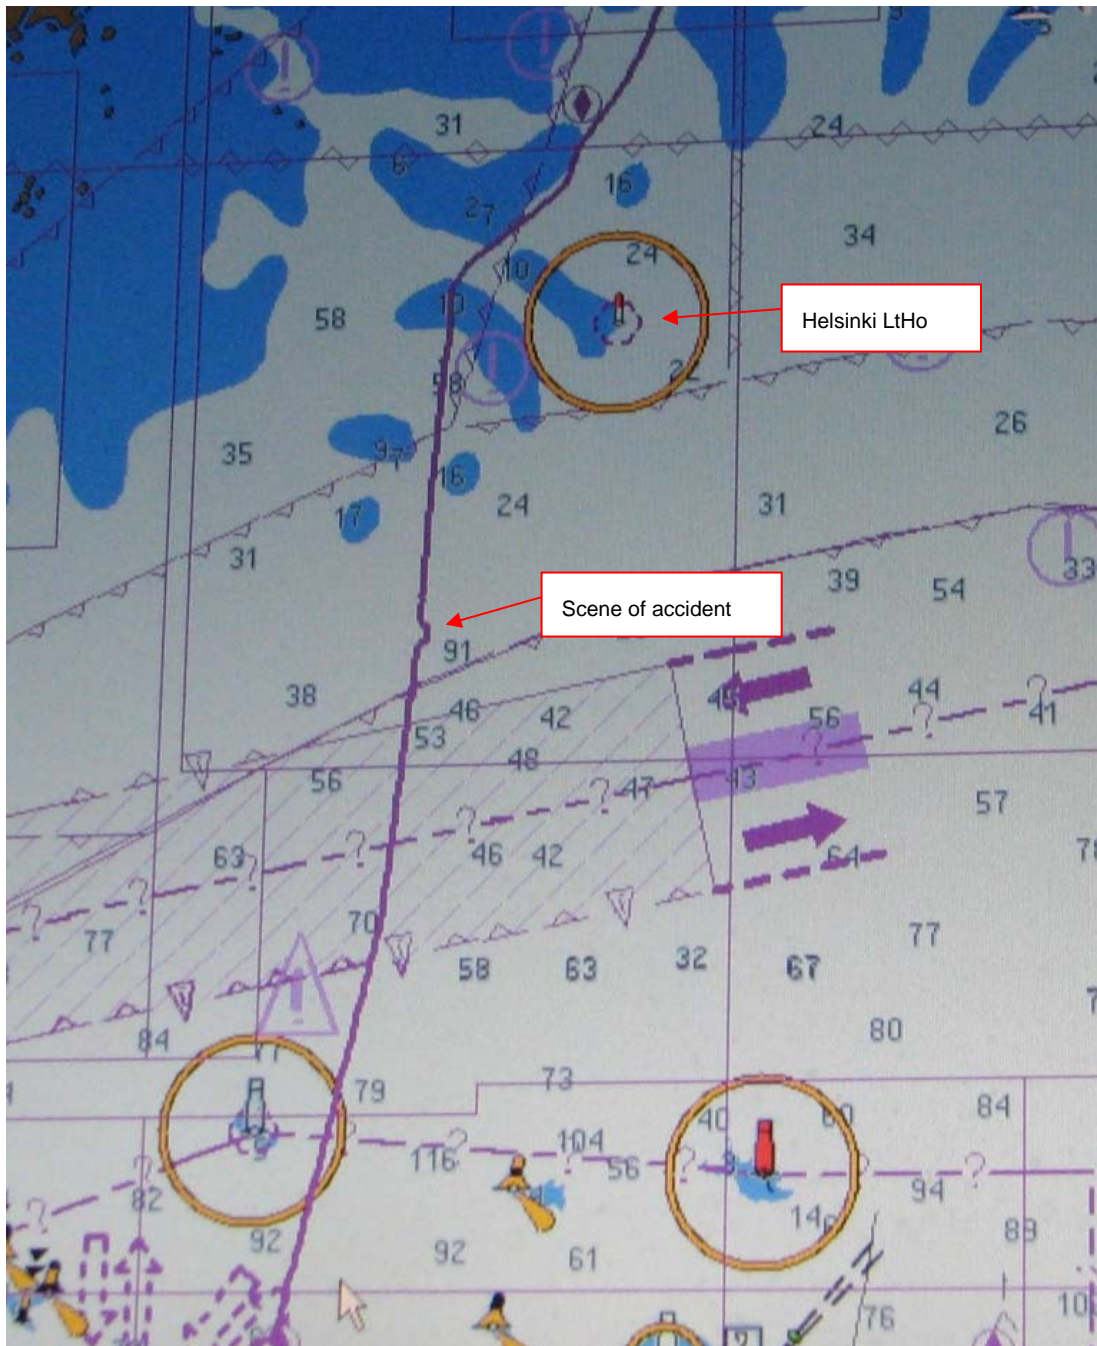
Figure 5. Extract from LED ZEPPELIN's computer chart display describing her track.

According to LED ZEPPELIN's skipper, he did not undertake any alteration of course as he did not see BIRKA CARRIER. Figures 4 and 5 do show precisely the movements of LED ZEPPELIN at the moment of the collision. According to the figures, LED ZEPPELIN turns over to starboard pushed by the collision.

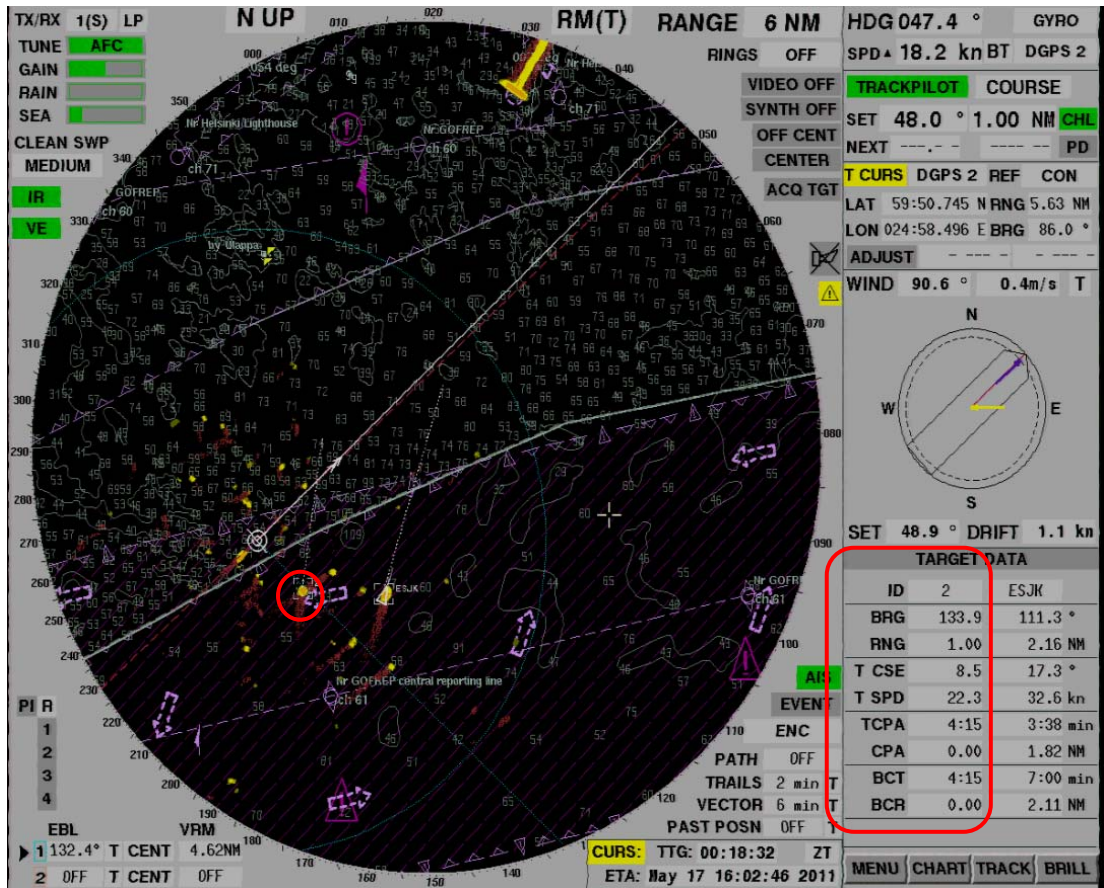
Figure 6. Extract from BIRKA CARRIER's S-VRD. Figures inside the red highlighted box informs about the observation of LED ZEPPELIN in ARPA-radar 4 min 15 sec before the collision. Bearing 087 degrees on starboard side and CPA 0,00. It is also a noteworthy fact that the radar's buzzer informing about the risk of collision had been switched off.

The collision can be determined to have occurred at 15.47.48. Observations by radar in very short distances are scanty and therefore unreliable. The alarm of Arpa -radar had been switched off.

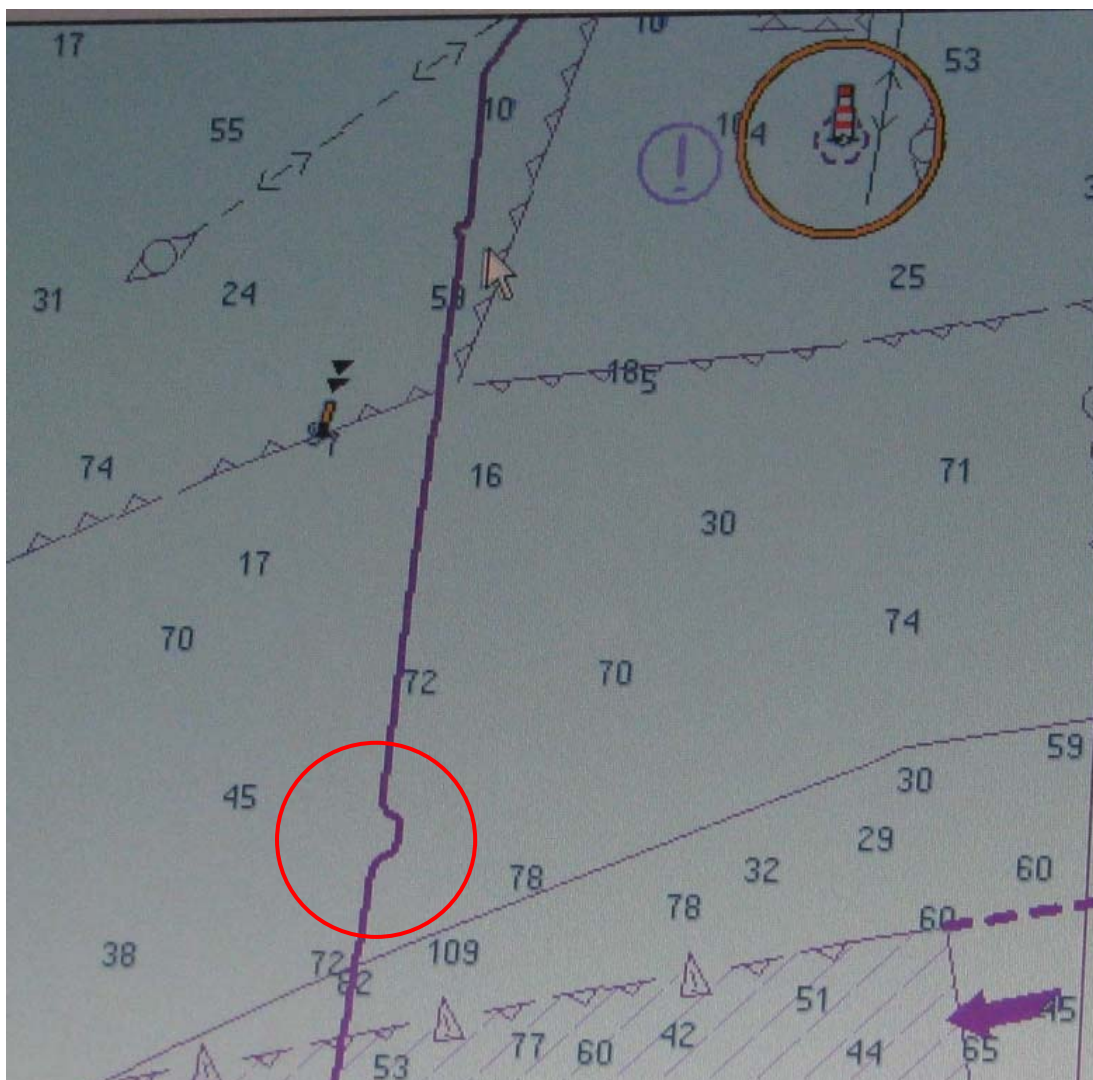
Figure 7. Extract from the electronic chart of LED ZEPPELIN's computer.

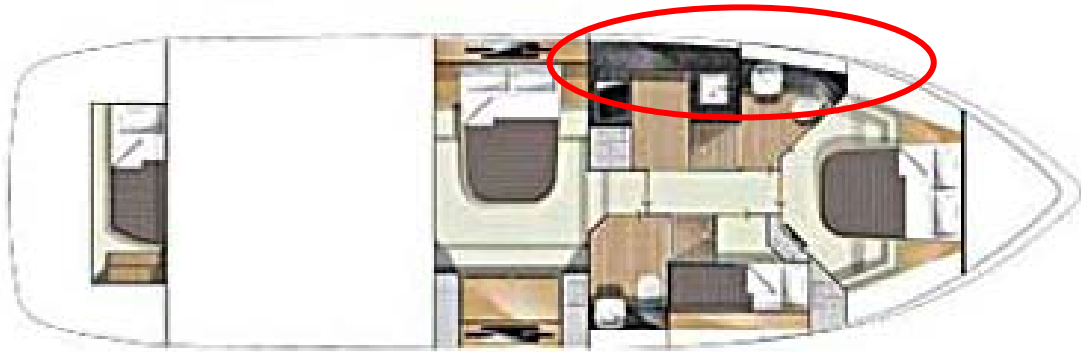
Damages on LED ZEPPELIN's port side do indicate that the angle of crash was not very sharp. The bow was not damaged.

Picture 8. The red ellipse shows roughly the damaged area.
