Preliminary report

D8/2011M

M/S ALWIS (ATG), fall of able seaman in a hoisting cage into the cargo hold in the Port of Pori, Finland on 10 December 2011

Preliminary report. Translation of the original Finnish report.

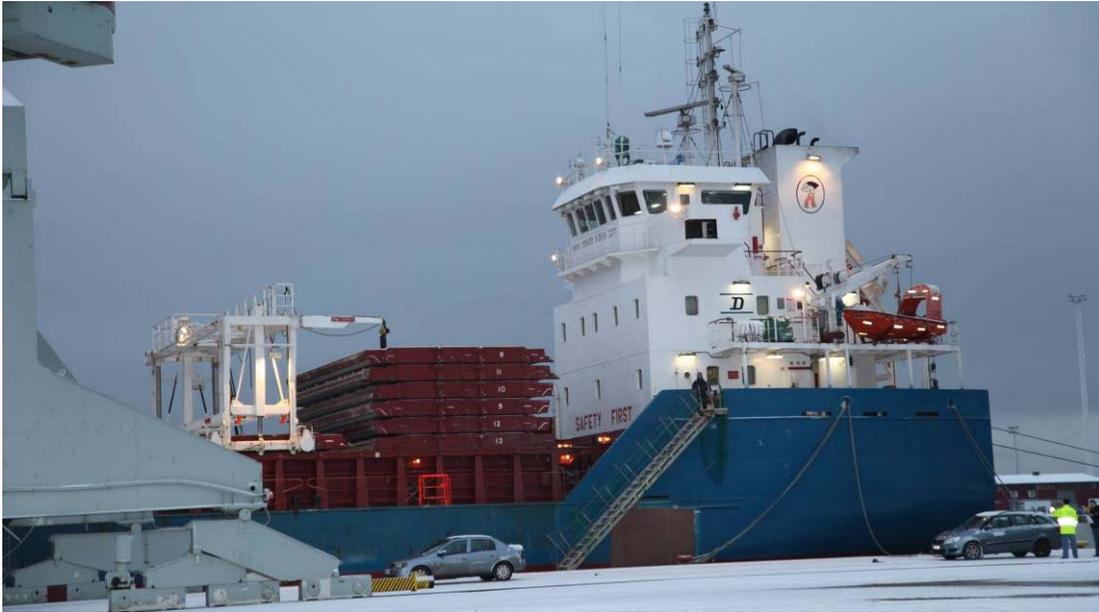
Picture 2. Hatch cover gantry crane in which the quay-side hoisting apparatus can be seen above the hatch-covers. The accident hoisting apparatus is on the SB-side.

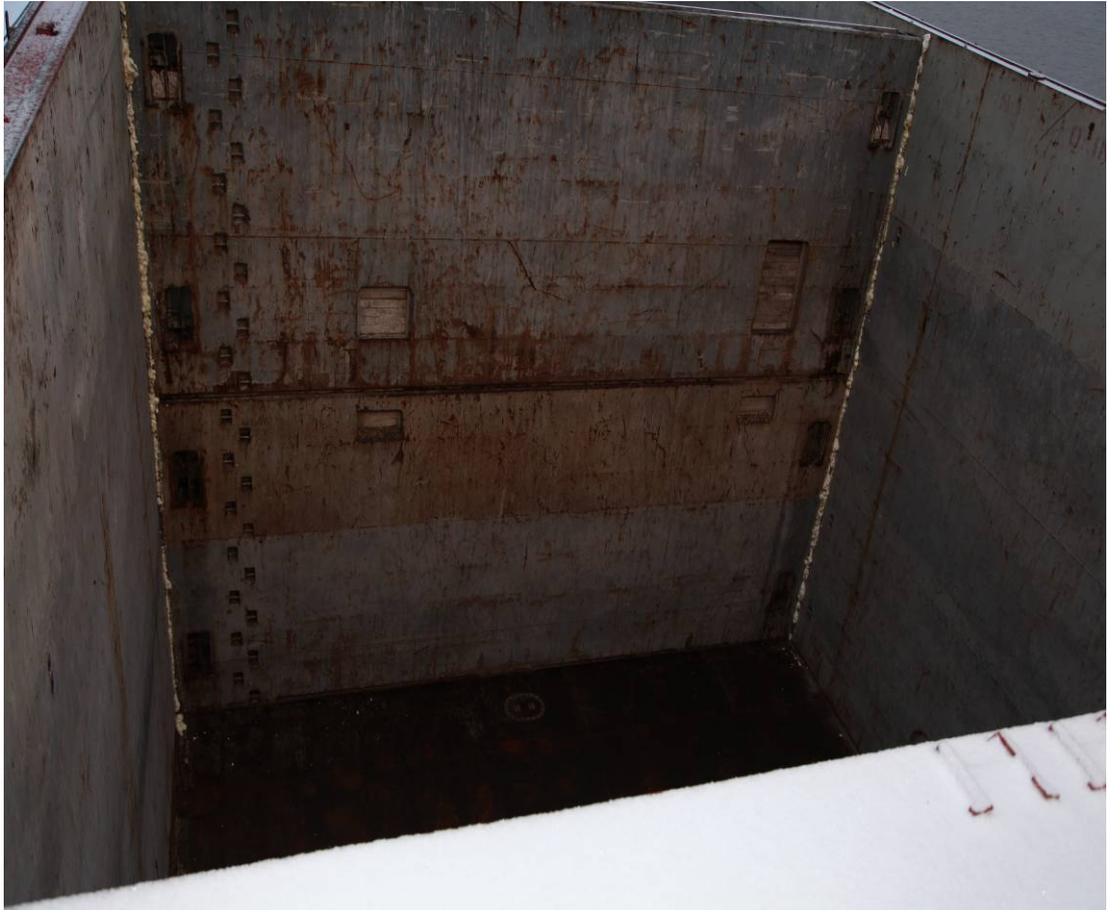
The sealing operation was done from a hoisting cage. The person in the cage both hoists and lowers the cage by him/herself. The AB was in the starboard side cage approximately in 6,5 metres height as the hoisting chain broke and the cage fell down to the bottom of the hold. The AB got severe injuries. After the accident the co-workers alarmed the officers onboard.

Picture 3. The cargo hold, where the AB fell in the hoisting cage.

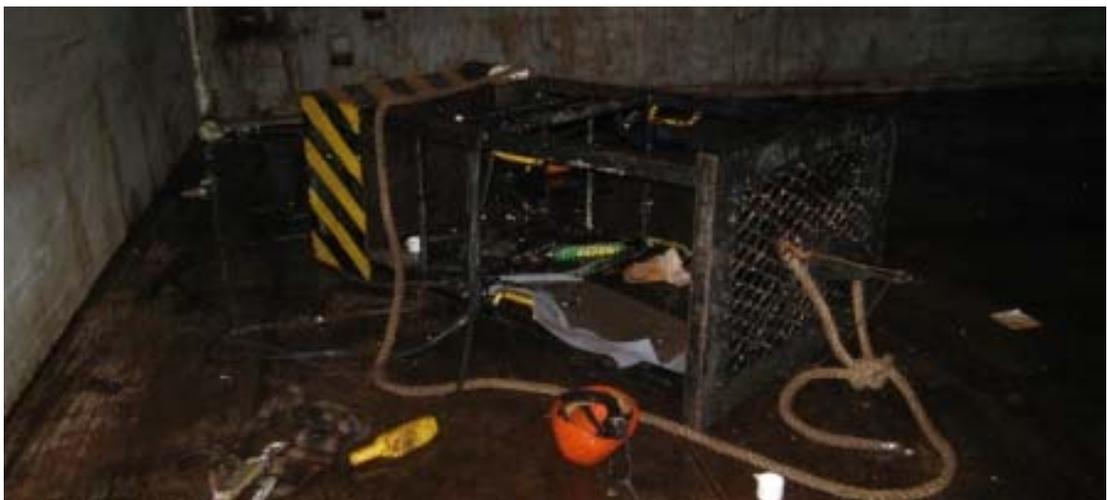
Picture 4. The hoisting cage in the cargo hold.

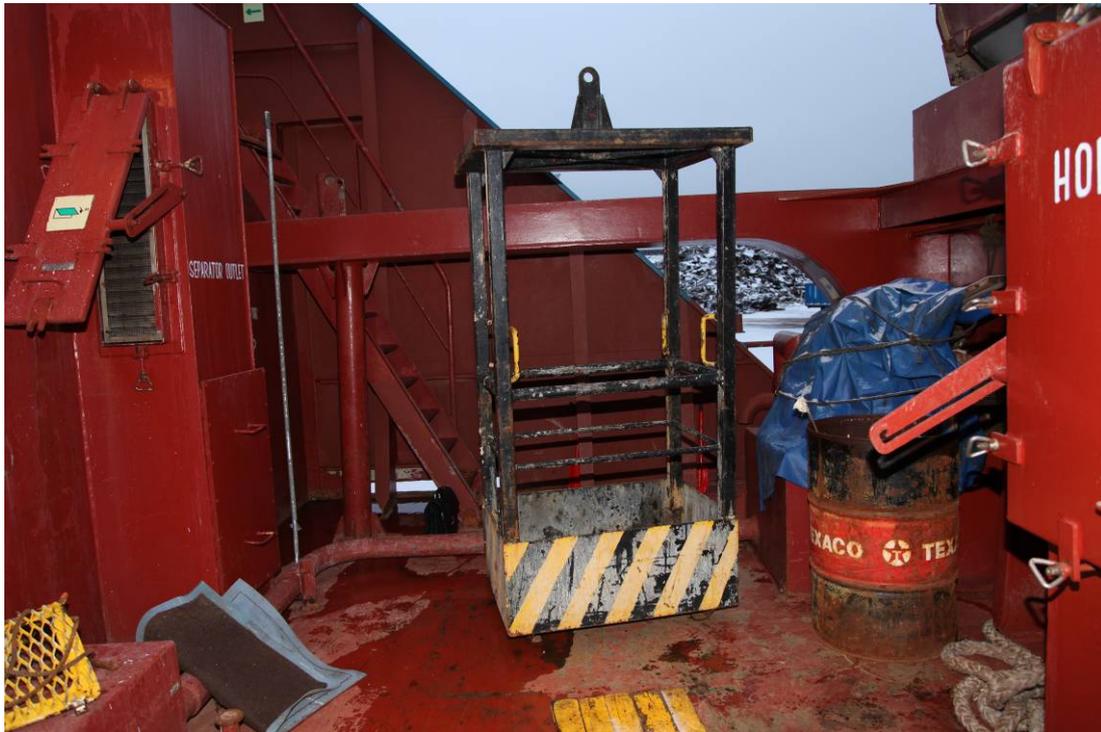
Picture 5. The hoisting cage on the deck.

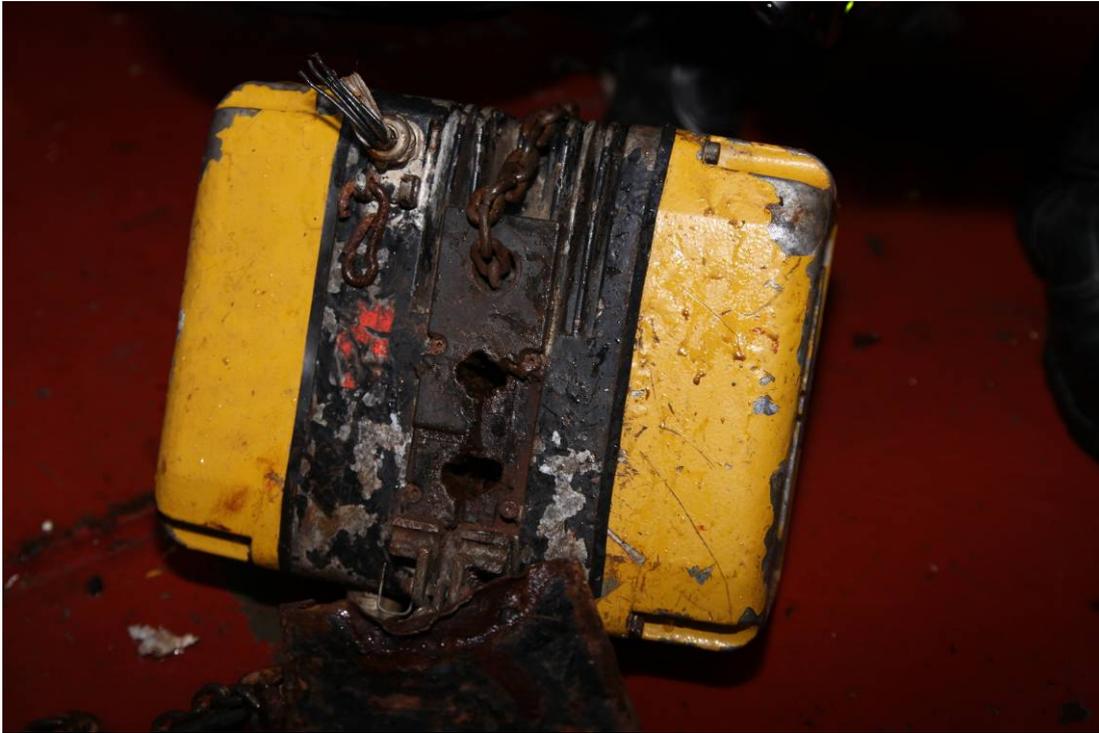
The SIA ordered a thorough inspection for the hoist from the company Tuotetekno Oy, which is the distributor of the GIS Chain hoists in Finland. In the inspection protocol are listed items which did not meet the requirements; *Power supply Loader, Hoisting apparatus, Chains and rollers, Push Button Drive, Greasing; nipples, The Hoist is not in functional condition. The Hoist has not been served according the instructions.*

Picture 8. The bottom of the failed hoist.

When the accident took place, the sealing of the transversal bulkhead in the cargo hold was currently ongoing. The sealing operation was done from a hoisting cage. During the work in different heights there will arise transversal forces to the hoisting chain and to the cranes boom. The hoisting chain could not take these forces and broke off.

According to the inspection by the chain hoist distributor in Finland multiple places in the hoisting device did not meet the requirements. The Hoist had not been served according the instructions and was not in functional condition.
