Investigation Report

M2012-01

M/S BARENTSZDIEP (NLD), collision with the edge mark off Oulu on 10.1.2012

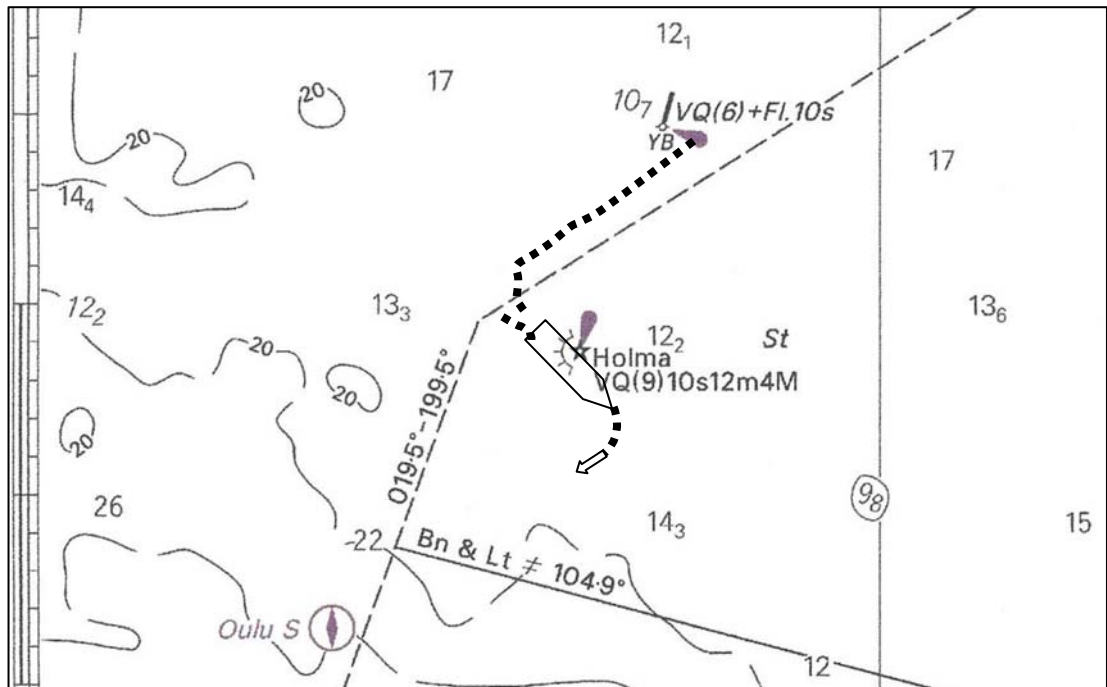
Figure 7. A Figure drawn on the basis of the Master's sketch describing the vessel's movements as she collided with the Holma edge mark.

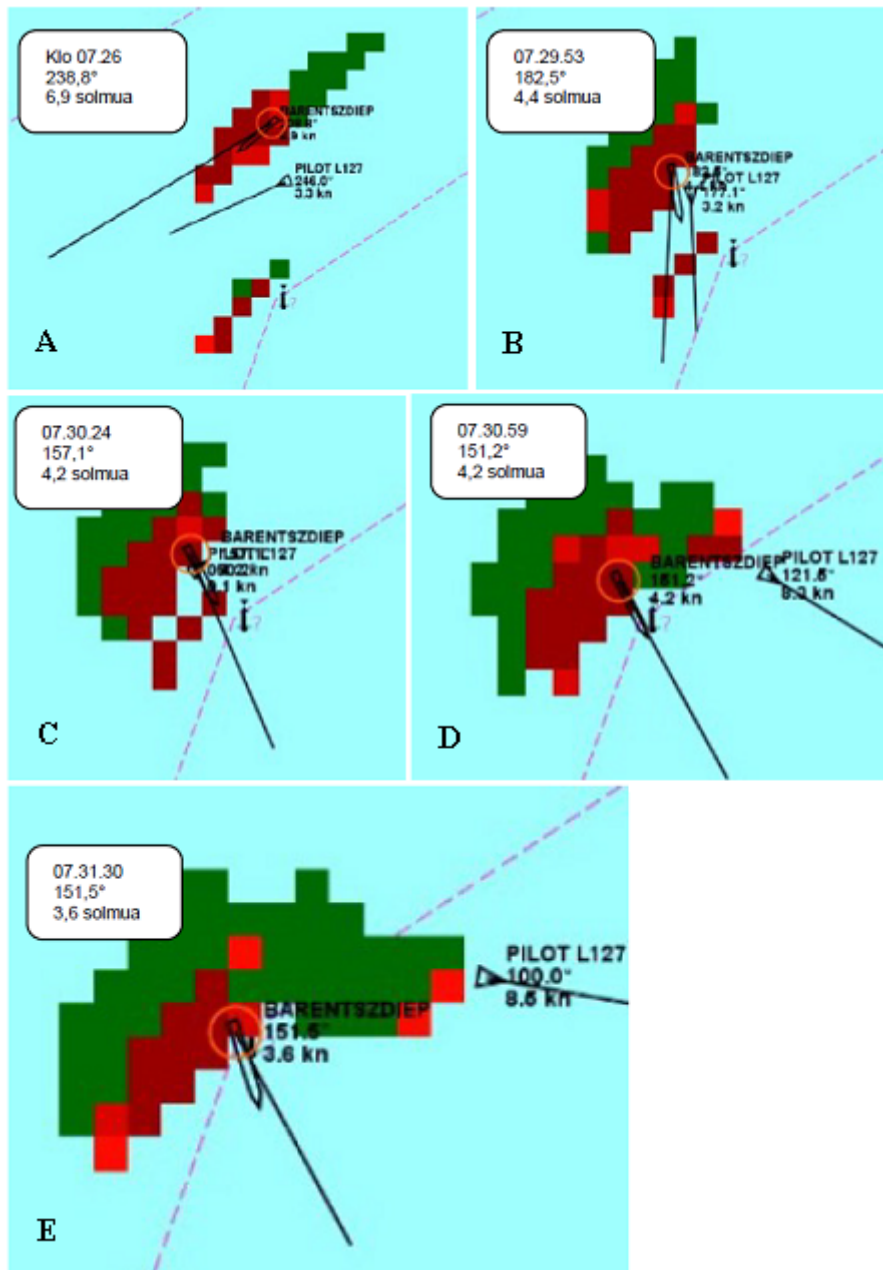
Figure 8. The accident according to the VTS recording (the vessel's radar echo and AIS information). The time, heading and speed are marked in the rectangles.

- A The pilot boat is approaching the vessel.
- B The vessel has turned on course 182.5° and the pilot boat is next to the vessel.
- C The Pilot disembarks the vessel.
- D The Pilot has disembarked the vessel, but the vessel has not yet started to turn to starboard.
- E Collision with the Holma edge mark.

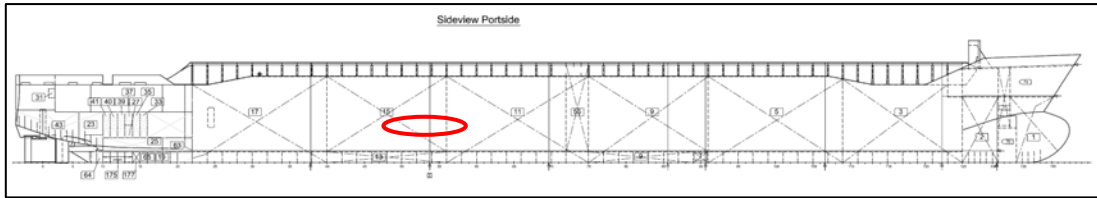
Figure 9. The red ellipse describes the location of the damages on one side of the vessel.

below the waterline. The damages were limited to the port side tank number 5 and the bottom tank number 6, which had leakages. Figure 9 describes the location of the damage on the port side, and a photo of the point of damage taken in connection of the docking can be seen in Figure 10. Vessels have also before suffered from severe damages because of colliding with edge marks equipped with ice cones⁴.

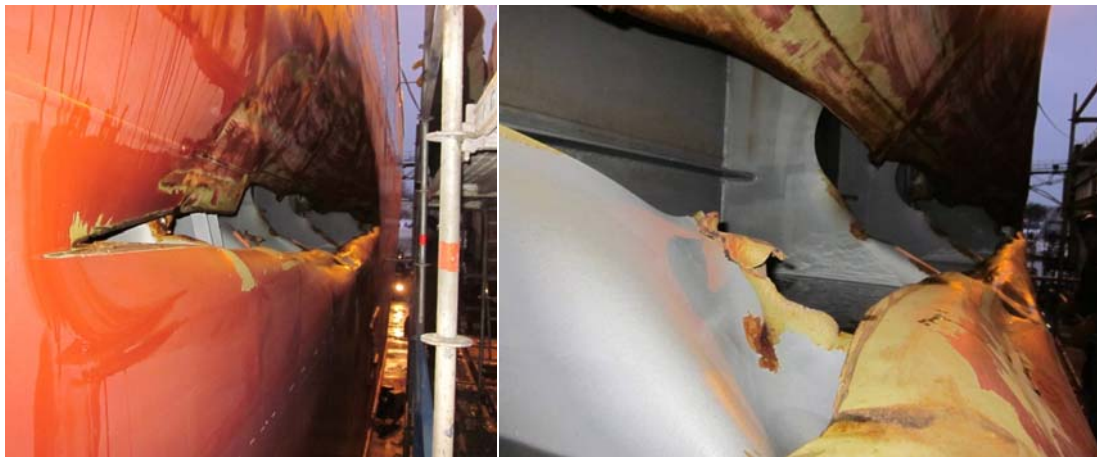
Figure 10. Damages on the port side.

After the collision, the vessel listed immediately 10° to port. The ice cone of the edge mark cut a 5–6 m long, up to 0.8 m deep slash to the side of the BARENTSZDIEP 2.5 m

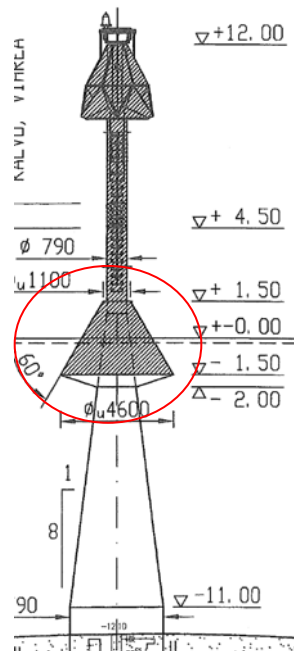
Figure 11. HOLMA edge mark. The vessel collided with the ice cone on the side of it with its side first. The edge mark did not suffer damages in the collision.

The structure of the HOLMA edge mark can be seen in Figure 11 and it is described in further detail in Appendix 2. The edge marked was firmly fastened to the bottom of the sea at the depth of approx. 11 metres and it had been designed to withstand/break moving pack ice with the help of the cone installed at the waterline of the cylindrical trunk. It did not suffer damages as the result of the collision.

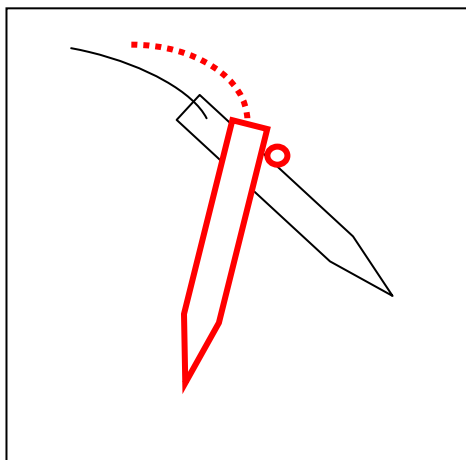
Reducing the rudder angle of automatic steering to 20 degrees in navigation in archipelago reduces operational preparedness in problematic situations if manual steering is not switched on. However, a last-minute swerve of the collision by using manual rudder would have been a demanding manoeuvre because the edge mark was not clearly visible in the dark. In a sharper turn the collision might have lead to more severe damages in case the hit was directed to the engine room. (Figure 12).

Figure 12. A sharper turn (red symbol) might have resulted in the collision with the edge mark being directed to the place where the engine room is situated.

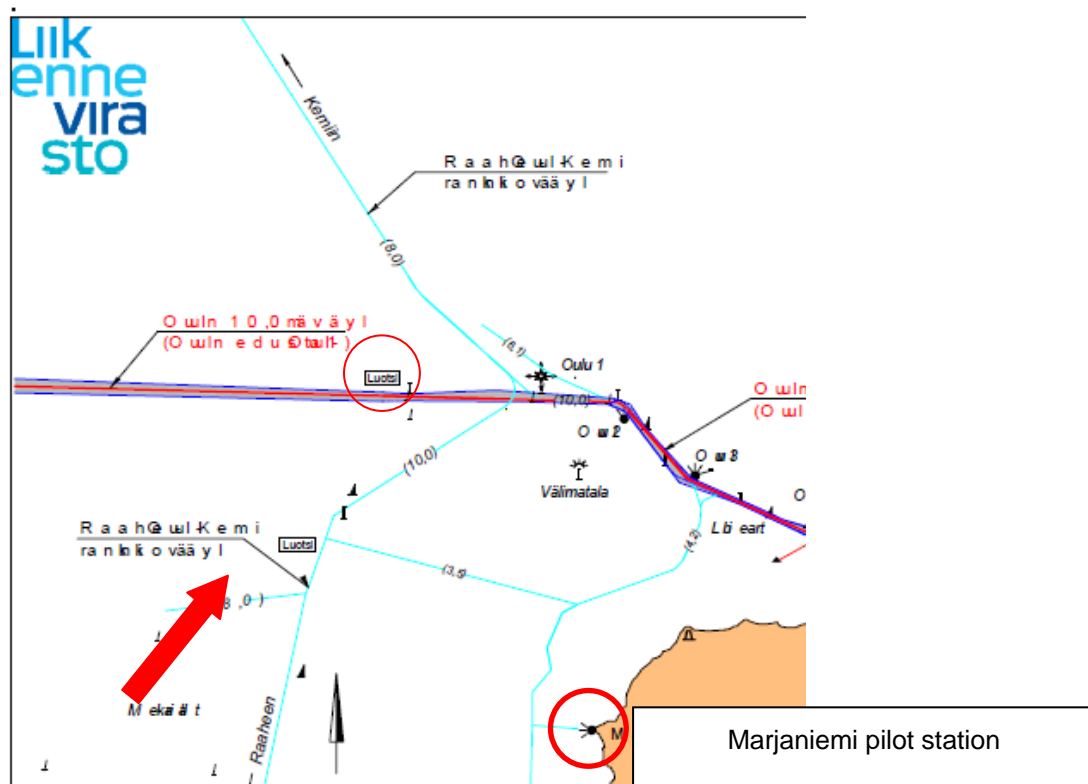
Figure 13. Excerpt from the Oulu track chart. The red arrow indicates the direction of the waves at the time of the accident. At both disembarkation positions, it would have been practical for the Pilot to disembark the vessel from the starboard side as the bow of the vessel pointed towards west. (© The Finnish Transport Agency)

The swell was from south-west, and because of this the vessel had to be turned more to port as the ladders were rigged on the port side. After the Holma edge mark, the collision risk would have been avoided in an area where it would have been possible to realise the changes in the course of the vessel in a safe manner or to turn the vessel to west as the pilot ladder was on the starboard side.
